Article

The Spatial Perspective in Post-Earthquake Evaluation to Improve Mitigation Strategies: Geostatistical Analysis of the Seismic Damage Applied to a Real Case Study

Department of Civil Engineering, Technical University of Cartagena, Campus Alfonso XIII, 30203 Cartagena, Spain

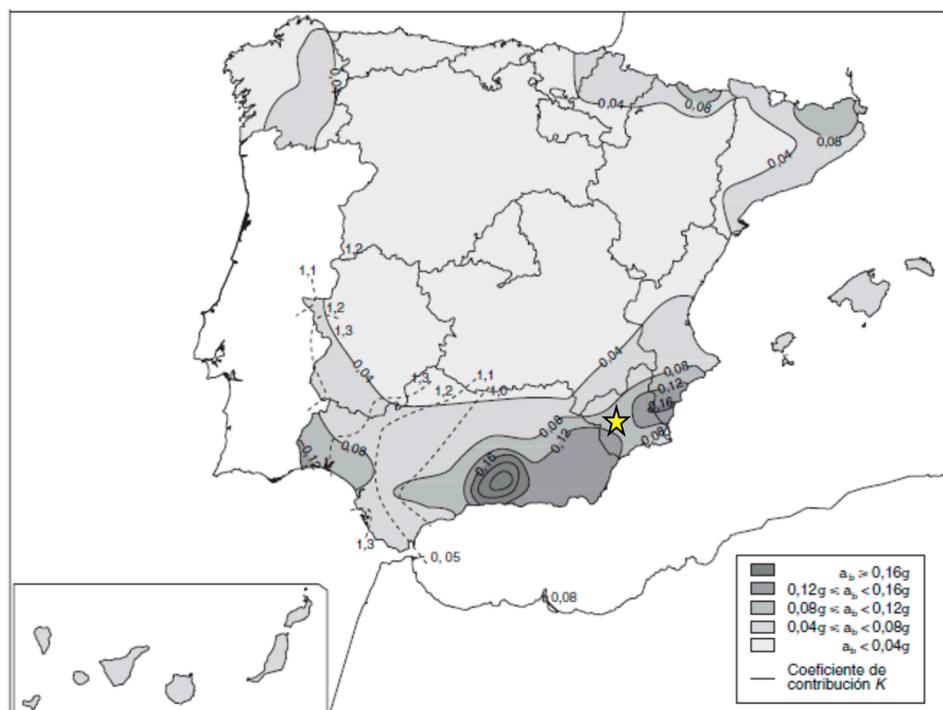
Figure 2. Map of seismic hazard in Spain (source: NCSE-02 [17], city of Lorca marked in yellow).

The southeastern region where Lorca lies is theoretically one of the most active seismic zones in Spain. Nevertheless, the Lorca urban area basic acceleration (parameter defined in the Spanish seismic standard NCSE-02 as the characteristic value of the horizontal ground acceleration, with 10% exceedance probability in 50 years) of 0.12 g in the Spanish standard [17] is not among the most dangerous areas (Figure 2).

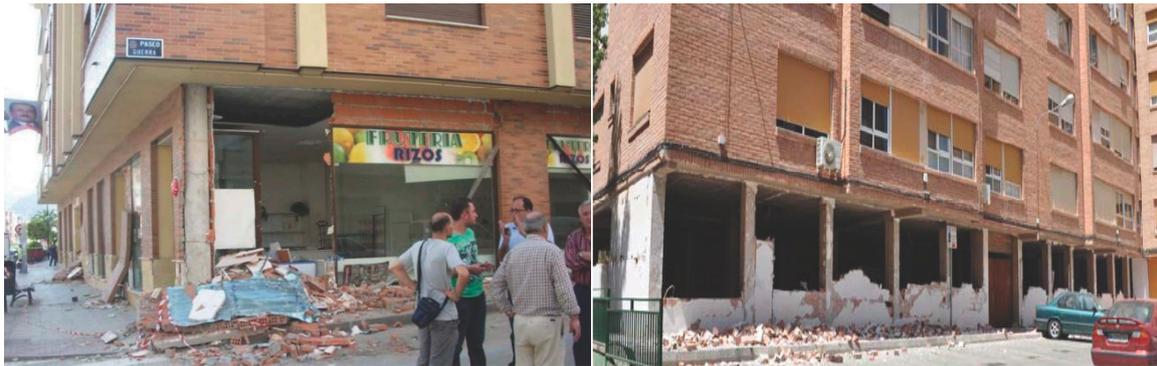
One of the most commonly detected phenomena in the Lorca earthquake was that of the buildings that suffered the so-called “soft story” effect [21]. In these cases, a non-regular distribution of masses could be found between the lower ground floor, which was of greater height and less compartmentalized than the rest of the floors due to the commercial use of the first one. This generates an affect at a structural level in buildings of medium height, where in the example of a 5-story building, the first to fourth floors behave as a rigid object that hardly suffers damage, while the damage is concentrated in the lower ground floor of the building (Figure 3).

Figure 3. Examples of the soft story phenomena that occurred in Lorca in 2011 after the quake.

The phenomenon of soft story, despite the spectacular nature of its damage with the explosion of the enclosures of the ground floors of buildings, has been shown to be far less catastrophic than the previous two (this phenomenon was essentially associated with green and yellow codes). It is a much more generalized phenomenon, in which the repair cost was much lower, since the structures did not collapse or the buildings were subsequently demolished. Therefore, it is not considered essential to modify its current conditioning elements due to the social and economic impact that this would have (local regulations require the commercial premises of buildings to have a height of at least 3.5 m). However, it is considered strategic to restrict excessive configurations that deepen this problem in new buildings (e.g., by limiting the maximum height to 4 m in these cases). This is consistent with the results obtained in seismic phenomena in other cities [33,34], but an analysis of these characteristics for a mid-level intensity earthquake has yet to be documented in the current scientific bibliography.

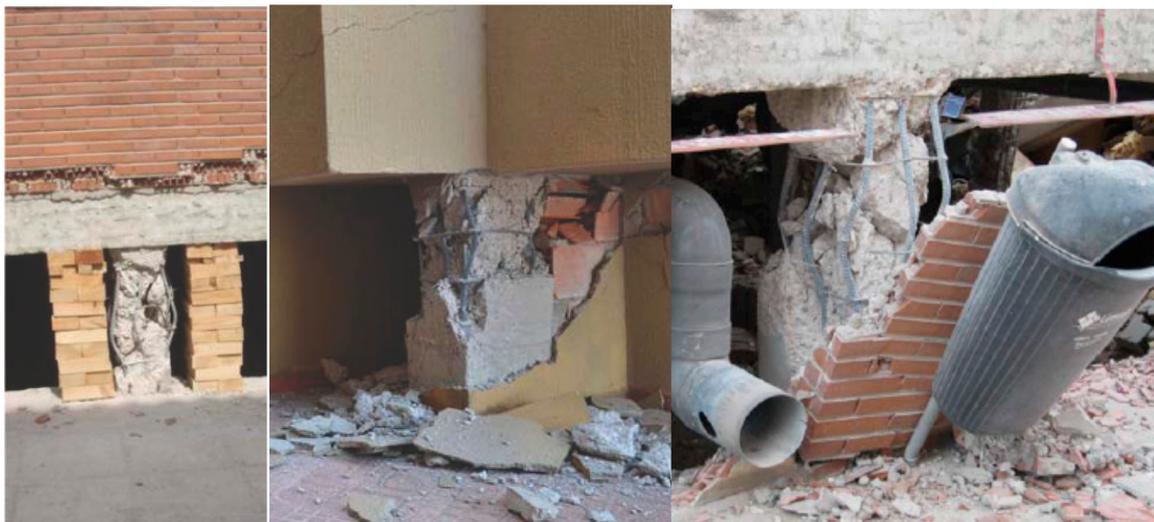
Another of the structural phenomena that were particularly relevant at the scientific level in the Lorca earthquake was the case of so-called “short columns”. This structural configuration produced important damage, and according to the opinion of several authors, led to the immediate or later forced collapse or demolition of several buildings (Figure 4).

Figure 4. Effect of short columns in different buildings of the city of Lorca after the quake.

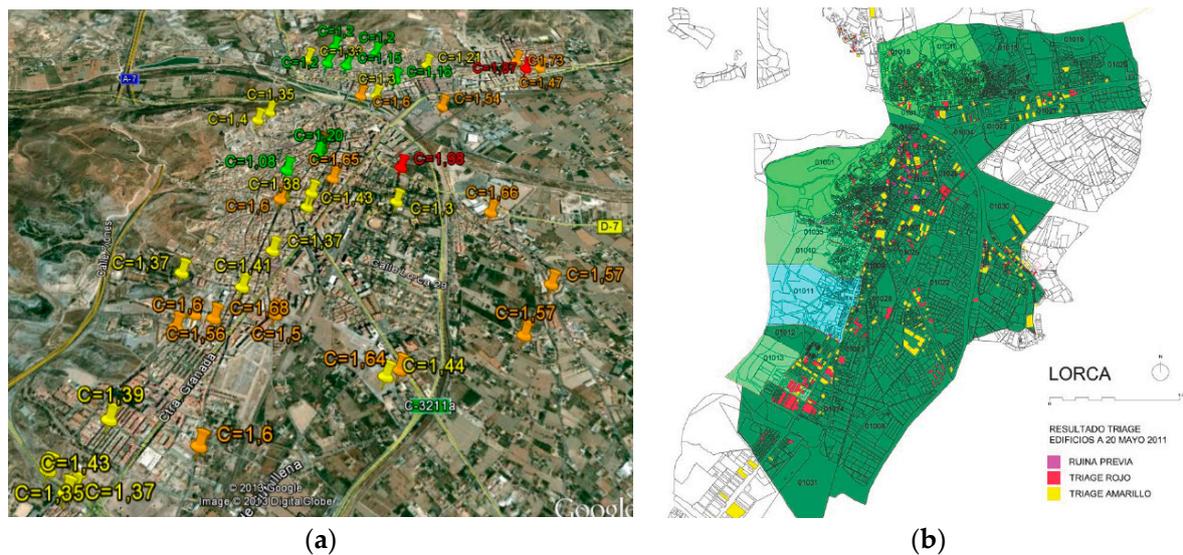
Figure 5. (a) Discretized model of the values of the amplification coefficient C, and (b) spatial model of the classification coefficient of the land superimposed with different levels of damage to buildings (data taken from previous work [22]).

A similar behavior can be observed with the GIS indicator *I_{SAC}* (“existence of soils with high amplification capacity of seismic waves”), where the neighborhoods located in areas with high amplification capacity presented greater damage intensity than the neighborhoods with less capacity, describing a clear Low–Low (LL) /High–High (HH) phenomenon with few outliers. For *I_{SS}*, we found inverse behavior. There is a strong geostatistical correlation at a general level between both indicators, but a high level of the existence indicator of the soft story phenomenon is generally associated with green or yellow codes (High–Low (HL)), while in those buildings with red or black codes this phenomenon is hardly referenced (Low–High (LH), both analyzed as outliers by the hot-spot analysis).

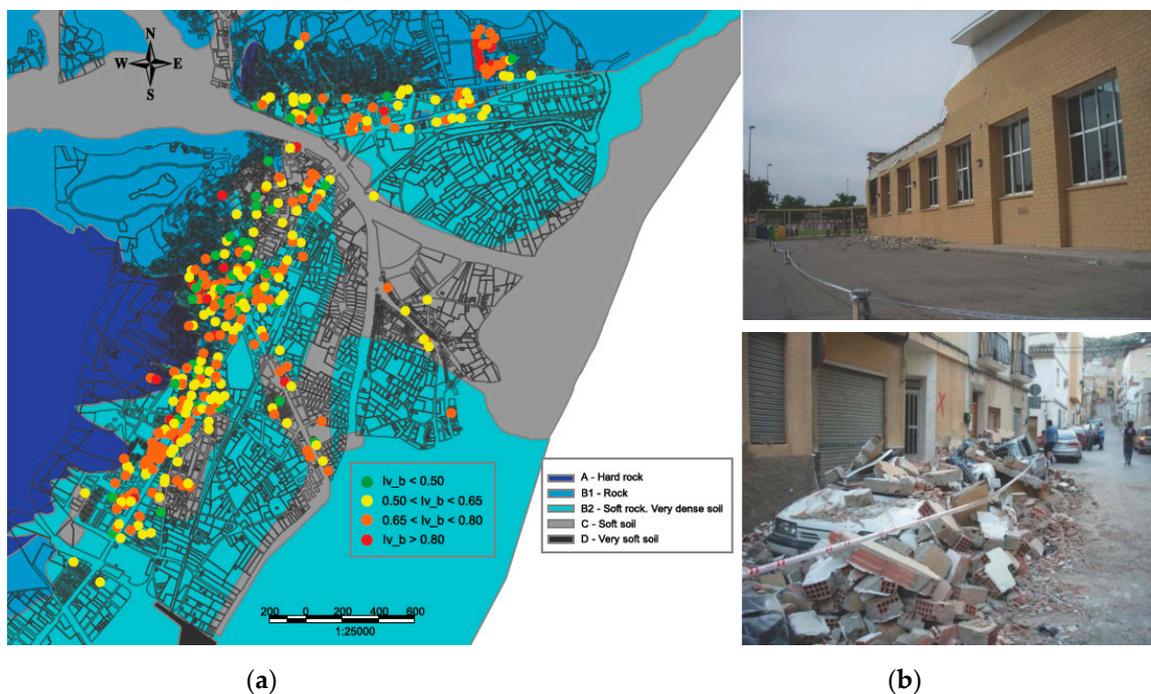
Figure 7. (a) Spatial distribution of vulnerability index I_{v-b} according to the criteria in previous work [9]. (b) Example of the effects of inadequate seismic design in the architectural configuration of buildings linked to long unbraced parapets on the roofs (data taken from previous work [12]).

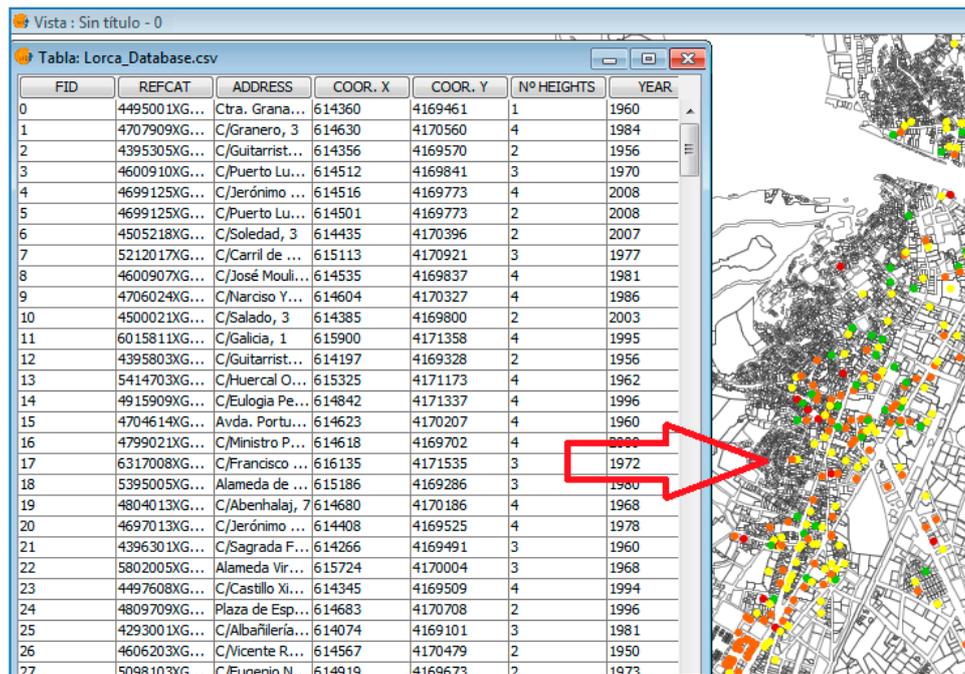
Figure 8. GIS cadastral database of buildings of Lorca considering different levels of damage.

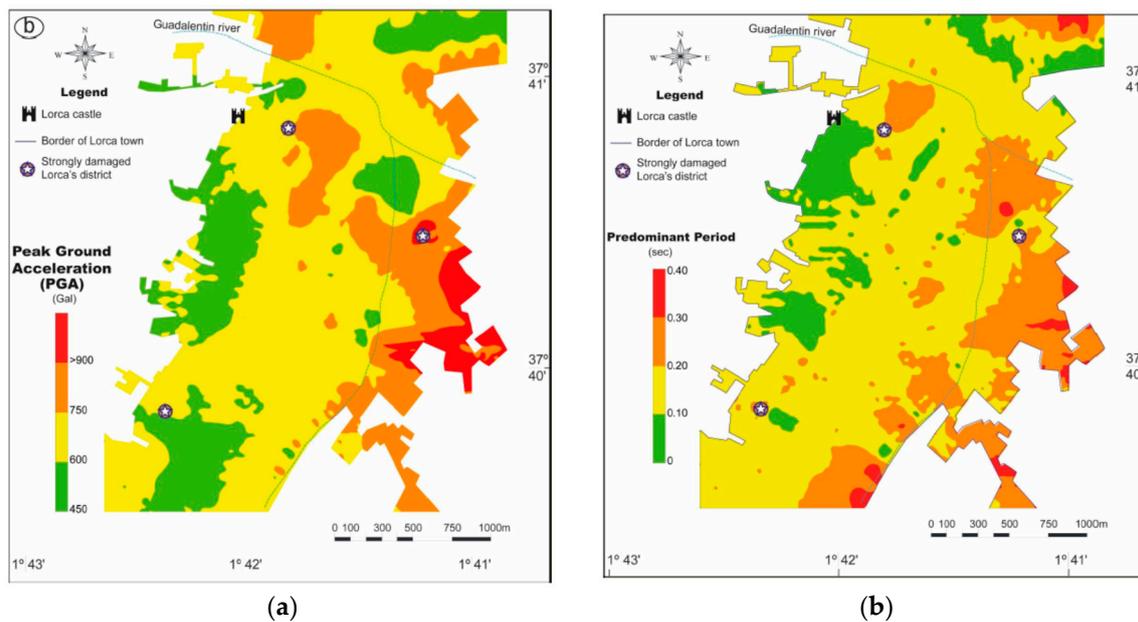
Figure 9. Spatial distribution of (a) PGA and (b) PP during the Lorca earthquake (data taken from previous work [28]).

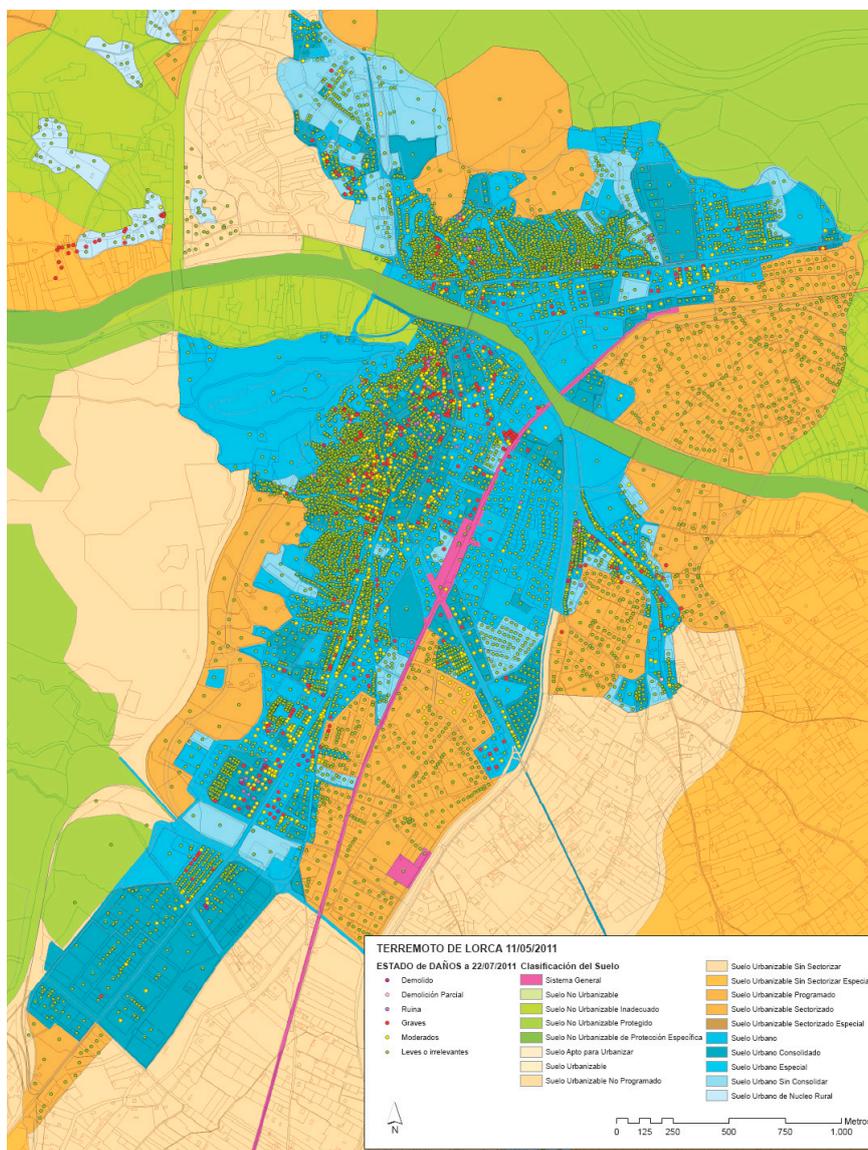
Figure 11. Spatial distribution of the final situation of buildings used to elaborate the database.

This database, containing all of the collapsed, demolished, or damaged buildings and created from reports performed by volunteers or specialized technicians (such as that in Figure 10), has been homogenized and spatially geolocated by the authors (maintaining the anonymity of the owners in all cases, with the database being referenced only by the numerical codes of the cadaster). To implement the geostatistical analysis, four levels of damage were established (green, yellow, orange, and red) to describe situations without or with irrelevant damage, with minor non-structural damage (fundamentally damaged facades, interior partitions or elements not belonging to the set columns-beams-slabs), reparable structural damage, and irreversible structural damage, respectively (the criterion established to determine if a building was in a situation of reparable or irreparable damage was the legal one adopted by the administration in the reports, through which a building is declared ruined if it is in a state of imminent structural collapse or if the cost of its repair exceeds the cost of construction thereof by 50%). Minor non-structural damage fundamentally referred to damaged facades, interior partitions, or elements not belonging to the set columns-beams-slabs. In some cases, a black level was also included for very serious cases in which there had been fatalities. This enabled us to create an Index of Level of Damage in Building (I_{LDB}) based on the cloud point distribution of these discrete geolocated values structured into four levels (value 0 assigned to green code and 3 assigned to the red one). The detailed technical criteria used to identify each of the categories in the reports are those found in previous work [12] and the spatial distribution of the final situation of the 1062 buildings analyzed for the implementation of the database can be observed in Figure 11.

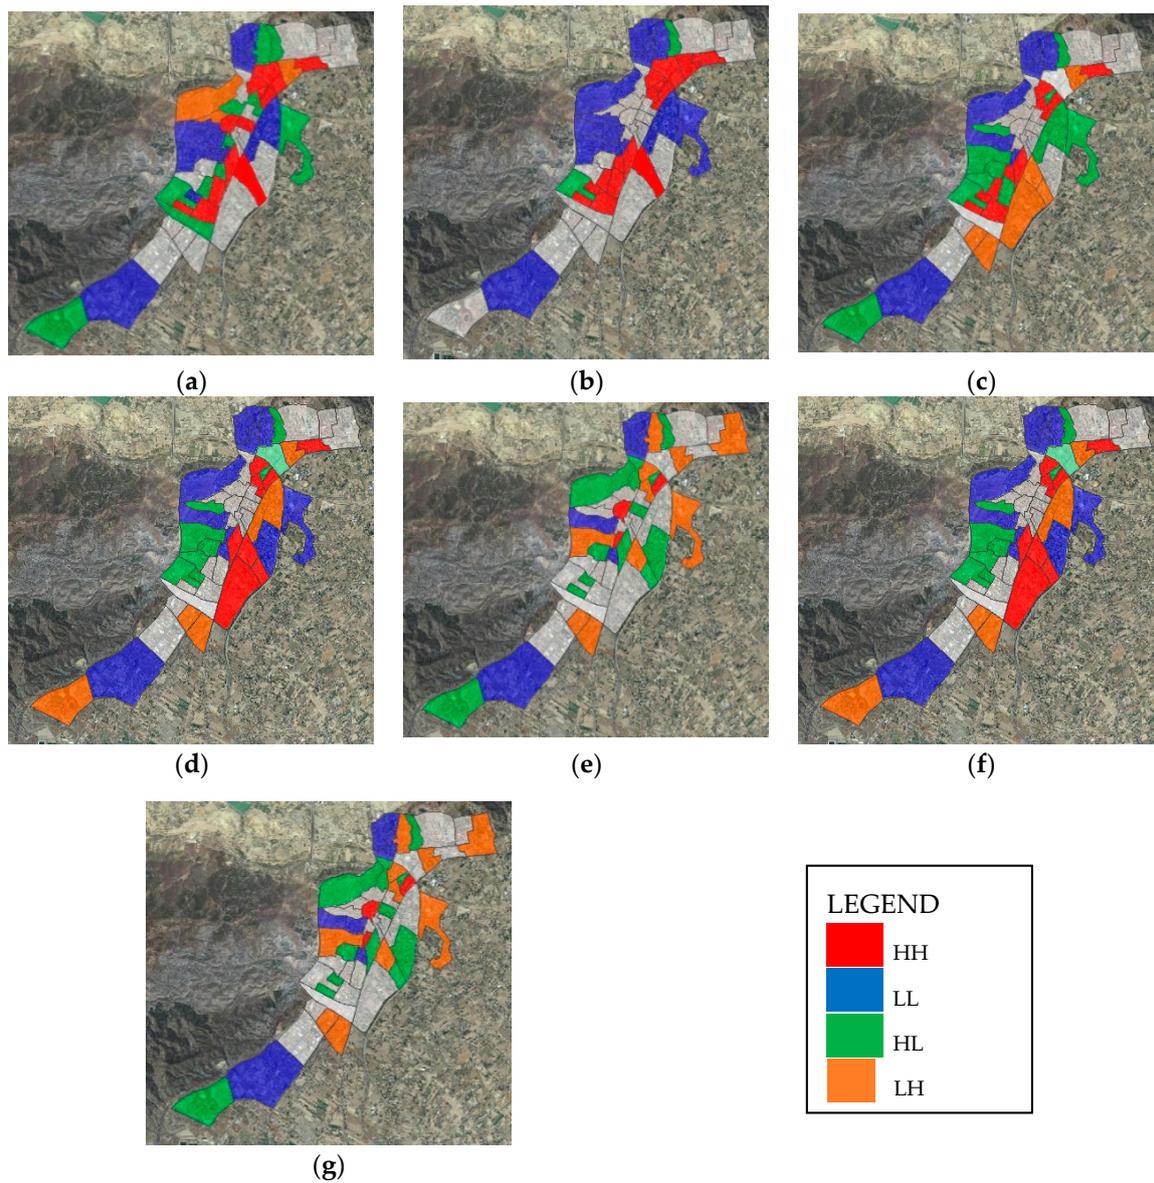
Figure 12. Hot spot spatial analysis for LISA bivariate results for (a) $I_{SS} - I_{LDB}$, (b) $I_{SC} - I_{LDB}$, (c) $I_{SAC} - I_{LDB}$, (d) $I_{IUC} - I_{LDB}$, (e) $I_{IARSD} - I_{LDB}$, (f) $I_{BA} - I_{LDB}$, and (g) $I_{SF} - I_{LDB}$.

The two-dimensional numerical analysis of Low–High geostatistical results in Figure 12 is also quite revealing. To begin with, the results obtained previously at the numerical level are confirmed at a spatial level (for example, there are no specific differences in damage between the historical center and the new areas of the city). On the other hand, we can observe that there are phenomena showing an important correlation with the existence of damage in buildings, but whose level of correlation varies greatly with the intensity of the damage. This is the case of the phenomena modeled through the indicators *I_{SC}* (“buildings with short columns”) and *I_{SS}* (“buildings with soft stories”). In the first case, there is a clear statistical correlation at a spatial level, with high levels of damage to buildings (red codes) with an important presence of short pillars (High–High and Low–Low correlation), and the absence of high damage in a large part of the buildings that do not have problems related to this phenomenon.

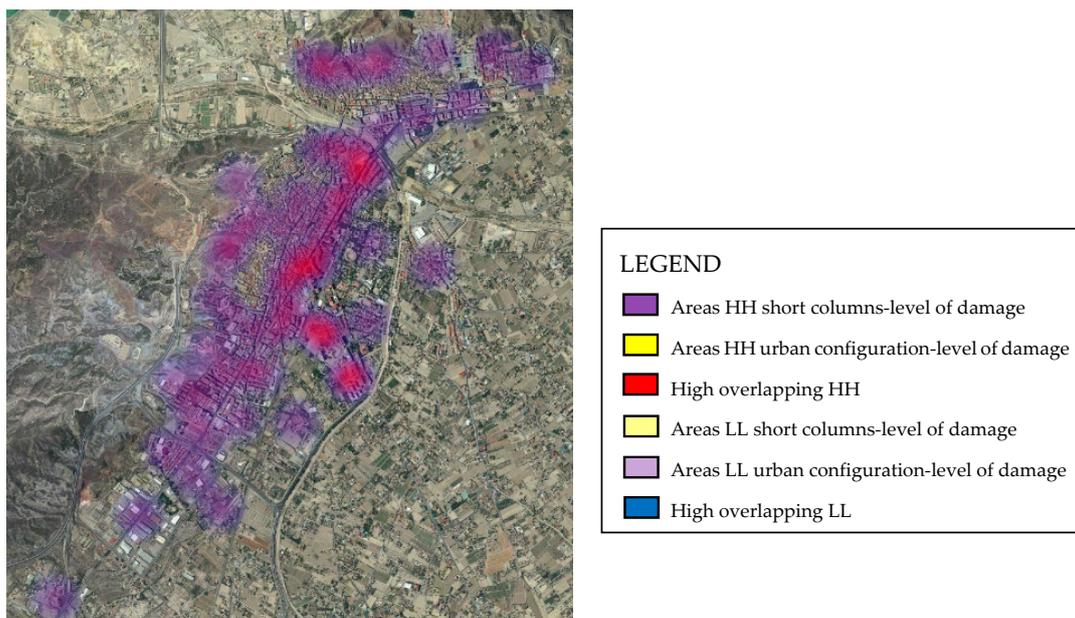
A triangular simulation of the levels of overlap in the geostatistical correlations HH and LL of the pairs “short columns–damage level” and “urban configurations–damage level” is graphed in Figure 13. In this figure, we can see the intensity level for the two pairs of bivariate geostatistical correlation. As can be observed, we can appreciate areas with HH geostatistical correlation for “short columns–damage level” (in purple) in different parts of the city, but no specific HH areas for “urban configurations–damage level” (in yellow). This is because these areas always overlap with the previous ones (in red), given that all the cases of inadequate urban configuration that generated a high level of damage were always linked to the appearance of short columns in buildings as a result of these urban configurations.

Figure 13. Triangular simulation (Kernel rounded) of the overlapping levels in the geostatistical correlations High-High (HH) and Low-Low (LL) of the pairs I_{SC} (“short columns–damage level”) and I_{UC} (“urban configurations–damage level”).
