## Article

# Application of Thermal Image Data to Detect Rebar Corrosion in Concrete Structures

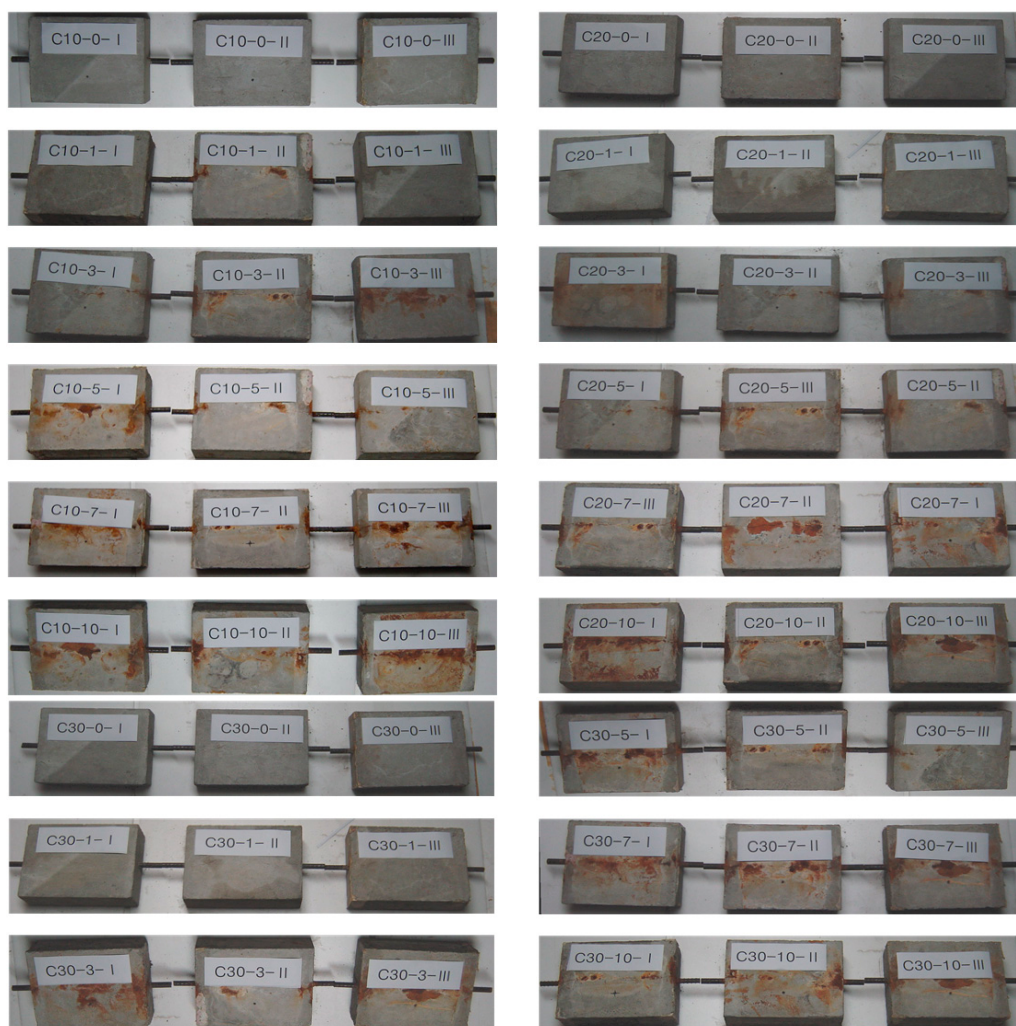
**Figure 3.** Specimen photographs.

The specimens are shown in Figure 3. To examine the impact of the cover thickness, the experiment variables were set at cover thicknesses of 10, 20, and 30 mm and rebar corrosion ratios of 0%, 1%, 3%, 5%, 7%, and 10%. The corrosion ratio determined in this study was calculated the corrosion rate, which would be able to occur when the concrete is generally exposed to the outside. Moreover, the corrosion ratio 0% was added to the experiment under the assumption that corrosion would not

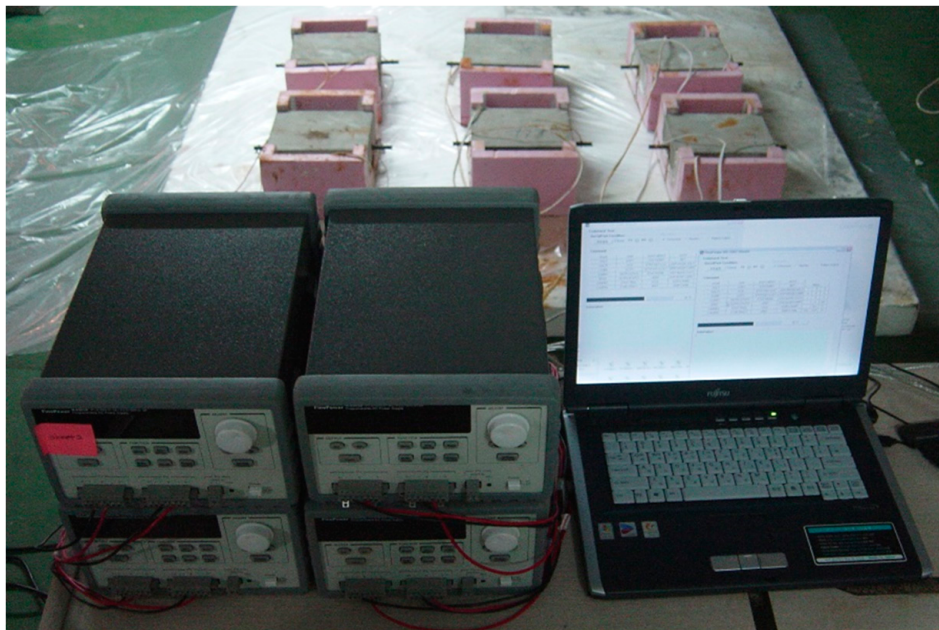
**Figure 6.** Induced rebar corrosion using the rebar corrosion automation system.

The corrosion automation system that was built during this study automatically stops the corrosion process after it reaches the desired extent (see Figure 6). Therefore, it can be used to induce corrosion more accurately and easily than the existing corrosion inducing methods.

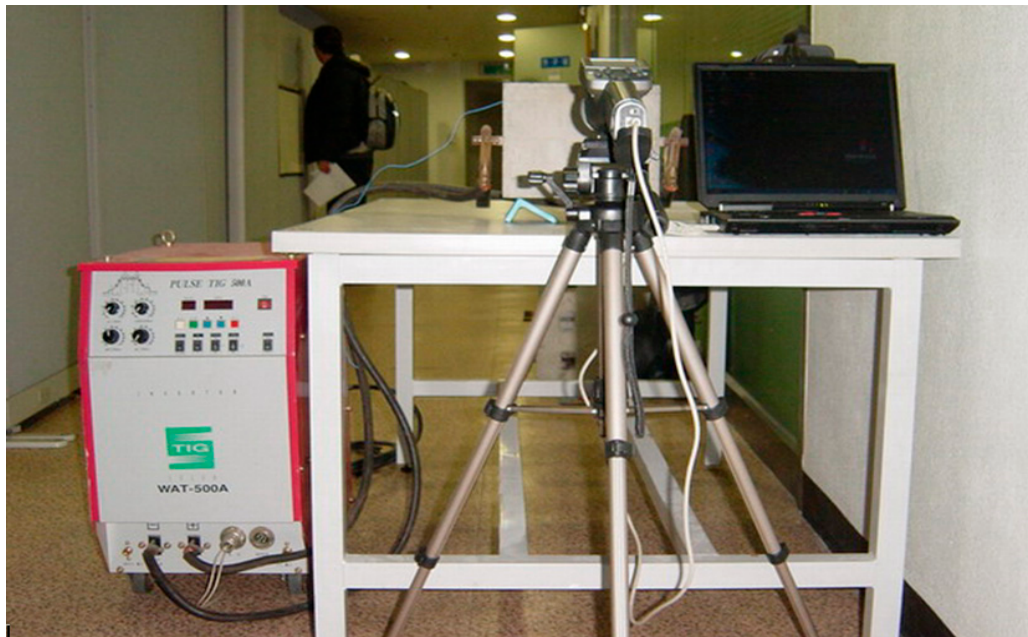
Figure 8. Infrared imaging system.

As shown in Figure 8, an inverter welder was used at both ends of the target structure's rebar, and current was applied. While maintaining a 40 cm distance from the concrete surface, a chamber was used to shoot infrared images. Thus, the infrared imaging system was built. Next, the electric heater was used to apply 150 A of current to the 10 mm cover specimen, 200 A to the 20 mm cover specimen, and 250 A to the 30 mm cover specimen. The rebar of each specimen was heated for 300 s while the thermography data were collected. Even after the current was cut off 300 s after the heating began, the specimens were left at a high temperature for 180 s, and the system continued to collect thermography data. At this time, the infrared camera was used at 30 s intervals to capture the thermographic data. The system was able to obtain 16 thermographic data values for each specimen.
