Vibration Analysis of a Roller Bearing Condition Used in a Tangential Threshing Drum of a Combine Harvester for the Smooth and Continuous Performance of Agricultural Crop Harvesting

Shankar Bhandari * and Eglė Jotautienė

Department of Agricultural Engineering and Safety, Agriculture Academy, Vytautas Magnus University, LT-53362 Akademija, Lithuania

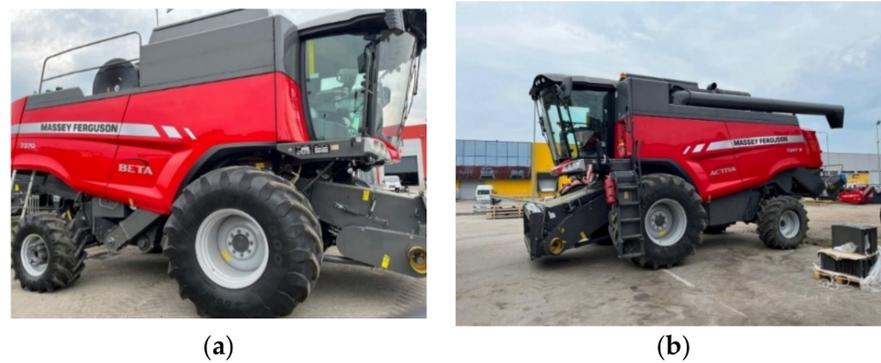
Figure 1. (a) Massey Ferguson 7370 Beta; and (b) Massey Ferguson 7347 s Activa.

The Massey Ferguson 7374 s ACTIVA with 1300 engine hours (EH) and the new Massey Ferguson 7370 Beta were investigated for vibration analysis as shown in Figure 1.

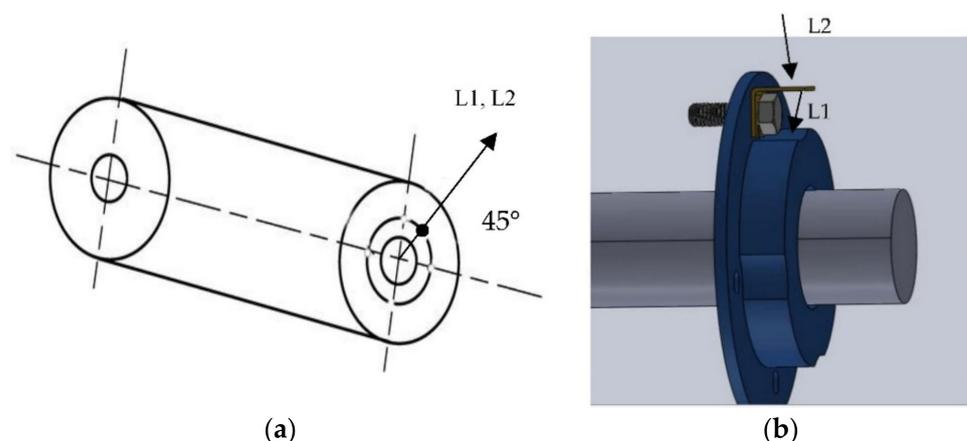
Figure 2. Sensor mounting position: L1 when the accelerometer is placed directly on a bearing seat; and L2 when the accelerometer is placed on a manufactured bracket: (a) The angle of the accelerometer mounted, and (b) The position of the accelerometer mounted.

The measurement was taken at 45° with the horizontal radial axis of the threshing shaft. The measurement was taken in the bracket and the housing on the new Beta version, but only in housing for the Activa version of Massey Ferguson as the bracket mounting was not viable for the Activa version due to the compact housing design. The variable working measuring speed was the same for both combine harvesters. The measuring speeds were 900, 1100, 1800, and 2500 engine RPMs, corresponding to 220, 290, 410, and 470 threshing drum RPMs, respectively. These engine speeds, which are the real operating speeds used during the harvesting period on the farm from low- to high-speed range, were obtained from the operators themselves, whilst the corresponding speeds at a threshing unit were obtained from the inbuilt sensor mounted in the Massey Ferguson combine harvesters. The major parameters of the threshing unit are shown in Table 2. The measuring position of the accelerometer on the bearing housing is shown in Figure 2.

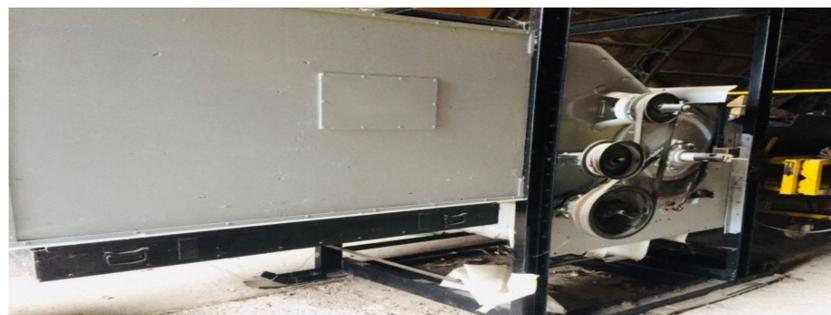
**Figure 3.** Tangential threshing unit bearing test bench.

To validate the measuring positions, using the vibration method and FASIT tool technology, all the processes were again verified on the threshing stand test bench. The tangential threshing drum bearings test bench was constructed and investigated for vibration analysis, as shown in Figure 3. The threshing unit was procured from a NIVA SK-5 combine harvester and modified. The main units of the tangential threshing units consist of the bearing, bushing, top cover, shaft, disks, rasp bar, and bottom cover, as shown in Figure 4.

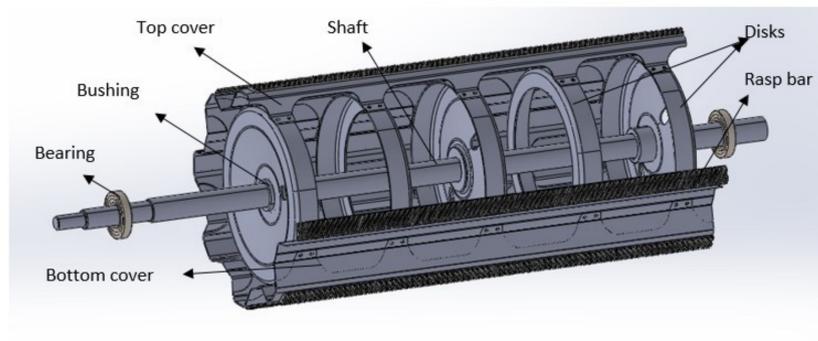
Figure 4. Computer-aided design of the main units of the tangential threshing units of the test bench.

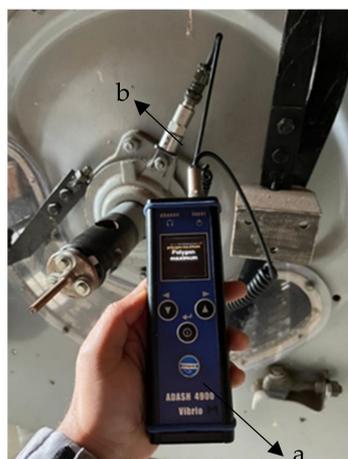
Figure 5. a. Adash A4900 Vibrio M device; and b. AC150 piezoelectric sensor.

The threshing cylinder rotation frequency was changed by a voltage frequency converter DeltaVFD-C2000 SERIES and a cylinder gear variator. The test bench was driven by a 30 kW electric motor. The measurement was taken at 45° with the horizontal radial axis of the threshing. The vibration measuring device Adash A4900 Vibrio M device with an AC150 piezoelectric sensor was used, as shown in Figure 5.

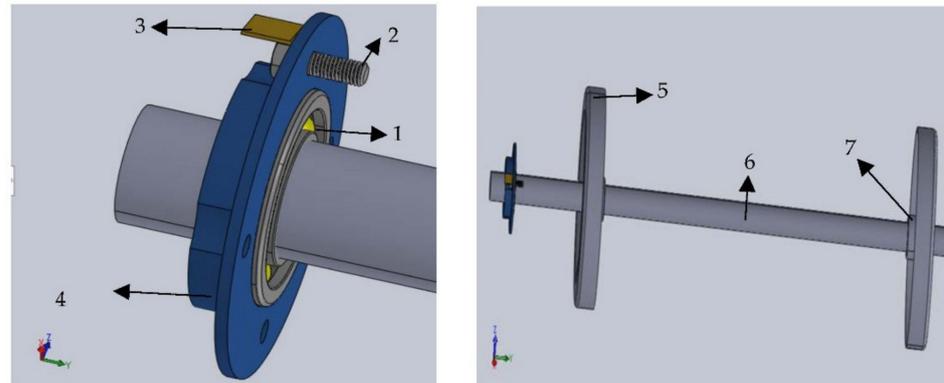
Figure 6. CAD modal of components: 1. Bearing, 2. Bolt, 3. Bracket, 4. Housing, 5. Threshing disk, 6. Threshing shaft, 7. Hub.

The 3D CAD modal of components (bearing, bracket, housing, bolt, hub, threshing shaft, and threshing disk), as shown in Figure 6, are designed in the solid works software and exported to the Ansys software for modal analysis.

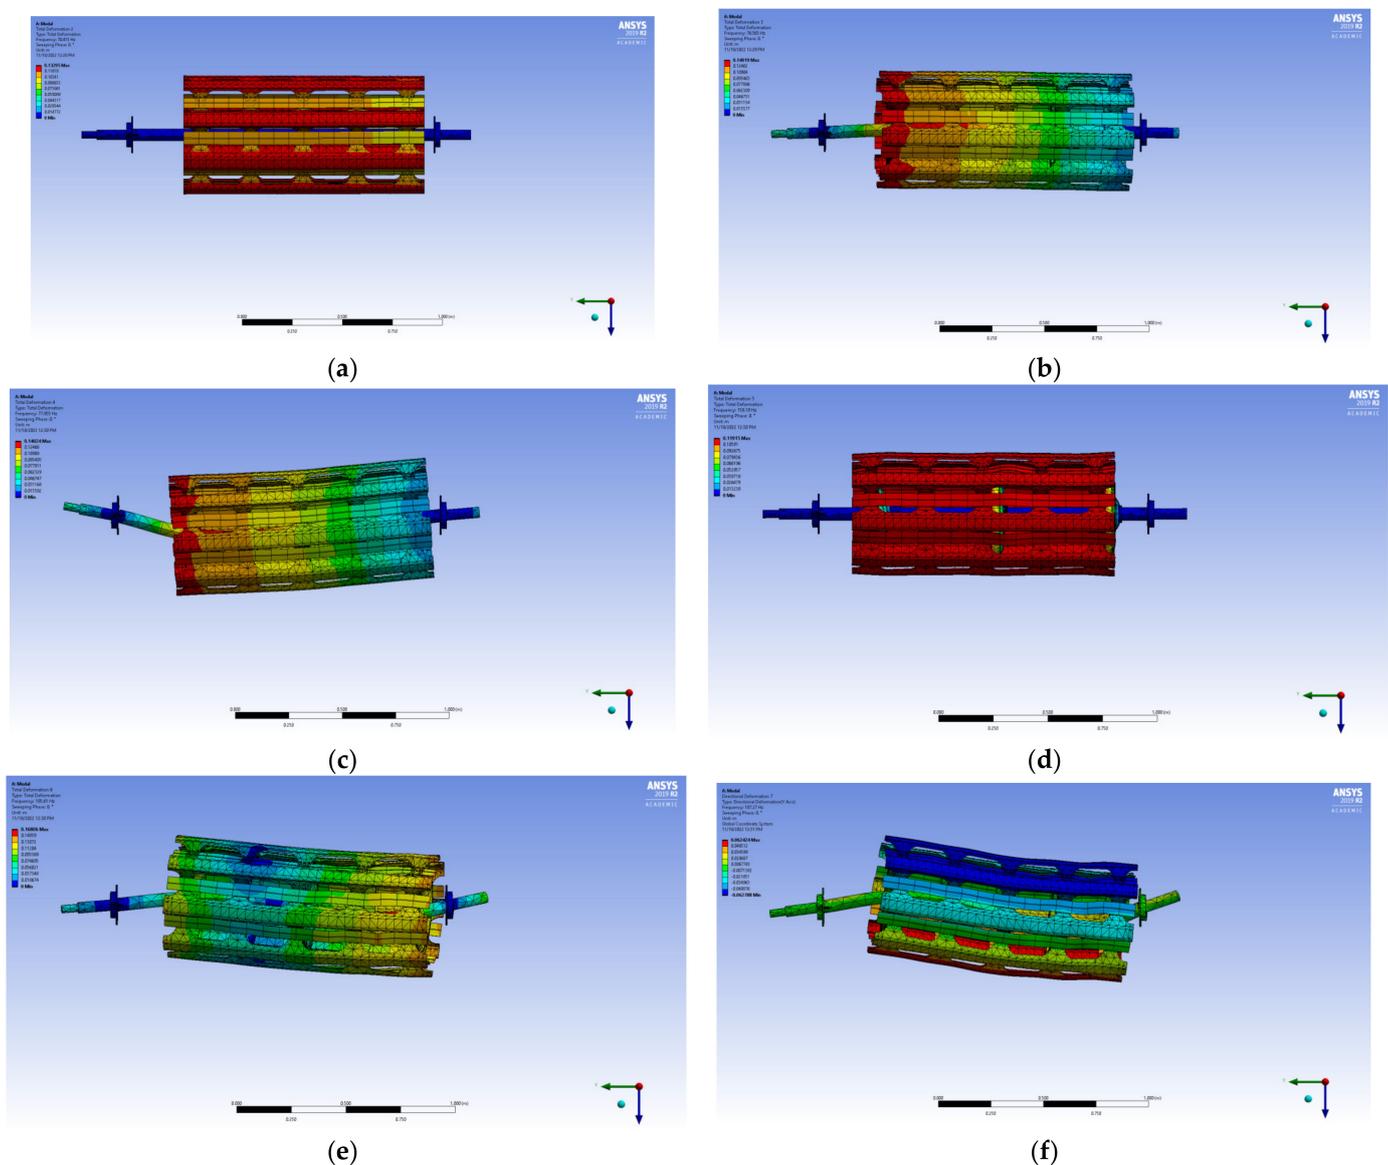
Figure 7. Modal analysis of the threshing cylinder. (a) First-order modal shape (70.41 Hz); (b) Second-order modal shape (76.56 Hz); (c) Third-order modal shape (77.85 Hz); (d) Fourth-order modal shape (158.9 Hz); (e) Fifth-order modal shape (185.61 Hz); and (f) Sixth-order modal shape (187.27 Hz).

The rotational constraint of 470 RPM was imposed based on the established threshing cylinder finite element model, and the natural frequencies of the sixth-order constraint mode and the related modal shapes are presented in Figure 7. The first-order modal shape has the maximum deformation, measuring 0.123 m, occurring at the outer covers. The second-order modal shape was general bending; the maximum deformation, measuring 0.14 m, occurred at the intersection of the outer cover, inner cover, drum, and shaft. The third-order modal shape was general bending; the maximum deformation, measuring 0.14 m, occurred at the intersection of the outer cover, inner cover, drum, and shaft. The fourth-order modal shape has the maximum deformation, measuring 0.119 m, occurring at the outer covers. The fifth-order modal shape was general bending; the largest maximum deformation, measuring 0.168 m, occurred at the shaft. The sixth-order modal shape was general bending; the largest maximum deformation, measuring 0.168 m, occurred at the shaft.

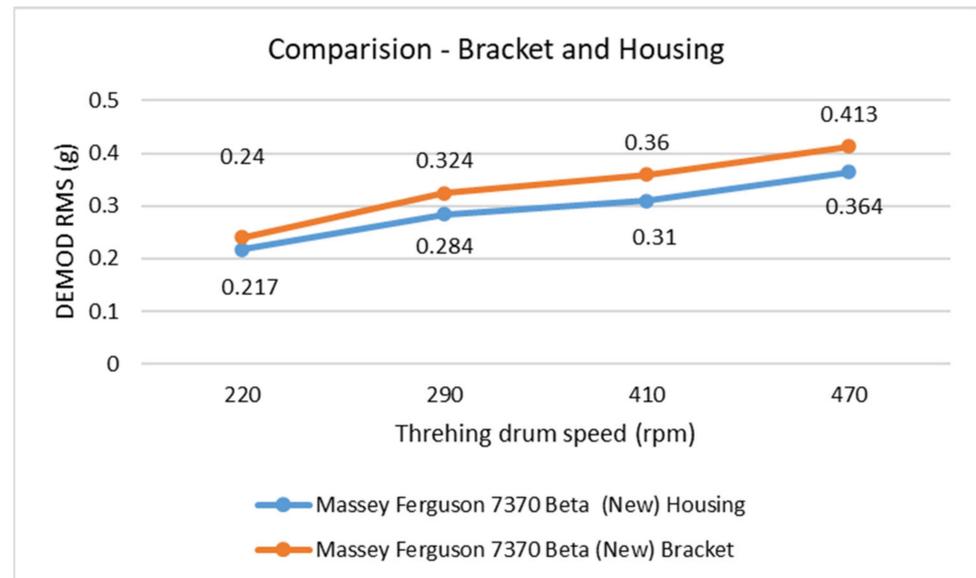
Figure 8. Comparison of the demodulated RMS value when the sensor is mounted on a bracket with respect to the housing of the Beta version in different threshing rotating speeds.

bracket is analyzed, which is up to 16.13% increased for the data measured on the bracket compared to those on the housing, as shown in Figure 8. The metal bracket can therefore be utilized to help with the vibration measurements of the threshing drum bearings if it is properly fitted in specific spots. The demodulated RMS value increases with respect to the speed for both conditions, which satisfies the proper vibration measurement.

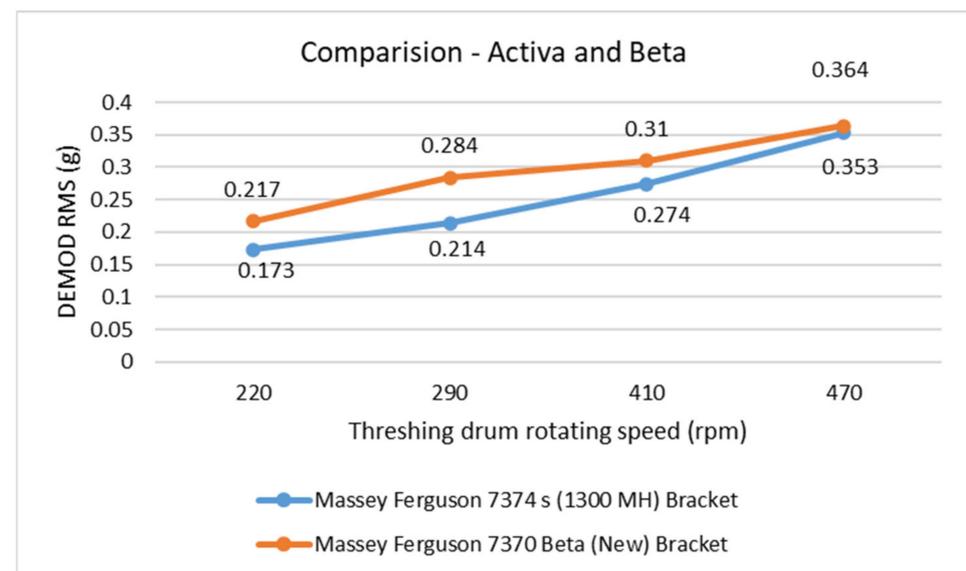
Figure 9. Comparison of the demodulated RMS value when the sensor is mounted on a bracket of the Beta and Activa versions at different threshing rotating speeds.

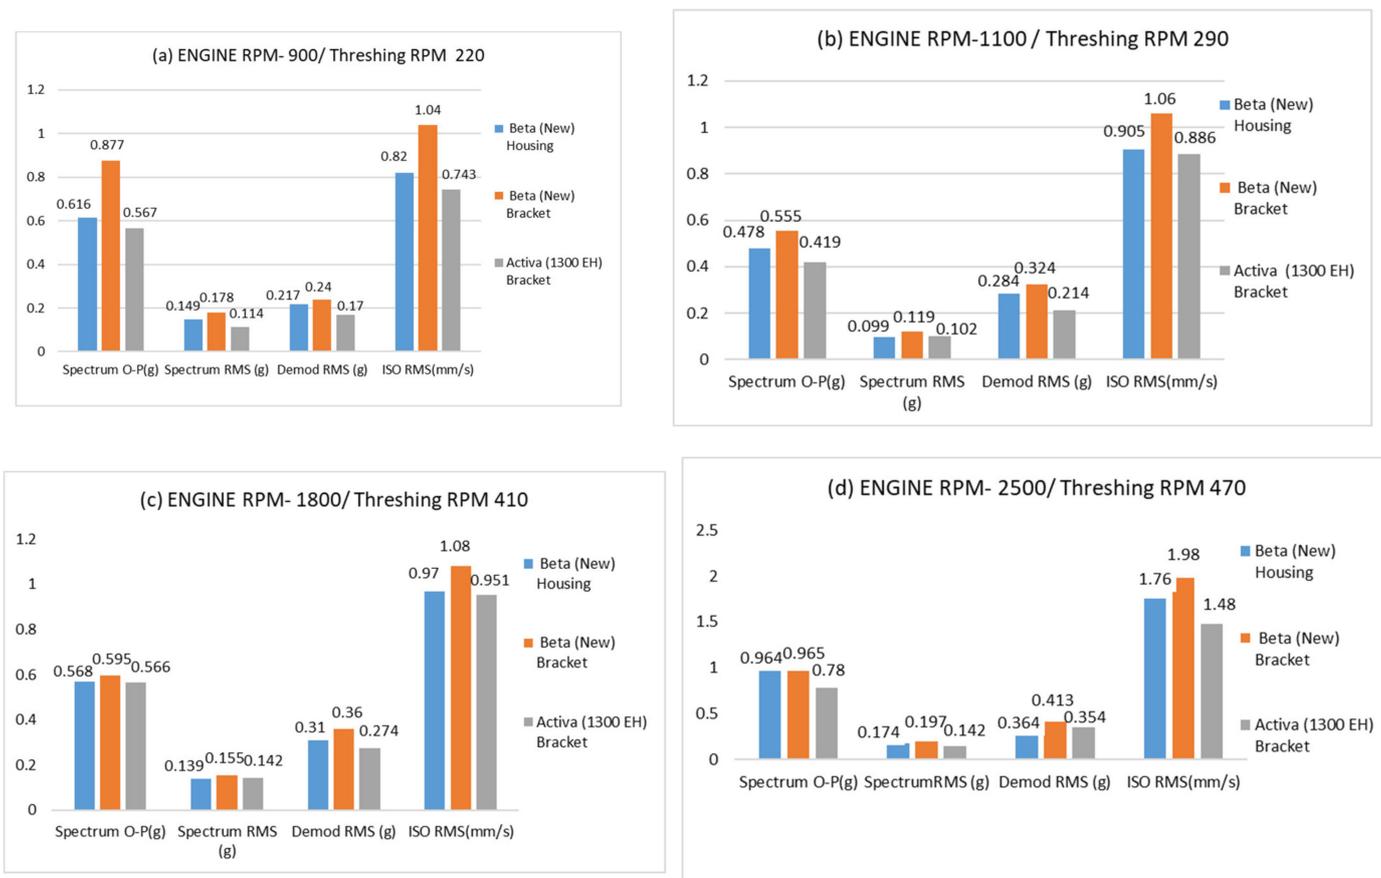
Figure 10. Comparison of the vibration parameters values when the sensor is mounted on bracket and the housing of Beta and Activa versions at different threshing rotating speeds: (a) Threshing drum rotating at 220 RPM; (b) Threshing drum rotating at 290 RPM; (c) Threshing drum rotating at 410 RPM; and (d) Threshing drum rotating at 470 RPM.

The demodulated RMS (g) values are compared between the two versions of the Massey Ferguson (Figure 10) as the constructions are with some changes in shaft and drum dimensions, as shown in Tables 1 and 2. The recorded value increases with the speed and is higher for the new Massey Ferguson 7374 s (1300 EH), which satisfies the condition as the dimensions of the threshing units such as the drum and shaft are larger compared to the Activa version. The comparison of the vibration measurement is collectively analyzed in the Activa and Beta versions with and without bracket with the vibration analysis parameters, as shown in Figure 5. The difference in the vibration measurement was compared in the Beta (New) version and Activa version with the vibration parameters such as the spectrum (O-P, g), spectrum (RMS, g), demodulated RMS (g), and velocity RMS (g). The recorded vibration data show a higher magnitude with the bracket measurement compared to the housing measurement in the Beta version. As the threshing unit of both combine harvesters was similar in construction with a similar bearing, the recorded data were compared with both harvesters when measured on a bracket. The maximum amplitude was obtained for the new Beta version as the dimension is higher which results in a larger radial load and high vibration magnitude.

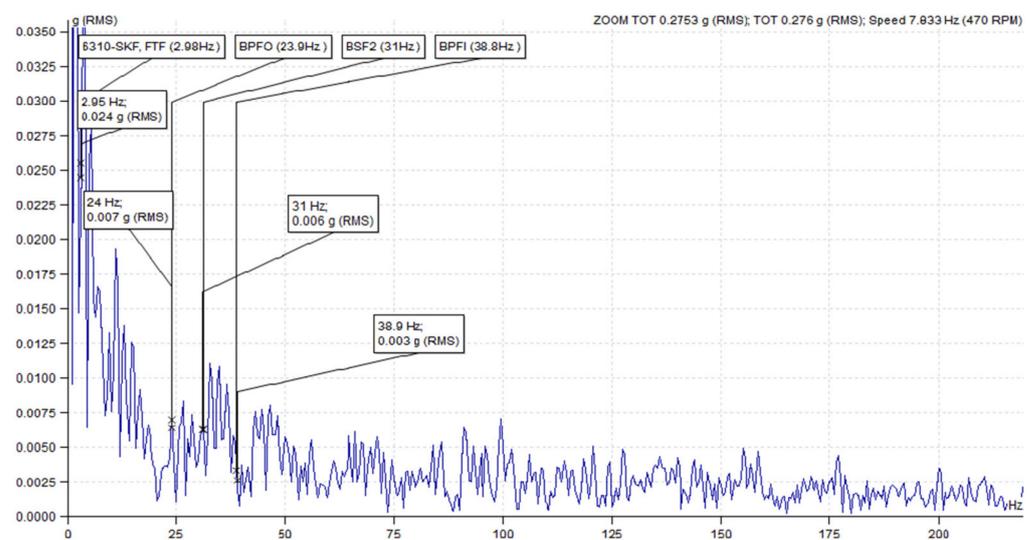
Figure 11. The fast Fourier transform (FFT) (500 Hz–16 kHz) demodulation of the 6310 SKF of the non-driving end of the threshing drum of Massey Ferguson 7374 s (1300 EH) Activa, a sensor mounted on a bracket.

Peak amplitude is under the noise threshold for envelope analysis. The demodulated FFT spectrum with an amplitude RMS(g) and a threshing speed of 470 RPM for bearing failure frequencies FTF (2.98 Hz, 0.024 g), BPFO (23.9 Hz, 0.007 g), BSF (31 Hz, 0.006 g), and BPFI (38.8 Hz, 0.003 g) were measured (Figure 11). The higher RMS values should be as near to zero as possible when being assessed.

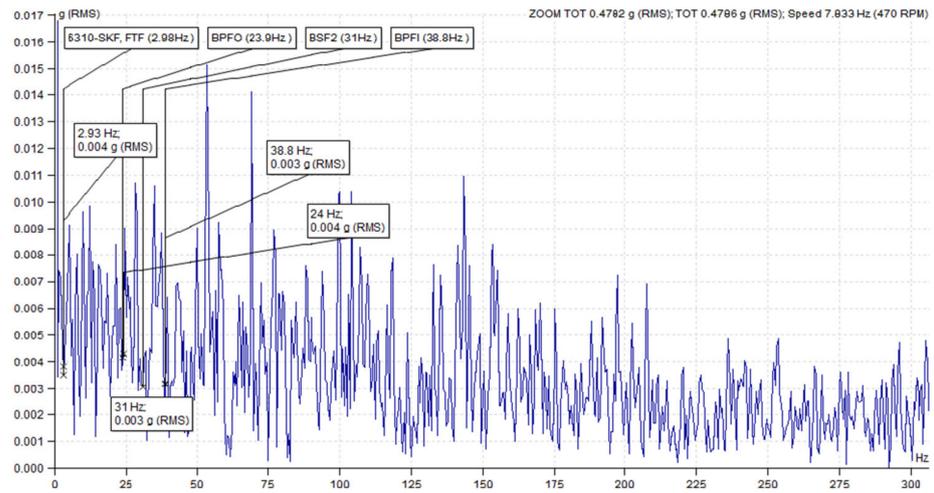
Figure 12. The fast Fourier transform (FFT) (500 Hz–16 kHz) demodulation of the 6310 SKF of the non-driving end of the threshing drum of Massey Ferguson 7370 Beta (New), a sensor mounted on housing.

Similarly, the demodulated FFT spectrum RMS analysis was performed for the Beta version when the sensor was mounted on the housing and on the bracket, respectively. The demodulated FFT spectrum with an amplitude RMS (g) with a threshing speed of 470 RPM for bearing failure frequencies FTF (2.98 Hz, 0.004 g), BPFO (23.9 Hz, 0.003 g), BSF (31 Hz, 0.003 g), and BPFI (38.8 Hz, 0.004 Hz) were measured when the data were recorded from the accelerometer mounting on the housing (Figure 12). The demodulated FFT spectrum with an amplitude RMS (g) with a threshing speed of 470 RPM for bearing failure frequencies FTF (2.98 Hz, 0.037 g), BPFO (23.9 Hz, 0.005 g), BSF (31 Hz, 0.008 g), and BPFI (38.8 Hz, 0.008 Hz) were measured when the data were recorded from the accelerometer mounting on the bracket (Figure 13).

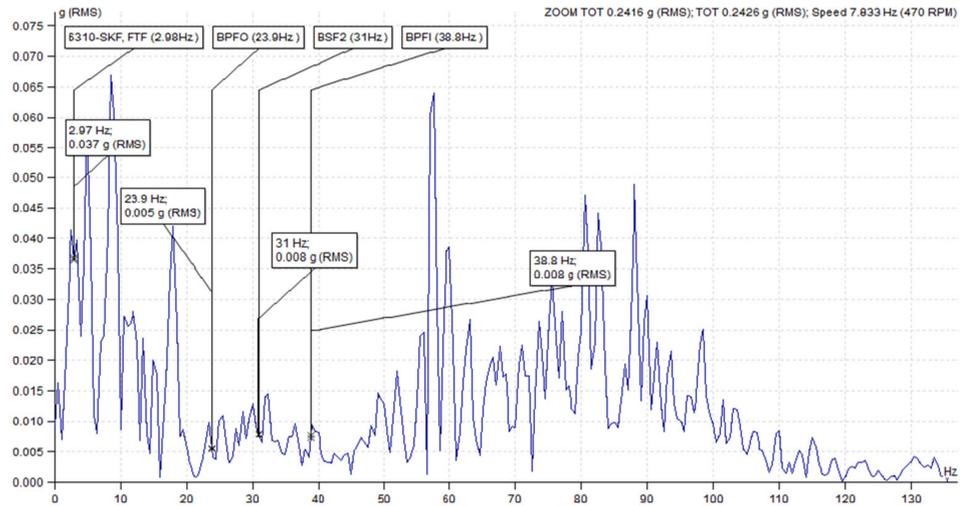
Figure 13. The fast Fourier transform (FFT) (500 Hz–16 kHz) demodulation of the 6310 SKF of the non-driving end of the threshing drum of Massey Ferguson 7370 Beta (New), a sensor mounted on a bracket.

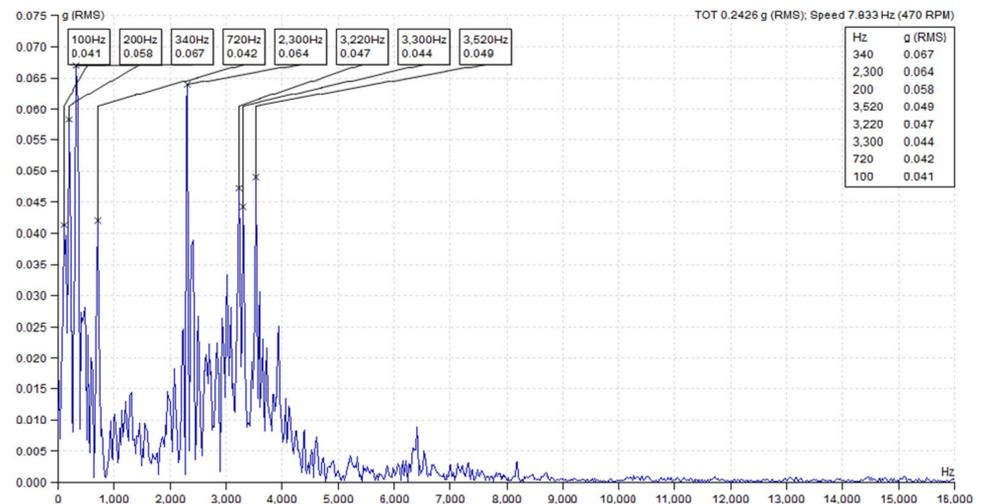
Figure 14. Top 8 peaks from the overall spectrum (10 Hz–16 kHz) of Massey Ferguson Activa.

To observe the higher amplitude peaks in the spectrum and to identify any sidebands and harmonics resembling the bearing and other parts, the overall spectrum (g) is considered for both combine harvesters, as shown in Figures 14 and 15. No higher amplitude peaks, harmonics, and side bands are present in the analyses. The bearing is considered safe to operate. The magnitudes of the measured RMS value indicate no bearing faults in the Massey Ferguson 7370 Beta (New). The bearing condition is in good condition to operate. The RMS bearing static amplitude is 0.353 g, which indicates a lower number than the alarm limit specified on ISO 10800: Noise and Vibration standard alarm set on the DDS software.

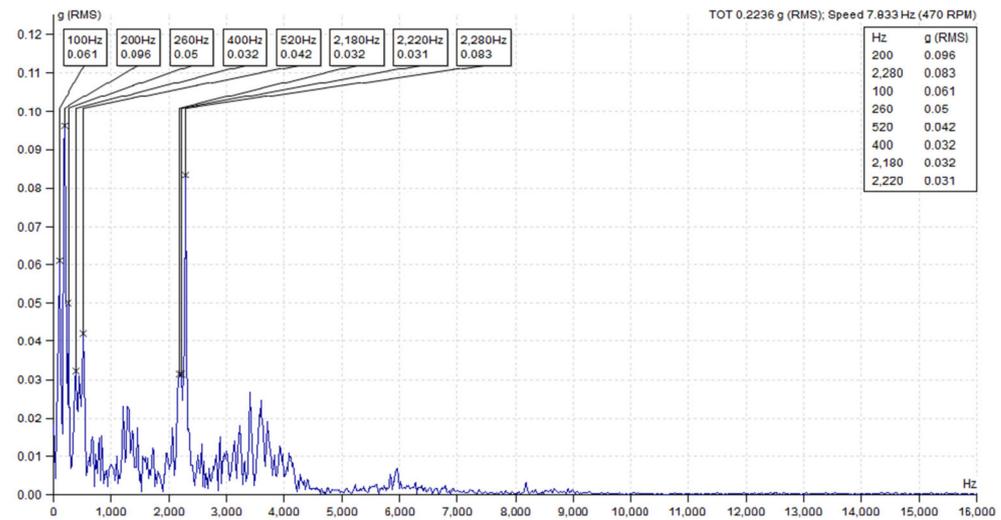
Figure 15. Top 8 peaks from overall spectrum (10 Hz–16 kHz) of Massey Ferguson Beta.

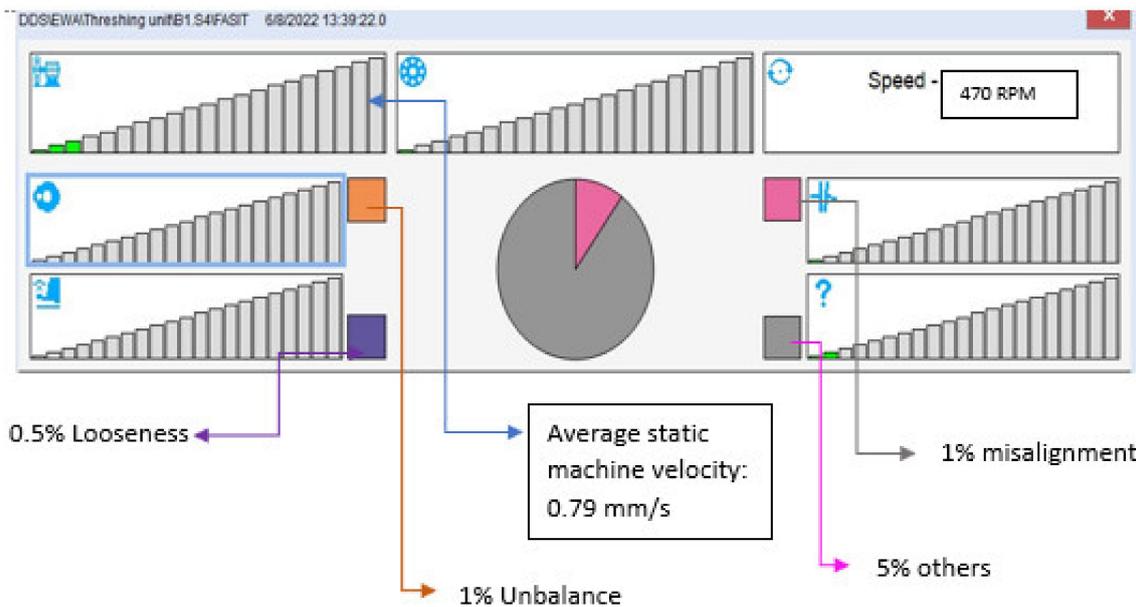
Figure 16. The Adash FASIT tool display for correctable mechanical conditions (looseness, misalignment, bearing, unbalance, and speed).

The FASIT tool provided by the Adash DDS helps identify the other mechanical condition of the threshing unit. The results show 0.5% looseness, 1% unbalance, 1% misalignment, and 5% other mechanical faults, as shown in Figure 16.

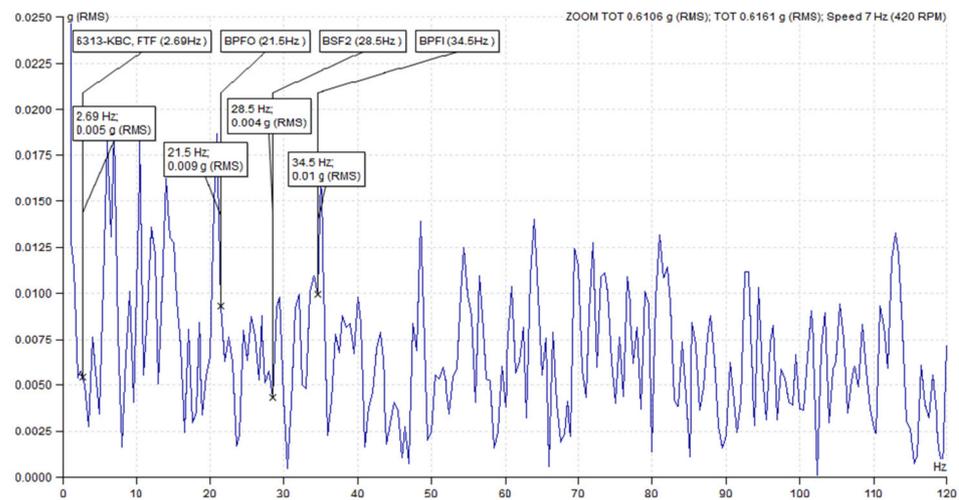
Figure 17. The fast Fourier transform (FFT) (500 Hz–16 kHz) demodulation 6313 KBC of the non-driving end of the tangential threshing drum rotating at 420 rpm with the sensor mounted on the housing.

The demodulated FFT spectrum, with an amplitude RMS (g) with a threshing speed of 420 RPM (maximum operating speed), and when the sensor was directly mounted onto the housing for the bearing fundamental train frequency (FTF) (2.69 Hz, 0.005 g), ball passing frequency of outer race (BPFO) (21.5 Hz, 0.009 g), ball spin frequency (BSF) (28.5 Hz, 0.004 g), and ball passing frequency of inner race (BPFI) (34.5 Hz, 0.01 Hz), was measured and is shown in Figure 17. The RMS higher values should be as near to zero as possible when being assessed. Since the BPFI amplitude is close to the second digit after decibel and higher compared to the other amplitudes, it is further diagnosed with the digital camera with 12-megapixel-wide and ultrawide lenses (Figure 18). It is observed that the bearing has initiated the abrasive marking with contamination. The main causes include filthy hands, contaminated workspaces, dirty instruments, and foreign objects in lubricants.

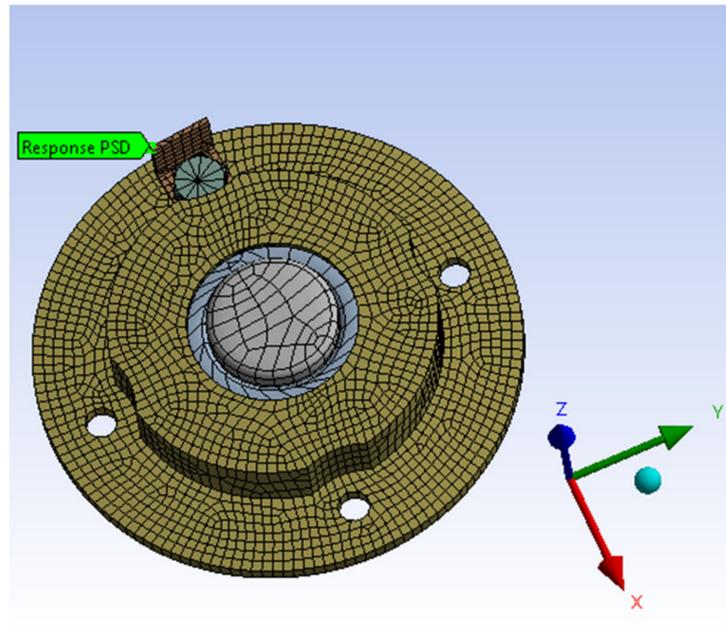
Figure 19. PSD response vertex.

The first sigma represents 68.26% deformation, and the third sigma represents 99.73% deformation. Since the deformations on the brackets are negligibly very small, the deformation on the other parts can be calculated and analyzed using a bracket. Furthermore, the PSD response is taken on the vertex of the bracket, as shown in Figure 19 in the x direction.

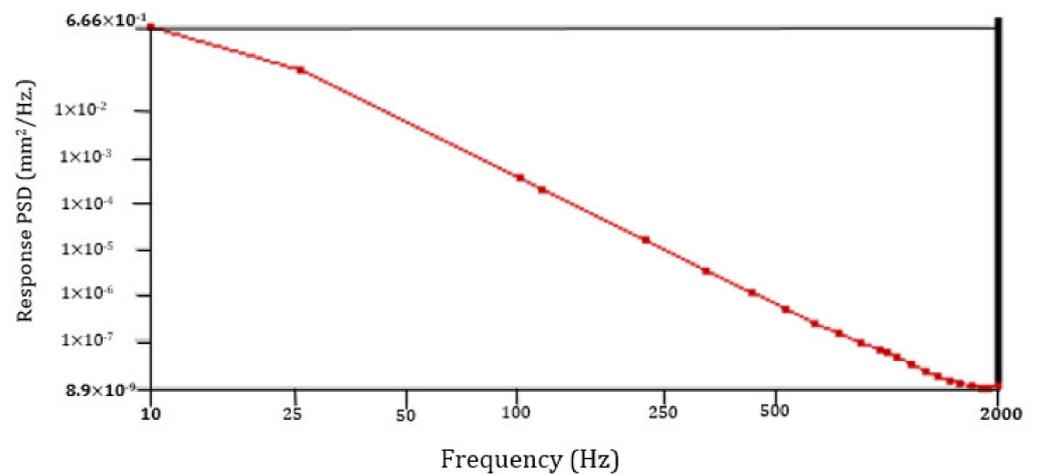
Figure 20. PSD response graph displaying peak g acceleration responses.

The PSD response (RPSD) provides the spectral response of a structure subjected to random excitation and the RPSD plot gives the information as to where the average power is distributed as a function of frequency. This gives the RMS value of the selected frequency range over the entire available frequency range as well as information about the peak g acceleration responses that occur at the resonant frequency on the assembly (Figure 20).

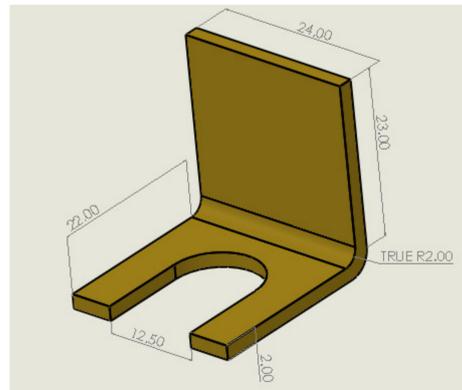
Figure A1. Manufactured Bracket (Dimensions in mm).

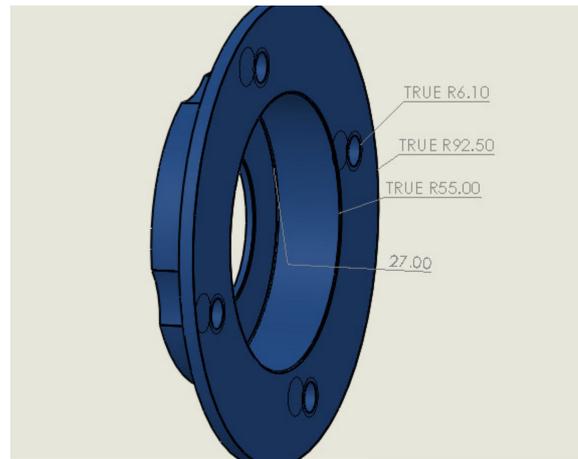
Figure A2. Bearing housing (Dimensions in mm).

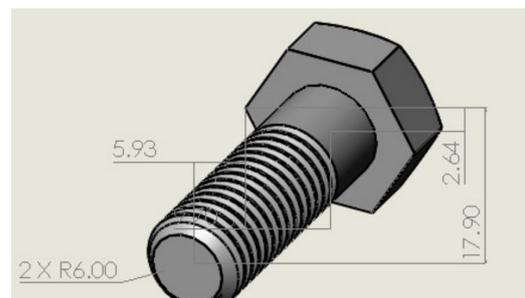
Figure A3. Bolt M12 (Dimensions in mm).

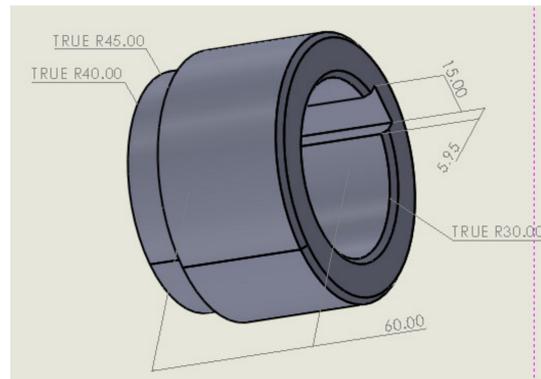
Figure A4. Hub (Dimensions in mm).

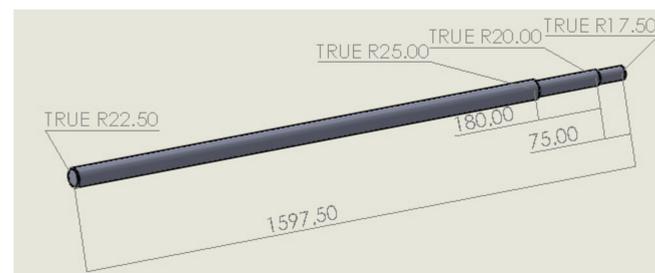
Figure A5. Threshing shaft (Dimensions in mm).

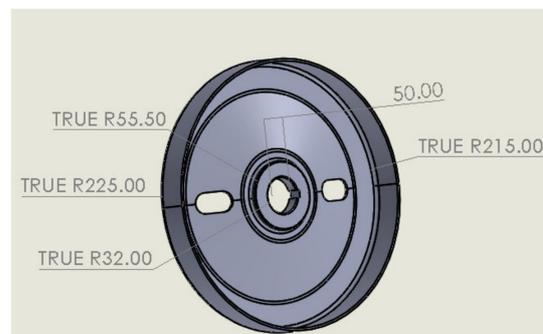
Figure A6. Threshing disk (Dimensions in mm).

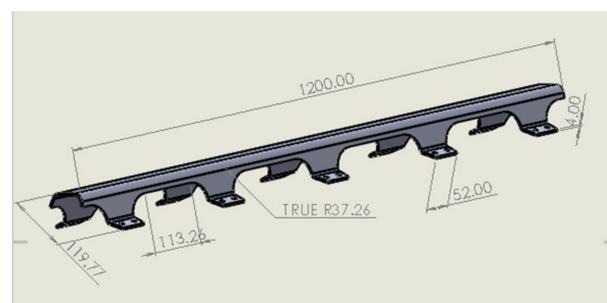
Figure A7. Top cover (Dimensions in mm).

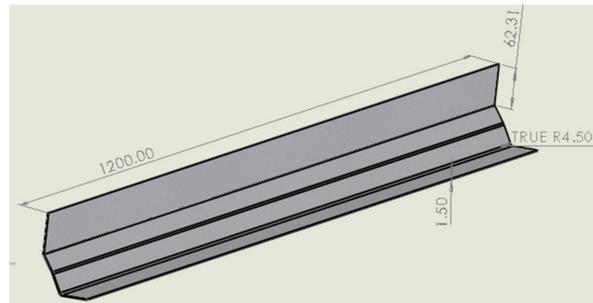
Figure A8. Bottom cover (Dimensions in mm).

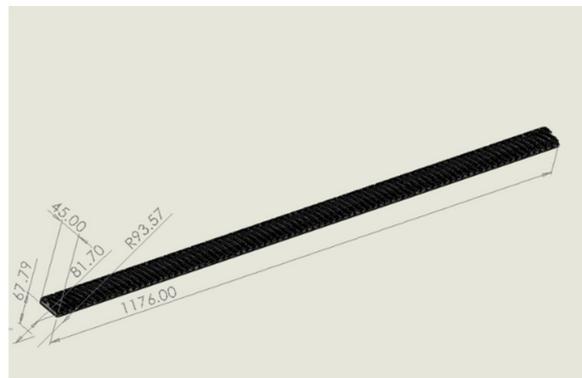
Figure A9. Rasp bar (Dimensions in mm).
