# Change over Time in the Mechanical Properties of Geosynthetics Used in Coastal Protection in the South-Eastern Baltic

**Abstract:** The most massive design on the Baltic shore used geosynthetic materials, the landslide protection construction in Svetlogorsk (1300 m long, 90,000 m<sup>2</sup> area, South-Eastern Baltic, Kaliningrad Oblast, Russian Federation) comprises the geotextile and the erosion control geomat coating the open-air cliff slopes. Due to changes in elastic properties during long-term use in the open air, as well as due to its huge size, this structure can become a non-negligible source of microplastic pollution in the Baltic Sea. Weather conditions affected the functioning of the structure, so it was assessed that geosynthetic materials used in this outdoor (open-air) operation in coastal protection structures degraded over time. Samples taken at points with different ambient conditions (groundwater outlet; arid places; exposure to the direct sun; grass cover; under landslide) were tested on crystallinity and strain at break. Tests showed a 39–85% loss of elasticity of the polymer filaments after 3 years of use under natural conditions. Specimens exposed to sunl

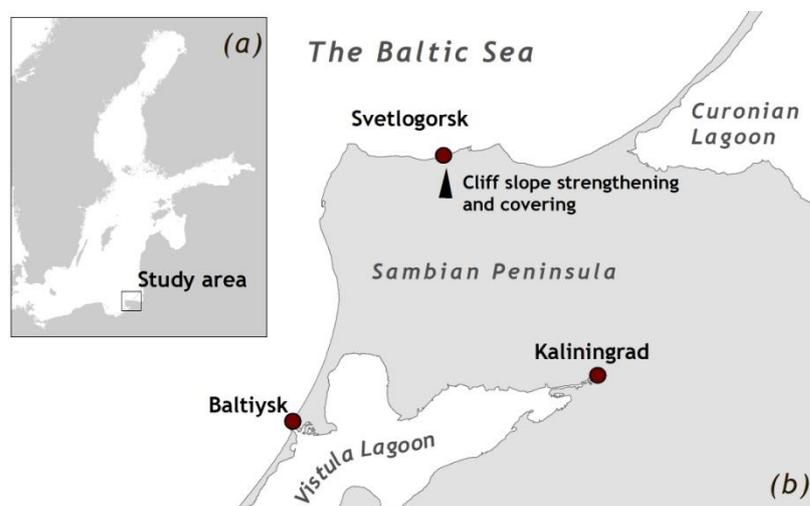
**Figure 1.** The coastal landslide protection construction, the biggest in the Baltic Sea region (a), is located in the City of Svetlogorsk (Kaliningrad Oblast, Russia) at the northern shore of the Sambian Peninsula (b).

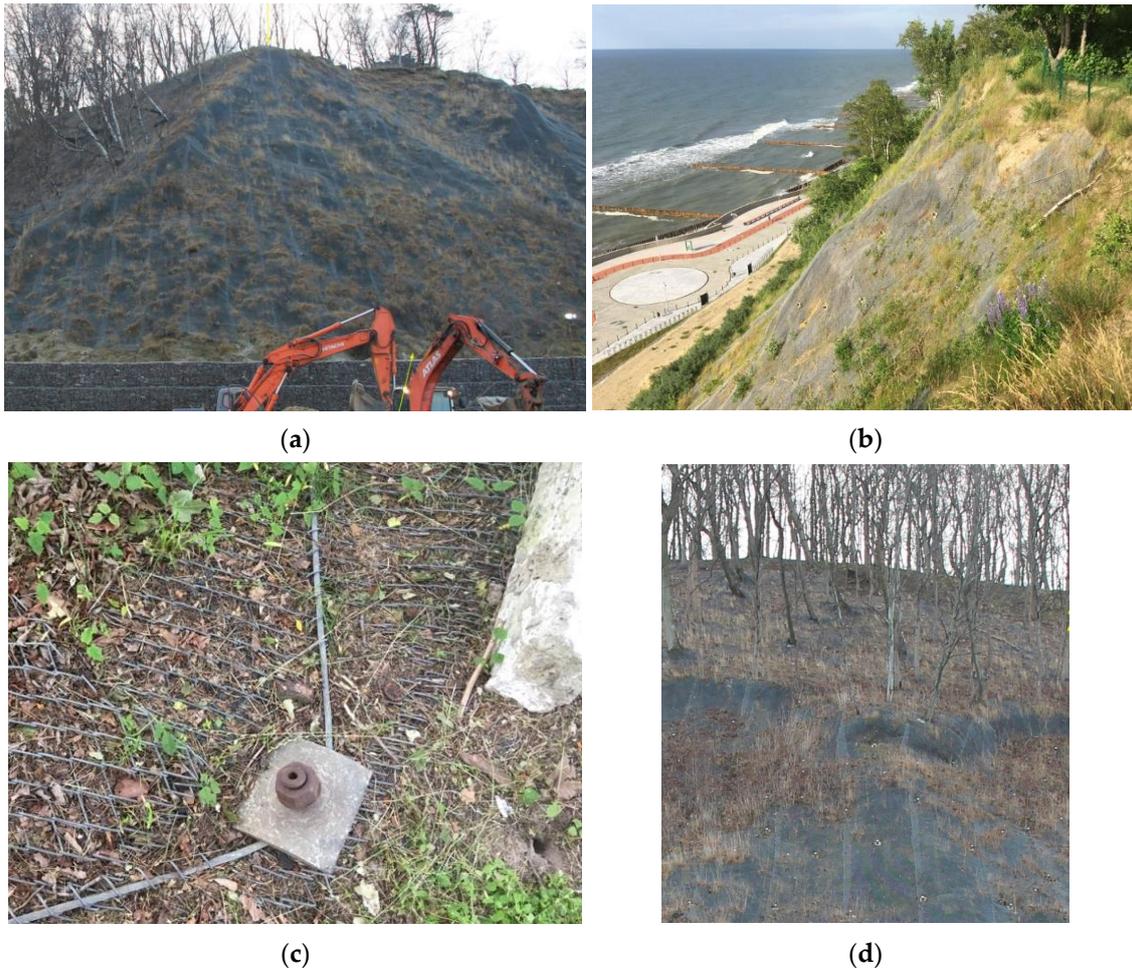
**Figure 2.** Cliff slope in Svetlogorsk during construction (a) and after completion (b) of the slide protection, which includes a geomat layer armoring of landslide slopes (c) and flexibly adjusted (d) to existing tree cover.

The situation of continual cliff erosion changed with the construction in 2015–2017 of the largest coastal protection structure in the South-Eastern Baltic, the complex engineered protection of landslide slopes in Svetlogorsk (Figure 2a,b). This structure includes several

levels of gabions placed at the slope's base and the geomat layer armoring landslide slopes with steel mesh on slopes having an inclination of 1:1.5–1:2 (Figure 2c,d).

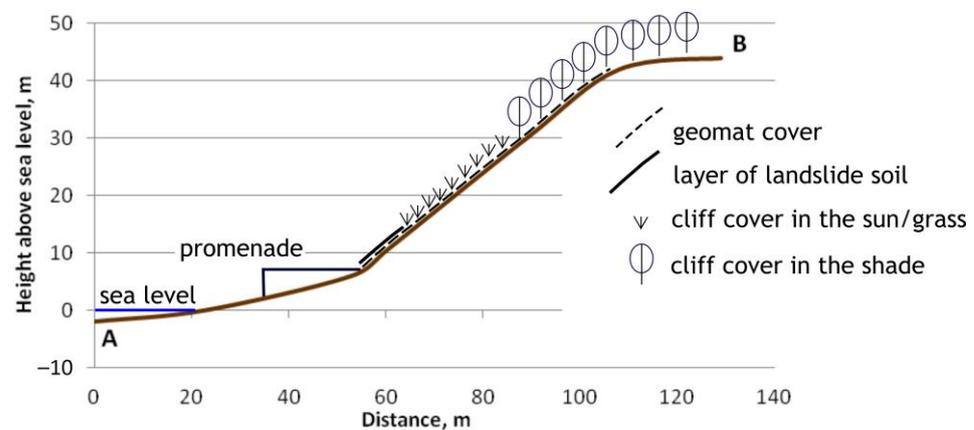
**Figure 3.** Cross profile of the slope drawn along the line AB (location see on Figure 5).

Engineered protection measures on landslide slopes in Svetlogorsk were carried out in accordance with recommendations [30,31] with the task of stabilizing the cliff and fixing the grass cover and other vegetation. The anti-landslide base is a system of anchors embedded 18 m deep into the slope. Anchors were drilled into the slope to “interlock” the layers and hold the surface layer. This was supplemented by the construction of gabions and piled retaining walls, anti-slide protection of slopes with a metal mesh, and storm net trays (Figure 3).

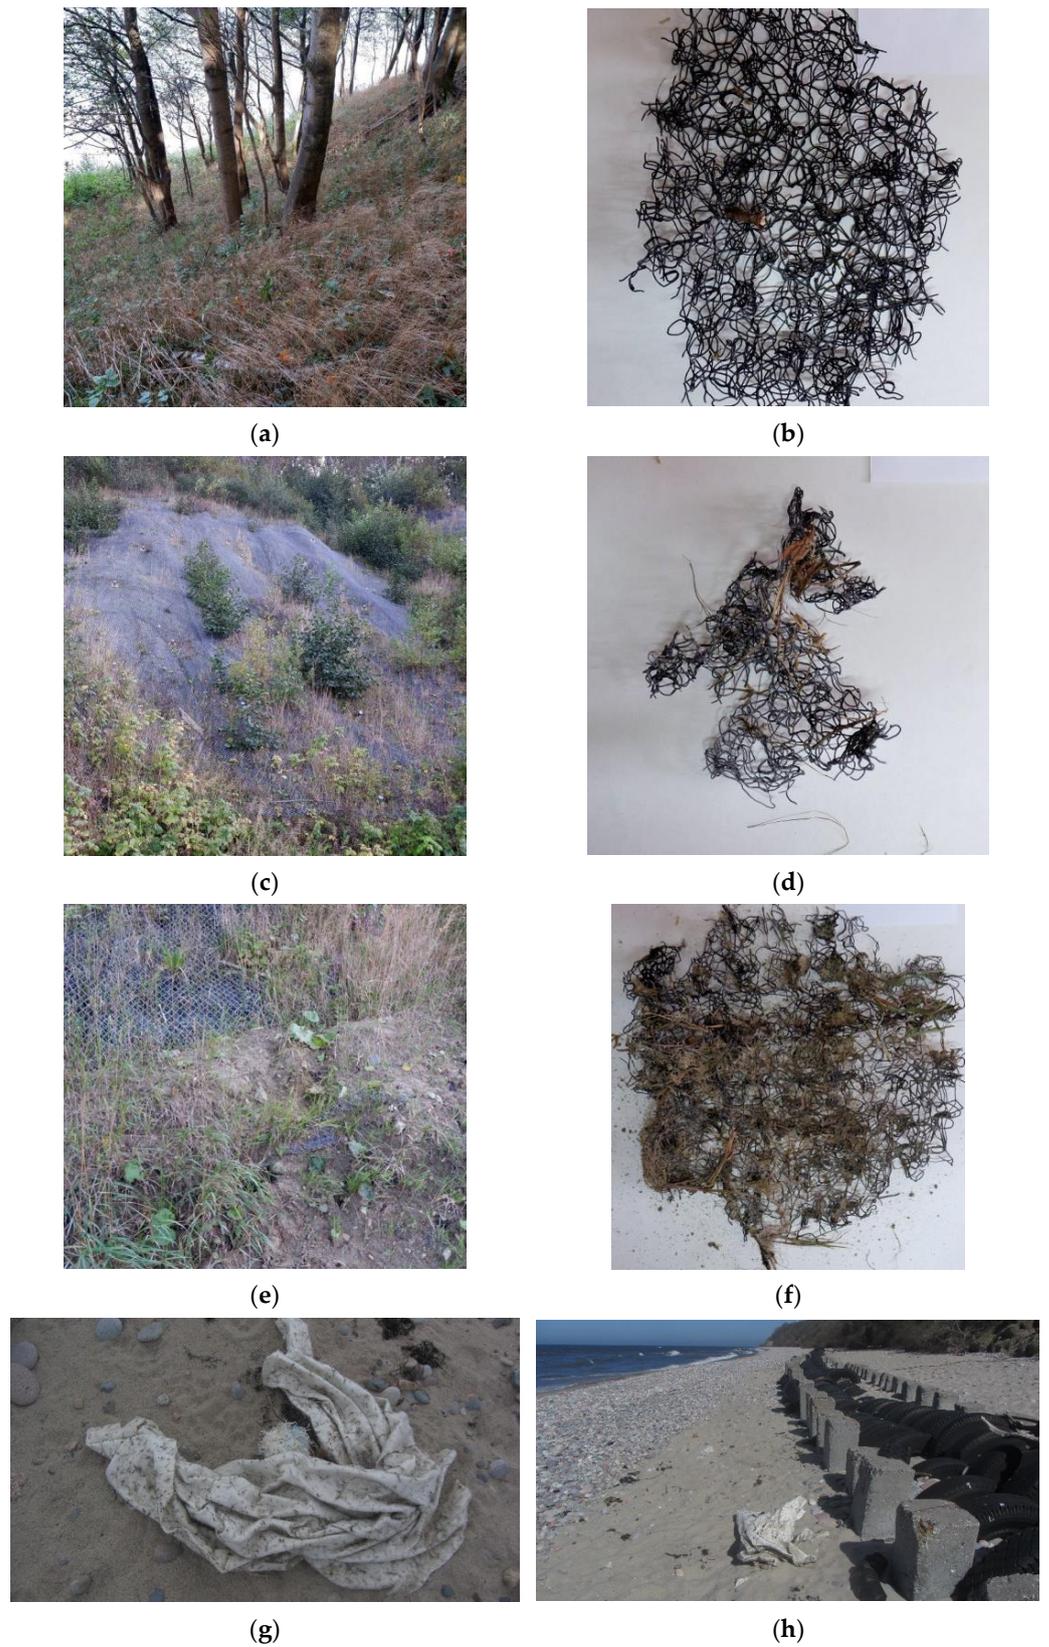
**Figure 4.** Various conditions in which the anti-slide coating is located: the upper, mostly grass-covered (a), and lower (c) (open and with small bushes) parts of the slope or covered by the landslide natural material (e). The samples of geomat taken in these locations (b,d,f). The pieces of geotextile Dornit released from the protection construction were sampled from the beach (g,h).

The geotextile (non-woven material, trademark “Dornit”, widely used in coastal constructions in Russia) was used as the pad interlayers [30] between gabions used as revetments. The pieces of Dornit may be released from the construction due to direct wave impact or by improper installation (Figure 4g,h, sample Ryb01).

The geomats under the steel mesh and geotextile at the base comprise the geosynthetic content of the structure. These geosynthetic materials are either partly exposed to direct solar radiation, or are located either in the shade, in conditions of groundwater seepage, in dry places, or hidden in the grass cover (Figures 3 and 4).

The following types of natural coverage are found throughout the structure: trees; the grass cover shaded under the trees; the grass cover without shade; local landslides without a grass cover; shrubs as undergrowth; shrubs punctuated on the slope; trees on the upper edge of the slope; trees dotted or in small groups. Some variations of the coverage are illustrated in Figure 4.

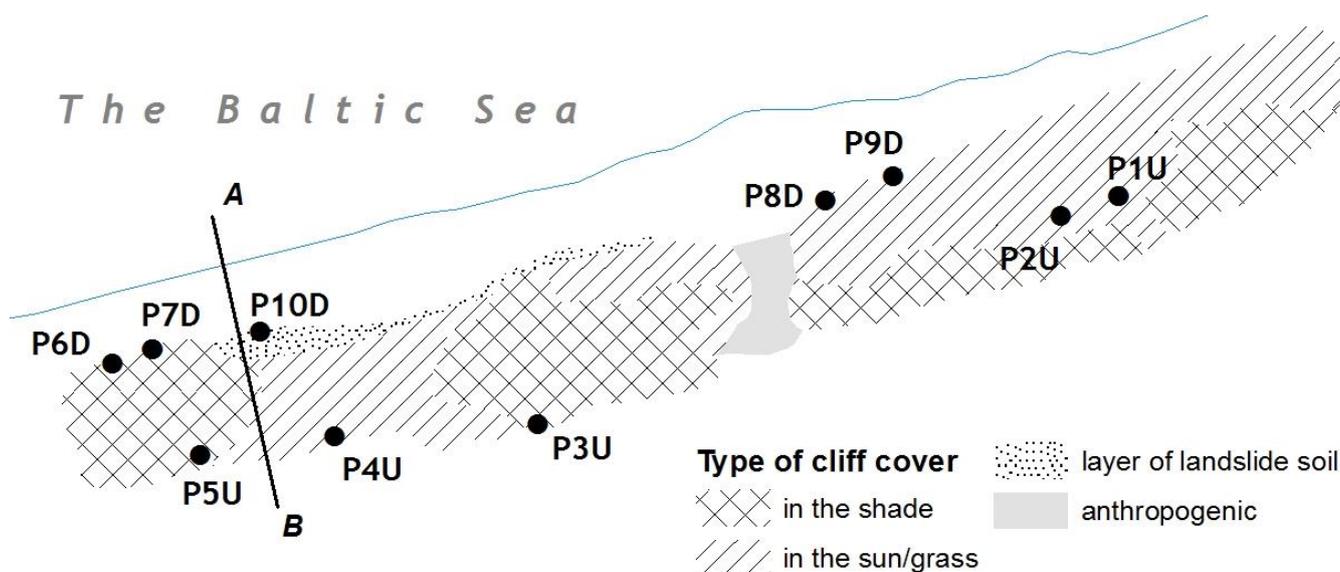
**Figure 5.** Sampling points for geomats in the complex of the structure engineered to strengthen the slopes in Svetlogorsk (of 1300 m length and up to 140 m width). The outer border of the promenade is taken as the border of the depicted coastline. The line AB shows the cross profile of the slope (Figure 3).

Ten **sampling points** (Figure 5, Table 1) were selected as test sites for different exposure conditions for the geosynthetic used in the engineered anti-slide construction. Four points were at the bottom part of the construction and five points at the upper part (heights were approximately 5 and 25 m, respectively). Due to the fact that sampling means cutting out a piece of the coating, i.e., partial destruction of the covering, permission was obtained to take the minimum possible number of samples and only at 10 points. Samples were taken carefully to avoid damage during the exhumation process. Samples of geosynthetic material were taken from the edge of the structure by cutting. This made it possible to preserve the integrity of the structure itself, and also not damage the sample. In addition, only the central part of the sample was used for laboratory analyses.

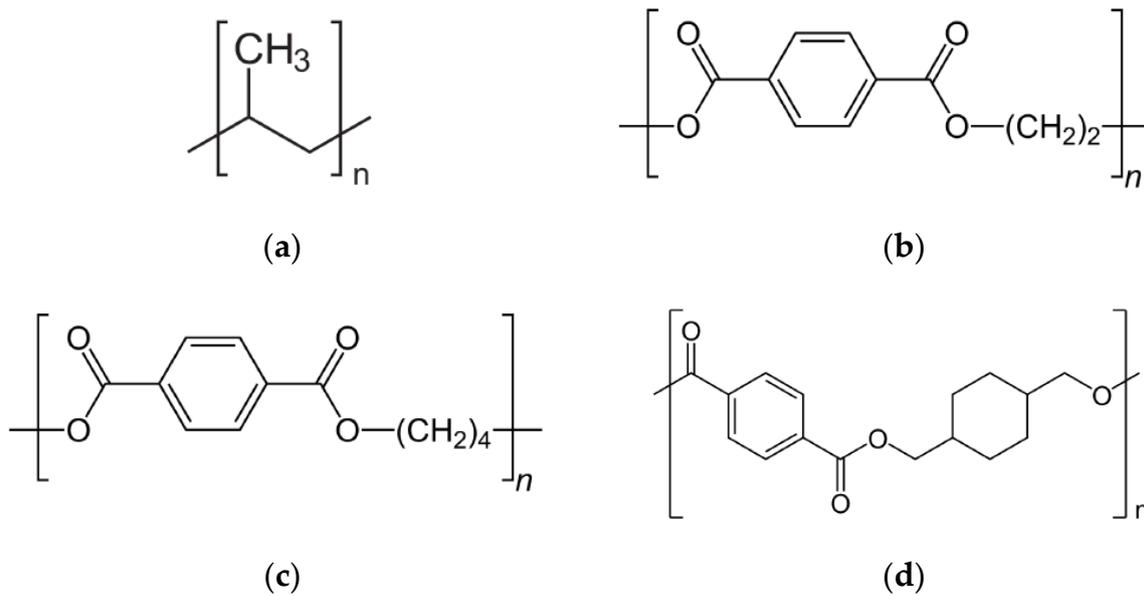
**Figure 6.** Reference materials for IR database: (a) Polypropylene (PP), (b) polyethylterephthalate (PET), (c) polybutylterephthalate (PBT), and (d) polycyclohexylenedimethylene terephthalate (PCT).

There are **different types of geosynthetic materials** (Figure 6), e.g., polypropylene (PP), polyethylene terephthalate (PET), polybutylene terephthalate (PBT), and polycyclohexylenedimethylene terephthalate (PCT). To identify the material composition, attenuated total reflection infrared spectroscopy (ATR-IR) was performed with a Spectrum 2000 (Perkin Elmer) device. The samples were fixed to an ATR-IR crystal (diamond) with a clamp. To increase the contact area between the sample and the crystal, the sample was melted to create a plane surface. In the first step, a background spectrum without a sample was measured using the spectrometer’s control software (Spectrum, Perkin Elmer). After that,

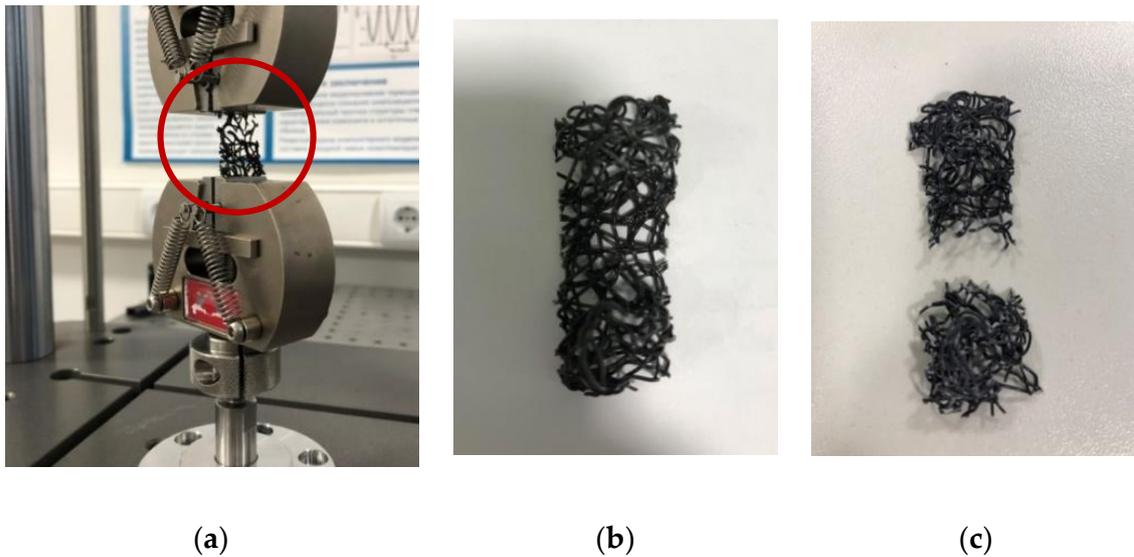
**Figure 7.** Rupture test of the erosion control geomat sample using (a) the Instron ElectroPuls E1000 and a (b) virgin and a (c) broken sample.

Measurement of the geomat filaments' tensile strength was not possible because the geomat was too brittle to extract single filaments long enough for measurements with Vibroscope and Vibrodyn. The tensile-strength testing machine Instron ElectroPuls E1000 was used to conduct studies of the mechanical break (rupture test) of pieces of the three-dimensional structure (see Figure 7b) of the geomat. The value of the load was in the range of 1–100 kg, max 1000 N, as determined by the sensor. For each sample, the number of longitudinal filaments, which accounted for the tensile load, was calculated. The tests were carried out until all longitudinal filaments of the test sample were completely broken (Figure 7).

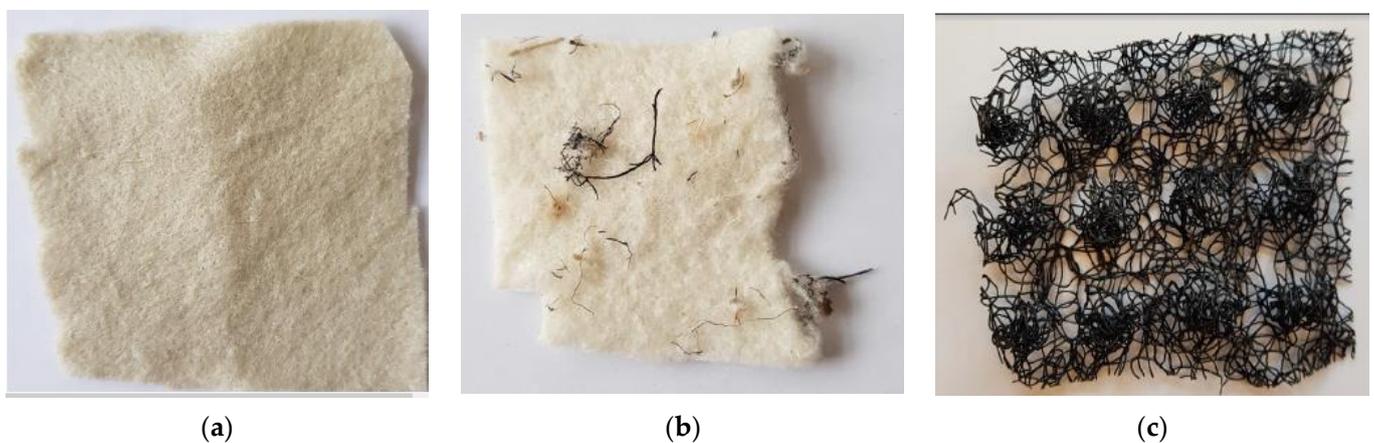
**Figure 8.** Analysed samples: (a) virgin geotextile Dornit ECO 300, (b) naturally aged geotextile sampled (sample Ryb01) after several months of exposure under natural conditions, and (c) virgin erosion control geomat.

Two types of geosynthetic material (Figure 8) used in the structure were selected for mechanical analysis—the geotextile “Dornit ECO 300” (300 g/m<sup>2</sup> mass per unit area) and the erosion control geomat. The results of the ATR-IR analysis (Table 2) showed that geotextile is made from PET while the geomat is made from PP.

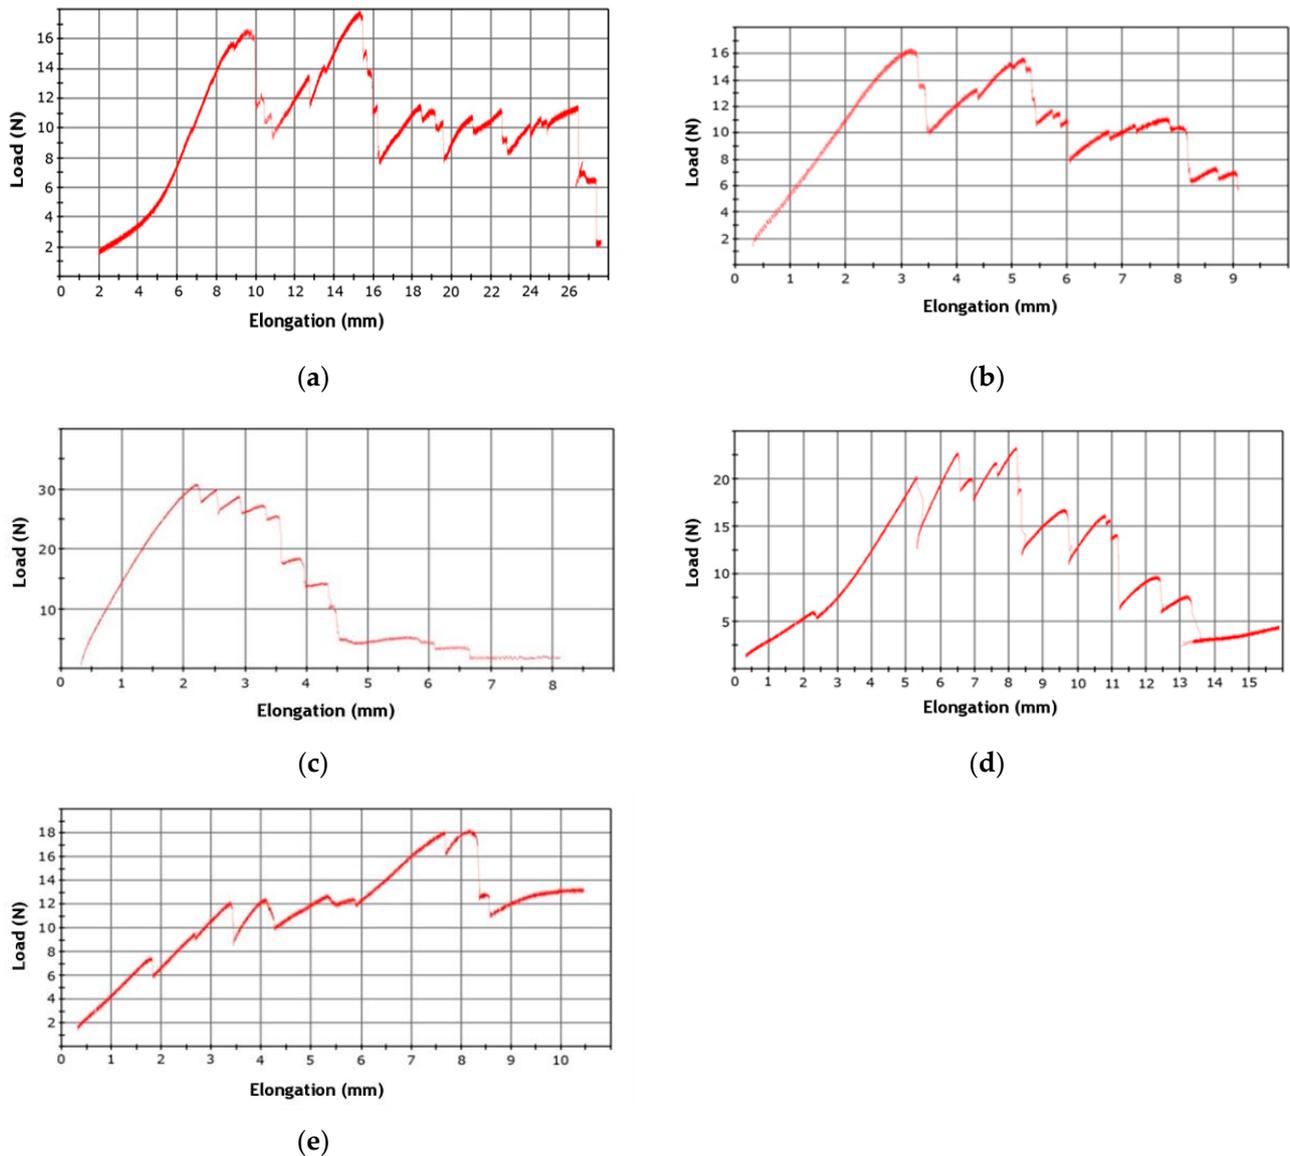
**Figure 9.** Load-elongation diagrams for (a) the reference sample; (b) sample P7D\_Sh-d located in the shade; (c) sample P7D\_Sh-d-Grass covered by grass in the shade; and (d) sample P8D\_Sun located in the sun; and (e) sample P10D\_Slid taken from under the landslide layer. Sharp increases in load are associated with successive filament breaks.

The reference sample (Figure 9a) and sample P7D\_Sh-d taken in the shade (Figure 9b) showed behavior similar to each other—the load reaches the limit value. After that, 2–3 filaments are torn, and then the sample withstands approximately the same load (50–70% of the maximum), but the filaments are torn one by one. This means that the load is not borne by the entire set of filaments, but by one or a few them. Therefore, when one filament breaks, the situation changes only slightly—the next filament takes on the entire load.

Although samples P7D\_Sh-d-Grass (Figure 9c) and P8D\_Sun (Figure 9d) were under different field conditions (P7D\_Sh-d-Grass—in the shade, covered by grass; P8D\_Sun—in the sun), they demonstrate the expected behavior for samples with a set of filaments loaded approximately evenly: the load, having reached its limit, then dropped to virtually zero through a series of filament breaks.

Sample P10D\_Slid taken from under the landslide layer (Figure 9e) demonstrated behavior similar to the reference sample. The load was not perceived by the entire set of filaments, but most likely by one or two. According to the diagram, each next filament withstood a greater load than the previous one. The results obtained showed that the values of the maximum load per filament for samples P7D\_Sh-d-Grass, P\_Sun, and P10D\_Slid were in a range similar to those of the reference sample. As for the P7D\_Sh-d sample, the maximum load per filament turned out to be roughly 50% of that of the reference sample.

In terms of deformation, the reference sample was found to be the most elastic. The most brittle samples were P7D\_Sh-d-Grass (in the shade, covered with grass) with a loss of 85% and P10D\_Slid (under a layer of soil landslide) with a loss of 70% of the elasticity of the reference. Samples P7D\_Sh-d (in the shade) and P8D\_Sun (in the sun) also lost elastic properties (39% and 50%, respectively) (Table 3).
