Article

# Fatigue Damage Evaluation of Compressor Blade Based on Nonlinear Ultrasonic Nondestructive Testing

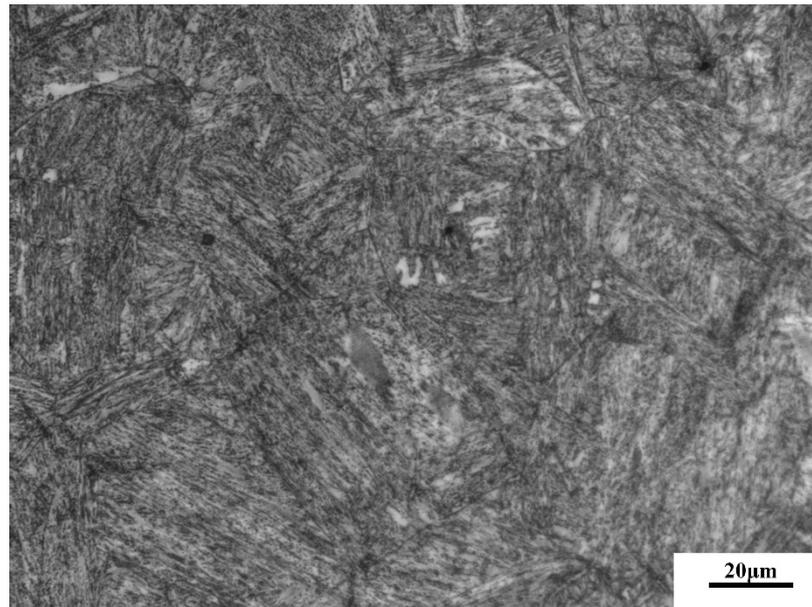
**Figure 1.** Microstructure of the KMN steel.

All test plates in this paper were from Shenyang Blower Works Group Corporation. The parameters in Table 3 refer to the technical requirements of the compressor blade heat treatment [25]. The heat treatment process of KMN steel involves quenching at 980 ± 10 °C for 1–1.5 h followed by oil cooling and then tempering at 700–750 °C for 1.5–2 h before air cooling. The metallographic specimen of KMN is corroded by nitric acid alcohol. The microstructure of KMN is shown in Figure 1. The metallographic structure is mainly needle-like and lath-like martensite. The microstructure is small and the distribution is relatively uniform. Some tiny inclusions can be found in the microstructure, and the size is about 1–2 μm.

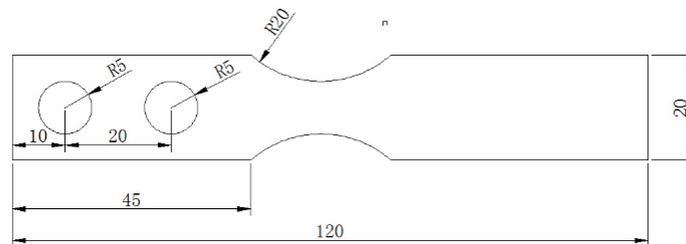
**Figure 2.** Shape and dimensions of the KMN vibration fatigue specimen (mm).

The ET-10d-240 type vibration test bench was used to perform a vibration fatigue test on the KMN specimen. The shape and size of the fatigue specimen are shown in Figure 2, and the thickness was 2 mm. The blade specimen was taken from impeller and the three-dimensional structure and the surface state after service was preserved, as shown in Figure 3. Before the fatigue test, the specimen surface was mechanically polished to keep the surface state consistent. The roughness  $R_a = 0.2$ .

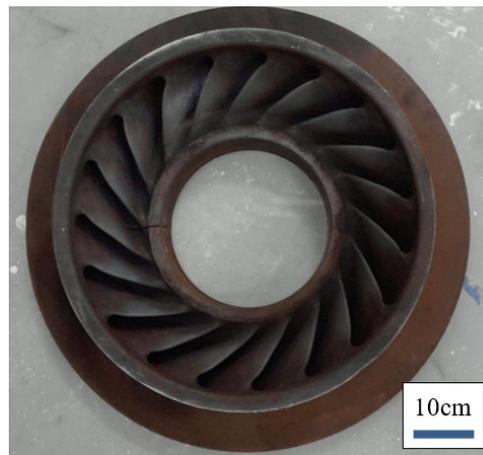
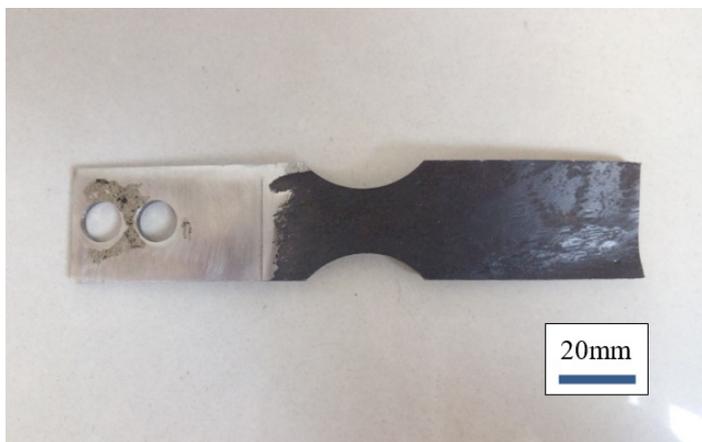
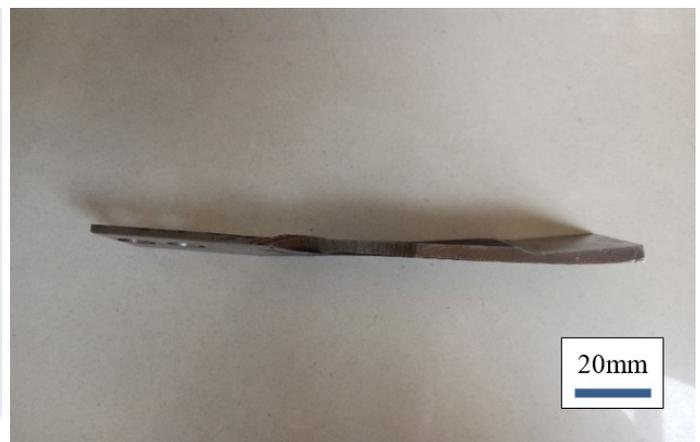
**Figure 3.** Impeller and KMN blade specimen. (a) Impeller; (b) KMN blade specimen after service; (c) top view of blade specimen.

We obtained the complete blade from the KMN compressor impeller and processed it into a specimen to keep its surface in service. In addition, we chose a blade specimen to polish the surface as a control specimen. The blade specimens were loaded with different cycles of fatigue, and then the RitecSNAP ultrasonic system was used for nonlinear ultrasonic testing to obtain the relationship curve between the nonlinear ultrasonic coefficient  $\beta$  and the cycle of fatigue, as shown in Figure 9.

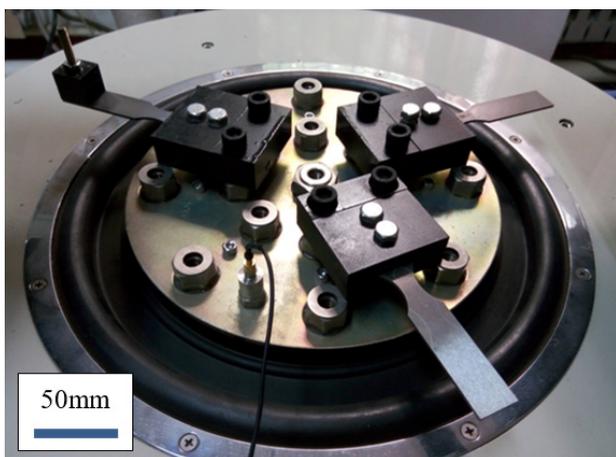
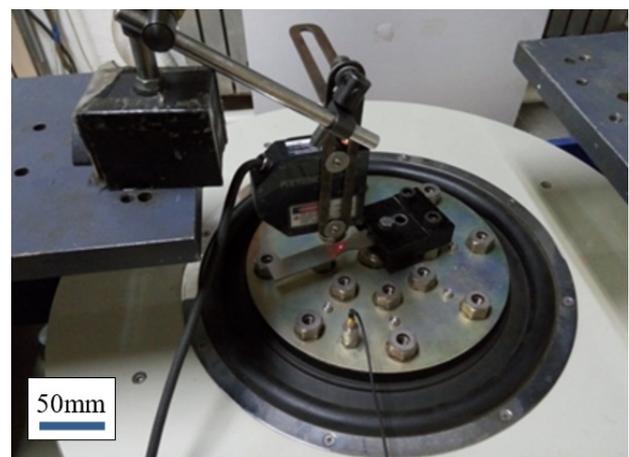
**Figure 4.** Vibration fatigue test of KMN. (a) Vibration test bench; (b) laser displacement sensor.

During the test, one end of the specimen was fixed on the surface of the vibration test bench by the fixture, and the other end was free to vibrate. When the excitation frequency of the vibration test bench was near the resonance frequency of the specimen, the specimen resonated. The measured first-order bending resonance frequency of the specimen was 59 Hz. The KMN specimen was subjected to fatigue loading with different cycles (until  $10^7$ ) using the vibration test bench, and fatigue specimens with different cycles were obtained, as shown in Figure 4. The acceleration control model was used during the test, the test temperature was room temperature, the loading waveform was sine wave, the loading frequency was 59 Hz, and the acceleration was  $5 \text{ m/s}^2$ . The vibration test in this paper followed HB 5277-1984 “Vibration Fatigue Test Method of Engine Blade and Material”. The main cause of blade fatigue failure was wake-induced vibration, and the first-order bending resonance frequency of the fatigue specimen was 59 Hz [25].

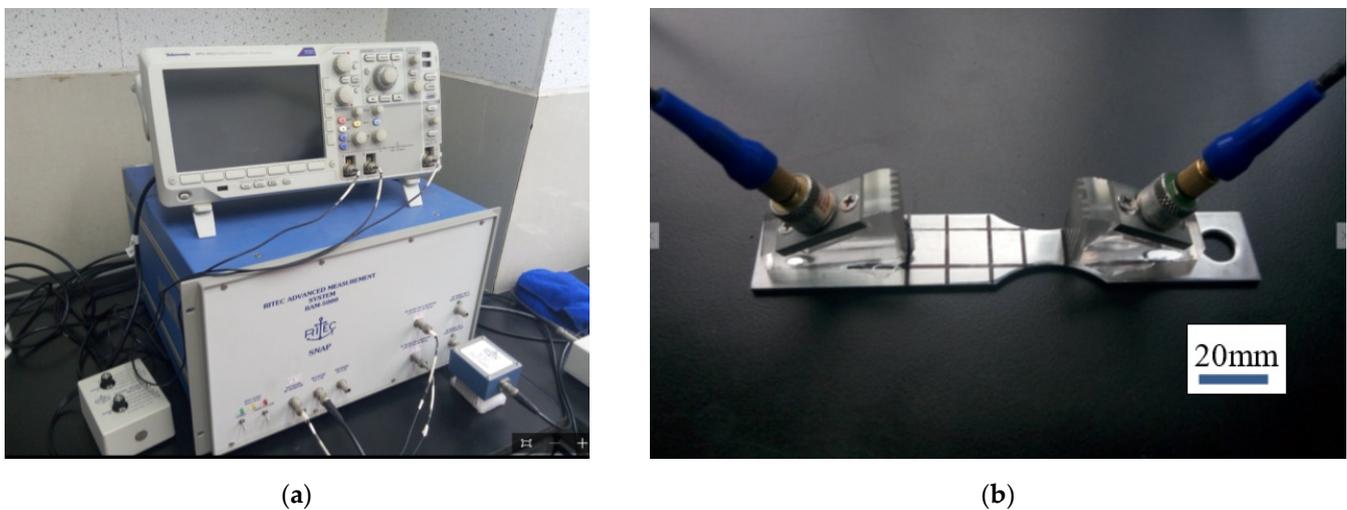
**Figure 5.** Nonlinear ultrasonic test system. (a) RitecSNAP ultrasonic system; (b) specimen and ultrasonic piezoelectric transducer.

The RitecSNAP high-energy ultrasonic system was used to perform ultrasonic Lamb wave nonlinear measurements on KMN specimens with different fatigue damage, as shown

in Figure 5. The pulse signal was excited by a signal generator, filtered by a low-pass filter, and then transmitted to the ultrasonic piezoelectric transducer. At this time, the voltage signal was converted into an ultrasonic vibration signal and entered the material to be measured. After wave propagation in the specimen, the ultrasonic signal was received by the piezoelectric transducer under the action of the nonlinear stress and strain of the material, and then obtained after passing through a high-pass filter. During the experiment, a narrowband piezoelectric transducer with a center frequency of 5 MHz was used as the transmitting probe, and a broad-band piezoelectric transducer with a central frequency of 10 MHz was used as the receiving probe. The frequency of the excitation signal was 5 MHz, the sampling rate of the oscilloscope was 1.25 GS/s, and the incident angle was  $27^\circ$  [22]. The probes at both ends were fixed by a fixture, and the pressure on the base surface of the probe was controlled at a relatively similar level during each measurement using a pressure sensor.

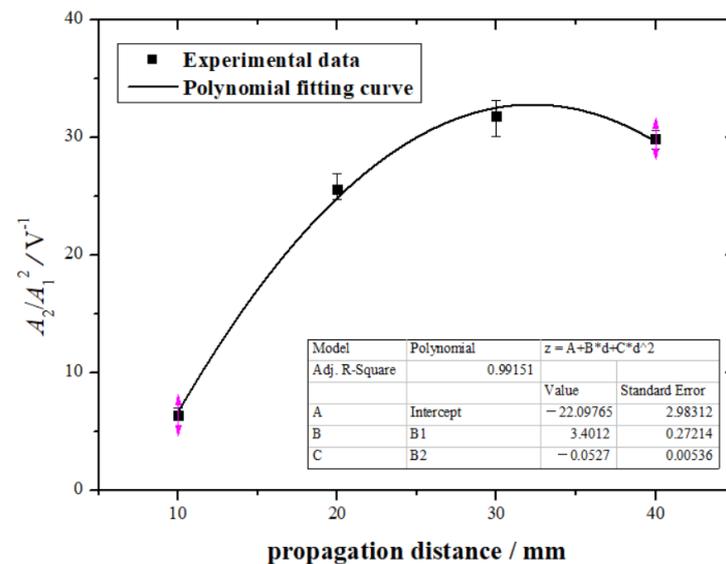
**Figure 6.** Relationship curve between  $A_2/A_1^2$  and the propagation distance of KMN vibration fatigue specimen. ( $R^2 = 0.99$ ).

When the incident voltage is fixed, there is a linear relationship between  $A_2/A_1^2$  and the propagation distance. We kept the incident voltage signal unchanged and changed the distance of the two transducers (10–40 mm). From Figure 6, we can see that when the propagation distance was relatively close, as the propagation distance increased,  $A_2/A_1^2$  also increased, which shows that the second harmonic signal we received came from the specimen itself. When the propagation distance was great, the value of  $A_2/A_1^2$  decreased instead. This is mainly determined by the size and shape of the specimen. When the propagation distance increased, the coupling of the signal in the specimen became worse. Therefore, we use a propagation distance of 10 mm in the subsequent experiments. At this time, the second harmonic signal was generated by the Lamb wave propagating in the material, rather than the harmonic signal generated by the wedge-shaped block or coupling agent.

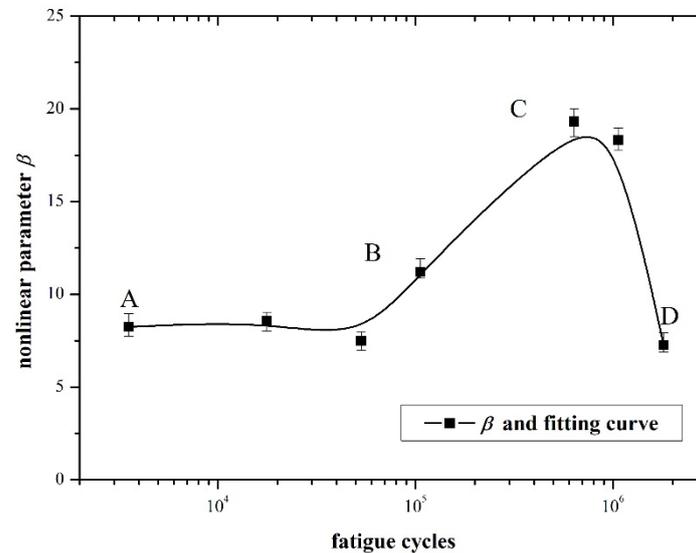
**Figure 7.** Relationship curve between nonlinear coefficient and fatigue cycles of the KMN vibration fatigue specimen. ( $R^2 = 0.93$ ).

normalized nonlinear coefficient to characterize the fatigue damage, and the relationship curve between the nonlinear ultrasonic coefficient  $\beta$  and the number of fatigue cycles was obtained, as shown in Figure 7.

From the figure, we can see that the nonlinear coefficient showed a trend of first rising and then falling with the increase in the number of fatigue cycles. At the beginning of fatigue (about before  $5 \times 10^4$  cycles), there were a few micro-defects inside the material. The fatigue damage at this time was mainly a small amount of dislocation slip and microstructure deterioration. These few defects cannot cause significant changes in the second harmonic, so the nonlinear coefficient  $\beta$  remained basically constant. In the early stage of fatigue (before  $10^6$ ), the nonlinear coefficient  $\beta$  increased with the increase in the number of fatigue cycles. The nonlinear coefficient  $\beta$  reached its peak when the micro-cracks started to initiate. In the late stage of the specimen's fatigue life (after  $10^6$ ), the nonlinear coefficient decreased. This shows that there is a corresponding relationship between the nonlinear coefficient  $\beta$  of the material and the fatigue damage. As the number of fatigue cycles increased, the fatigue damage inside the specimen also accumulated. When the ultrasonic wave signal propagated inside the material, the second harmonic wave excited by the sound wave at the damage also increased, and finally the nonlinear coefficient  $\beta$  of the material continued to increase. As the internal fatigue damage degree increased, the appearance of cracks increased the attenuation coefficient of the material, resulting in a decrease in the nonlinear coefficient in the late fatigue life.

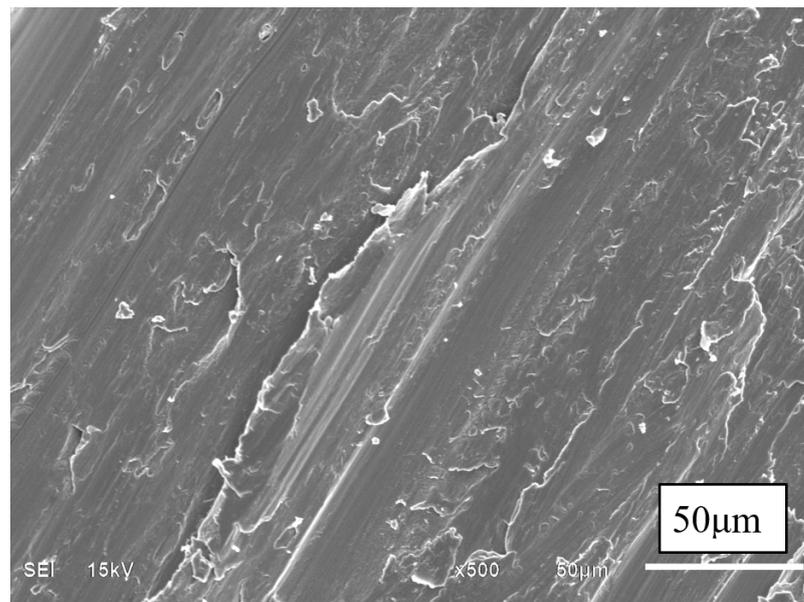
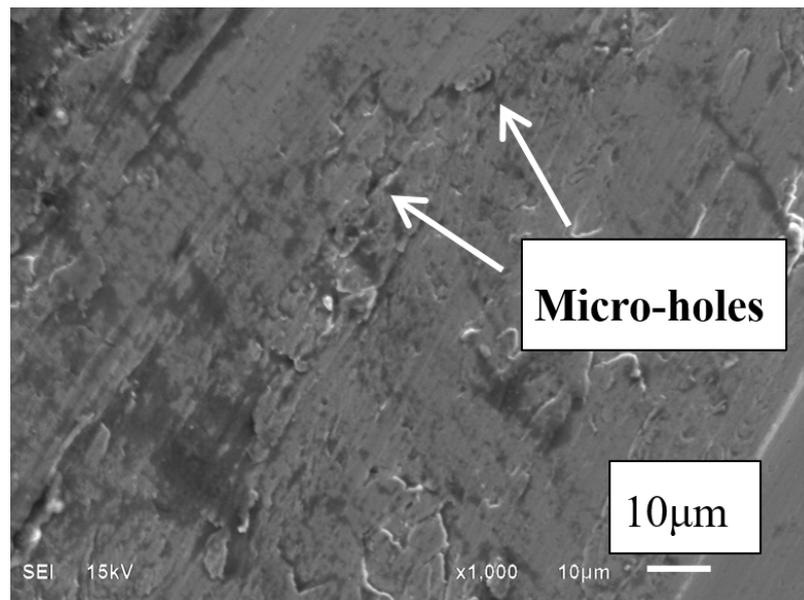
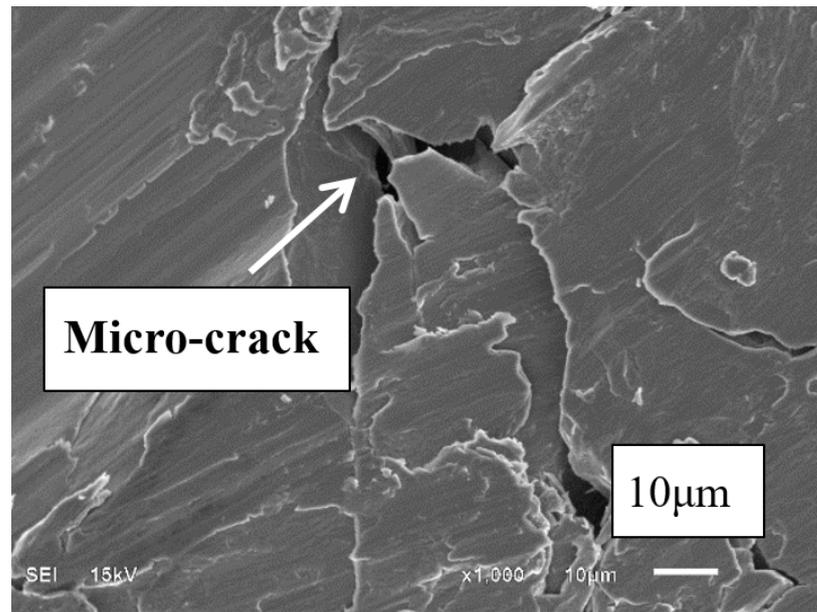
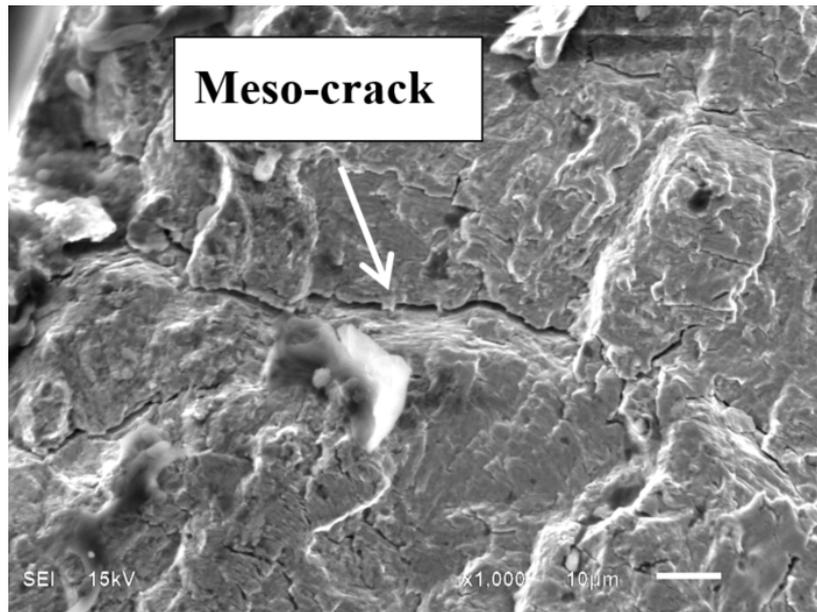
**Figure 8.** SEM microstructure of KMN vibration fatigue specimen. (a) Point A in Figure 7; (b) point B in Figure 7; (c) point C in Figure 7; (d) point D in Figure 7.

In order to further study the relationship between the nonlinear coefficient and the micro-damage inside the material, the stress-concentration zone of the KMN vibration fatigue specimen was dissected and its microscopic appearance was observed. At the narrowest part of the specimen, there was a maximum stress level, and fatigue cracks initiated from this position. It was found that as the number of fatigue cycles increased, the microstructure of the specimen deteriorated relatively, as shown in Figure 8. Figure 8a presents the original specimen, and the material matrix is relatively flat. There were no obvious defects, and the nonlinear coefficient  $\beta$  corresponding to point A in Figure 7 was low. At the beginning of fatigue (about before  $5 \times 10^4$  cycles), there were a few micro-defects inside the material, so the nonlinear coefficient  $\beta$  remained basically constant. As the number of fatigue cycles increased, we can see from Figure 8b that the material had tiny defects such as micro-holes. Corresponding to point B in Figure 7, the

nonlinear coefficient  $\beta$  increased slightly. From Figure 8c, we can see that there were micro cracks in the material matrix. Corresponding to point C in Figure 7, the nonlinear coefficient  $\beta$  increased significantly and reached the peak value. With the further increase in the number of fatigue cycles, the specimen displayed macroscopically large cracks, as shown in Figure 8d. The appearance of cracks increased the attenuation coefficient, resulting in a decrease in the nonlinear coefficient. Corresponding to point D in Figure 7, the nonlinear ultrasonic coefficient  $\beta$  began to decrease. It was proved that there is a corresponding relationship between the material's nonlinear coefficient  $\beta$  and the material's internal damage, and the material's nonlinear coefficient  $\beta$  can be used to characterize the material's fatigue damage.

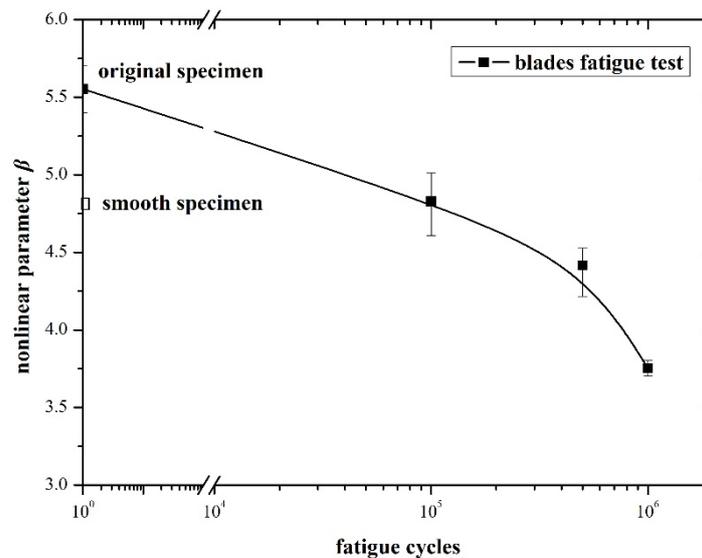
**Figure 9.** Relationship curve between nonlinear coefficient and fatigue cycles of KMN blade fatigue specimen.

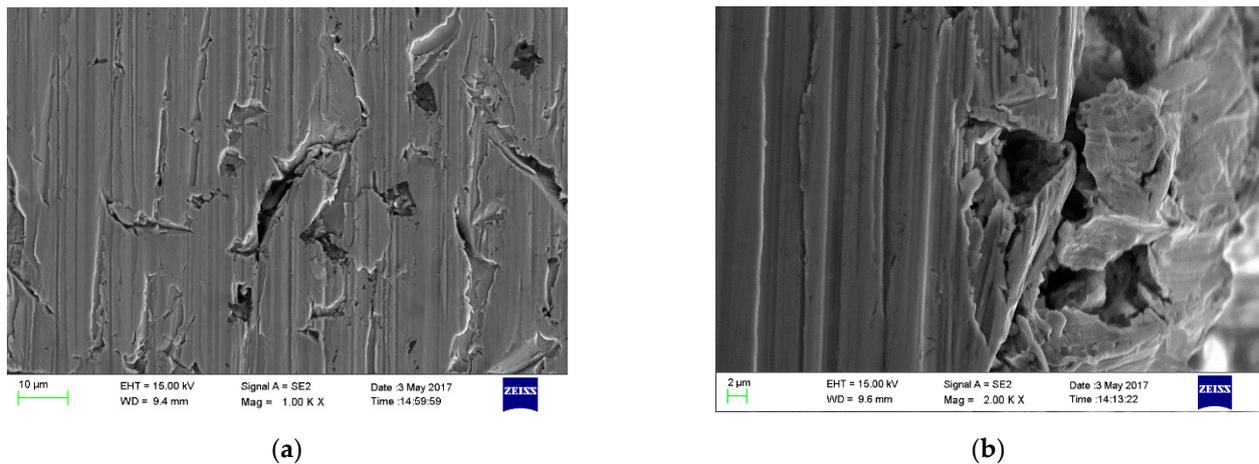
**Figure 10.** SEM Microstructure of KMN blade fatigue specimen. (a) The middle of the cross section; (b) the cross section close to the surface.

It can be seen from Figure 10 that the nonlinear coefficient  $\beta$  of the blade fatigue specimen gradually decreased with the increase in the number of fatigue cycle. This is because the blades of the impeller have been in service for a long time, and defects such as fatigue micro-cracks have been generated inside. The blade has entered the late stage of its fatigue life, that is, the falling stage of the  $\beta$ - $N$  curve. At this time, the micro-cracks inside the specimen cause the attenuation coefficient of the material to increase, and the nonlinear coefficient  $\beta$  decreases with the increase in the number of fatigue cycles. In addition, the original specimen and smooth specimen in Figure 10 were used to study the influence of surface condition on nonlinear coefficient. Because the Lamb wave propagates inside the material, the defects inside the specimen are more important than surface condition. Comparing the original specimen and the smooth specimen, it could be found that the nonlinear coefficient of the smooth specimen was slightly lower than that of the original specimen, but the difference between the two was not much. This is because the nonlinear ultrasonic Lamb wave propagates inside the specimen, and the signal received in the experiment mainly comes from the second harmonics excited by the internal defects of the specimen. Therefore, the measured nonlinear coefficient was more sensitive to the internal defects of the specimen, which shows that the nonlinear ultrasonic detection can be used for the detection of small damage and defects in the initial fatigue stage of the material.

The stress-concentration zone, that is, the narrowest part of the specimen, of the fatigue specimen of the KMN blade was dissected, and its microscopic appearance was observed. It was found that there were a large number of microscopic defects such as holes and cracks inside the specimen, which also proved that the blade had entered the late stage of fatigue life at this time, as shown in Figure 10.

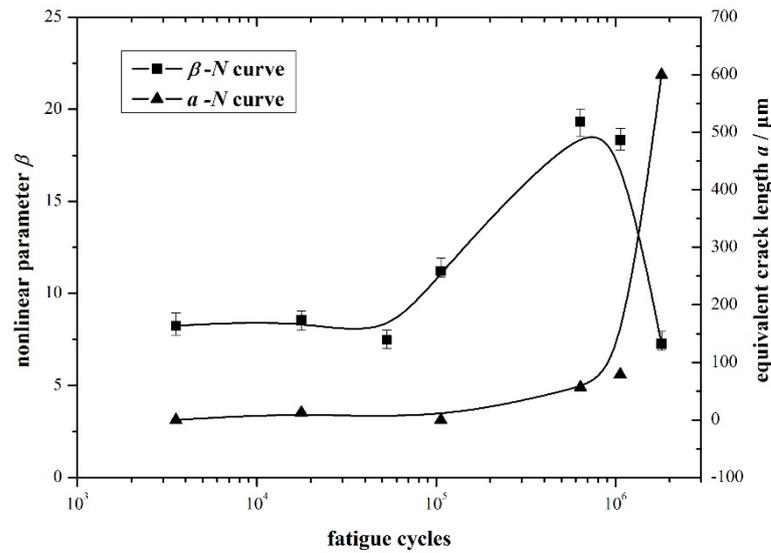
**Figure 11.** Relationship between nonlinear coefficient  $\beta$ , equivalent crack length, and fatigue cycles of the KMN vibration fatigue specimens. ( $R^2 = 0.93$  for  $\beta$ - $N$  curve).

As the number of fatigue load cycles increases, the microstructure of the specimen will become defective and cracks will form, which will eventually lead to fatigue failure. Combined with the microstructural analysis of the stress-concentration zone of the vibration fatigue specimen, the number and length of fatigue cracks in the 10 standard fields ( $500 \times 500 \mu\text{m}$ ) of view of each specimen were counted, as shown in Table 4. The equivalent crack length refers to the sum of all crack lengths in 10 standard fields [30–33]. Since the received signal of the nonlinear ultrasonic Lamb wave is the sum of the second harmonic generated by all of the defects in the sampling area, it is more reasonable to use the equivalent crack length in the research than the single crack length. From Figure 11, we can see that the number of cracks and the equivalent crack length continued to increase with the increase of fatigue cycles, reflecting the process of continuous crack propagation in the specimen. In particular, when the specimen had large macro-cracks, the number and size of the internal cracks increased significantly.

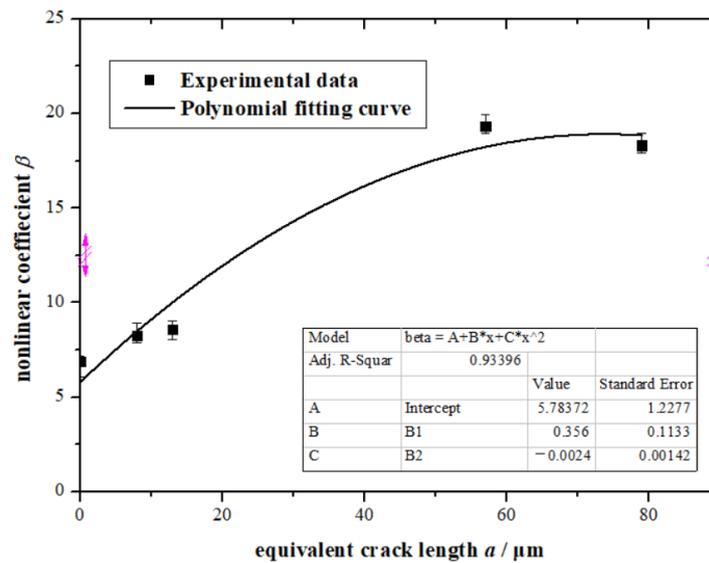
**Figure 12.** Relationship between equivalent crack length and nonlinear coefficient of the KMN vibration fatigue specimens.

In order to further analyze whether there is a connection between the micro-cracks inside the specimen and the measured nonlinear coefficients, we established the relationship curve between the equivalent crack length of the material and the nonlinear coefficient (i.e., the  $\beta$ - $a$  curve). It can be seen from Figure 12 that, as the length of the crack increased, the nonlinear coefficient of the material also increased, indicating that there is indeed a certain corresponding relationship between the nonlinear coefficient and the propagation of the crack, so we can use the nonlinear coefficient to reflect the propagation process of fatigue cracks inside the material.

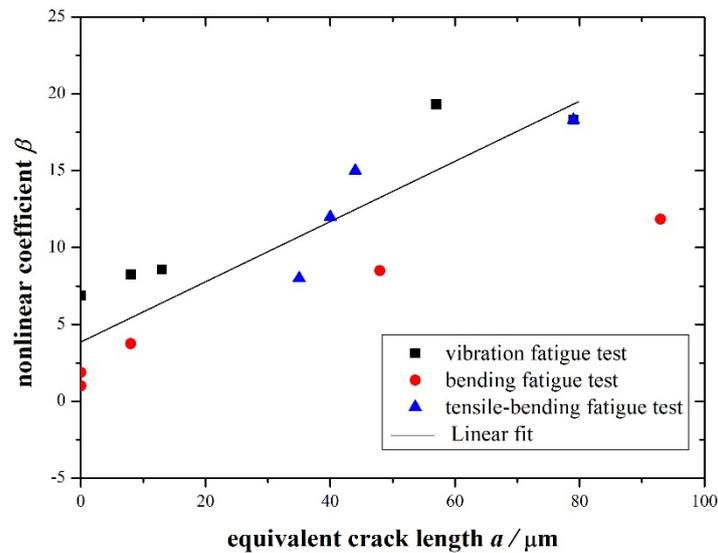
Figure 13. Relationship between nonlinear coefficient and crack propagation size. ( $R^2 = 0.79$ ).

On the basis of the KMN vibration fatigue test in this paper, two sets of KMN specimens for the bending fatigue test and tensile-bending fatigue test were added. Their normalized nonlinear coefficients and the equivalent crack length were obtained, and then, the relationship curve between the KMN nonlinear coefficient and the crack growth size was obtained, as shown in Figure 13.

Fitting the data points in the figure, we can establish the empirical formula of the blade material KMN nonlinear coefficient and the crack growth size:

$$\beta = 4.04 + 0.19a \tag{1}$$

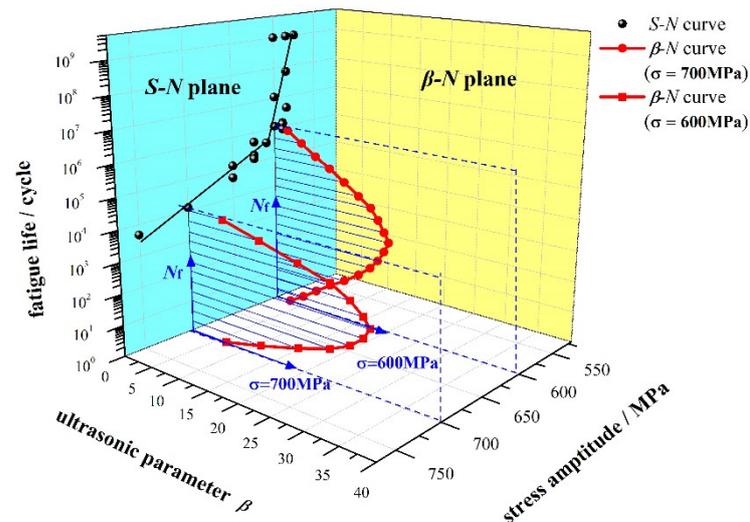
Figure 14. Schematic diagram of the  $\beta$ - $S$ - $N$  three-dimensional model.

In the previous research, we obtained a very high cycle fatigue  $S-N$  curve and  $\beta-N$  curve of the blade material KMN, both of which reflect the fatigue performance of the material [22–24]. In order to observe the relationship between the two more intuitively, we created a  $\beta-S-N$  three-dimensional model containing the  $S-N$  plane and the  $\beta-N$  plane, as shown in Figure 14. It can be seen from the figure that the  $\beta-N$  curve we studied is the change in the nonlinear coefficient  $\beta$  under the stress of a certain point in the  $S-N$  curve with the increase of fatigue cycles, and the maximum value is the fatigue life corresponding to the stress.

Corresponding to any point on the  $S$ - $N$  curve, the fatigue life is  $N_f$ . The nonlinear ultrasonic testing of the material was carried out, and then the  $\beta$ - $N$  curve when the fatigue life is  $N_f$  can be obtained.  $\beta$ - $S$  plane is mainly used to describe the relationship between  $\beta$  and stress. Normally, a larger stress level will result in a higher value of  $\beta$ . The dislocation string model was used to convert the nonlinear ultrasonic  $\beta$ - $N$  curve measured under the calibrated stress [35–38], and the nonlinear ultrasonic  $\beta$ - $N$  curve under arbitrary load can be obtained.
