# Multi-Analytical Research on the Caisson Painting of Dayu Temple in Hancheng, Shaanxi, China

**Abstract:** In this research, the caisson painting of Dayu Temple in Hancheng, Shaanxi, China, was analyzed via a multi-analytical methodology, using a pH meter, an ultra-depth-of-field optical microscope, a scanning electron microscope-energy dispersive spectrometer (SEM-EDS), a high-resolution X-ray diffractometer (XRD), a micro-confocal laser Raman spectrometer, a gas chromatography mass spectrometer (GC-MS), and X-ray fluorescence spectroscopy (XRF). With the corroborative evidence derived from the above analyses, it could be determined that the caisson painting of Dayu Temple was painted on bamboo paper and attached to hemlock wood substrate of the Pinaceae *Tsuga* genus using starch paste, with common colorants such as carbon black, cinnabar mixed with a small amount of red lead, ultramarine, and ultramarine mixed with Paris green, with animal glue having been adopted as a sizing agent. These results provide important scientific data for the production craft of precious caisson paintings, contributing to the revelation of their historic, artistic, and scientific value, and should

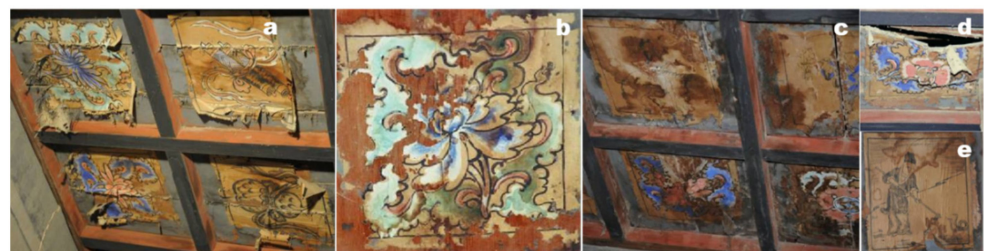
**Figure 2.** Deterioration of Caisson Paintings. (a) Falling off; (b) missing; (c) pollution; (d) plank cracking; (e) blistering.

The existing buildings include the dedication hall and the main hall, all of which are made up of shrines; the niches are made of wood with a brick base. The tops of the niches are made of caissons, the eaves of which are in a row, and there are five rows in the alcoves, each row containing 28 grids, with a total of 168 caisson paintings. Due to its brilliant color and exquisite brushwork, it has high historical and artistic value. The caisson paintings in the Great Hall of Dayu Temple in Hancheng are the most important part of the building. An on-site cultural relic survey found that large areas of the caisson paintings had been stripped, peeled off, polluted, warped, blistered, torn, and made brittle (as shown in Figure 2). Due to these factors, the wooden board base attached to the caisson paintings has also suffered from cracking, fracture, damage, decay, and other deterioration, placing the caisson paintings on the verge of self-destruction. If the caisson paintings are not repaired in time, they will disappear forever. This study aimed to use the multivariate analysis method to analyze and test the wooden board base, paper type, acidification
