Evaluation of Passivation Process for Stainless Steel Hypotubes Used in Coronary Angioplasty Technique

Abstract: In the manufacturing of hypotubes for coronary applications, austenitic steels of types 304, 304, or 316 L are being used. The manufacturing process involves bending steel strips into tubes and the continuous longitudinal welding of the tubes. Manufacturing also includes heat treatments and stretching operations to achieve an external/internal diameter of 0.35/0.23 mm, with a tolerance of ± 0.01 mm. Austenitic steels are sensitive to localized corrosion (pitting, crevice, and intergranular) that results from the welding process and various heat treatments. An extremely important step is the cleaning and the internal and external passivation of the hypotube surface. During patient interventions, there is a high risk of metal cations being released in contact with human blood. The aim of this study was to evaluate the state of passivation and corrosion resistance by using electrochemical methods and specific intergranular corrosion tests (the Strauss test). There were difficulties in passivating the hypotubes and assessing the corrosion phenomena in the interior of the tu

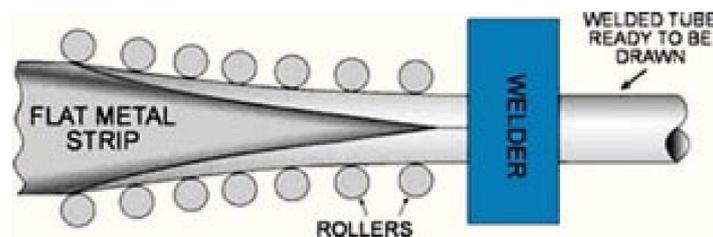
Figure 1. The manufacturing process of a welded hypotube.

Hypotubes for coronary applications, made of austenitic 304 (DIN 1.4301), 304L (DIN 1.4306), or 316L (DIN 1.4435) grade steels, are manufactured from metal strips, rolled and welded, and then stretched several times to obtain the desired dimensions and hardness. Austenitic stainless steels may cause cracking problems at high temperatures, are sensitive to grain magnification, and require certain welding precautions. Choosing the right welding process and procedure can avoid many problems, particularly intergranular corrosion. Thus, welding can be carried out by a micro plasma or tungsten inert gas (TIG) system, and the filler metal can be TIG ER 316L or W 19 12 3 L. Usually, welding is carried out by a continuous process over a length of 260 m (torch process) (Figure 1) [7–9].

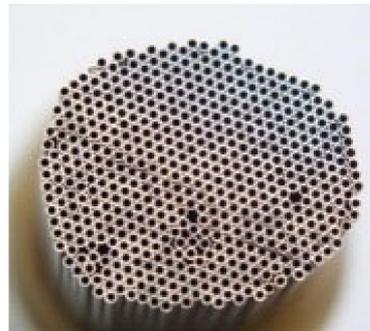
Figure 2. Image of a bundle of 500 hypotubes.

The hypotubes—with an external diameter (ED) = 0.35 mm, internal diameter (ID) = 0.23 mm (+/− 0.01mm tolerance) and length (L) = 2600 mm—were cleaned, pickled, and passivated. The tightness of their walls was tested by using water with a fluctuation between 20 and 50 bars. A bundle of 500 hypotubes is shown in Figure 2.

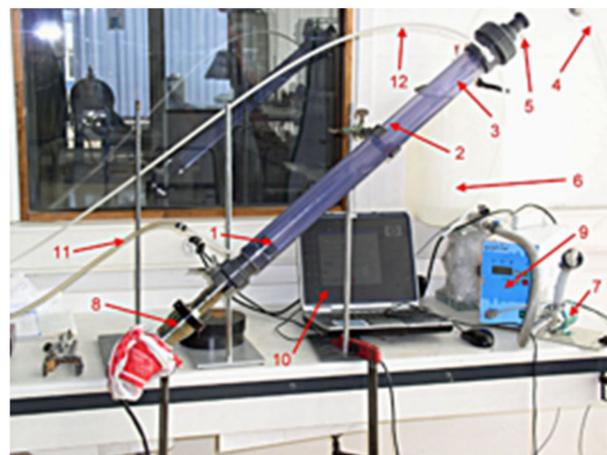
Figure 3. Micro-pilot for pickling and passivation of the hypotubes. 1: Tube originating from the tank (6); 2: reactor containing water (conduction of ultrasonic waves and refrigerant); 3: reactor containing the hypotubes; 4: pipe originating from the tank (6); 5: reactor (3) outlet pipe; 6: buffer tank; 7: pump; 8: sonotrode (titanium booster—2 pieces at 20 kHz); 9: ultrasound generator (20 kHz, with a maximum of 4000 W); 10: generator (9) control software; 11: refrigerating water (arrival); 12: refrigerator water (exit).

A micro-pilot was designed according to Figure 3. The pickling reactor consisted of two concentric tubes. The central reactor (3) contained the pickling solution in which the hypotubes were placed. The pickling solution was continuously recirculated from the buffer tank (6) by the pump (7) with a flow rate of 2 L/min. The reactor was positioned with an incline of 45° to facilitate the removal of residual air from the interior of the hypotubes. For stirring, an ultrasound generator (9) was mounted at the bottom part of the reactor. To conduct the ultrasonic waves, water was recirculated within the two tubes. The high-power ultrasonic converter (sonotrode) was hosted in a fully protected housing.

The ultrasonic system was able to generate a strong and efficient ultrasonic-jet excitation of the hypotubes in order to accelerate the internal and external cleaning, surface treatment, and rinsing, based on the ultrasonic capillary effect and cavitation. The combined effects of chemical treatment and ultrasonic agitation aimed to significantly simplify and accelerate the cleaning of the hypotubes.

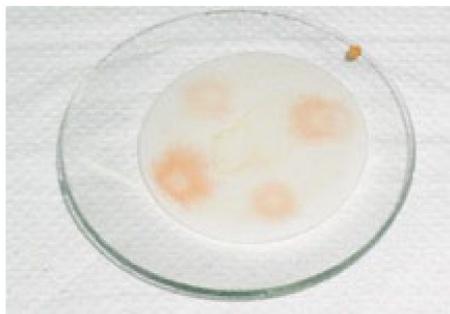
Figure 4. Red coloration due to the presence of orthophenanthroline hydrochloride inside the hypotubes.

Orthophenanthroline hydrochloride is a chemical indicator with the property of giving an intense red color when brought into contact with ferrous ions (Fe^{+2}). This property was used to highlight the circulation of water inside the hypotubes, with the detection limit being 0.7 mg/L. In a first step, the reactor was placed in a vertical position at 90° . Fifty hypotubes were introduced into the reactor, and then water containing orthophenanthroline hydrochloride (4 g/L) was added to fill the reactor. After 10 min of ultrasound, the reactor and tank were purged. In a second step, water (total volume: 15 L) was circulated under ultrasound for 10 min. Checking how many of the fifty hypotubes had been filled was done by emptying them onto filter paper soaked in an iron sulphate solution (1 g/L). The appearance of a red coloration on the filter paper indicated the presence of the indicator inside the hypotube (Figure 4).

Out of the fifty hypotubes, thirty-seven positively responded to orthophenanthroline (staining), eight negatively responded to orthophenanthroline, and six were clogged. According to this result, water circulated in only eight hypotubes out of fifty. By using this technique, the requirements imposed by medical-device legislation cannot be ensured because the interior and the exterior of the hypotubes must be passivated before use.

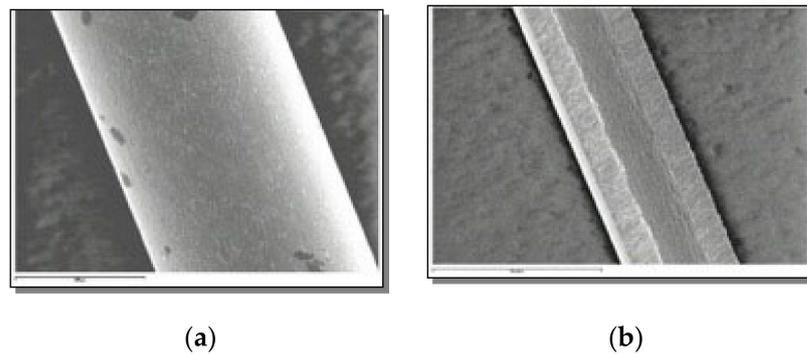
Figure 5. Images of hypotube #8(ref): (a) exterior surface (scale = 200 μm) and (b) interior surface (scale = 500 μm).

The chemical composition of the internal and external part of hypotubes #1–#17 was analyzed by energy-dispersive X-ray spectroscopy (EDX). An image of reference hypotube #8 is given in Figure 5. The samples were cut and washed with ethanol p.a. under ultrasound.

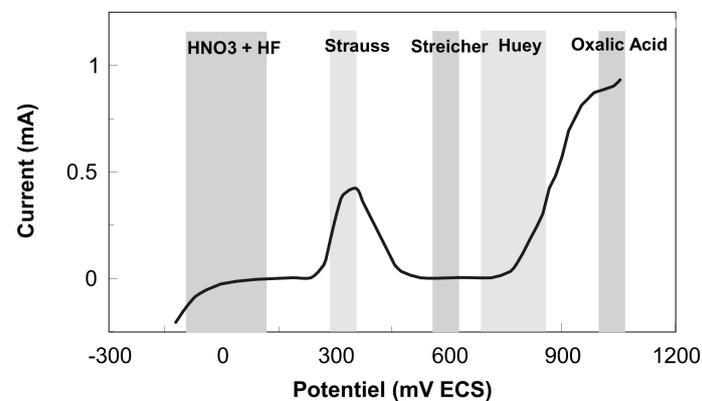
Figure 6. Corrosion potential corresponding to the various intergranular corrosion tests superimposed on a polarization curve of a 304L austenitic steel in 1M H_2SO_4 .

This test investigates the intergranular corrosion behavior of steels in a potential range between 110 and 300 mV, according to Streicher (Figure 6) [14,15].

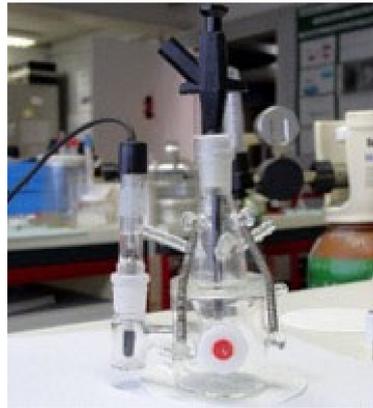
Figure 7. Electrochemical cell for the evaluation of the external surface.

For the external surface, a glass electrochemical cell with a volume of 5 mL of electrolyte was designed (Figure 7). The hypotube, with a length of 3 cm, was immersed in the measuring cell and linked to an electrode holder (Figure 7: black, in the center of the cell). The counter electrode was made of 70% Pt and 10% Ir. The electrolyte was 9 g/L NaCl.

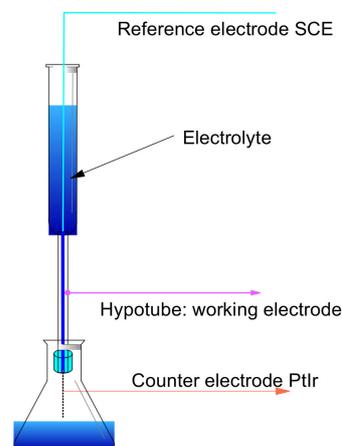
Figure 8. Assembly for the evaluation of the internal surface of the hypotube.

For measurements of the internal surface of the hypotubes, another assembly—consisting of a 1 mL electrolyte reservoir—was used (Figure 8). The hypotube, 5 cm long, was connected to the working electrode channel of the potentiostat. The reference micro-electrode (saturated calomel electrode-SCE) was positioned at the entry of the hypotube, and the Pt–Ir micro counter-electrode (with a diameter 0.150 mm) was positioned at the exit of the hypotube. The hypotube stood as the measuring electrode, and the electrical contact with the potentiostat was made on the exterior of the hypotube. The electrolyte flowed through the hypotube at a rate of 1 mL for approximately one hour. The electrolyte was 9 g/L NaCl. The insulating sheath from microlumen polyamide (ED = 0.20 mm; ID = 0.18 mm). This sheath could be introduced into the hypotubes with an ID = 0.23 mm.

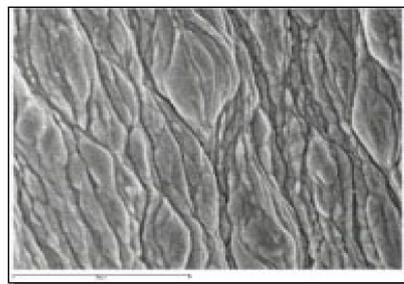
Figure 9. Hypotube #8(ref): structure of the interior surface (scale = 20 μ m).

The hypotubes were examined by SEM. The irregular appearance of the structure coincided with the rough appearance of the internal surface (Figure 9).

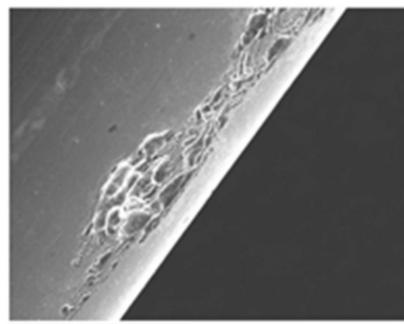
Figure 10. Longitudinal defect of hypotube #6 (scale = 200 μ m).

Hypotube #6 presented a longitudinal defect (Figure 10)—due not to corrosion but instead to a tearing off, probably a consequence of the stretching process.

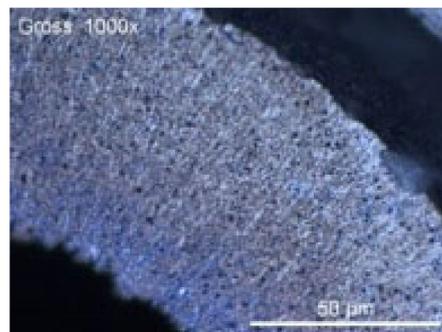
Figure 11. Microstructure of hypotube #8(ref): transverse surface (scale = 50 μm).

Because the microstructure was very fine and hardened, it would have been very difficult to assess the grain index (Figure 11).

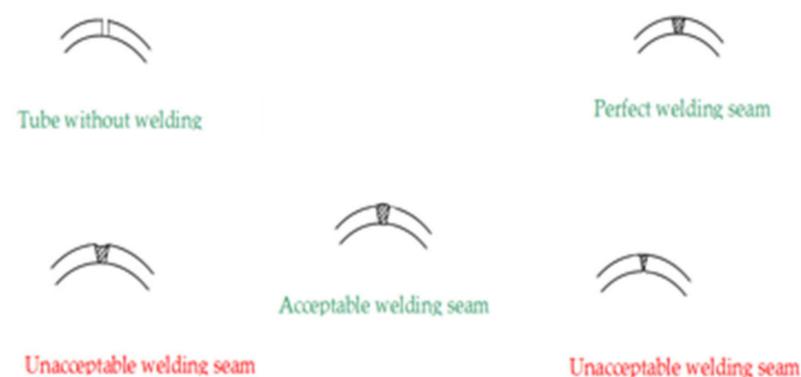
Figure 12. Welding seam criteria.

There is a very strict acceptance protocol after a welding process, and the following, extremely strict requirements for the parameters have to be respected:

(a) The external diameter must be $ED \pm 1.5\%$ or minimum of 0.23 mm. (b) The wall thickness must be $WT \pm 10\%$ or minimum 0.2 mm. (c) Lines, scratches, indents, and cavities, should be considered as defects. When counting the number of defects per meter, several defects within 1 cm (the unit of measurement) are considered to comprise one 1 cm defect. The maximum acceptable limit is 5 cm of defects per meter. (d) Regarding the crushing resistance test: when swatting a hypotube with a hammer, if the weld resists, it should be considered compliant. (e) A metallographic analysis should be used to show the eventual porosities, cracks, and welding seam shape and position. (f) The shape or geometry of the welding seam considered acceptable following welding seam criteria is shown in Figure 12. (g) The heat treatment condition must be considered, whether it is welded from hot-rolled or cold-rolled strip or it is bright annealed (annealing carried out in conditions that make it possible to obtain a metal surface free of oxides or showing only very slight coloring). Heat treatment should be done in a controlled atmosphere to retain the material's non-oxidized surface or to remove any present oxidized layers. (h) One must obtain a material certificate (through chemical analysis) and measure the mechanical properties ($R_{p0.2}$ Mpa or N/mm^2 , $R_{p1.0}$ Mpa or N/mm^2 , R_m Mpa, or N/mm^2 and A_{100} (%)).

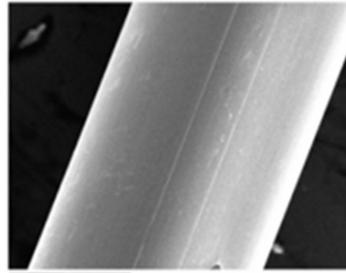
Figure 13. Longitudinal welding cord: hypotube #8(ref) (scale = 200 μm).

Figures 13 and 14 show the weld appearance of hypotube #8(ref). The transversal cross section reveals the welding cord due to the manufacture process (Figure 14).

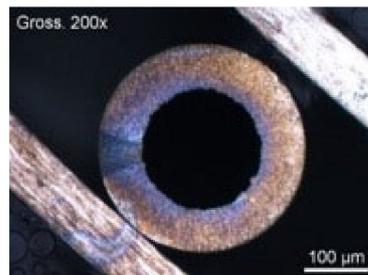
Figure 14. Weld in cross section: hypotube #8(ref) (scale = 100 μm).

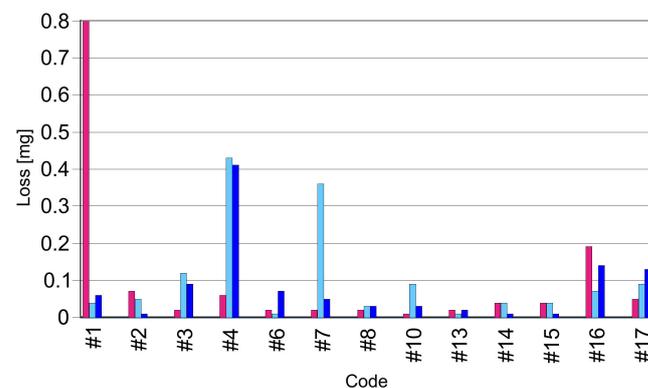
Figure 15. Mass loss of the samples tested.

Hypotubes #1, #2(ref), #3, #4, #6, #7, #8(ref), #10, #13(ref), #14, #16, and #17 (Table 2) were evaluated by the Strauss test. Three samples from each hypotube were tested. For each sample, the following investigations were carried out: SEM examination, mass loss measurements on an analytical balance $\pm 10 \mu\text{g}$, and (after folding observation for possible cracks), optical microscopy. Figure 15 shows the mass loss for the tested hypotubes. The average mass loss for each hypotube is presented in Table 5.

In general, the tested hypotubes did not exhibit intergranular corrosion, as mass losses were low. Most of the samples showed a very small mass loss, close to the limit of the analytical balance. Nevertheless, hypotubes #1, #4, and #16 showed very significant mass losses (Figure 15 and Table 5).

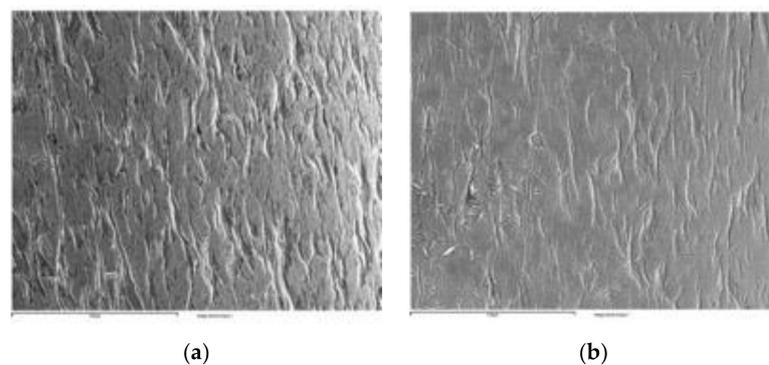
Figure 16. Images of hypotube #1: (a) before the intergranular test (scale = 100 μm) and (b) after the intergranular test (scale = 100 μm).

SEM observations at magnification did not show any obvious degradations of the surfaces. Observation of the surfaces enabled us to qualitatively discriminate the samples without speaking of intergranular corrosion. Thus, hypotubes #1, #4, and #16 presented the most degraded surfaces (Figures 16–18). Considering the mass losses and the electronic micrographs, it appears that hypotubes #1 and #4 were most affected (Figures 16 and 17). The rest of the hypotubes had roughly the same behavior with respect to this test. For comparison, Figure 19 presents reference hypotube #13.

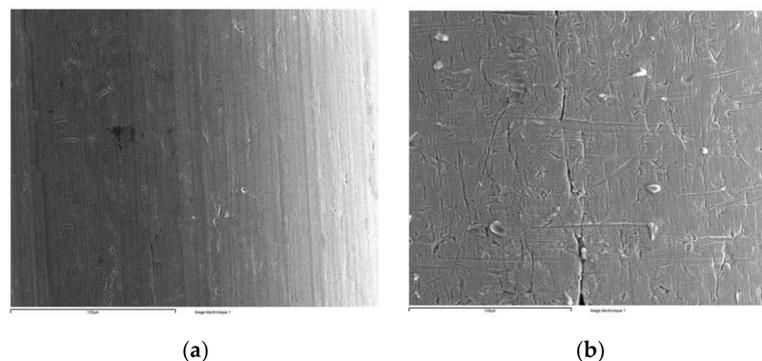
Figure 17. Images of hypotube #4: (a) before the intergranular test (scale = 100 μm) and (b) after the intergranular test (scale = 100 μm).

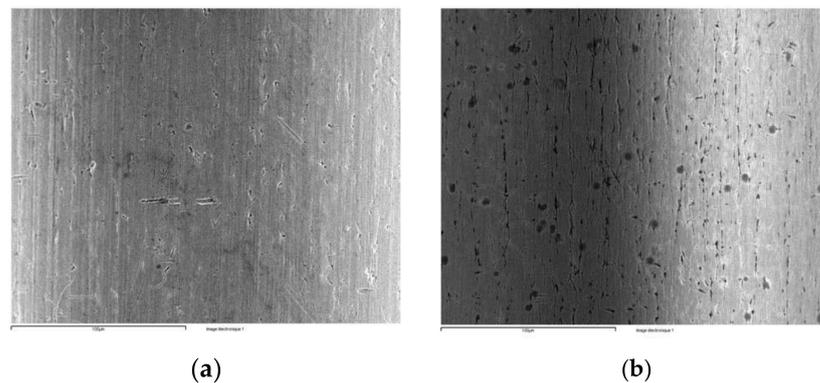
Figure 18. Images of hypotube #16: (a) before the intergranular test (scale = 100 μm) and (b) after the intergranular test (scale = 100 μm).

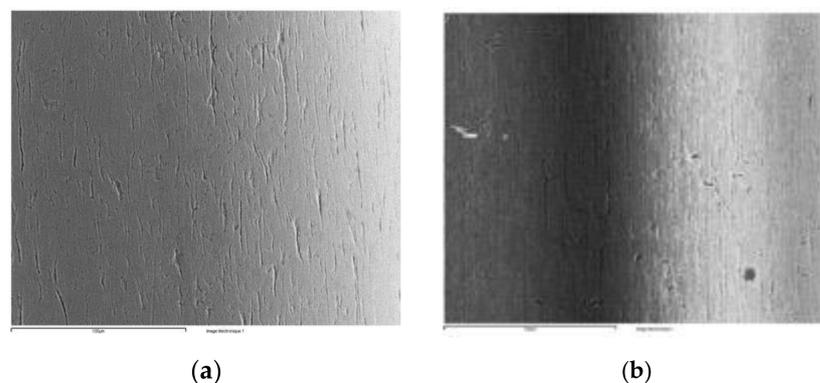
Figure 19. Images of reference hypotube #13(ref): (a) before the intergranular test (scale = 100 μm) and (b) after the intergranular test (scale = 100 μm).

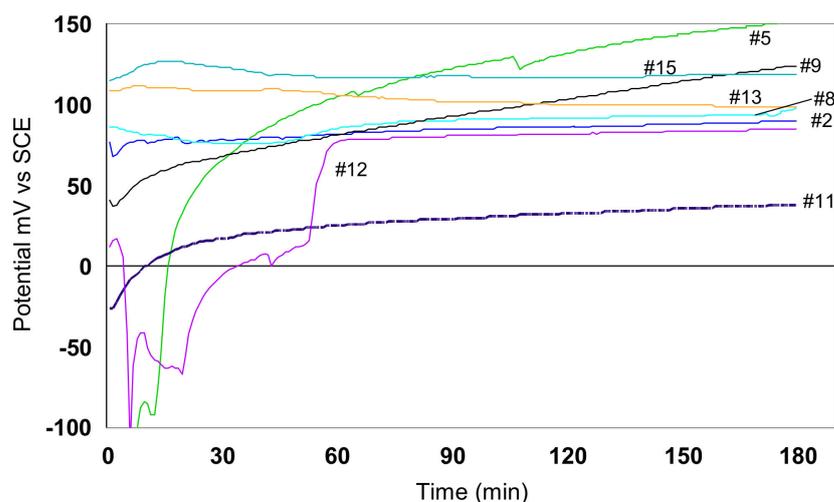
Figure 20. The open circuit potentials measured on the external surfaces of the hypotubes.

For both the external and internal surfaces, the open circuit potentials were measured for 180 min. The open circuit potential as a function of time in the external surface of the hypotubes is shown in Figure 20.

Hypotubes # 5, #11, and #12 revealed insufficient passivation. They started from negative (anodic) potential values but had a “passivation” tendency in time in the considered electrolytic medium. The open circuit potential value of a passivated type 304 steel was around +100 mV SCE. Hypotubes #9, #11, and #5 continued to passivate in the electrolytic medium. The hypotubes that underwent a chemical passivation were #2(ref), #8(ref), #13(ref), and #15, as their open circuit potential was characterized by small variations and did not reveal disturbances. In the case of hypotube #4, the external surface presented an electrically non-conductive protective layer for the considered time period of 180 min, so registering the potential was not possible.

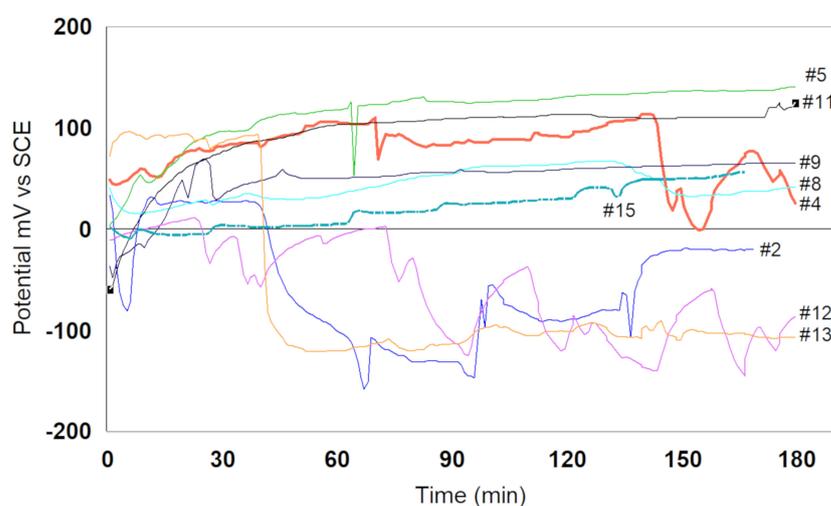
Figure 21. The open circuit potentials measured on the internal surfaces of the hypotubes.

The open circuit potentials measured for the internal surface of the hypotubes are presented in Figure 21. Hypotubes #2(ref), #5, #9, #11, #12, #13(ref), and #15 were not chemically passivated. There was a tendency of passivation as a function of time. Hypotubes #2(ref), #9, #11, and #13(ref) started at negative (anodic) potentials. Hypotubes #5 and #15 started at low positive potentials (Table 6) but had a tendency to passivate over time towards a level of 150 mV vs. SCE. The only hypotubes that underwent the passivation of the internal surface were #4 and #8(ref). On the other hand, the electric potential was quite low, and it was difficult to conclude if these values expressed a true chemical passivation in comparison with the external surface of hypotube #8(ref).

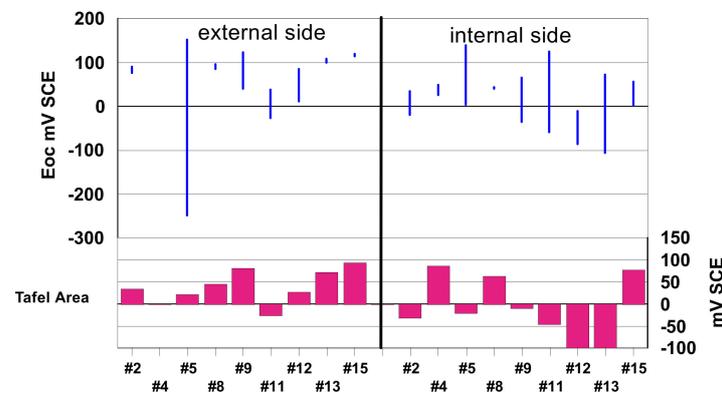
Figure 22. Summary of results.

In Figure 22, a summary of the results is represented. In the upper section, the open circuit potential values—, or more precisely, the starting value and the value at the

end of the test—are represented. In the lower section, the E_{corr} values after plotting the potentiodynamic polarization curves in the Tafel domain are represented.
