Flexural Strength of Damaged RC Beams Repaired with Carbon Fiber-Reinforced Polymer (CFRP) Using Different Techniques

Abstract: In this study, an experimental program was developed to investigate the flexural behavior of pre-damaged reinforced concrete (RC) beams that had been repaired and strengthened using carbon fiber-reinforced polymer (CFRP) laminates under a monotonic load. Two techniques were used: externally bonded reinforcement (EBR) and near-surface-mounted (NSM) reinforcement, to repair and strengthen the tested beams. The experimental program involved casting and testing nine simply supported RC rectangular beams; one beam was considered as the reference beam and did not undergo additional strengthening, and the remaining beams were strengthened using CFRP laminates. These eight beams were divided into two main groups for the purposes of strengthening: beams for which the EBR technique was used, and beams for which the NSM technique was used. The primary variables observed in the EBR and NSM groups included four damage percentages obtained according to the preload (20, 40, 60, and 80%) from the ultimate load carried by the reference beam. The experimental results show

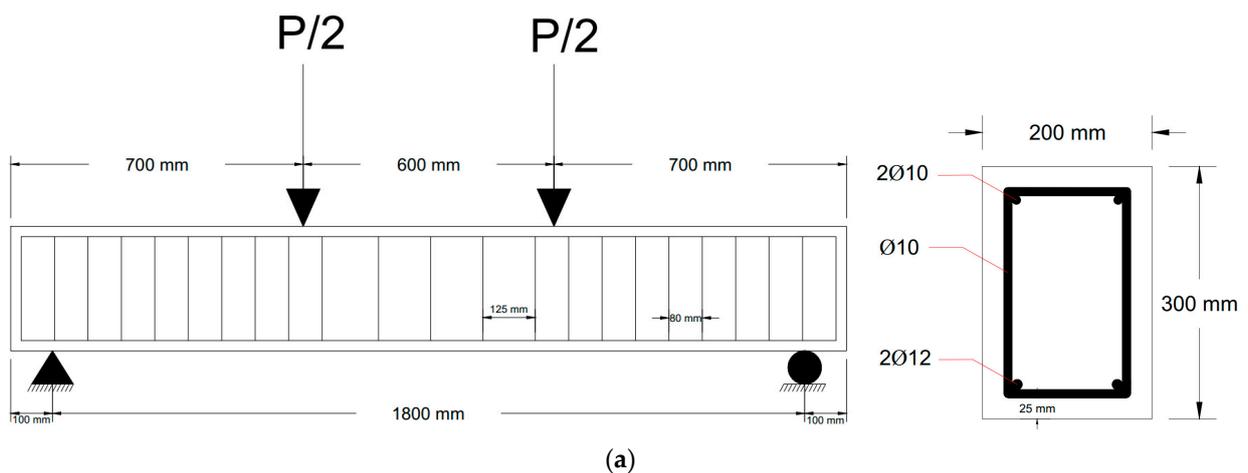
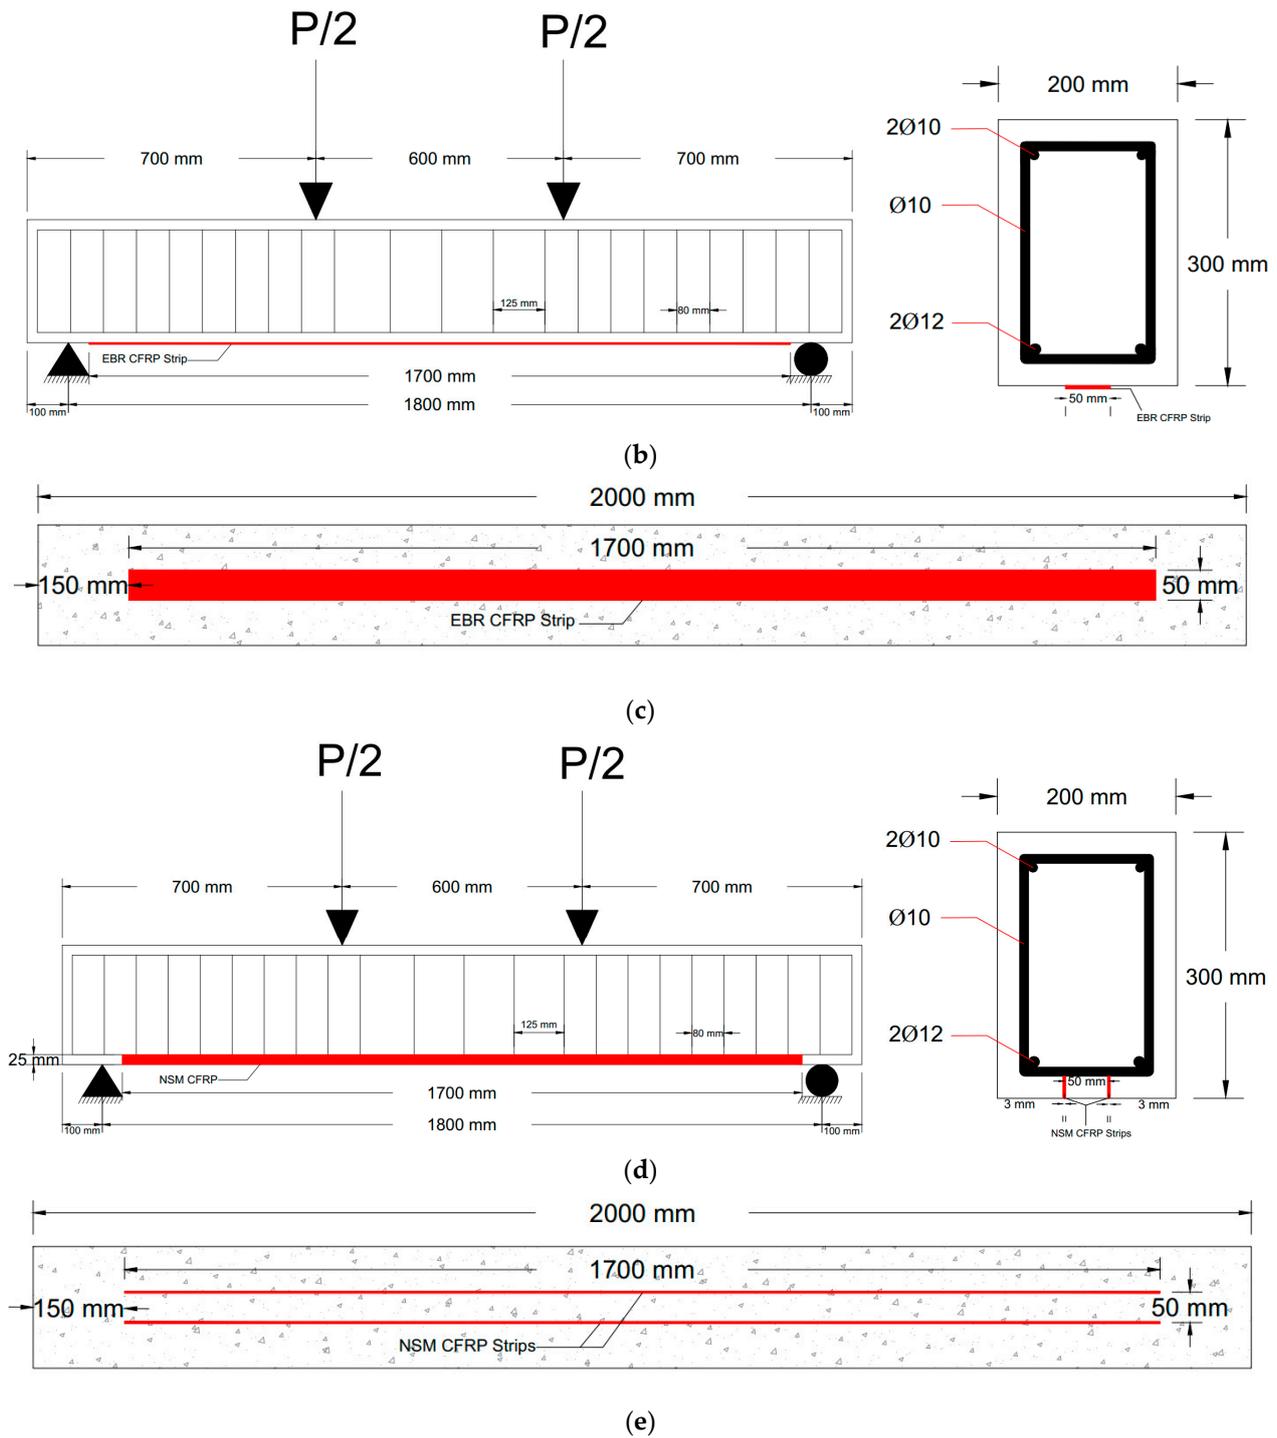
Figure 1. Beam details: (a) control (un-strengthened) beam. (b) EBR group. (c) EBR bottom face. (d) NSM group. (e) NSM bottom face.

All of the tested beams had the same dimensions (200 mm × 300 mm × 2000 mm) and reinforcement type. The simply supported beam was subjected to a two-point load during the test. After damage induction, all beams in the EBR group were strengthened with an external CFRP strip with a width of 5 cm and length of 170 cm that was glued to the bottom face of the beam, while the beams in the NSM group were strengthened via the NSM technique, using two CFRP strips with a width of 2.5 cm and length of 170 cm that were glued inside the concrete cover of the bottom face of the beam (2.5 cm). The steel bars used to reinforce all of the beams were 2Ø12 at the bottom and 2Ø10 at the top, with stirrup Ø10 spacing of 80 mm near the support and 125 mm at the middle part of the beam; the concrete cover was 2.5 cm. Figure 1 shows the beam’s cross-section, reinforcement, and CFRP strengthening.

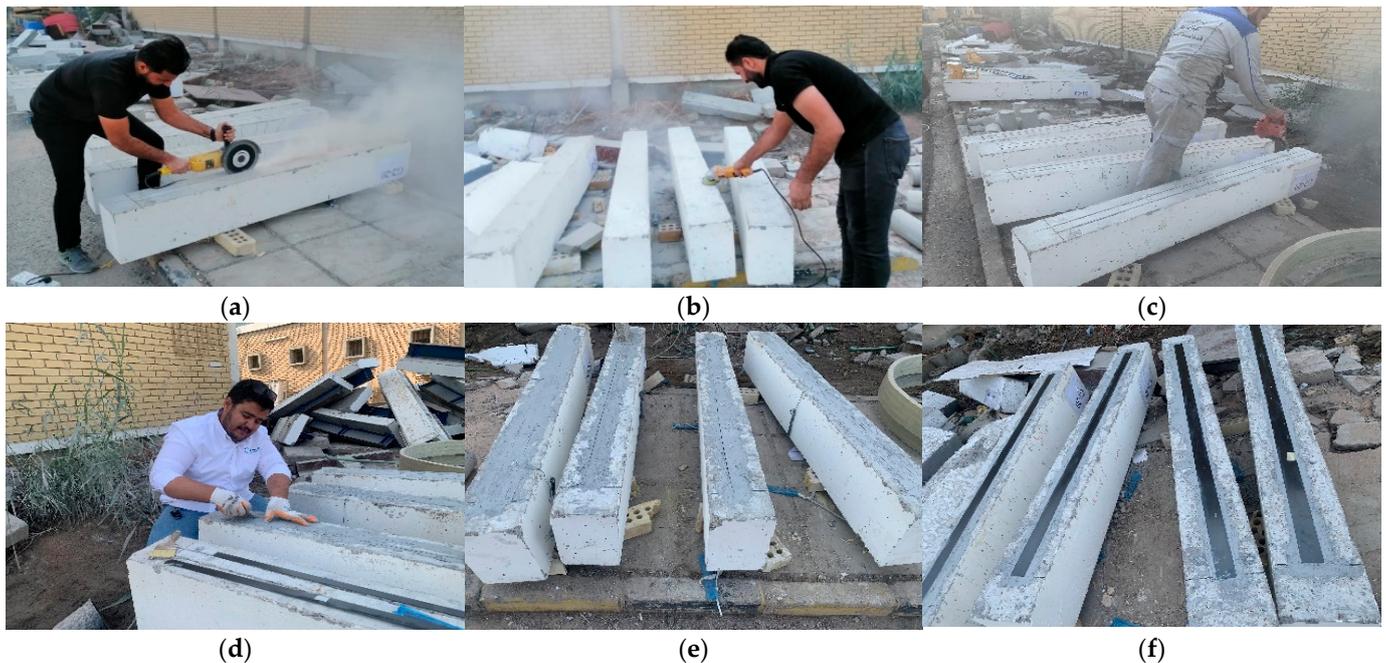
Figure 2. Surface preparation and CFRP installation of the RC beams. (a) Making the grooves for NSM group. (b) Surface cleaning and roughing for EBR group. (c) Cleaning the beams from dust. (d) Strengthening the beams with epoxy adhesive. (e) NSM group after strengthening. (f) EBR group after strengthening.

The damaged (preloaded) beams were strengthened with CFRP using the EBR and NSM techniques; in the EBR technique, the surface is first roughened with a grinder

machine and cleaned to remove any dust; then, the RC beams are marked in order for the laminate to be installed in the correct place. The laminate is installed on the bottom face of the concrete using epoxy. In the NSM technique, the CFRP laminates are cut into two strips from the middle after damaged (preloading), each one with a width of 25 mm; then, at the bottom face of the RC beams, two grooves that are 25 mm in depth are made, and the strips are installed into these grooves using the epoxy adhesive. For both the EBR and NSM strengthening techniques, the CFRP was 170 cm in length; the installation process is depicted in Figure 2.

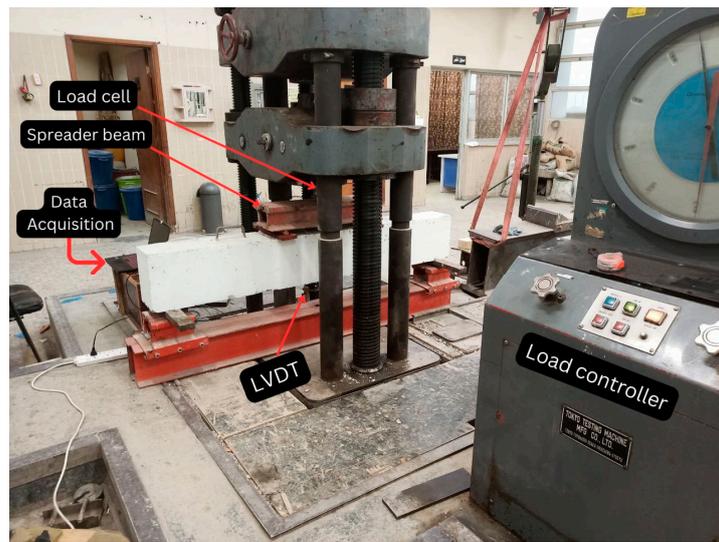
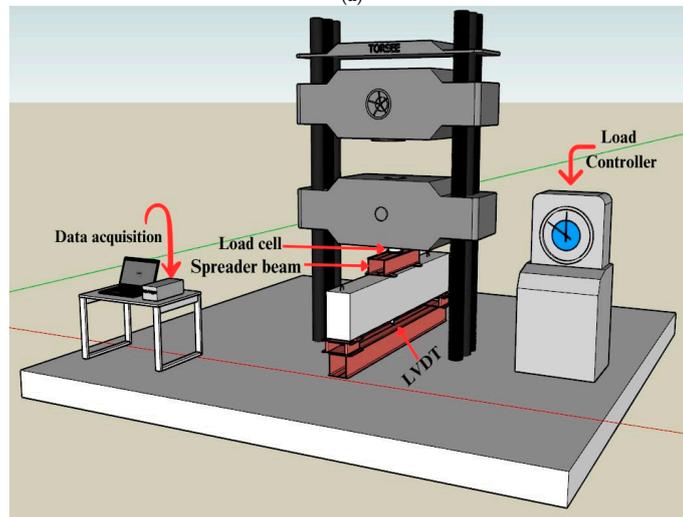
Figure 3. (a) Test setup. (b) Typical test setup.

To perform the testing, all of the reinforced concrete (RC) beams were simply supported beams that were then subjected to monotonic loads using a spreader loading beam and TORSEE'S universal test machine with a capacity of 2000 kN. The applied load was measured using a load cell connected to a data acquisition system. To measure the deflections at the mid-span of each beam during the loading test, a linear displacement sensor (LVDT 100 mm) was used (as shown in Figure 3). Strain measurements were recorded on the concrete surface and on the steel rebars. For the concrete strain measurements, PL-60.011-5L strain gauges were utilized and placed on the top face of the specimens, specifically at the compression face. FLAB-5-11-3LJC-F-type electrical strain gauges with a base length of 5 mm were attached to the outer surface of the main longitudinal tensile steel reinforcement at the lower layer (as depicted in Figure 4). These strain gauges were sourced from Tokyo Measuring Laboratory (TML).

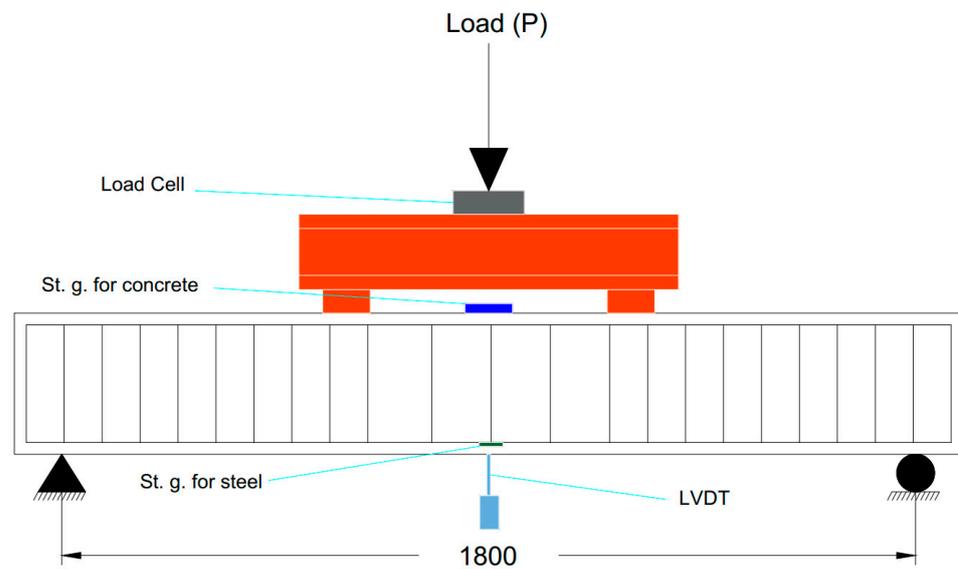
Figure 4. Beam incrementations (St. g. = strain gauge).

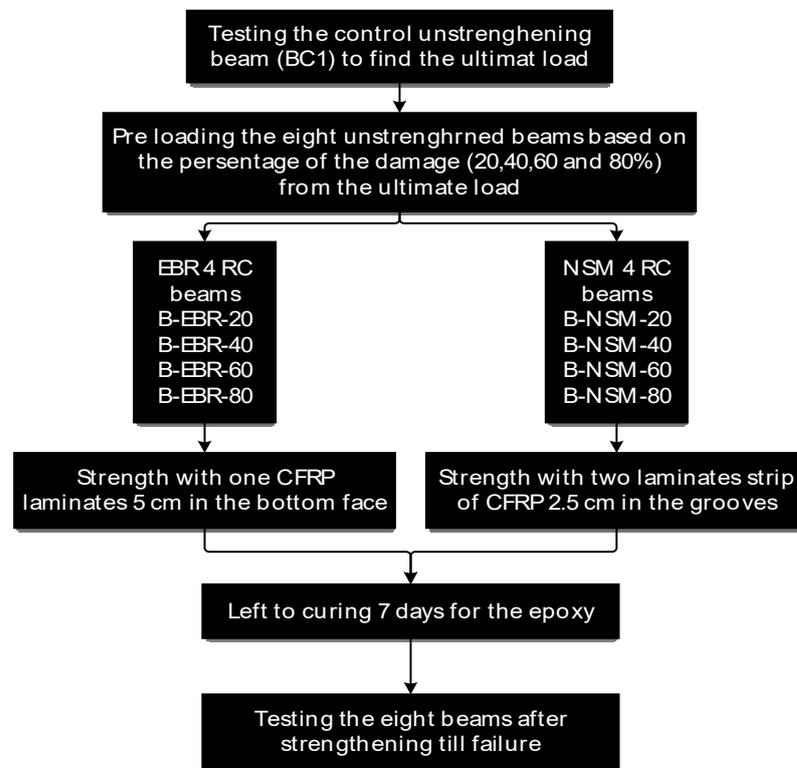
Figure 5. Testing procedure.

The testing procedures implemented in this study are represented in Figure 5.

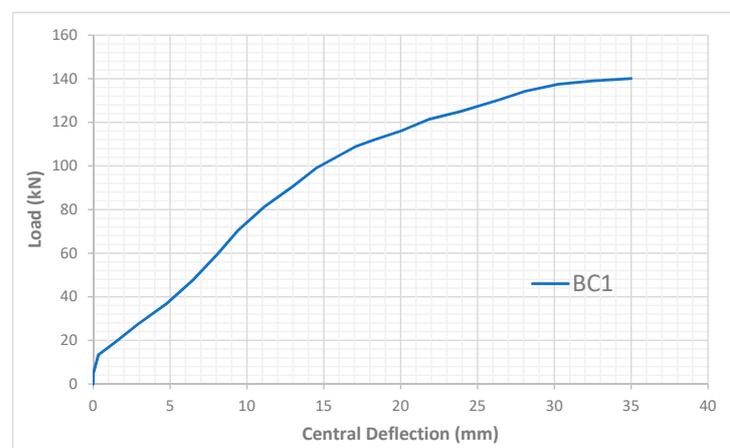
Figure 6. Load vs. deflection curve for the control reference beam.

The reference beam was tested up to failure to determine the ultimate flexure capacity. Figure 6 shows the load–deflection curve of beam control failure obtained with a load of 140.1 kN and failure by the steel reinforcement to improve yield, followed by concrete crushing. The damage (preload) percentage (20, 40, 60, and 80%) of the ultimate load of the reference beam was chosen to obtain the damaged (preloaded) RC beams for both the EBR and NSM groups (see Figure 7).

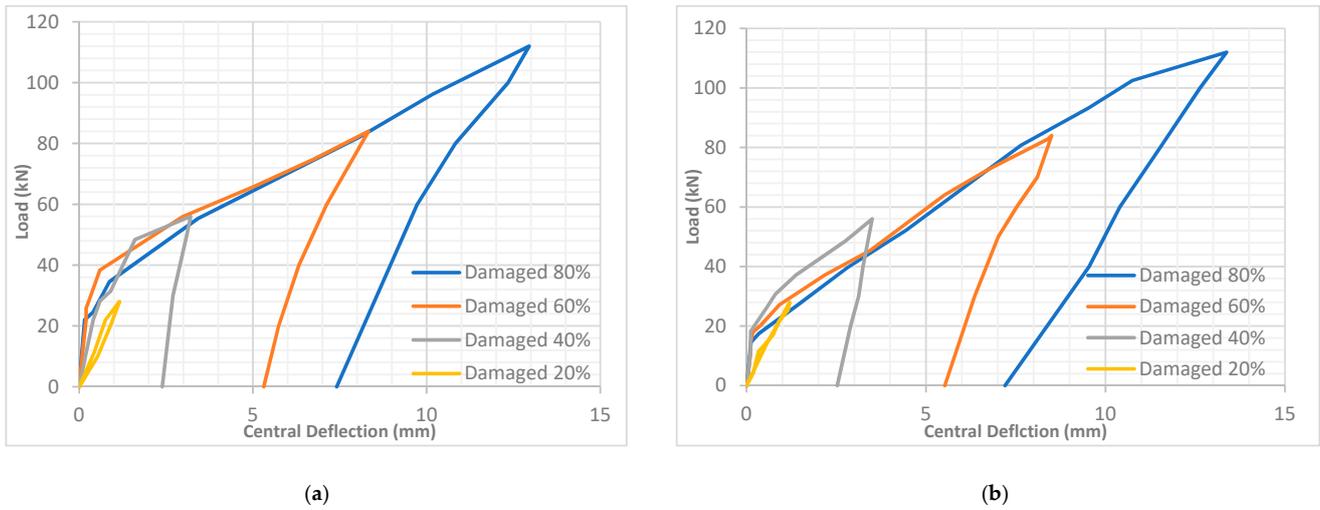
Figure 7. (a) Preloading curves of EBR group. (b) Preloading curves of NSM group.

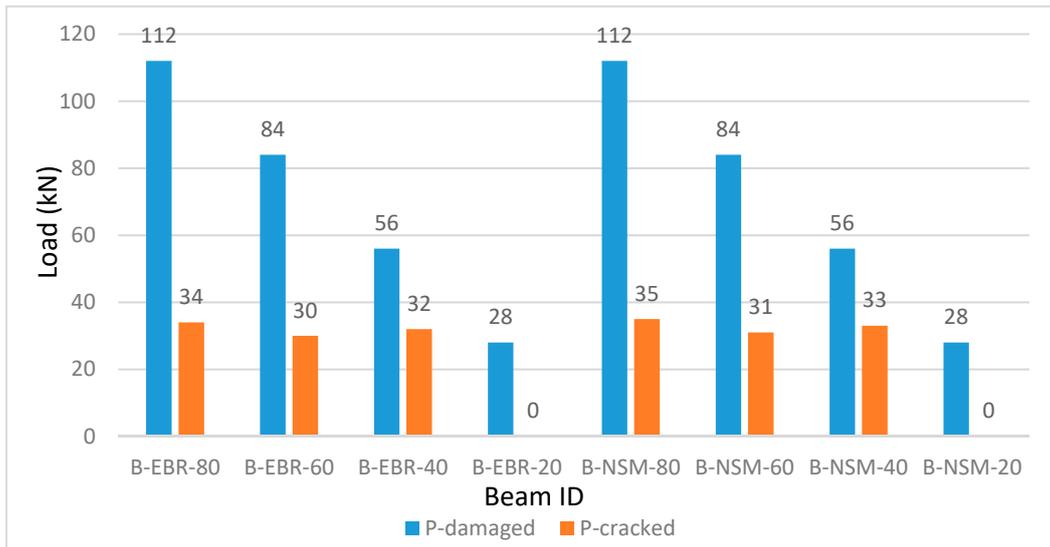
Figure 8. Load at the cracking and damage stages (note that beams B-EBR-20 and B-NSM-20 were not cracked during the first loading stage).

The first flexural crack appeared at an applied load of 33 kN. The ratio of the first crack load (P_{cr}) to the ultimate load (P_u) was approximate for the reference beam. For the beams in the EBR group, the first flexural crack occurred within the range of 30 to 34 kN. Similarly, for the beams in the NSM group, the first flexural crack appeared within the range of 31 to 35 kN. Figure 8 illustrates the load levels corresponding to the cracking at the damage stage (preloading).

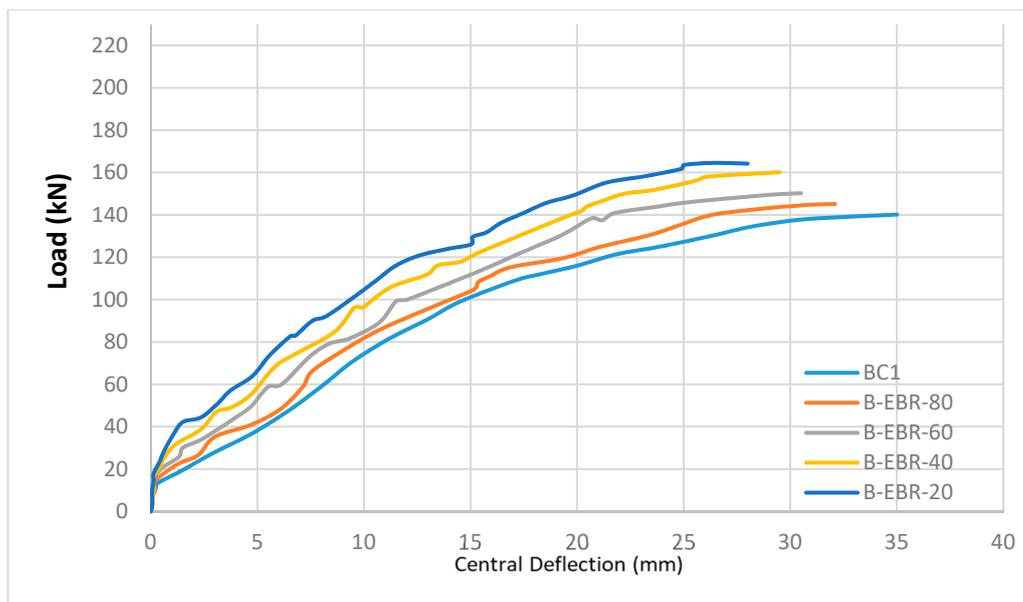
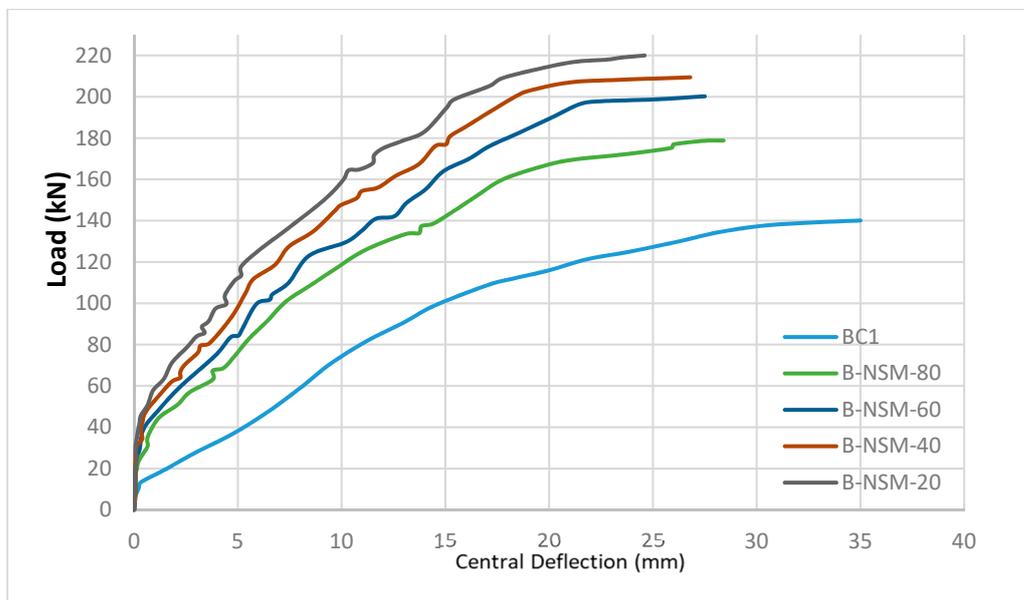
Figure 9. Load–deflection curves (a) EBR group. (b) NSM group.

Deformability can refer to the strain in a body, the curvature in a section, and the rotation and deflection of the member. Figure 9 shows the relationships between applied load and mid-span deflection from zero loading to the failure stage for all of the tested

Figure 9 shows how the damage affects load deflection at the middle of the span for all reinforced beams. Load–deflection graphs show that almost all of the beams have the same stiffness in the elastic region. However, after the tension support yields, the damage percentage is inversely related to beam stiffness, meaning that the beam bends less under the same load.

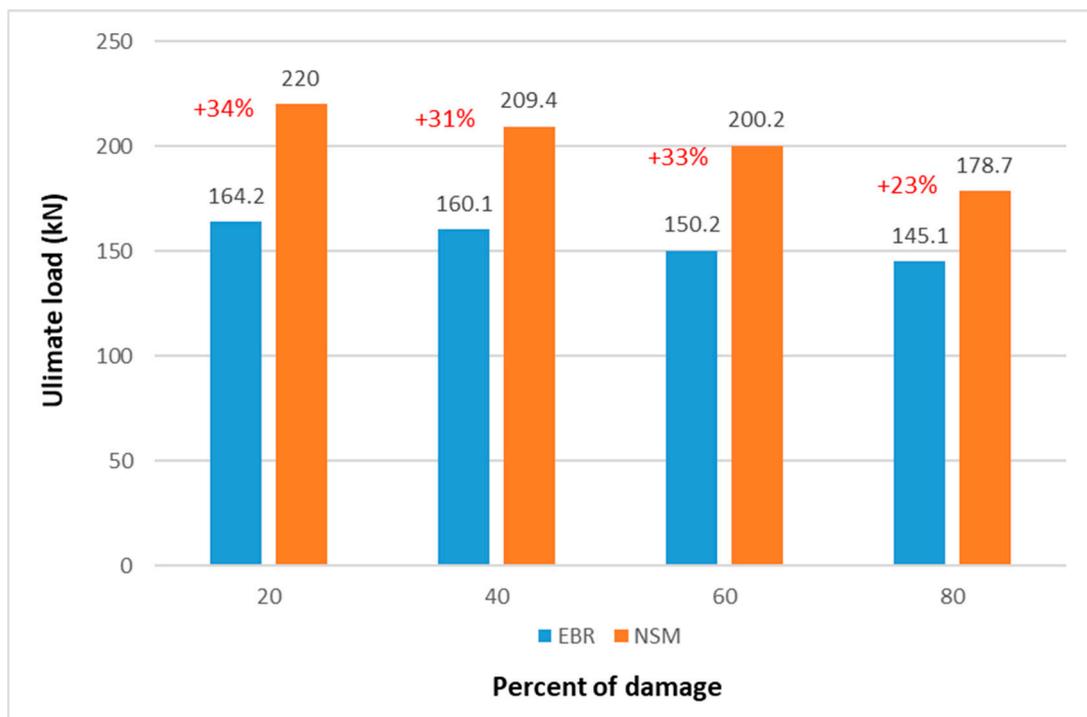
Figure 10. A comparison of ultimate load between the two strengthening methods (EBR and NSM).

The near-surface-mounted technique is an innovative approach that significantly enhances the flexural strength of reinforced concrete beams. This method involves cutting grooves into the underside of the beam, inserting CFRP strips into these grooves, and securely bonding them to the concrete using a suitable adhesive agent. Comparing the NSM strengthening method to the externally bonded reinforcement method, the former proved to be more effective, and this is because NSM provides a larger bond area, is less susceptible to debonding, and is less disruptive. The CFRP reinforcement is embedded in the concrete, providing a larger bond area than EBR, as shown in Figure 10. The figure shows that as the damage percentage increased (20%, 40%, 60%, and 80%), the NSM technique resulted in a higher percentage increase in the ultimate load capacity, with values of 34%, 31%, 33%, and 23%, respectively. At the ultimate load, the mid-span deflection decreased by 8.3, 12.9, 15.7, 20, 18.9, 21.4, 23.4 and 29.7% for B-EBR-80, B-EBR-60, B-EBR-40, B-EBR-20, B-NSM-80, B-NSM-60, B-NSM-40, and B-NSM-20, respectively, with regard to the reference beam, BC1.

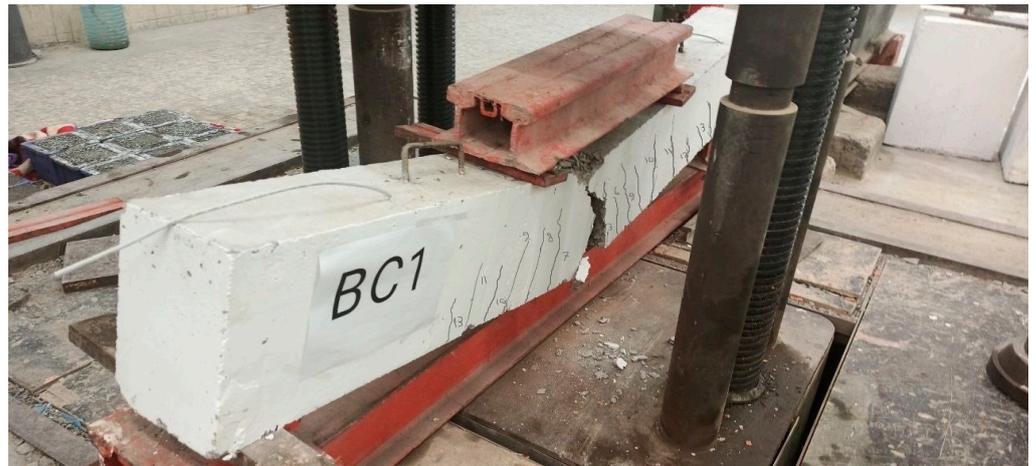
Figure 11. Crack pattern at failure of specimen BC1.

In the reference beam (BC1), failure was caused by cracks that started from the beam soffit at the largest bending moment; these cracks progressed toward the top zone due to steel yield, followed by compression failure at the load point (flexural failure).

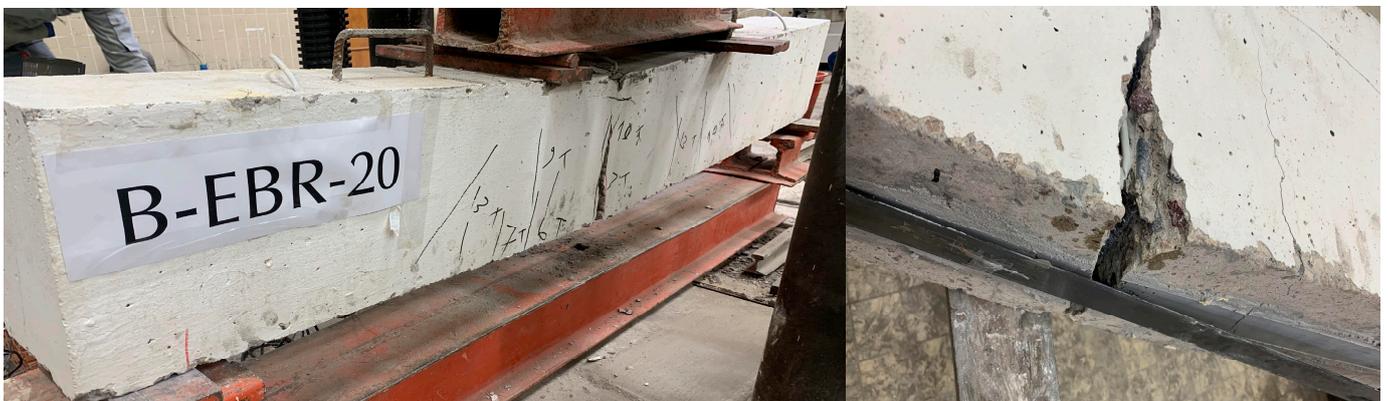
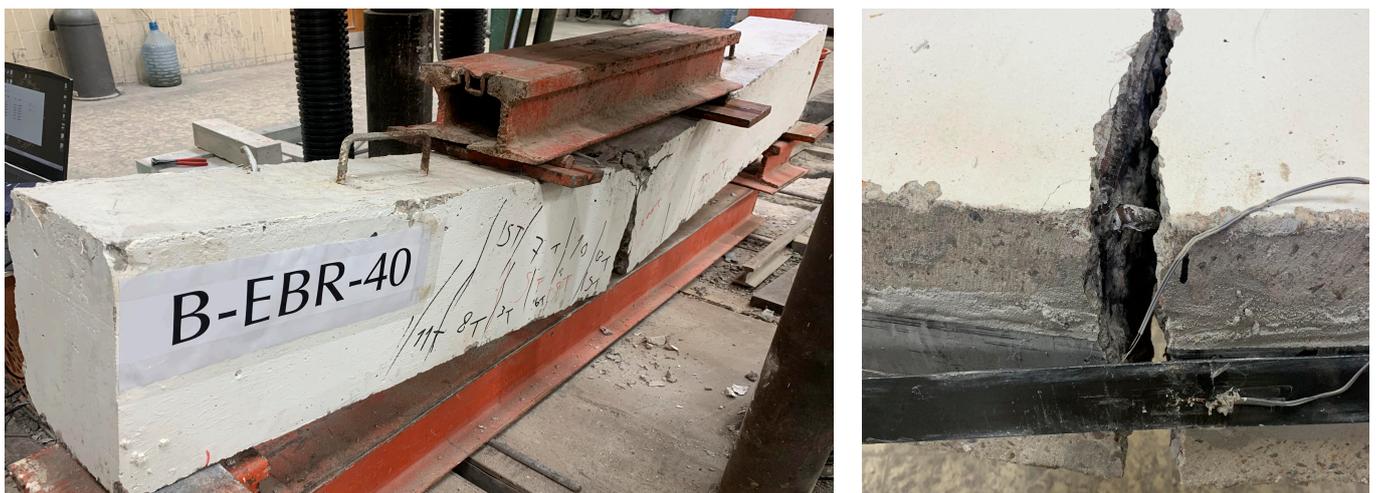
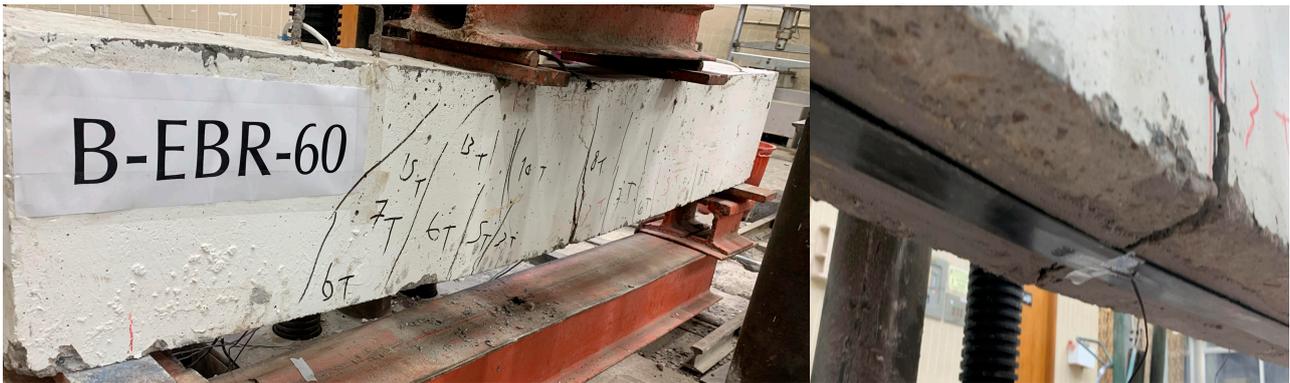
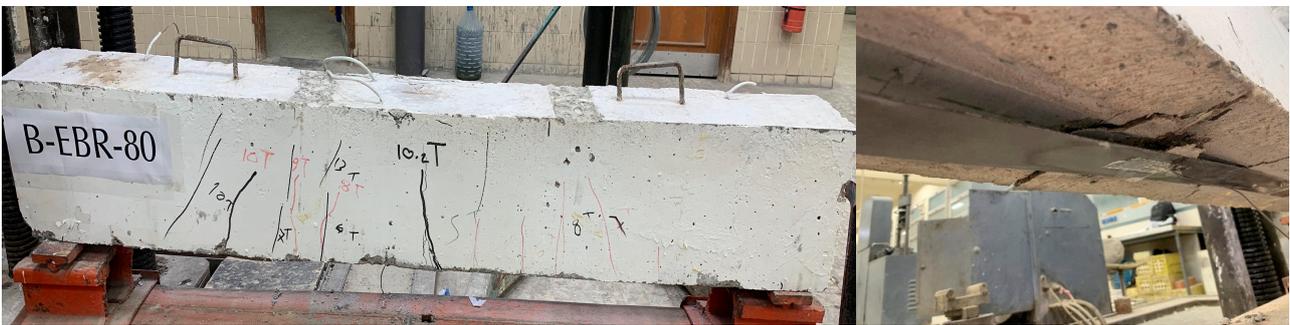
Figure 12. Crack pattern at the failure of specimen B-EBR-20.

Figure 13. Crack pattern at failure of specimen B-EBR-40.

Figure 14. Crack pattern at failure of specimen B-EBR-60.

Figure 15. Crack pattern at failure of specimen B-EBR-80.

While for the strengthened beam with EBR CFRP laminate in B-EBR-20, B-EBR-40, B-EBR-60, and B-EBR-80 at the damage percentages of 20, 40, 60, and 80%, respectively, failure was determined by intermediate flexure cracks, followed by the debonding of CFRP at the bottom of the beams strengthened with the CFRP laminate.

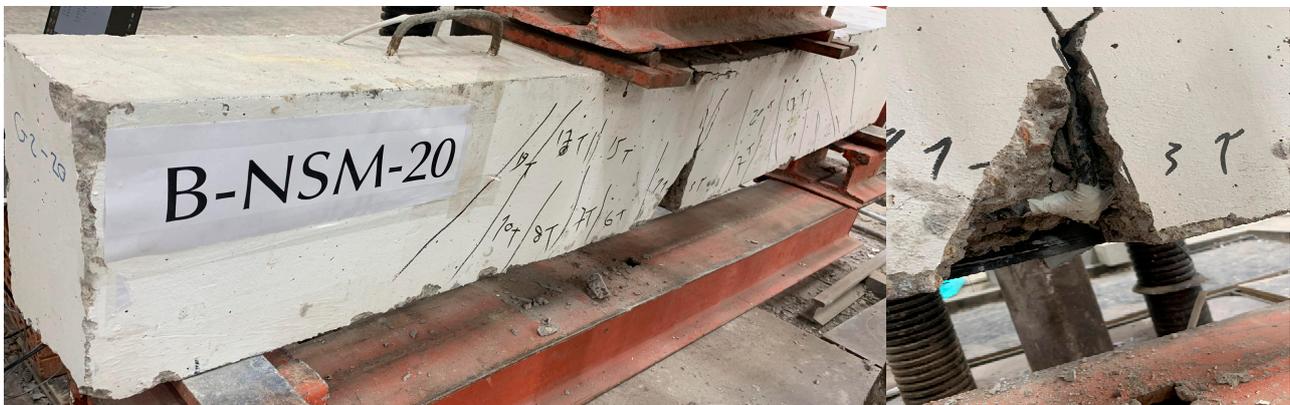
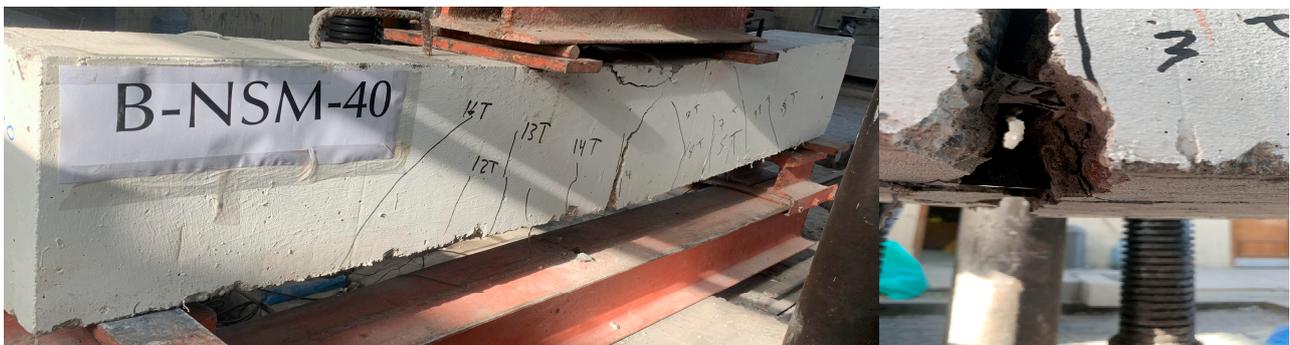
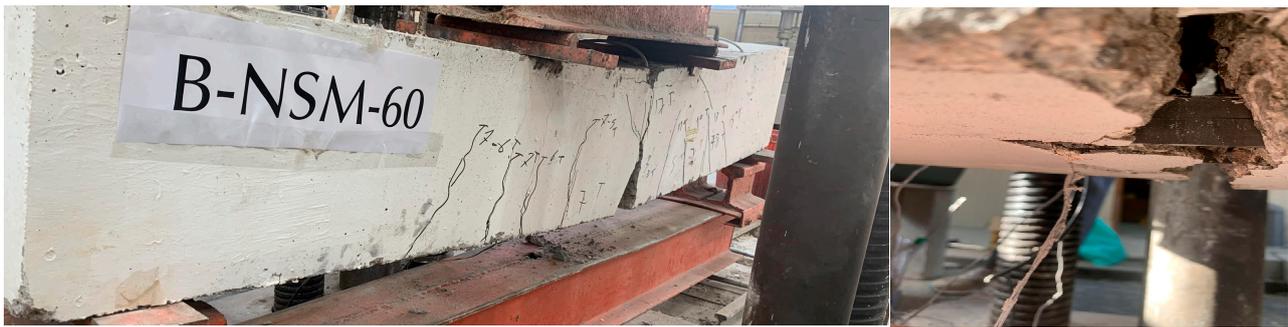
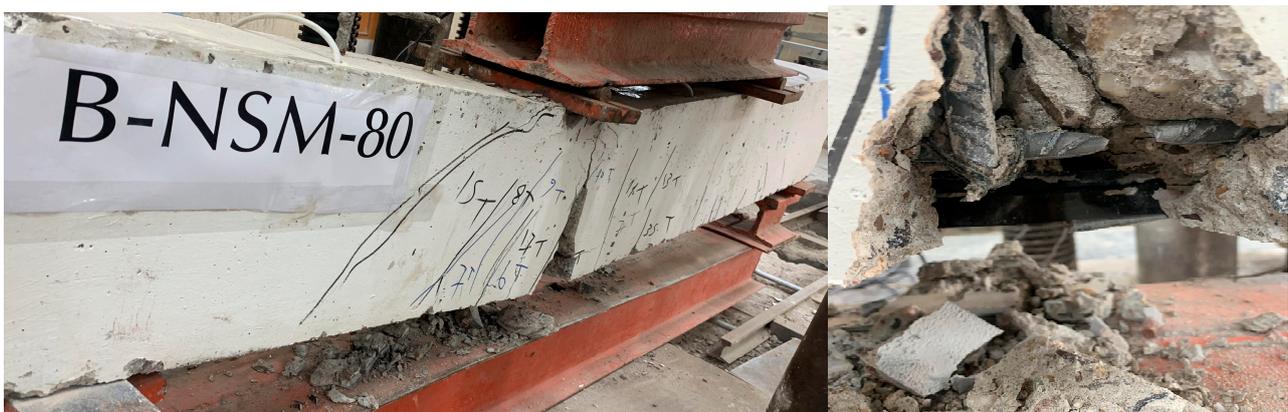
Figure 16. Crack pattern at failure of specimen B-NSM-20.

Figure 17. Crack pattern at failure of specimen B-NSM-40.

Figure 18. Crack pattern at failure of specimen B-NSM-60.

Figure 19. Crack pattern at failure of specimen B-NSM-80.

Finally, for the beams with NSM CFRP laminate B-NSM-20, B-NSM-40, B-NSM-60, and B-NSM-80 at the damage percentages of 20, 40, 60, and 80%, respectively, failure was indicated by concrete crushing, followed by a localized cover separation; in this mode of failure, a trapezoidal or triangular piece of concrete becomes separated from the beam due to the combination of bond cracks around the maximum moment area as well as shear and flexural cracks, with the last two crack types occurring before the first one.

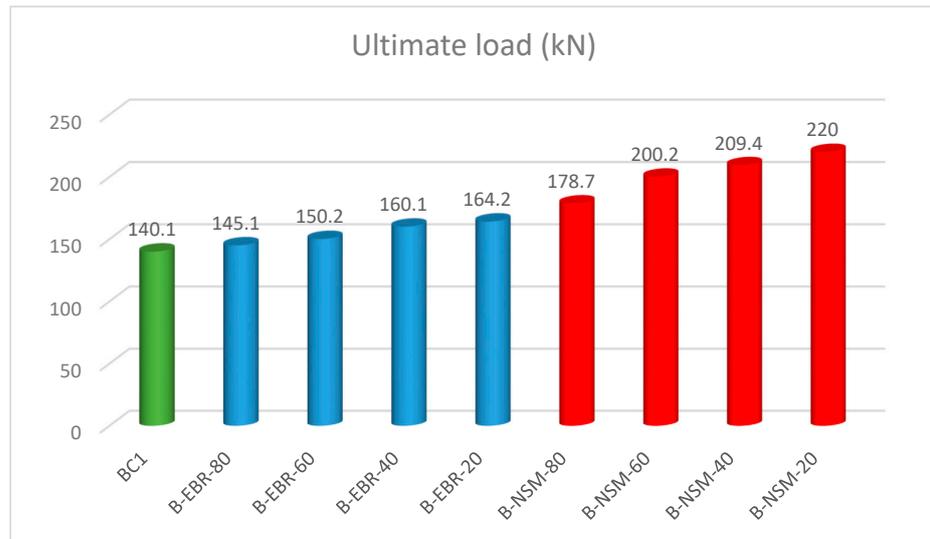
Figure 20. Ultimate load for all beams.

The damage percentage is inversely proportional to beam stiffness. Additionally, the suggested NSM strengthening method was more effective than the EBR method (see Figure 20).

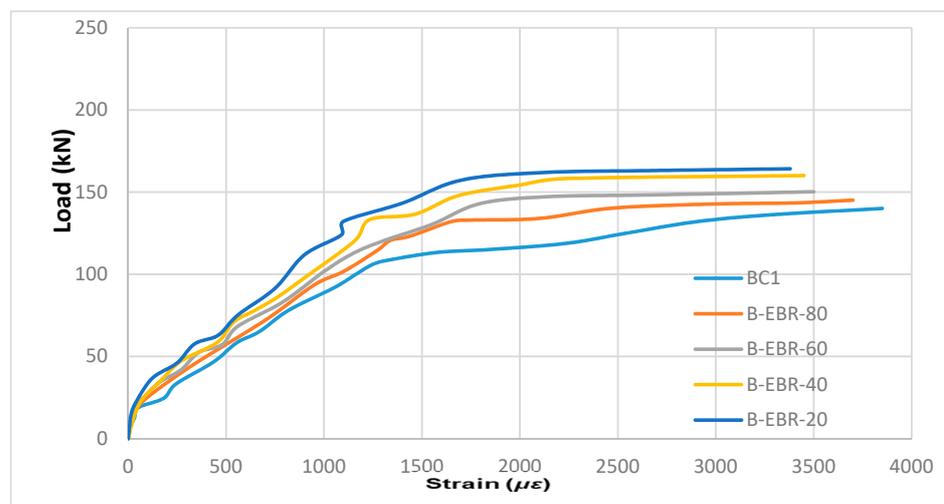
Figure 21. Load versus longitudinal compressive concrete strains at the top mid-span of beams from the EBR group.

Figure 21 shows the load versus longitudinal compressive concrete strains at the top mid-span in the beams from the EBR group, while Figure 22 shows the load versus longitudinal compressive concrete strains at the top mid-span in the beams from the NSM group.

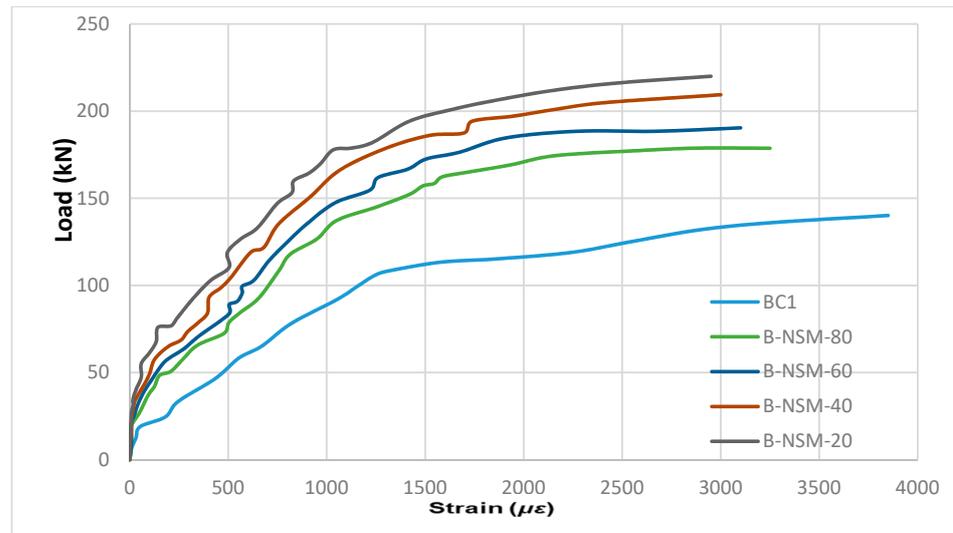
Figure 22. Load versus longitudinal compressive concrete strains at the top mid-span of beams from the NSM group.

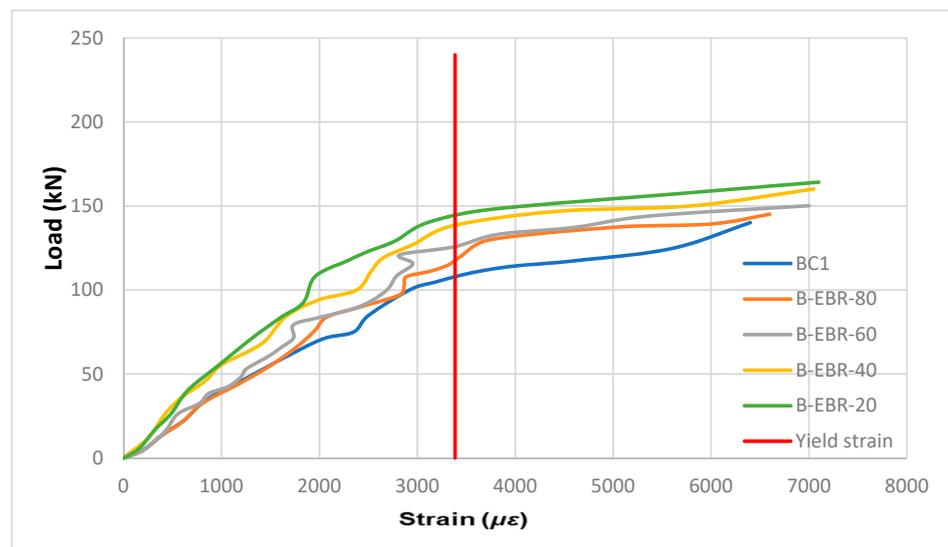
Figure 23. Load versus longitudinal steel strain for beams in the EBR group.

The strain was measured in the lower layer of the steel reinforcement ($\varnothing 12$ mm) using electrical FLAB-5-11-3LJC-F-type strain gauges with a base length of 5 mm attached to the outward surface of the reinforcing bars. Figures 23 and 24 demonstrate that all beams behave almost linearly at the start of loading up to about 30 kN and that the strains that develop are small. At higher loading stages, the reference beam that has not been strengthened shows a higher increase in strain than the strengthened beams. By reducing the strain at the same load level, decreasing the damage percentage makes it stiffer. At their maximum load, all of the beams in the flexural group were stronger than the yield strength of the steel bars ($3385 \mu\epsilon$).

Figure 23 shows the load versus longitudinal compressive concrete strains at the top mid-span of the beams from the EBR group, while Figure 24 shows the load versus longitudinal compressive concrete strains at the top mid-span in the beams from the NSM group.

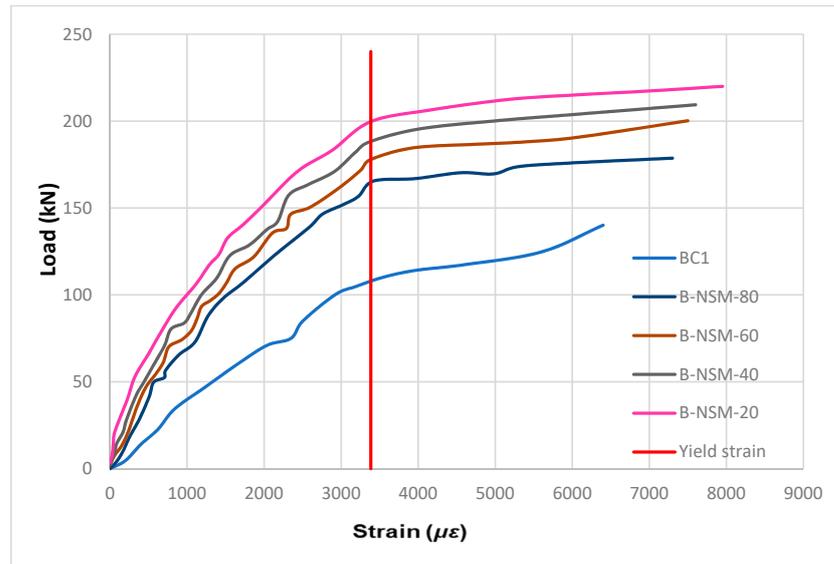
Figure 24. Load versus longitudinal steel strain for beams in the NSM group.

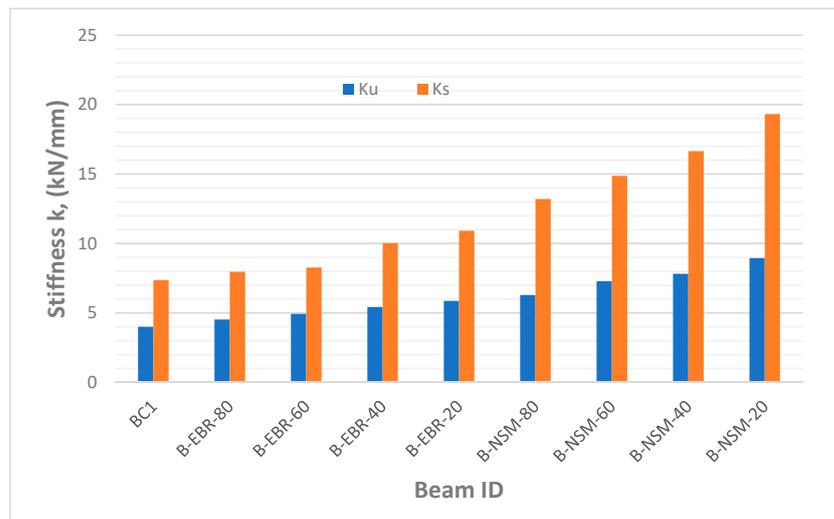
Figure 25. A comparison of stiffness values of tested beams.

The stiffness of reinforced concrete (RC) beams is an important property that affects their behavior and performance. Stiffness is defined as the resistance of a material to deformation under an applied load. A body’s stiffness K is primarily determined by flexural stiffness, which measures the beam’s resistance to bending. Table 8 shows the stiffness of the beams during the service load and ultimate load stage. Adding CFRP to an RC beam increases its stiffness and load-carrying capacity by improving its flexural strength and ductility. In this study, CFRP was typically applied externally to the beam using the EBR and NSM methods. During loading, CFRP was bonded to the surface of the beam using a high-strength epoxy adhesive. See Figure 25, which shows a comparison of the stiffness values of the tested beams (where K_u : stiffness at the ultimate load stage, and K_s : stiffness at the service load stage).

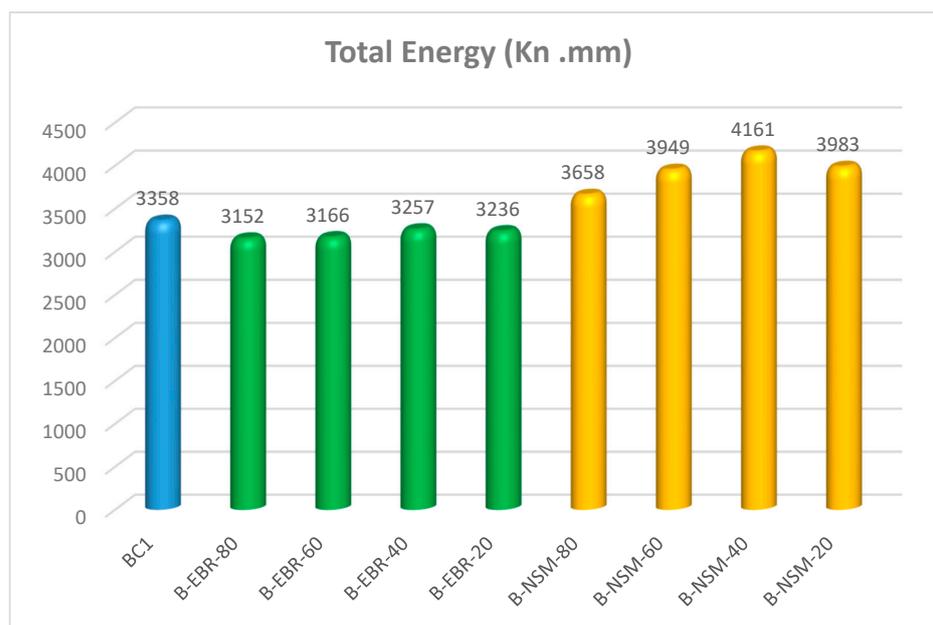
Figure 26. A comparison of total energy values of tested beams.

The area under the load–deflection curves was used to calculate the flexural toughness (total energy) of each beam in this investigation. This computation was achieved using AutoCAD. Overall, energy absorption capability is what is being referred to when describing a material’s flexural toughness. As a measure of the potential energy that may be stored in a loaded concrete structure, it is an important metric in the context of concrete structures. Both the maximum load value and the deflection at failure affect the absorbed energy, which is shown by the area under the load–deflection curve of the monotonic applied load. The total energies of the tested beams are listed in Table 9, and a comparison is shown in Figure 26. The flexural toughness of the beams in the NSM group was found to be superior to that of the EBR beams.
