Article

Influence of Cutting Temperature on the Tensile Strength of a Carbon Fiber-Reinforced Polymer

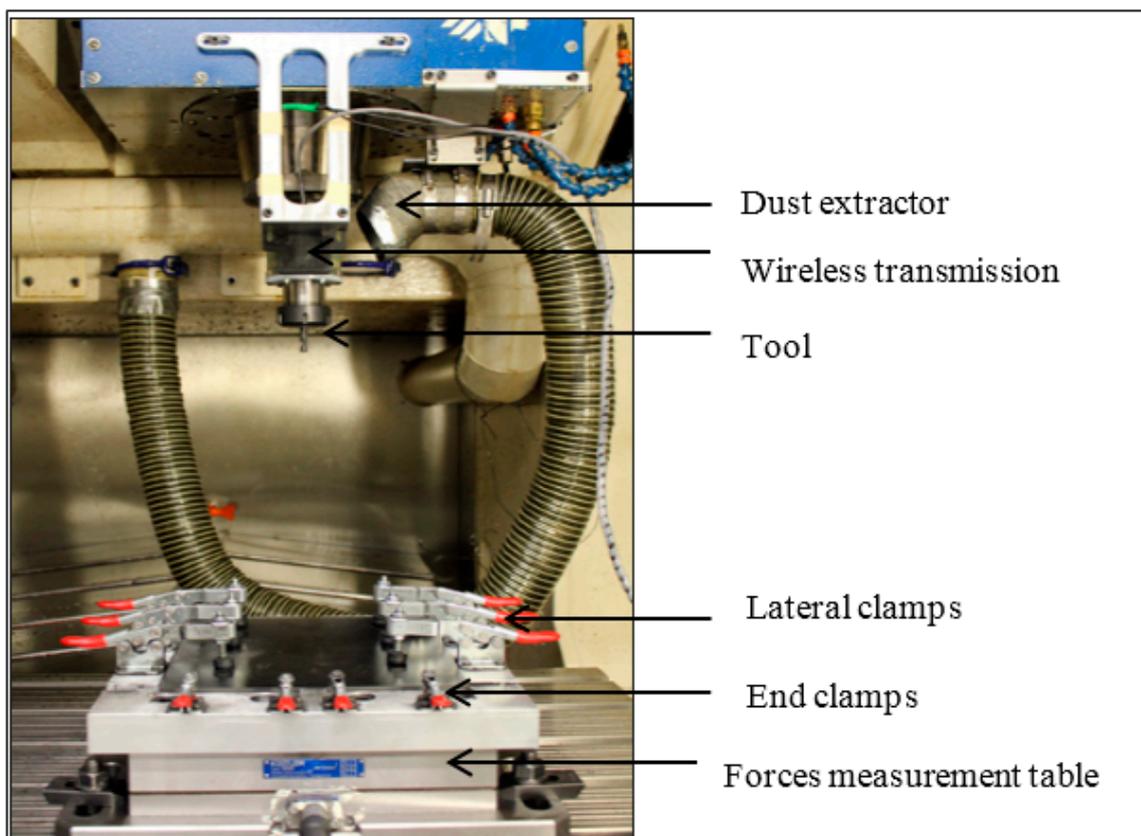
To trim the tensile test coupons, a 3-axis computer numerical control (CNC) HURON K2X10 high-speed machining center and special setup was used (Figure 1). This setup included lateral clamps to maintain the plate during machining, and end clamps to maintain the specimen to be cut. After each pass of the tool, the plate was turned to have a symmetrical temperature profile for each side of the specimen (Figure 2). Moreover, with this arrangement, the same extra material was obtained for each test specimen. This material corresponded to a specimen with edges machined using the down-milling machining mode rather than the up-milling mode. This meant there were $(n-2)$ specimens machined in the down-milling mode and n specimens machined in up-milling mode (Figure 2). All these specimens were kept and compared to one another. Finally, the extremities of the specimens were cut to the desired length of 250 mm (10') with an abrasive saw. A total of 60 tensile-test specimens were produced as indicated in Table 1. The specimens were made in four iterations (T1 to T6; T7 to T12; T13 to T22 and T23 to T34). The thermocouples provided the cutting temperature profiles at the cutting edge of the teeth for each sample, except for the following specimens, T3, T11 and T12, where the thermocouples broke through the effect of centrifugal force, and were peeled off due to the flow of chips. Cutting forces were measured using a 3-axis dynamometer table (Kistler 9255B) (Figure 1).

Figure 1. Machining assembly.

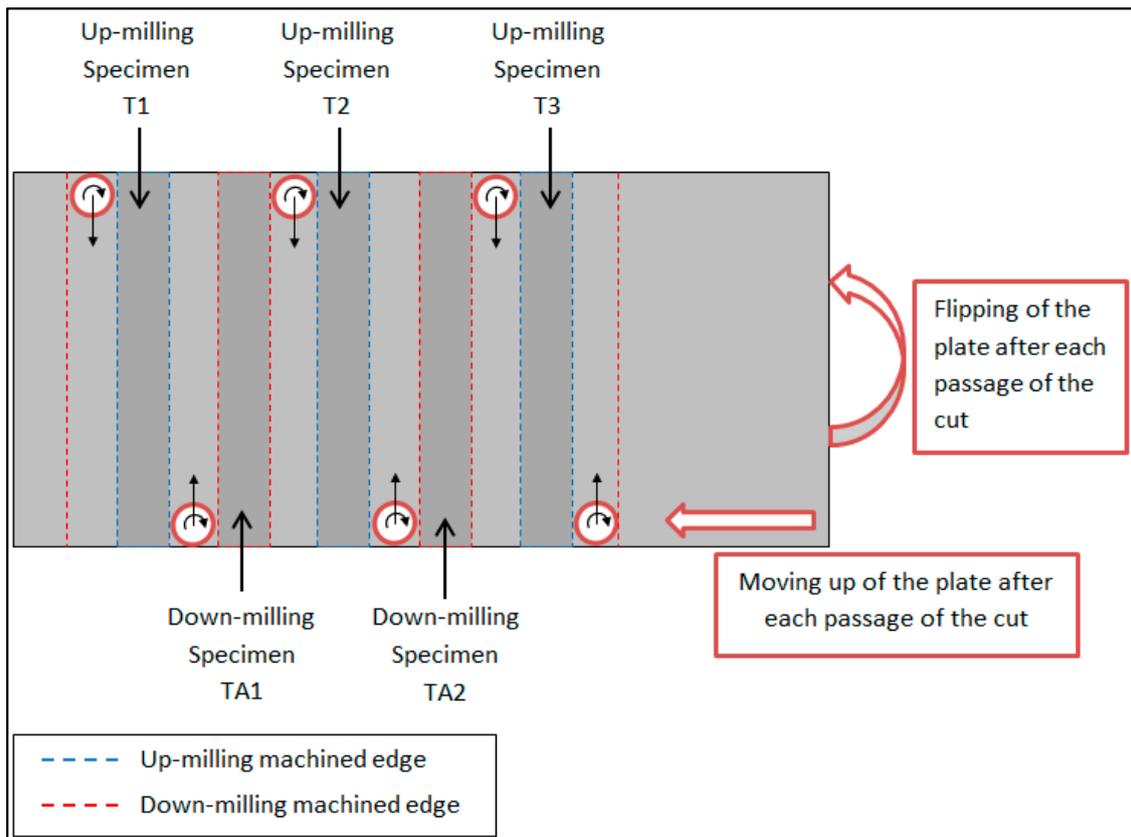
Figure 2. Sample production procedure.

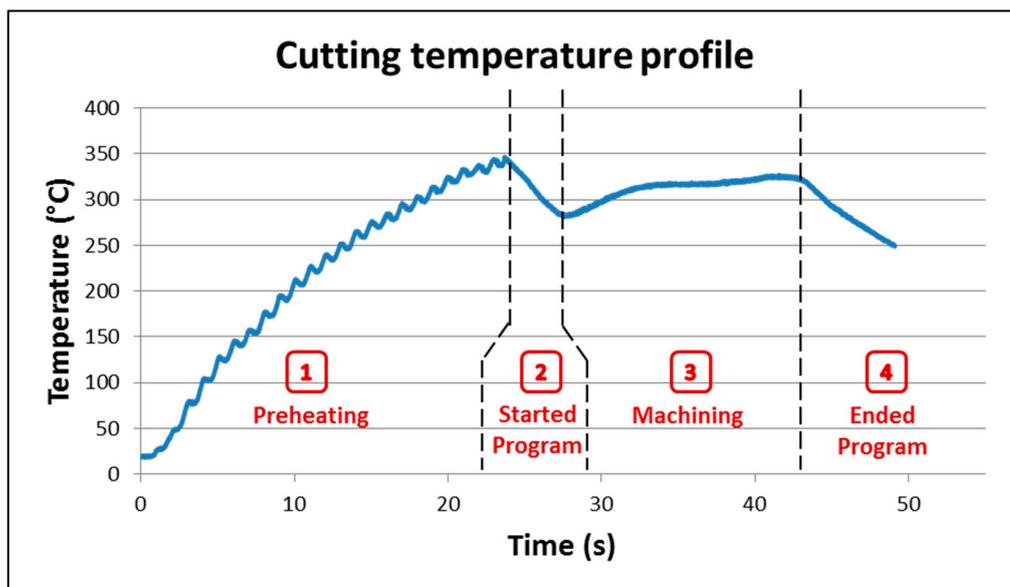
A typical temperature profile was divided into four stages as shown in Figure 3:

- Stage 1: The tool was pre-heated using a blowtorch, the temperature increased up to the required pre-heated temperature.
- Stage 2: The CNC doors were closed, the machining program was started, the tool moved from its origin to the part piece. The temperature decreased during this movement.
- Stage 3: The tool cut the material. An increase in the temperature up to stabilization was observed.
- Stage 4: The machine program ended and the tool came back to its origin. The temperature slowly decreased to ambient temperature.

Figure 3. Cutting-temperature profile.

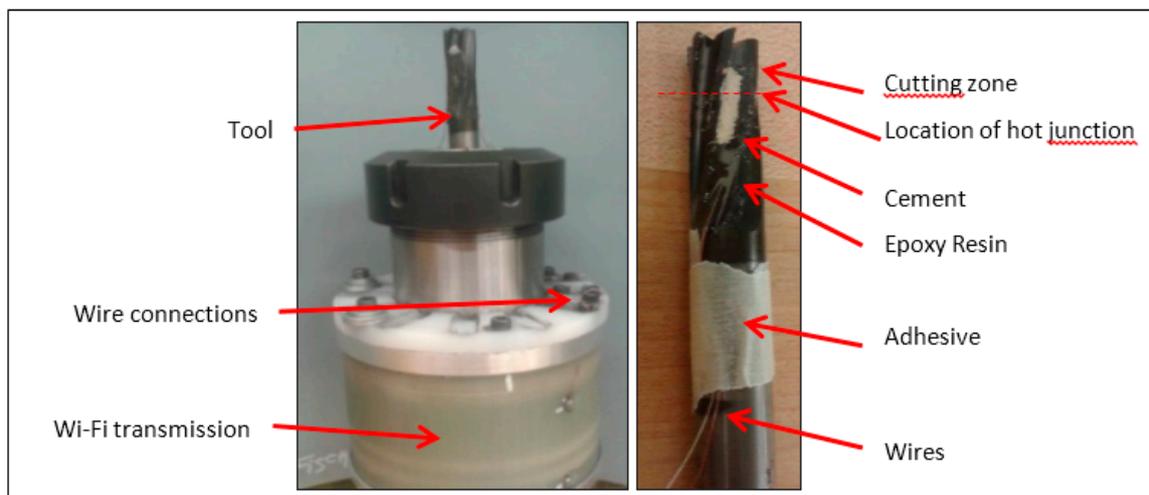
To measure the cutting temperature, the tool was equipped with two embedded K-type thermocouples placed at 180°. They were placed against the cutting edge closest to the cutting area and bonded with OMEGABOND® 400 # OB-400 cement, which is an excellent thermal conductor and covered with epoxy resin enabling the thermocouple to remain in place during the cutting process. Preliminary tests by Mullier [24] showed that a distance of 1.7 mm from the cutting edge enables the holding of thermocouple on the tool despite the combined effect of the chip flow and temperature variation (Figure 4). The tool was then installed in a special mandrel (type M-320, manufactured by Michigan Scientific Corporation), using special connections for thermocouples, and the data was transmitted wirelessly (Wi-Fi) to the data-acquisition system (Figure 4).

**Figure 4.** Mandrel and new tool equipped with thermocouple.

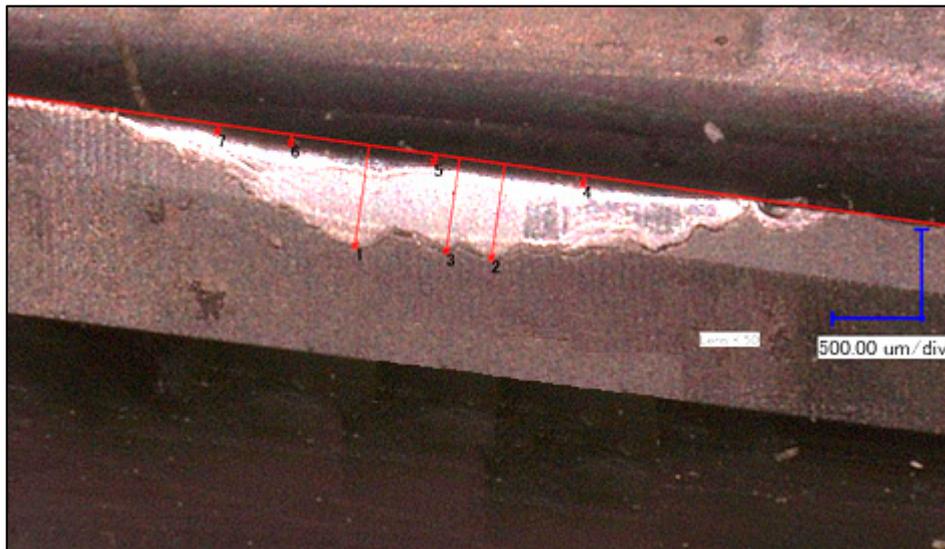
For the trimming operations, a new tool and a worn tool ($V_b = 50 \mu\text{m}$ before machining) were used (Figure 5). Tool wear has a significant influence on the cutting temperature, thus this approach will show the influence of the cutting temperature on the mechanical properties of the coupons. The tool wear was measured using a Keyence VHX-500FE optical microscope equipped with image-processing software. Regarding the worn tool, the measurement of the initial flank wear (V_b) resulted to $50 \mu\text{m}$ (wear of the coating and substrate), and we observed a removal of about $550 \mu\text{m}$ of the diamond coating.

Figure 5. Tool wear before machining ($V_b = 50 \mu\text{m}$, $V_{ba} = 550 \mu\text{m}$, Lens X50).

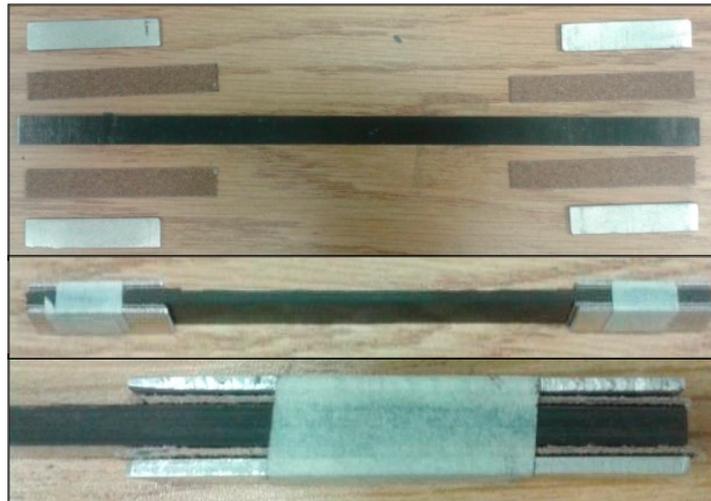
The tensile tests were performed on an Alliance RF/200 testing machine. They were performed according to the ASTM D3039/D3039M-00 standard. The test specimens were clamped in the grips of a length of 50 mm at each end, as recommended by the standard. The use of aluminum tabs bonded at the end of the coupon was adopted to limit the number of coupons breaking in the grips. Aluminum tabs of 12 mm \times 50 mm or 6 mm \times 50 mm (depending of sample width) were used. To prevent slippage between the specimen and the aluminum tabs, double-face sandpaper with medium grain (100) was placed between the specimen and the tab (Figure 6).

Figure 6. Sample with sandpaper and aluminium tabs.

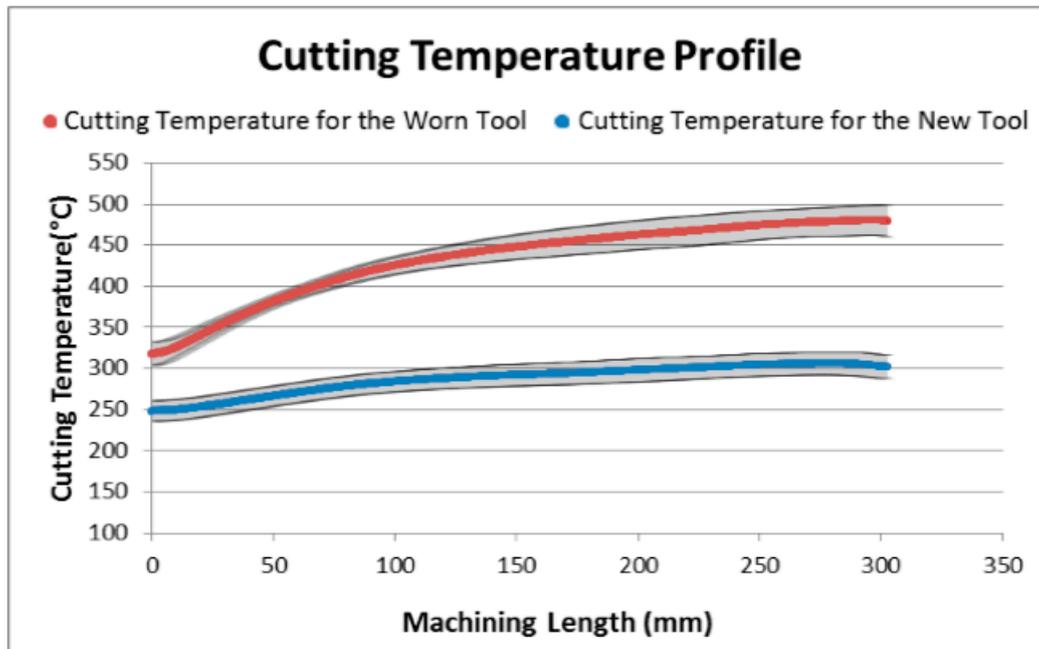
For better visibility, the average temperature profile was plotted with error intervals expanded to a confidence level of 95% for each profile, as shown in Figure 7. These curves relate to zone 3, which is the machining zone, as defined in Figure 3. Concerning the cutting temperature, the new tool was pre-heated to 350 °C (662 °F) and a constant cutting temperature of 300 °C (572 °F) was obtained (Figure 3, stage 3). The temperature was nearly constant throughout the specimen, which was excellent (Figure 7). The second tool (worn tool) was pre-heated to 400 °C (752 °F), for a cutting temperature of about 475 °C (887 °F) after the first 150 mm of cutting. It was impossible to pre-heat the tool to more

than 400 °C (752 °F), because thermal degradation of the resin maintaining the thermocouple was observed. Thus, it became difficult to obtain constant temperature levels. The time interval between the end of pre-heating and the start of machining caused a temperature drop to about 250–300 °C (482–572 °F) for both tools. Otherwise, for each machining condition, the temperature profiles for all the samples were globally the same.

Figure 7. Cutting-temperature profile.

- Concerning the cutting-temperature profile, the new tool was pre-heated to 350 °C and an almost constant cutting temperature of 300 °C was reached. The temperature was almost constant throughout the test (step), which was very encouraging. The second tool (worn tool) was pre-heated to 400 °C for a cutting temperature of 475 °C. For each condition, the temperature profiles among the samples were globally the same.

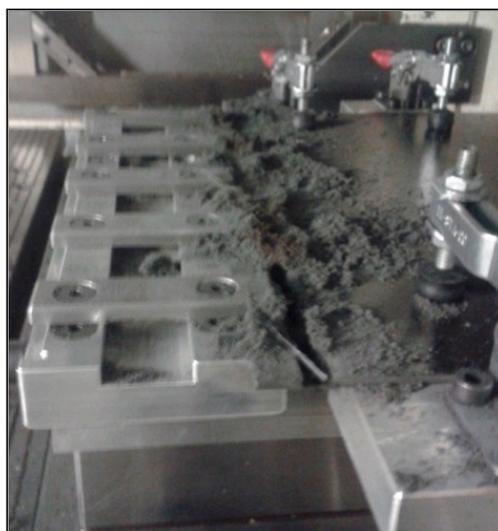
The results showed a significant influence of tool wear not only on the cutting temperature, but also on the resulting chip. Indeed, with the worn tool, the glass transition temperature (T_g) of the resin was greatly exceeded, resulting in resin degradation. Consequently, the chip which consists normally of a fine black powder with the new tool was transformed to a sticky paste concentrated around the cutting area. This paste can be a source of poor heat dissipation increasing the thermal damage of the composite (particularly on the upper surface) (Figure 8).

Figure 8. Chip after cut (worn tool).

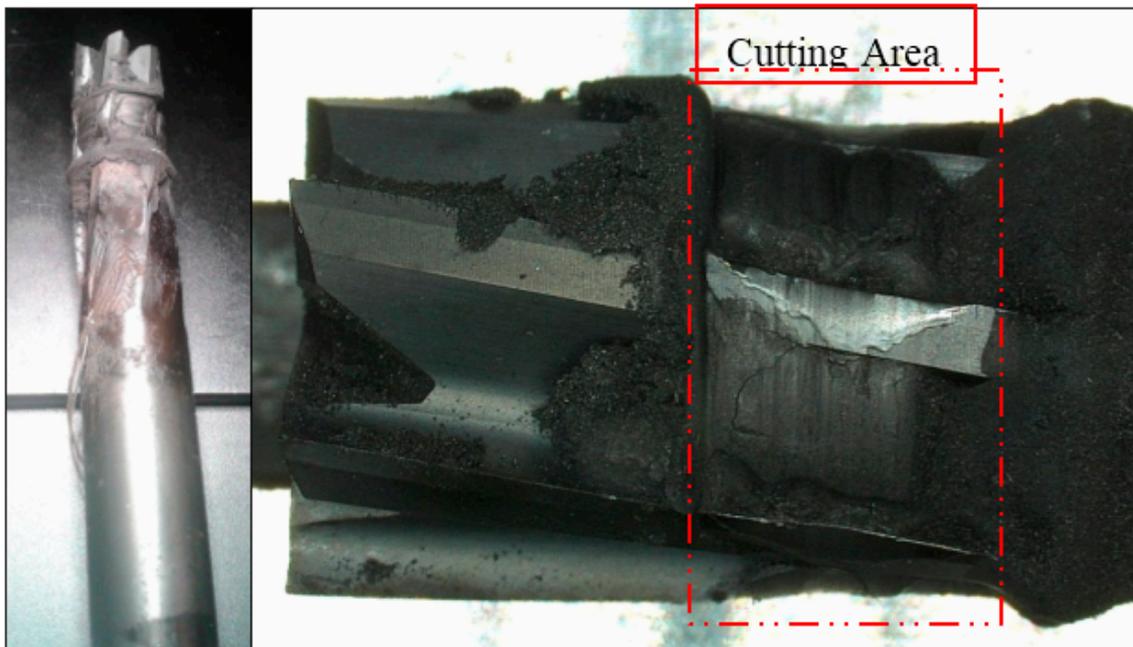
Additionally, regarding the cutting zone of the worn tool after machining, the thick paste forming the chip stuck to the tool, obstructing the flute and preventing any evacuation (Figure 9). This explains the high temperature reached with the worn tool, as the heat could not be dissipated through the chip because it remained on the tool, agglomerated around the cutting area, effectively forming a thermal insulator. Combined with the friction of the tool, this phenomenon produced a cutting temperature that was considerably higher than T_g of the resin, thus creating a heat-affected zone along the machined edge. On the other hand, the chip for the new tool was found to be completely evacuated. It looked like a cold, fine black powder that did not stick to the tool (Figure 10).

Figure 9. Cutting zone after machining (worn tool).

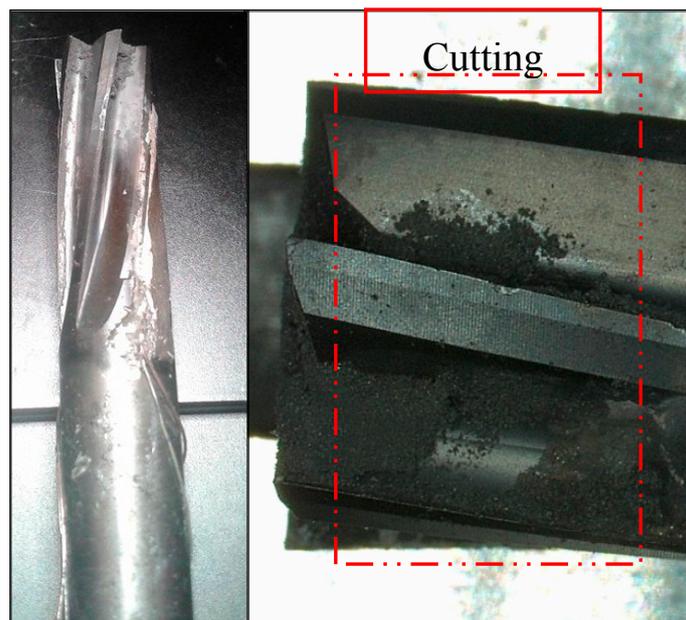
Figure 10. Cutting zone after machining (new tool).

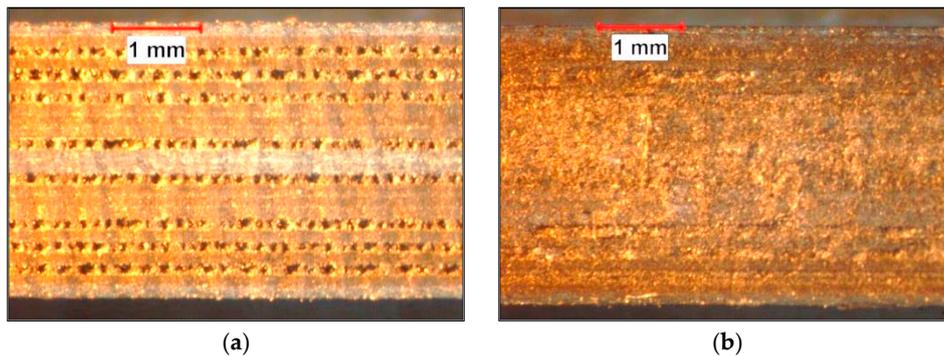
Figure 11 presents the microscopy of the machined edges with both the new and worn tools. The surface of samples machined with a new tool showed the most damage (looking like small holes, as shown in Figure 11a) for plies oriented at -45° , which was due to the fiber-cutting mode. In this case, no thermal damage caused by the cutting temperature could be seen (Figure 11a). For samples machined with the worn tool, it was clearly shown how the presence of thermal damage affects the machined surface. The plies could not be distinguished, resulting from the spreading of the hot and sticky matrix and surface homogenization (Figure 11b). The emergence of other defects such as uncut fibers or fiber pull-out can be seen in Figure 12.

Figure 11. Machining edge: (a) using the new tool; (b) using the worn tool.

Although the temperature at the cutting edge reached 300°C for the new tool (which is also above the glass-transition temperature), the surface did not appear to have suffered from thermal damage. The most credible hypothesis in this case is that heat was evacuated by the tool and the chip, thereby reducing its transmission to the material. Also, the diamond coating, which is an excellent heat conductor, probably helped heat dissipation. The machined surface using the worn tool was visibly thermally damaged.

The roughness measurements confirm what was observed in the literature. The up-milling machining configuration provided, on average, a lower roughness than the down-milling configuration (Figures 13 and 14). Machining with a worn tool also provided a lower roughness than with a new tool. This may seem surprising, but it is explained by the presence of the degraded matrix spread over the composite surface machined with a worn tool, as shown in Figure 11b.

- The analysis of the cutting surface with a binocular microscope showed a clear surface and a clear distinction between the plies on the surface machined with a new tool. The most mechanical damage was observed on the plies oriented at -45° . Moreover, the surface did not appear to have been thermally damaged. The most probable explanation was that the majority of the heat generated by cutting was dissipated by the tool and the chip, and was not transmitted to the work piece. For samples machined using the worn tool, a relatively smooth surface was observed, there was no ply distinction. The glass-transition temperature of the resin matrix was definitely reached on the machined surface, resulting in a smooth surface. The matrix was carbonized and the molten resin culminated in a "blur" and smoothing. Uncut fibers or fiber pull-out were also observed for the plies oriented at 0° and -45° for the samples machined with the worn tool in the down-milling configuration.

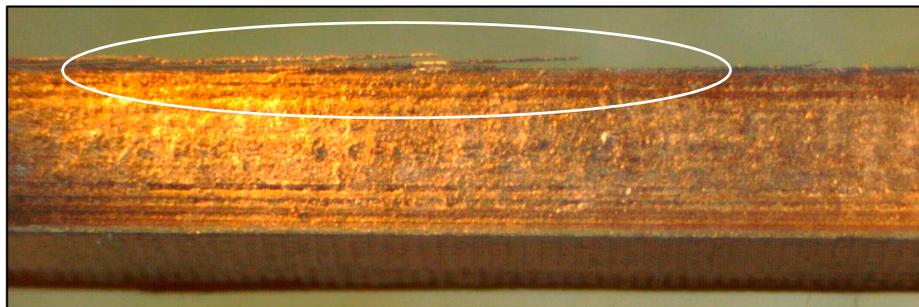
Figure 12. Delamination of test coupon machined using the worn tool.

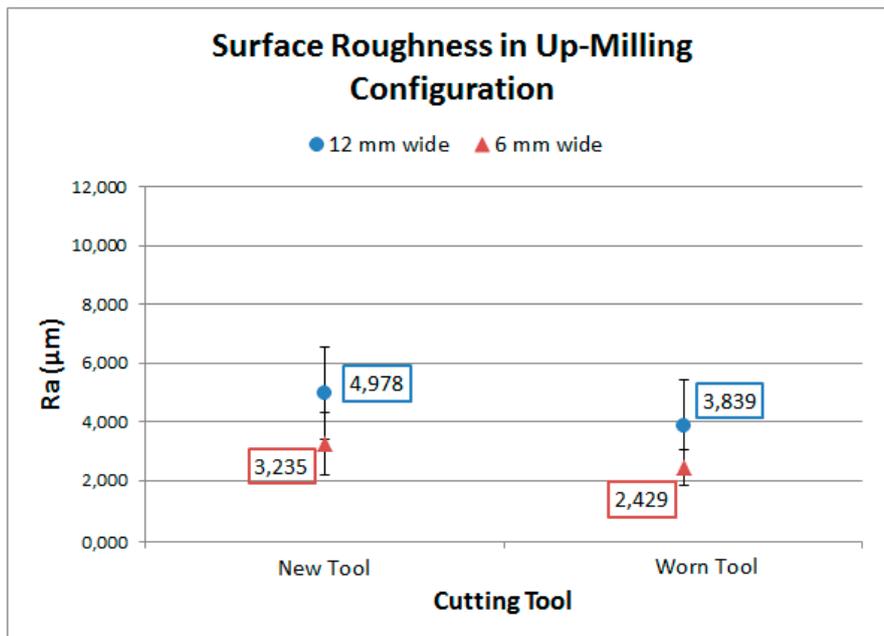
Figure 13. Surface roughness for both specimens widths in the up-milling.

The standard deviation of the roughness measurements is quite important, making this measure quite unreliable to qualify composite materials. This measurement makes the development of any model quite difficult because the internal defects, hidden by the presence of the degraded matrix spread over the cut surface, are underestimated by surface roughness measurements as also suggested when comparing Figure 11a,b. There was, on average, a decrease in the roughness (a better surface finish) when using a worn tool and this trend was confirmed whatever the specimen's width and machining configuration.

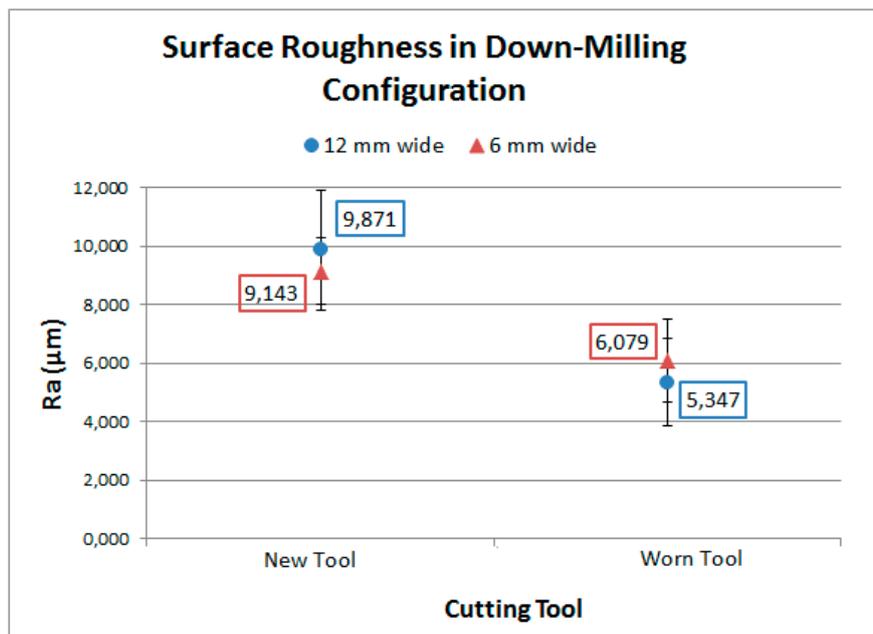
Figure 14. Surface roughness for both specimens width in the down-milling configuration.

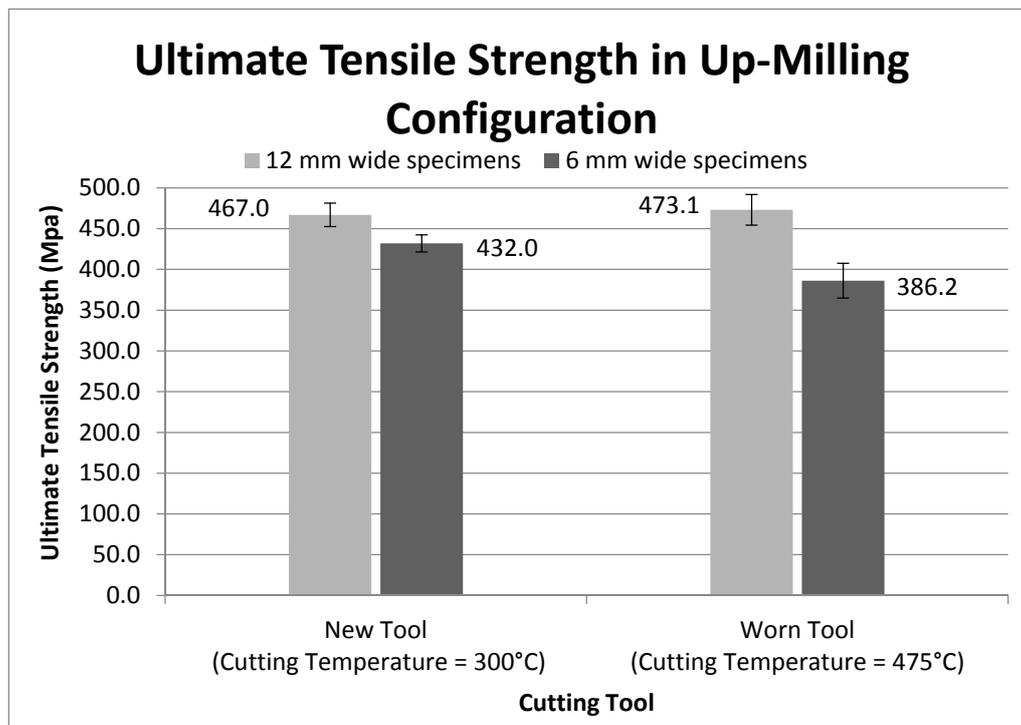
Out of the 60 samples tested, a total of 53 showed acceptable ruptures (considering ASTM D3039 requirements). A total of seven outliers were identified and removed from the analysis (Table 6). The results showed a very small variation of the ultimate tensile strength for the 12 mm-wide specimens. This low variation was equal to the interclass variation (standard deviation of a single group of samples). It can be concluded that the cutting temperature caused by advanced tool wear did not affect the tensile strength of the material for this specimen width. This phenomenon was observed for both machining configurations (up-milling and down-milling). This meant the damage (thermal and mechanical) was not significant enough to influence the tensile strength for this specimen width. For the second series of experiments however, cut to 6 mm (half the width of the first specimens), a significant difference was observed. A 10% decrease in mechanical properties was observed for test specimens machined with a worn tool compared to those machined with a new tool. The same trend was observed whatever the machining configuration (Figures 15 and 16). We can conclude that the cutting temperature generated by the tool wear influences the mechanical properties from a critical width.

Figure 15. Ultimate tensile strength in the up-milling machining configuration.

- There was little variation in tensile strength for 12 mm-wide specimens whatever the machining configuration or tool used. A significant decrease of 10% of the tensile strength for the 6 mm-wide test specimens machined by a worn tool was identified compared to those machined with a new tool. It appeared that the edge defects caused by the cutting temperature influenced the mechanical properties at a critical size at which the defect became significant. However, it was difficult to determine whether this decline was due to mechanical or thermal defects. Future development aims to succeed in cooling the tool to room temperature in order to differentiate the mechanical and thermal damage and hence determine which is predominant.

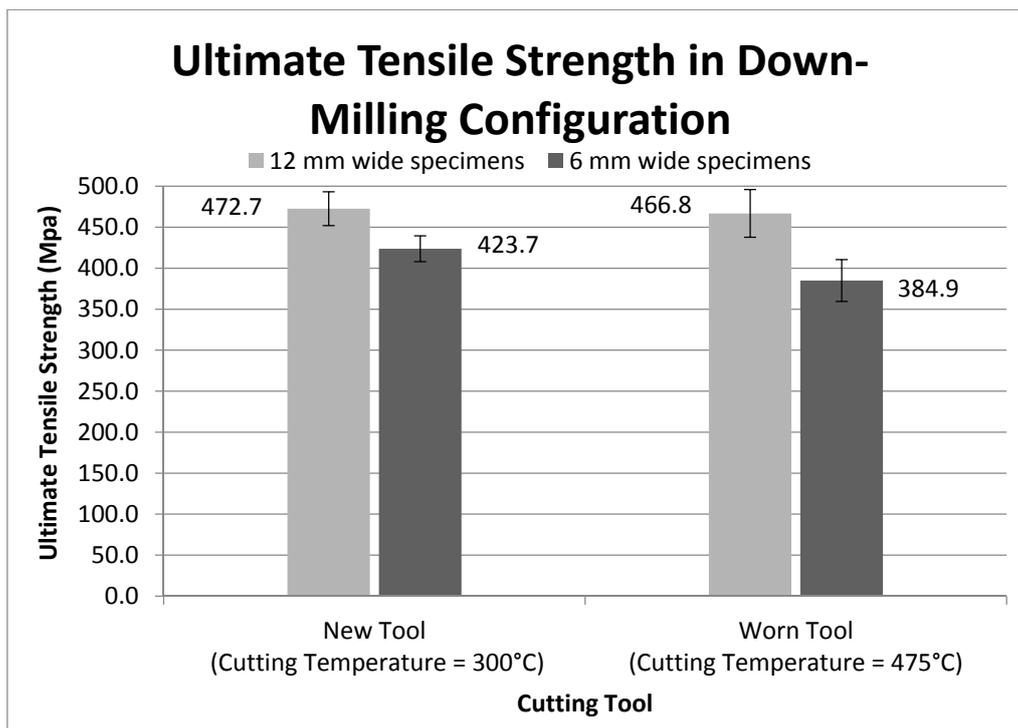
Figure 16. Ultimate tensile strength in the down-milling machining configuration.
