# Effects of Hybridisation on the Low Velocity Falling Weight Impact and Flexural Properties of Flax-Carbon/Epoxy Hybrid Composites

Matthew Chapman and Hom Nath Dhakal \*

School of Mechanical and Design Engineering, University of Portsmouth, Portsmouth PO1 3DJ, UK; matthew.chapman@myport.ac.uk

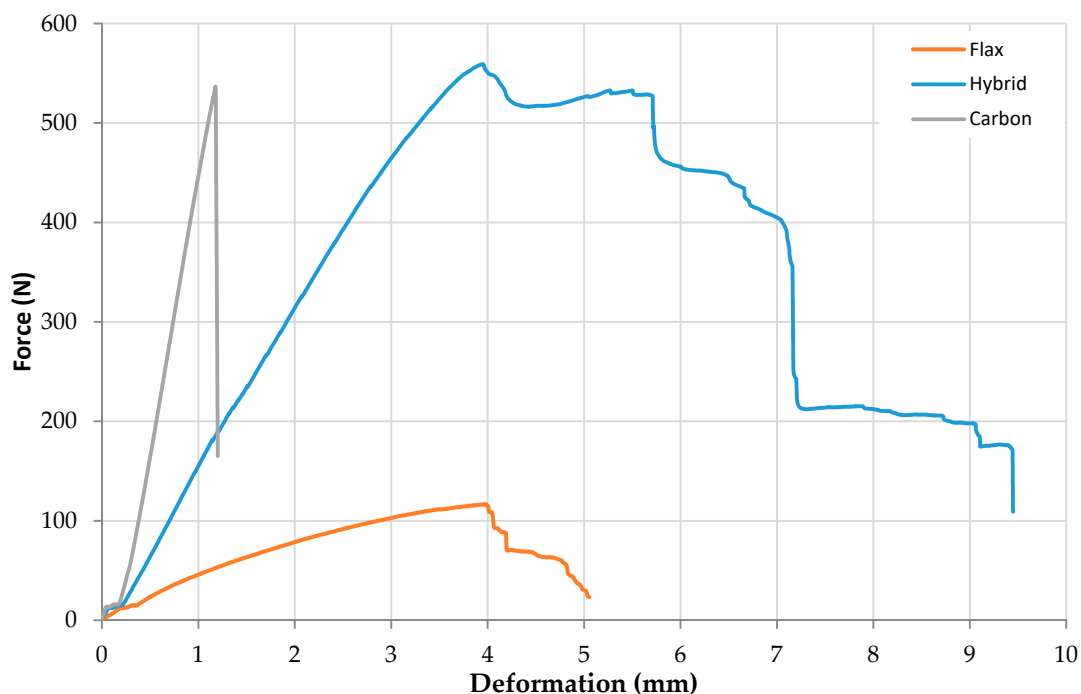
**Figure 2.** Force versus deformation traces obtained from flexural testing of flax/epoxy, carbon/epoxy and flax-carbon/epoxy hybrid composites.

The average flexural properties of three different types of composites are presented in Table 2, and load vs. deformation traces of these composites are shown in Figure 2. It can be extrapolated from

the results illustrated in Figure 2 that flax-carbon/epoxy hybridised samples have shown a significant improvement in flexural strength and modulus. Precisely, the flexural strength of plain flax/epoxy increases significantly from 95.66 MPa to 425.87 MPa (an approximate 345% improvement) with carbon fibre hybridisation. Similarly, the flexural modulus of plain flax composite was increased from 4.78 GPa to 17.90 GPa (an approximate 274% improvement) with carbon fibre hybridisation. These values represent the highest mean value amongst the studied composites. The significant enhancement in flexural modulus is dependent on several factors such as fibre content and modulus of fibre itself. Moreover, the compatibility between flax and carbon fibre as well as matrix and reinforcements may have contributed to the improvement in flexural modulus. This improvement is further attributed to the effect of hybrid mechanisms. The lay-up sequence for hybrid composites was two layers of high-modulus carbon fibres on the outside surfaces, and the pure flax fibre in the middle has contributed the highest strength and modulus. It is worth noting that flax fibre is a very stiff material which has further contributed to this significant flexural properties' improvement. The attainment of such property enhancement with carbon fibre hybridisation provides a significant potential of natural fibre hybrid composites to be used for structural light weight applications [14].

The incredibly high-flexural properties of the carbon/flax hybrid could support a theory of a very strong interfacial relationship between carbon fibre and flax fibre in an epoxy laminate under flexural

load. Similarly, the flexural deformation was significantly higher, increasing from 1.16 mm to 3.96 mm (an approximate 241% improvement) for flax-carbon hybrid systems compared to carbon/epoxy systems, indicating a hybrid system is a valid approach towards achieving an improved mechanical performance of natural fibre reinforced composites.

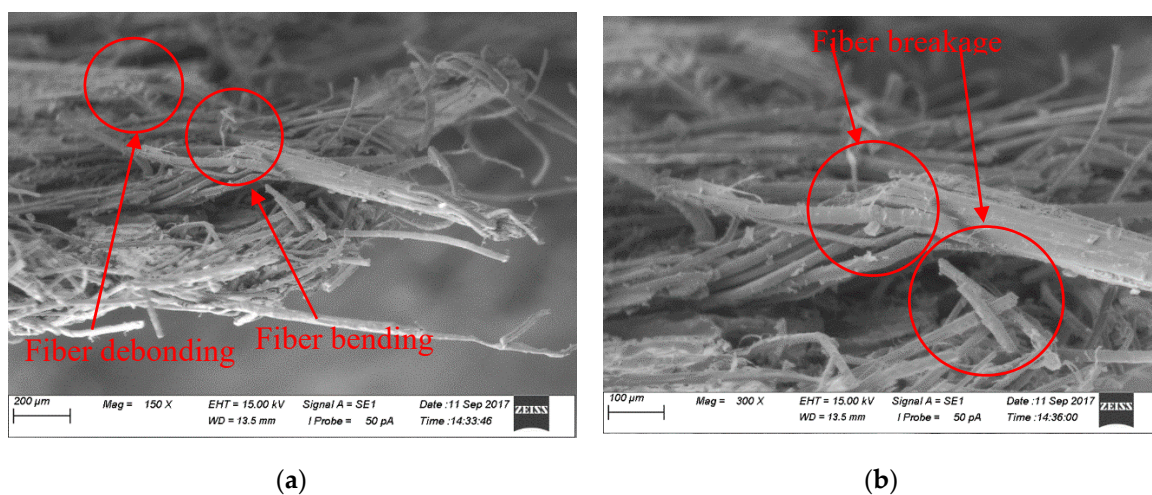
**Figure 3.** SEM images of fracture surface morphology of plain flax composites failed under impact loading at different magnifications (a) fibre debonding and bending; (b) fibre breakage.

Scanning electron microscopy (SEM) images of fractured surfaces after the impact of plain flax/epoxy composites are presented in Figure 3a,b which shows extensive fibre breakage and disorder, with one large group of fibres becoming an initial focal point. The following magnification scales (150 and 300), display matrix cracking and debonding of the epoxy from individual fibres, and additionally show the fibre bending and debonding around a kink band of the flax fibres structure, with clear twisted and flattened fibres. Similar failure mode under the low velocity impact testing was reported by Dhakal et al. for hemp fibre reinforced unsaturated based composites [15].

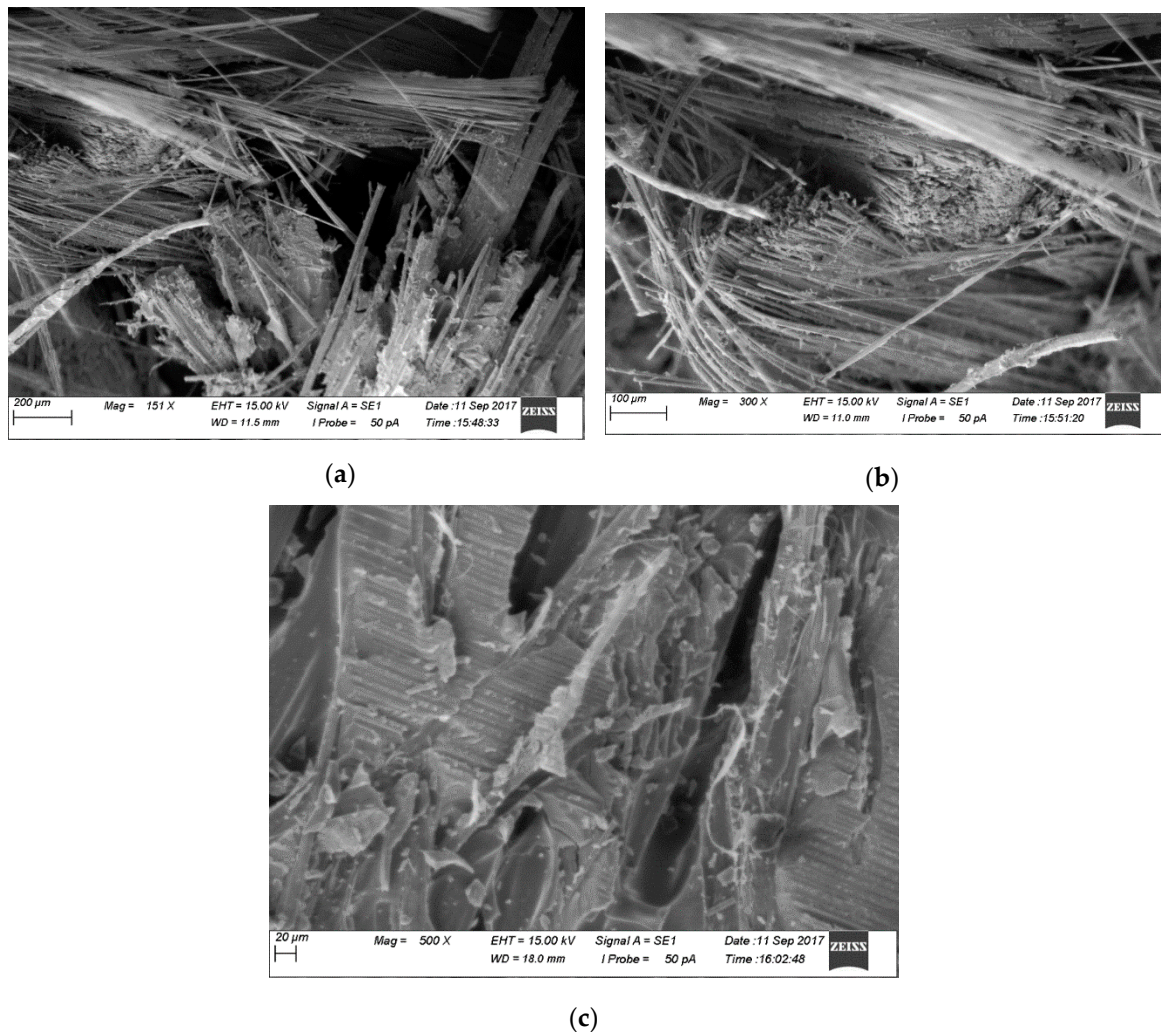
**Figure 7.** SEM images of flax/carbon/epoxy hybrid composites surfaces failed under impact loading at different magnifications. (a) flax fibres intersecting a carbon fibre layer at 151× magnification; (b) enhanced view of flax fibres intersecting a carbon fibre layer at 300× magnification; (c) fibre pull-out.

Figure 7a,b display the internal flax fibre core from the hybrid composite impact test, which exhibits a wide area of damage through the fibres, with a high degree of fibrillation present on the large fibres. When enhancing Figure 7c, the portion of the matrix shows significant cracking, tearing and delamination; with the fibres still attached becoming highly twisted and distorted as the matrix has been ejected from the primary sample body.

A further view of Figure 7a,b display both carbon and flax fibres in a chaotic site, where flax fibres from the core piles have intersected the carbon layer. The carbon to flax interface is at a 90° orientation, at a +45° offset to the topmost layer of the sample. At a higher magnification, the expected result is seen from an explosive event in a carbon fibre matrix structure. The carbon fibres that have debonded from the epoxy matrix have scattered and have not remained as a group; such as with carbon three-point bending.

Furthermore, the third site of interest is a fantastic example of fibre pull-out and the matrix surface after complete delamination. Again, in Figure 7, it can be seen that the flax fibre epoxy matrix has delaminated from the carbon fibre interface, leaving a strong pattern of convex valleys at a 90° orientation to the flax fibre direction. After increasing the magnification, Figure 7c shows the same explosive carbon fibre matrix contamination left behind on the matrix surface of the flax fibre layer.

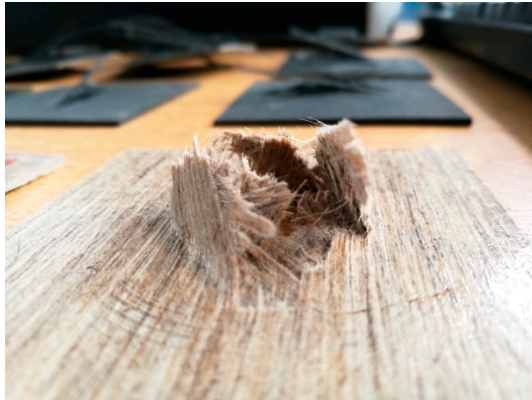
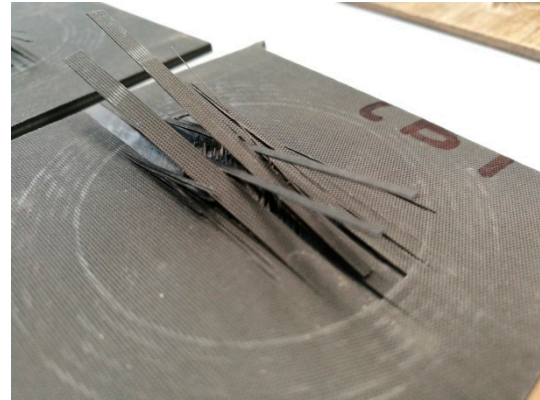
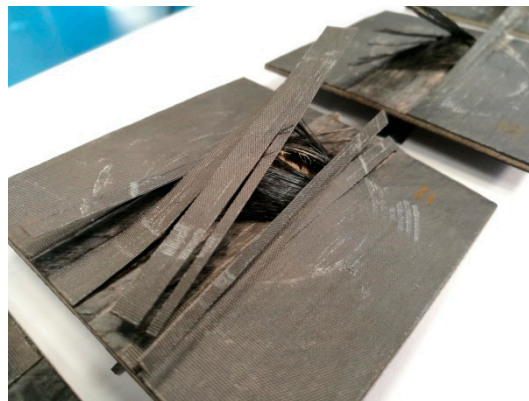
**Figure 9.** Post-impact test underside damage (a) flax fibre epoxy, (b) carbon fibre epoxy, (c) carbon-flax/epoxy hybrid composites.

Figure 9 displays the failed surfaces of impact loading showing rear sides of the samples, namely, flax/epoxy, carbon/epoxy and carbon-flax/epoxy hybrid structures.

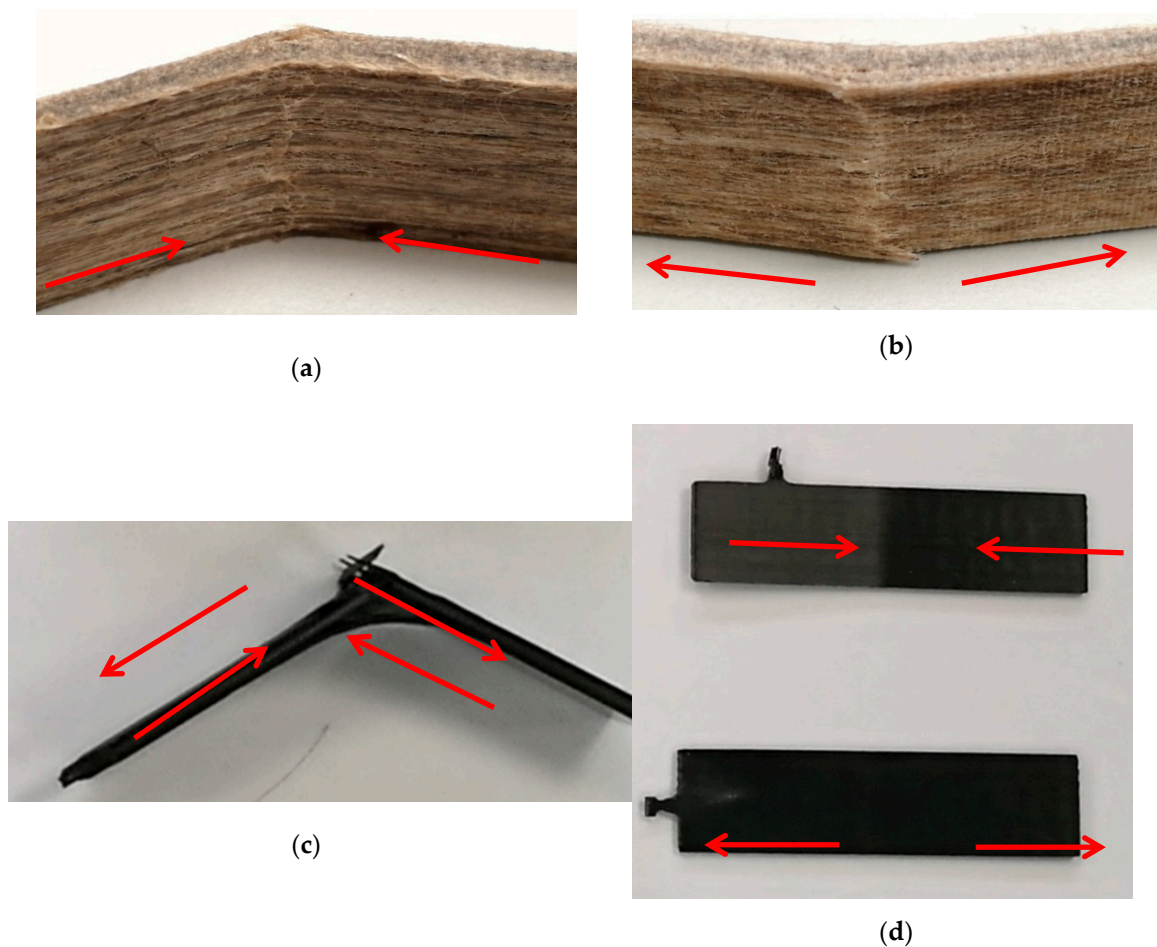
**Figure 11.** Failed samples under flexural loading (a) compressed plain flax/epoxy, (b) split outer layer of plain flax/epoxy under tension, (c) plain carbon/epoxy damage, (d) flax-carbon/epoxy hybrid composites.

The flax/epoxy samples all displayed crushed fibres around the point of the loading nose contact, where the fibres are under compression. This is shown in Figure 11a above with arrows marking the compressive and tensile load paths, including Figure 11b. The compressed topmost layers see excessive random delamination and matrix cracking. The bottom layers under tension see delamination and more fibre breakage.

The topmost layer of carbon fibre under tension, shown in Figure 11c, suffers massive delamination from the primary body, which begins to experience a greater form of fibre breakage and debonding until the primary layers under tension are shown to have an explosive failure. The hybrid samples in Figure 11d show minimal external damage visible using non-destructive testing methods.
