# Tiles from Aosta: A Peculiar Glaze Roof Covering

**Abstract:** The 18th century roof tiles from the “Casa delle vigne”, located in the Aosta region (north-east Italy), were investigated as an example of a peculiar historical roof covering: ceramic tiles with a lead-based glaze finishing to waterproof them are used to create colourful patterns. A conservation project proposed the integration of the original tiles with new ones, produced according to traditional methods. Ancient and new tiles were analysed with Fiber Optics Reflectance Spectroscopy, micro-Raman, Fourier Transform Infrared Spectroscopy and X-ray Fluorescence Spectrometry, Thermogravimetry and Differential Scanning Calorimetry for understanding the composition and the production technology of this manufacture. Their resistance to freezing and thawing cycles was then tested, considering their exposure in the severe alpine climate of Aosta. The use of pure clays with low calcium contents, high firing temperature and lead-rich glazes was found in ancient tiles, able to withstand several freezing-thawing cycles without damages. Iron and copper pigments were used in old yellow and green glazes. Zinc-based pigment, low le

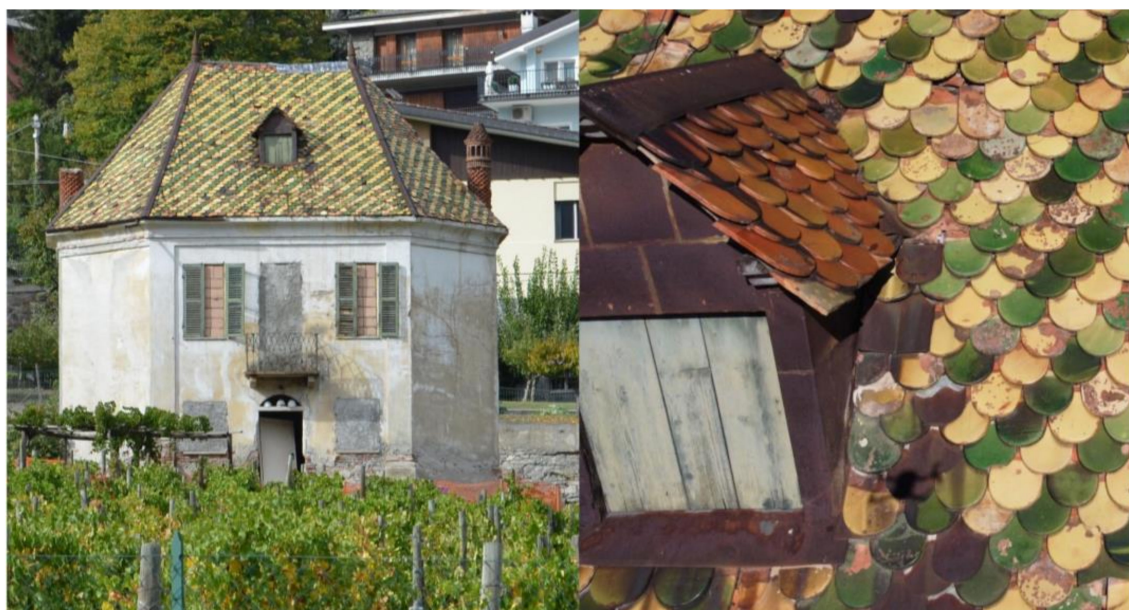
**Figure 1.** (Left): the 18th century pavillon “Casa delle Vigne” in Aosta (northeast Italy) with its peculiar tiles roof. (Right): the fish-scale pattern commonly used for tile alignment in roofing.

The “Casa delle vigne” (Figure 1) is a small pavilion located in the vineyard of the village of Pallin in Aosta Valley, Northern Italy. The building was constructed at the end of the 18th century by the noble Passerin D’Entrèves family as a facility serving the vineyard [2]. The pavilion stands out thanks to the roof covered with colourful glazed fish scale tiles. It is a roof covering peculiar for the Aosta region, but fashionable and used in the same years in Piedmont and typical in France. It is possible, given the high profile of the owners, that the tiles were imported from the nearby Piedmont region.

The hexagonal pavilion consists of two floors; on the ground floor there is the entrance flanked by two windows, and on the upper floor there is a small balcony and two windows with green shutters. The most characteristic part of the building is the polychrome roof, composed by glazed fish scale roof tiles.

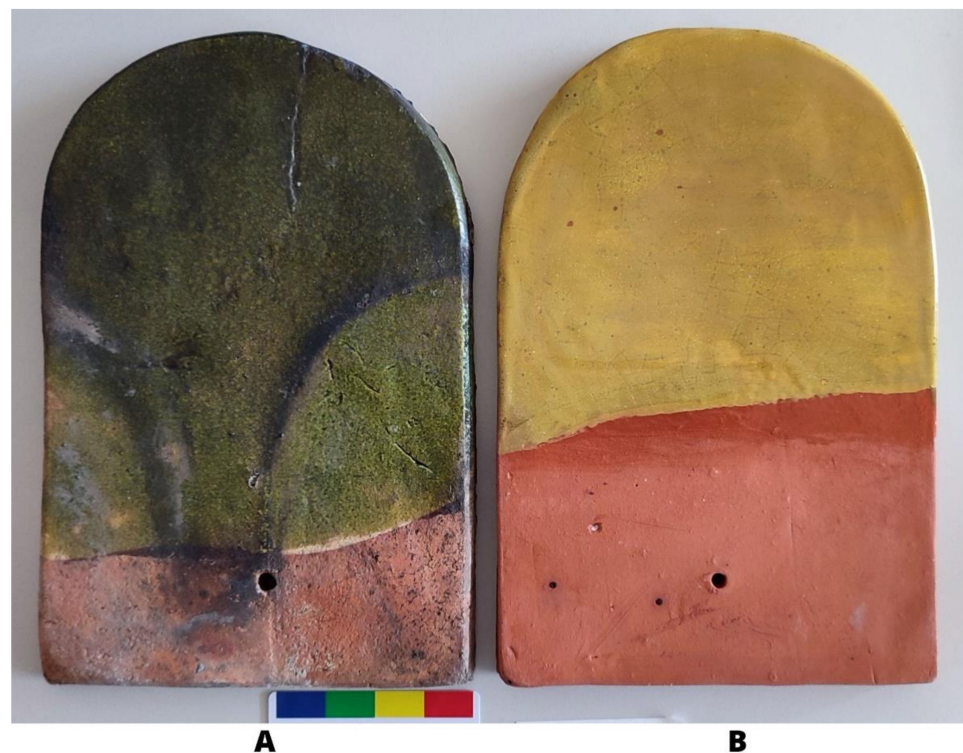
**Figure 2.** Image of an original roof tile ((A)—sample 13V) and a new one ((B)—sample 14G).

New tiles for replacing the damaged and lost ones were acquired from “Associazione Centro Ceramico Museo Fornace Pagliero 1814” of Castellamonte directed by ceramist Daniele Chechi (Figure 2B sample 14G). The Fornace Pagliero’s tiles are produced following the traditional Piemontese recipe described in texts of the early 17th–late 18th century. The historical quarries are currently closed, but the artisanal workshop is allowed to use for conservation intervention the material extracted in the 1960s and 1950s from the Chiria quarry.

The conservation state of the tile's surfaces (Table 1, Figure 4) depends mainly on the specific exposure to the environment. Three areas are recognizable for each tile (Figure 2A sample 13V): an external glazed area directly exposed to precipitation; a glazed area covered by the adjacent tiles; and a non-glazed area on the upper side of the tile and on the back. Dirt deposits are observed on the covered parts, while a network of cracks is visible on the glazed parts, less visible in green glazes. Despite the crack network present on almost all the samples, the glazes are extremely compact and adherent to the substrate. Several degradation processes are underway, including the formation of opaque and iridescent areas, colour variations pitting and staining. Interestingly, many of these forms of degradation are localized in the covered areas, where low atmospheric run off, pollutants deposition and water stagnation occurred, resulting in a chemical attack of glaze [22]. The new tiles by Fornace Pagliero are characterised by a yellowish-greenish hue given by a coloured glaze realized on a white slip covering the ceramic body. A dense
