A Novel Structural Health Monitoring Method for Reinforced Concrete Bridge Decks Using Ultrasonic Guided Waves

Ece Erdogmus^{1,*}, Eric Garcia², Ahmad Shoaib Amiri¹ and Michael Schuller³¹ Durham School of Architectural Engineering and Construction, University of Nebraska-Lincoln, Lincoln, NE 68182, USA; aamiri@unomaha.edu² School of Engineering, University of Mary, Bismarck, ND 58504, USA; egarcia@umary.edu³ Atkinson-Noland & Associates, Inc., Boulder, CO 80302, USA; mschuller@ana-usa.com

Abstract: This article presents the latest improvements in a recently developed nondestructive testing (NDT) approach for early detection of various flaws (corrosion, delamination, and concrete cracking) in reinforced concrete (RC) bridge decks. The proposed method involves the use of internal steel reinforcement as a wave guide for transmitting ultrasonic waves through the system and the measurement of leaked energy from the surface of the concrete. This paper builds upon the progress made in the previously published phases of the project and aims to further explore the capabilities and practicality of the proposed NDT method. Specifically, the limits of propagation distance, effect of bidirect

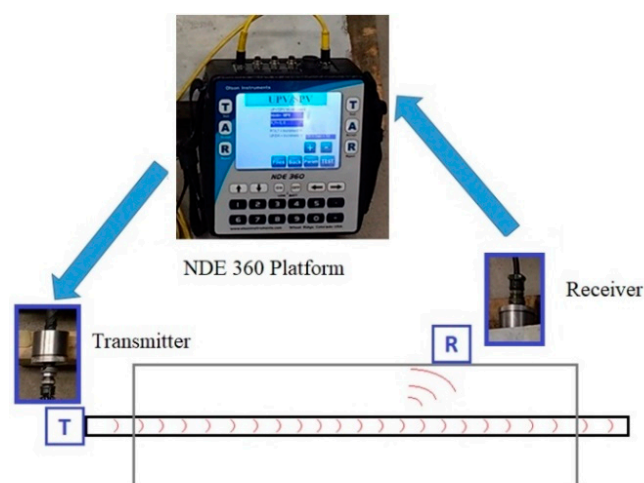
Figure 1. Ultrasonic experimental setup.

There are two unique aspects of the proposed methodology when compared to traditional ultrasonic testing. First is the utilization of the leaked energy from the ultrasonic guided waves into the surrounding concrete by coupling the transmitter to the steel rebar and receivers to the concrete surface (Figure 1). The hypothesis behind this approach is that, with a theoretical understanding of the wave propagation in steel and the leaked-wave propagation in concrete, the types and locations of different flaws (chemical corrosion, delamination, and independent cracks in concrete) can be identified.

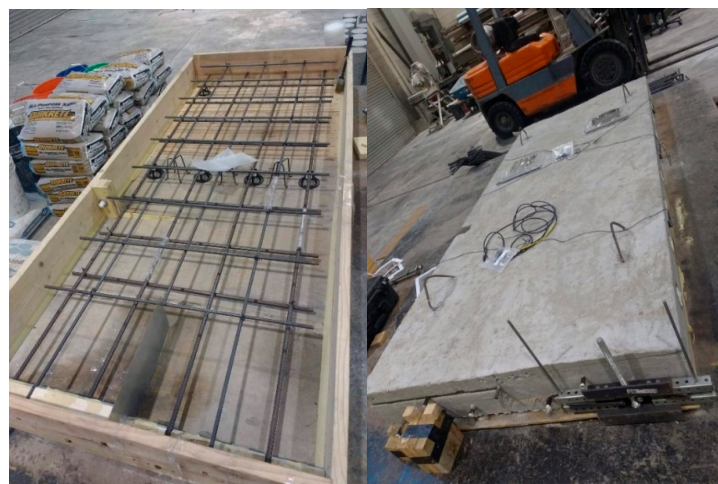
Figure 3. Specimen Set 2 formwork and bars before casting (left) and the final specimen (right).

The primary purpose of this longer (3 m or 10 ft.) specimen was to test at increased distances between the transmitter and receivers (Figure 3). Previous work investigated the propagation of the guided waves and the measured data (the leaked energy) over a maximum distance of 1.5 m (5 ft.), and the length of this specimen doubles that distance. A secondary purpose of the specimen set was to examine the influence of multiple layers and direction of reinforcement on the UGWL method. Finally, the specimen was used to evaluate whether the proposed method can detect a variety of flaws (corrosion, delamination, and cracks) in the same specimen.

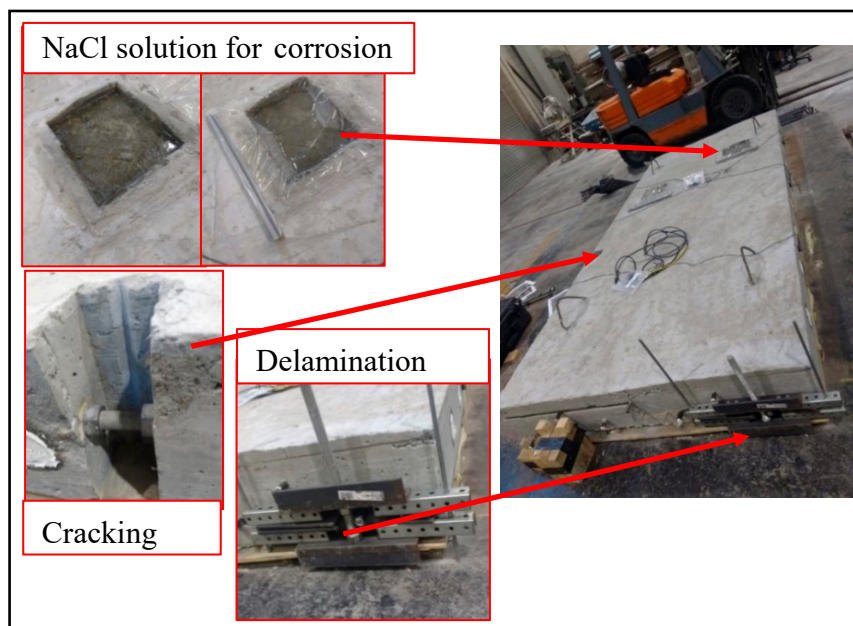
Figure 4. Specimen Set 2 and various areas of artificially introduced flaws.

Illustrations of Specimen 2 (photos in Figure 3 through Figure 5) are shown on the left side of Figures 14 and 15. In these drawings, the dark grey represents delamination and the yellow represents corroded areas. The reinforcing bar colored red in each figure indicates the reinforcing bar tested, and the blue boxes denote the transducer locations for the respective amplitude versus distance plots. The data points plotted in Figures 14 and 15 are averages of five readings.

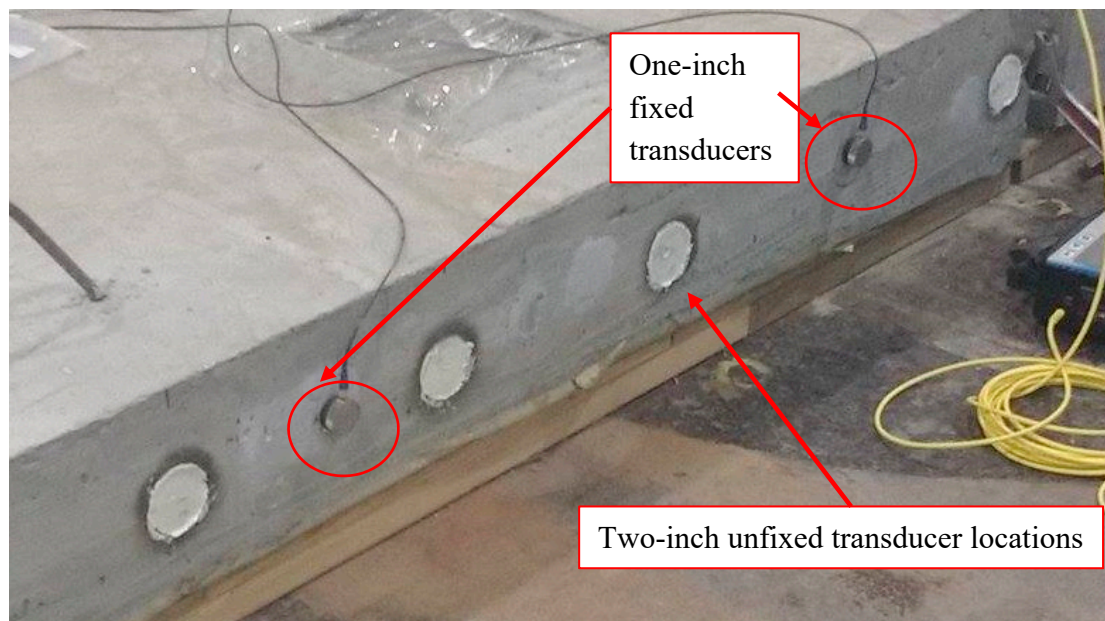
Specimen Set 2 was a larger reinforced concrete slab measuring 305 cm × 122 cm × 20.3 cm (10 ft. × 4 ft. × 8 in). This specimen was cast (1) to examine the influence of multiple layers and directions of reinforcement on the proposed UGWL method, (2) to test greater distances between the transmitter and receivers than those tested by previous experiments, and (3) to evaluate whether the proposed method can detect a variety of flaws (corrosion, delamination, and cracks) in the same specimen (Figure 3). Each layer of reinforcement had a cover of 6.35 cm (2.5 in.) from the outer surfaces and 7.62 cm (3 in.) of vertical distance between them. The specimen contained known areas with delamination and corrosion and a mechanism to create artificial cracks, as shown in Figure 4. Artificial cracking was intended to simulate cracks perpendicular to the surface that can be caused by a variety of reasons in the field and not as a separation between the rebar and the concrete. An array of sensor locations was marked on the side of the slab as shown in Figure 5.

Figure 5. Specimen Set 2 sensor locations.

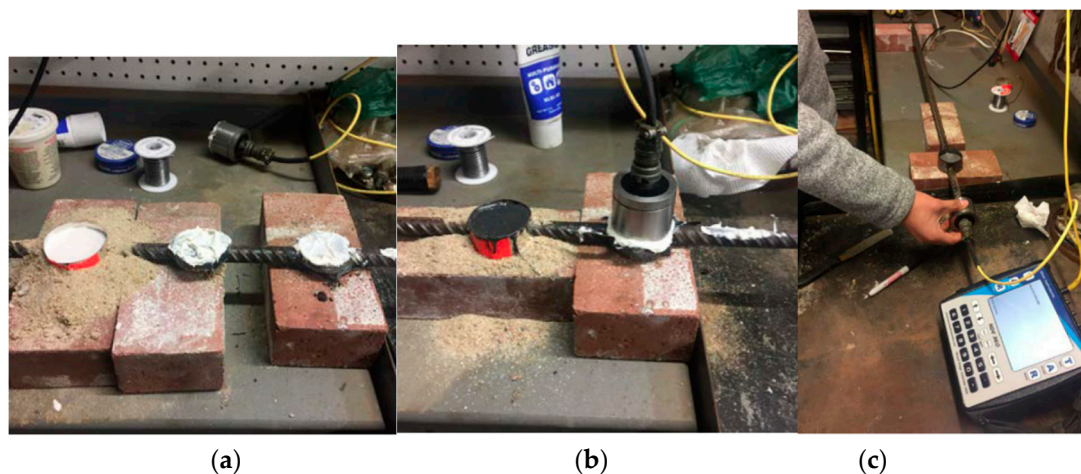
In order to investigate different sensor-to-rebar attachment materials for improved coupling, laboratory experiments were conducted using a 16 mm (Number 5) reinforcing bar. Energy was transmitted into the bar using the following five approaches (Figure 6):

1. The transmitter was coupled directly to the end of the rebar;
2. A 5.1 cm (2 in.) section of the rebar was ground flat, and the sensor was attached onto the rebar using a typical grease couplant;
3. A lead solder pad was created, where a sheet metal form was placed over the bar; sand was placed around the form as a seal to prevent solder leakage, and lead solder was melted onto the pad with a torch. The pad was filed flat after cooling;
4. A seat for the transmitter was created using steel-filled JB Weld epoxy, poured into a form around the bar; and
5. A seat for the transmitter was created using Hydrocal gypsum cement, poured into a form around the bar.

Figure 6. Attachment options: (a) Right to left: coupling via a solder pad, coupling via an epoxy pad curing in sheet metal form, and gypsum cement poured into sheet metal form; (b) Right to left: ground rebar and coupling with white grease, solder and epoxy pads fully cured; (c) Transmitter at the end of the rebar.

Specimen Set 3a comprised a single bar used to test various ideas for the attachment of the transmitter to the rebar in field conditions, as explained in Section 2.1.3 and shown in Figure 6. According to the experimental results (Table 2), the maximum energy transfer was achieved when the transmitter was coupled directly to the end of the rebar, which represents the original lab setup and aligns with the optimal wave propagation expected with wave guides. The second-greatest amplitude measurements were achieved using Hydrocal gypsum cement, despite perpendicular attachment to the rebar. This material also has a short curing time of approximately 20 min; therefore, it will not cause significant delays during field testing.

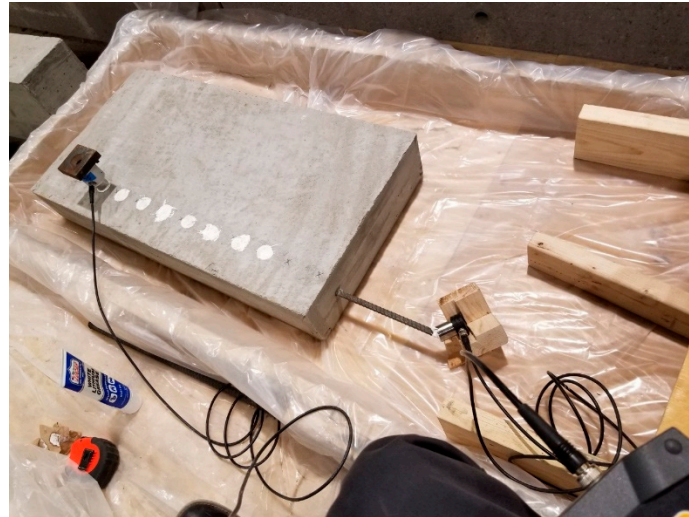
Specimen Set 3b comprised three reinforced concrete slabs that each measured 91.4 cm \times 45.7 cm \times 12.7 cm (36 \times 18 \times 5 in.) as shown in Figure 7. These slabs were cast with a 13 mm (No. 4) rebar embedded at the center slab cross section.

Figure 7. One of the Specimen Set 3 slabs, showing sensor locations.

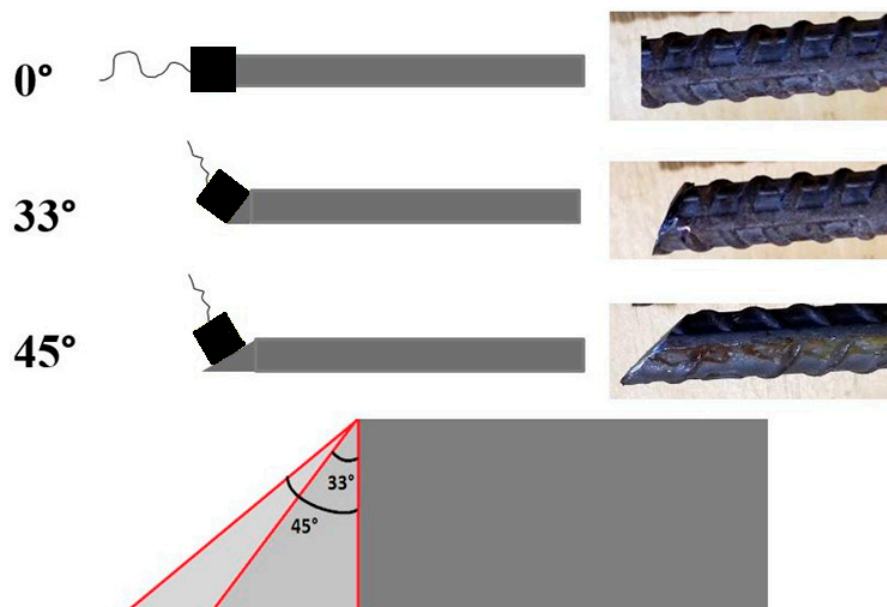
The purpose of this set of specimens was twofold: (1) to investigate via UGWL energy transmission with different bar end angles: 0 degrees, 33 degrees, and 45 degrees, cut with reference to the vertical axis, to simulate different transmitter-to-rebar attachment seat angles from the top of the bar (Figure 8); and (2) to compare two couplants to improve the coupling of the sensors to the test materials: Ultragel II from Magnaflux and White Lithium Grease from Lucas Oil Products.

Figure 8. Bar end angles.

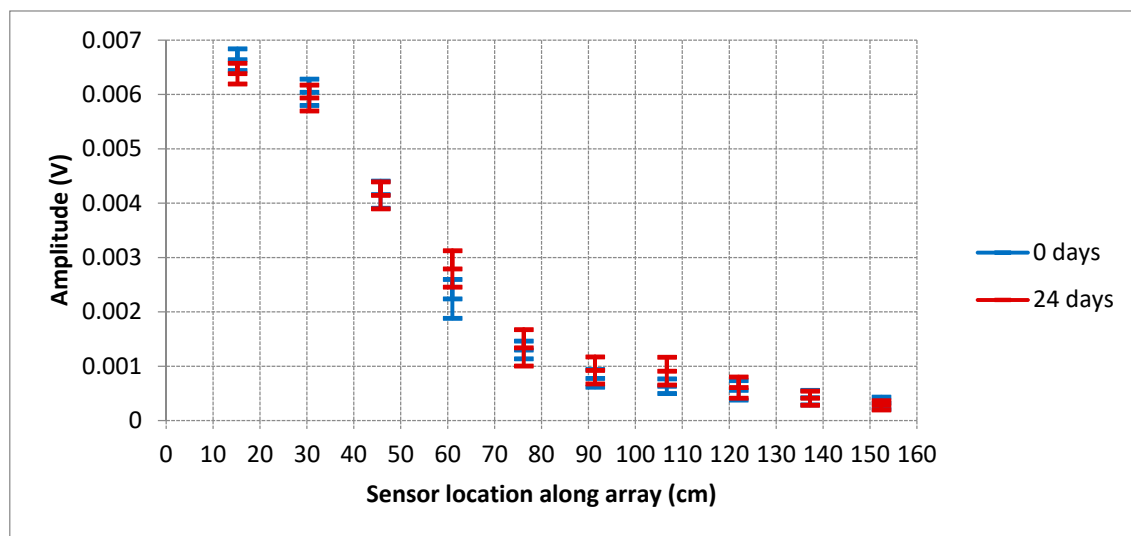
Figure 9. Amplitude of leaked waves versus sensor location plot for Specimen 1, with the transmitter on the corroded bar (Rebar 1: corrosion in the middle) and receivers 30.48 cm (1 foot) away from the bar.

The 24th day results (Figure 9) from the sensor array located at the near edge (30.48 cm or 1 ft. away from Rebar 1) follow a typical attenuation of signals in an exponential curve, as expected, and show only a slight change in signal amplitudes at roughly the 60 cm (23.6 in.) measurement point. The slightly increased amplitude correlates to the location of the start of the corrosion basin roughly at 46 cm (18 in.). The actual location and the detected location are essentially the same when the leakage angles are considered, which are between 24 and 42 degrees. Figure 10 presents the results for the array of sensors placed at the far edge, and while the signals are, in general, only 28% of those obtained from the near end, a more obvious increase of amplitude at 107 cm (42 in.) and 122 cm (48 in.) along the array is observed. These locations also correspond to the corrosive region in the middle, considering the leakage angle, which is explained in the next section.

First, the ultrasonic waves were transmitted from the end of Rebar 1 and the leaked waves were detected from an array of sensors first on the near edge (1 ft. away from Rebar 1 as shown in Figure 2) and then on the far edge (3 ft. away from Rebar 1 as shown in Figure 2). The near-end and far-end results are presented in Figures 9 and 10, respectively, for zero corrosion (Day 0) and at Day 24.

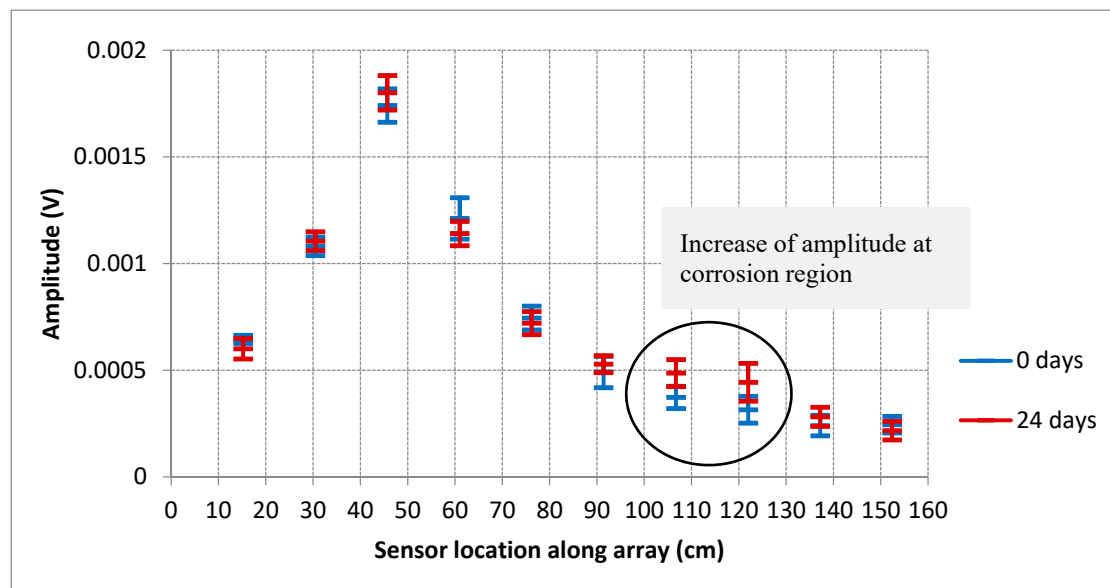
Figure 10. Amplitude of leaked waves versus sensor location plot for Specimen 1, with the transmitter on the corroded bar (Rebar 1) and receivers 91.44 cm (3 ft.) away from the bar (note that the vertical scale of this plot is 2/7 or 28% that of the plot in Figure 9).

Theoretically, the leaked bulk waves will propagate in two forms: longitudinal and shear waves. The leakage angle (or angle of refraction) may be theoretically calculated based on Snell's law which describes the relationship between angles of incidence and refraction when referring to waves passing through a boundary of two different media. The leakage angles for longitudinal and shear waves are calculated as 42 and 24 degrees, respectively [7]. This means that in Figure 10, for an array placed 91.44 cm (3 ft.) away from the bar used as the wave guide, there will be roughly a lag of 40 to 82 cm (16 to 32 inches) for signals associated with any localized flaws along the rebar. Given that the corrosive region is in the middle of the bar, roughly from 46 to 76 cm (18–30 in.) of the 152 cm (60 in.) long specimen, the expected locations of signal change for the leaked wave amplitudes range between 86 cm and 128 cm (34 to 50.4 in.). The most clearly detected increase of signal is at 122 cm (48 in.), which translates to a leakage angle of 26.6 degrees, well within the 24-to-42-degree range previously established. For Figure 9, where the signals are received at the near end of the concrete and the corrosive region starting around 46 cm (18 in.) from the corrosive region, the detected increase at 60 cm (23.6 in.) corresponds roughly to a leakage angle of 24 degrees.

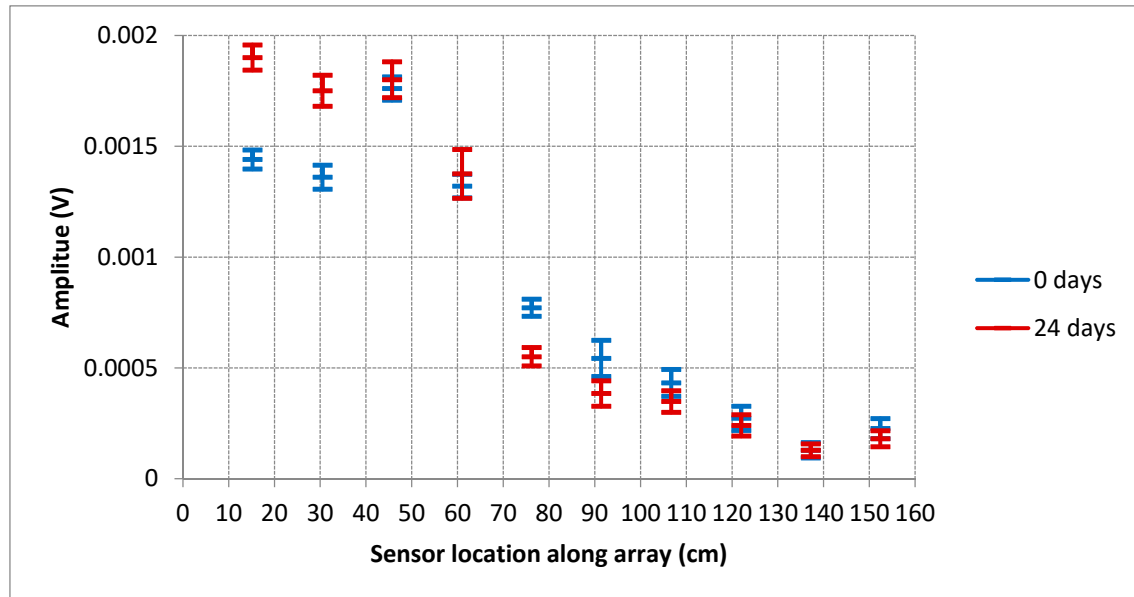
Then the transmitter was placed on Rebar 2, which has a corrosion region at the start, roughly between 5 and 35.5 cm (2–14 in.) from the transmitter end (Figure 2). Considering a leakage angle of 24 degrees, this corresponds to a corrosive region detection range as far as 63 cm (24.7 in.). As can be seen in Figure 11, the leaked wave amplitudes are considerably higher for the first four measurement points (until 61 cm from the end) for 24th day measurements compared to previous (0-day) readings, and they show a decrease from 76 cm onwards. The increase in amplitudes in the corrosion region is attributed to the improved bond between concrete and steel. It should also be noted that the velocity of ultrasonic waves through saturated concrete is greater than their velocity through dry concrete. Consequently, the attenuation can be less than the attenuation within dry concrete, keeping the readings from the concrete surface high. This can explain the fluctuations in the 0-day data in Figure 11. The decrease in amplitude of the guided wave after the corrosive region is also expected, as a significant portion of the guided wave already refracted into the surrounding concrete through the corrosion region.

This observation, namely, decreased amplitudes of energy transmitted through the wave guide in a steel member subject to corrosion, agrees with what has been found in previous studies, such as the work done by Miller [8].

Figure 11. Results for corrosive conditions at the beginning of the rebar (Rebar 2) and the measurement array at the concrete edge, 61 cm (2 feet) away from the bar horizontally.

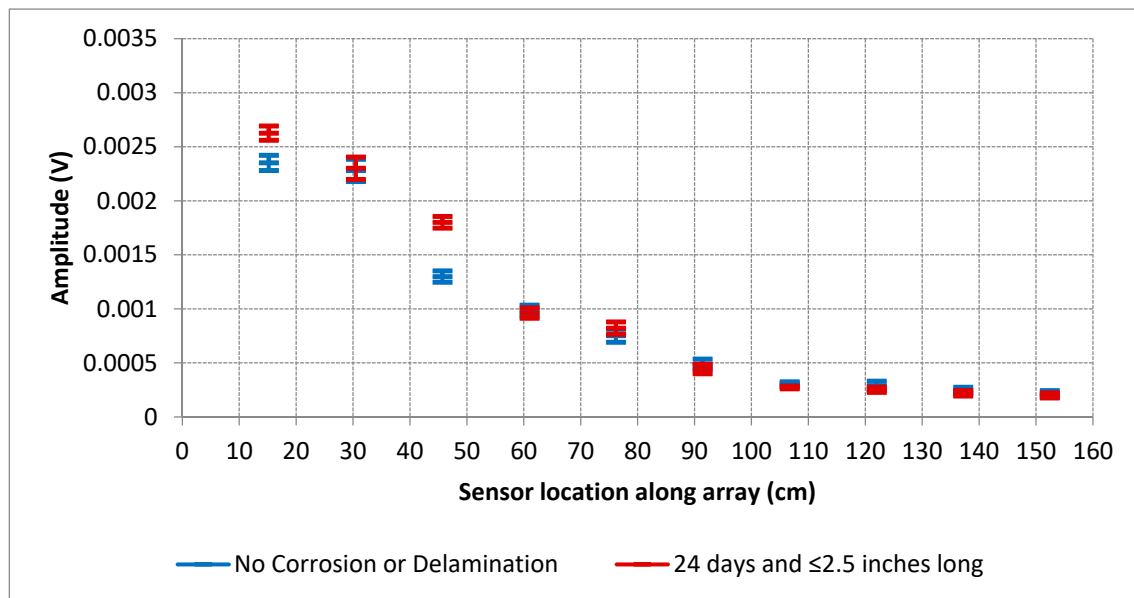
In Figure 12, an increase in the amplitudes can be observed through the corrosive region, and the amplitudes decrease beyond that. The delamination at the steel–concrete interface was 2.5 inches long at the 24-day measurements, and it can be seen in Figure 12 that it is difficult to discern the effect of the delamination *after* the corrosion-related decrease in amplitudes.

Figure 12. Corrosion and delamination test—Rebar 3: Transmitter located on the corrosion end and receiver array on the concrete edge 30.48 cm (1 ft.) away from the wave guide.

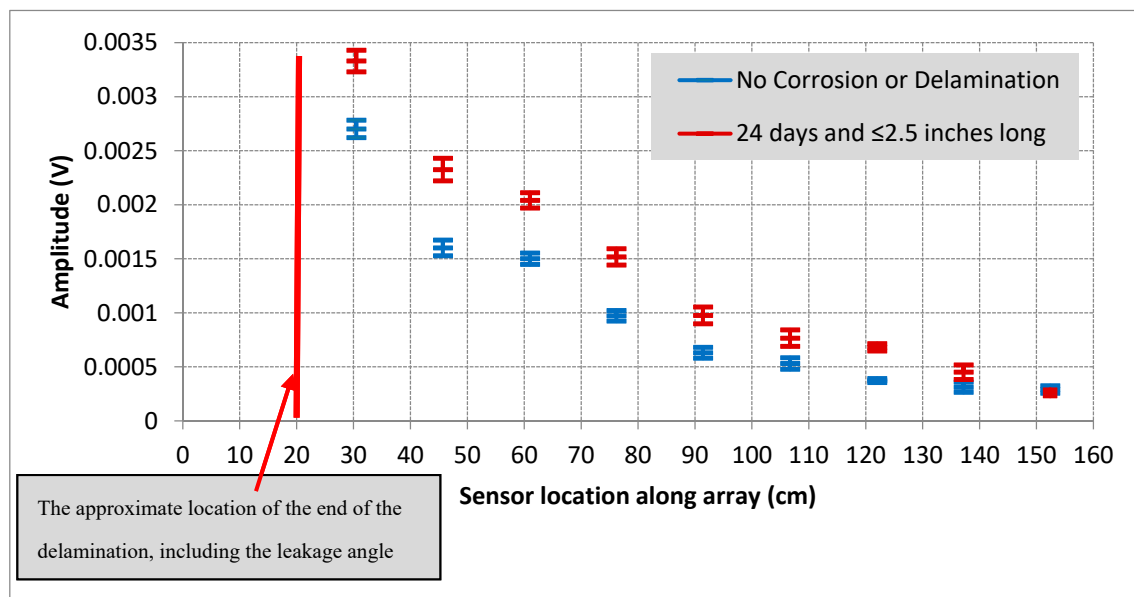
On the other hand, when the guided wave originated at the delamination end, the development of delamination caused significant increases in the leaked waves' amplitude monitored by any sensor located beyond the 6.35 cm (2.5 in.) long delamination, which corresponds to 20–34 cm (7.8–13.3 in.) considering the leakage angles of 24 to 42 degrees (Figure 13). This is because the energy stays in the wave guide when the connection with concrete is lost, producing no leakage. Once the location of the delamination is passed, there is more energy to leak into the surrounding concrete, increasing the amplitude of the readings. Also, the measurement points start at 30 cm from this end, due to the mechanism placed to create the delamination (Figure 2). Given that there were also corrosive conditions applied to the steel bar on the other end, the results shown in Figure 13 illustrate that at the start of the corrosive region, at 122 cm (48 inches) along the array, the amplitude appeared to increase more than at the other sensors. More notably, after the initial apparent increase, the amplitudes of the sensors beyond that saw decreases relative to the rest of the array, since the guided wave had already attenuated significantly by the time it reached the corrosive region. The variation in percent change in amplitude along the array is as follows: the percent increase in amplitude monitored by the

sensor located at the start of the corrosive region spiked to 82%, while the rest of the sensors somewhat consistently increased around 40 to 60%.

Figure 13. Corrosion and delamination test—Rebar 3: Transmitter located on the delamination end and receivers on the concrete edge 30.48 cm (1 ft.) away from the wave guide.

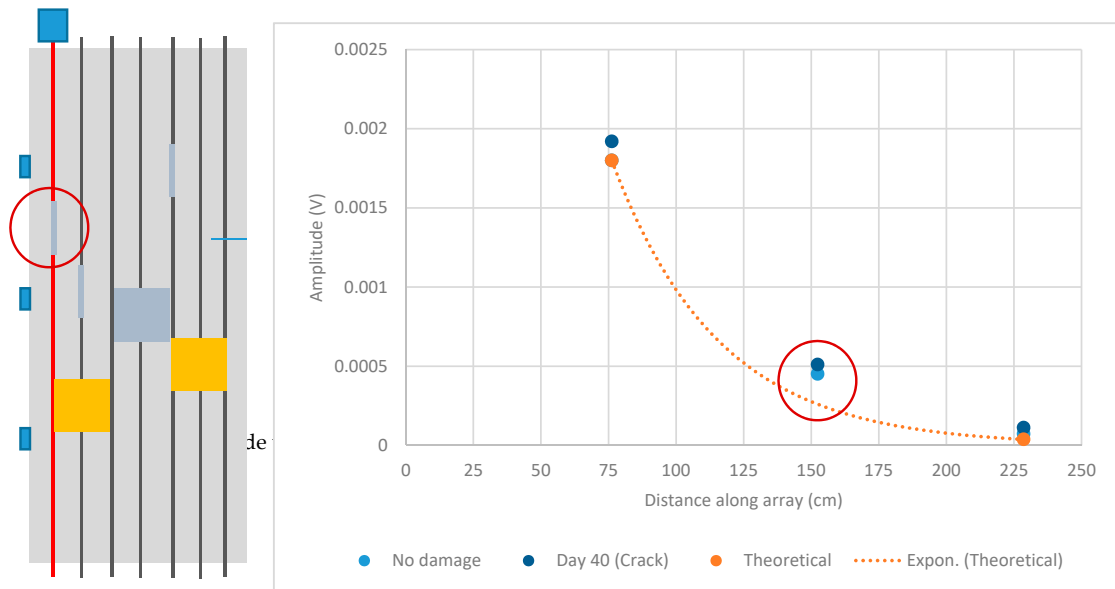
Figure 14. Amplitude versus distance plot for Specimen Set 2 using 1 inch transducers as sensors (an array of three sensors on the left side of slab) when the transmitter is placed on the far-left rebar.

Figure 14 shows the results of the array of 1 inch transducers and displays the expected result of the increase in amplitude readings that occurs after (i.e., at the second sensor point) due to the artificially inserted delamination, in the form of a laminate wrapped around the rebar. As can be seen, given such a permanent interruption between the wave guide and the surrounding material, consistently higher amplitudes of leaked waves are detected in the sensor after the rebar. This is attributed to the fact that in the delamination region, more of the energy remains in the wave guide.

In Figures 14 and 15, a theoretical curve is included. This curve was established using Equation (1). When guided wave attenuation is considered, the attenuation coefficient (α) describes the weakening

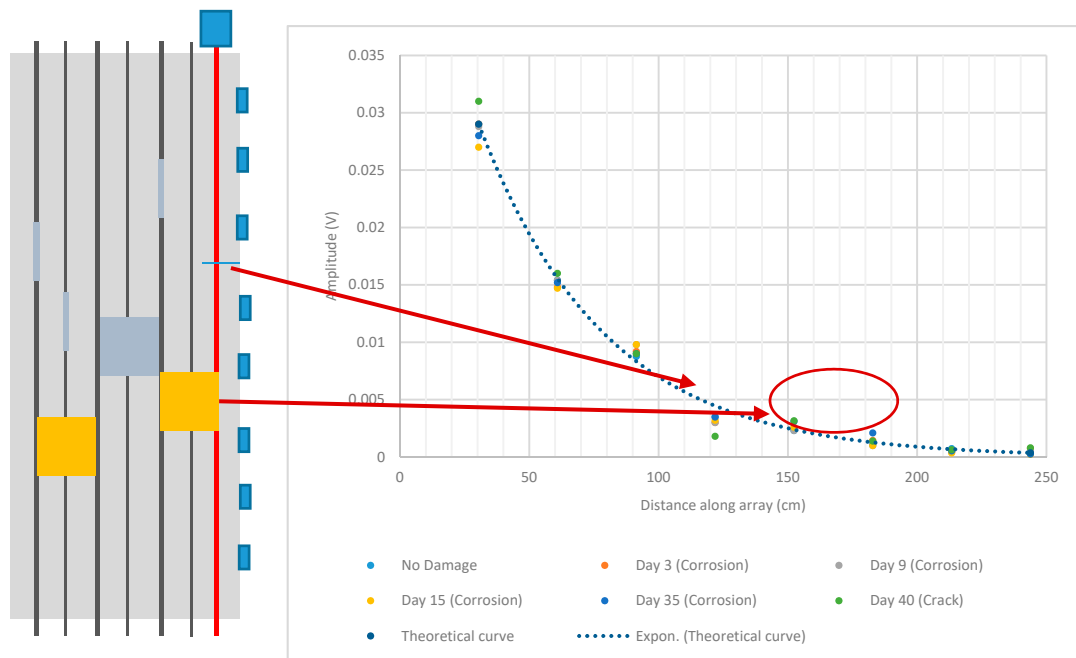
Figure 15. Amplitude versus distance plot for Specimen Set 2 using 2 inch transducers as sensors (array of eight sensors) when the transmitter is placed on the far-right rebar.

Sample results of the array using the 2 inch transducer are shown in Figure 15 for the case when the right-most rebar is used as a wave guide. This experiment was intended to investigate the ability of the method to identify a crack in the concrete simultaneous with corrosion progression. The impact of the embedded crack is attributed to the amplitudes detected by the sensor located roughly at 122 cm (48 in.), which are consistently lower than the theoretical values. The detection of the corrosion region (which is expected to change over time) is more difficult. A slight increase in amplitudes was detected by the sensors located roughly at 152 cm (60 in.) and 183 cm (72 in.). This uncertainty is attributed to (i) the energy already having attenuated significantly by this point and the amplitudes already being very small, and (ii) the positioning of the sensors possibly not being optimal when the leakage angles are considered.

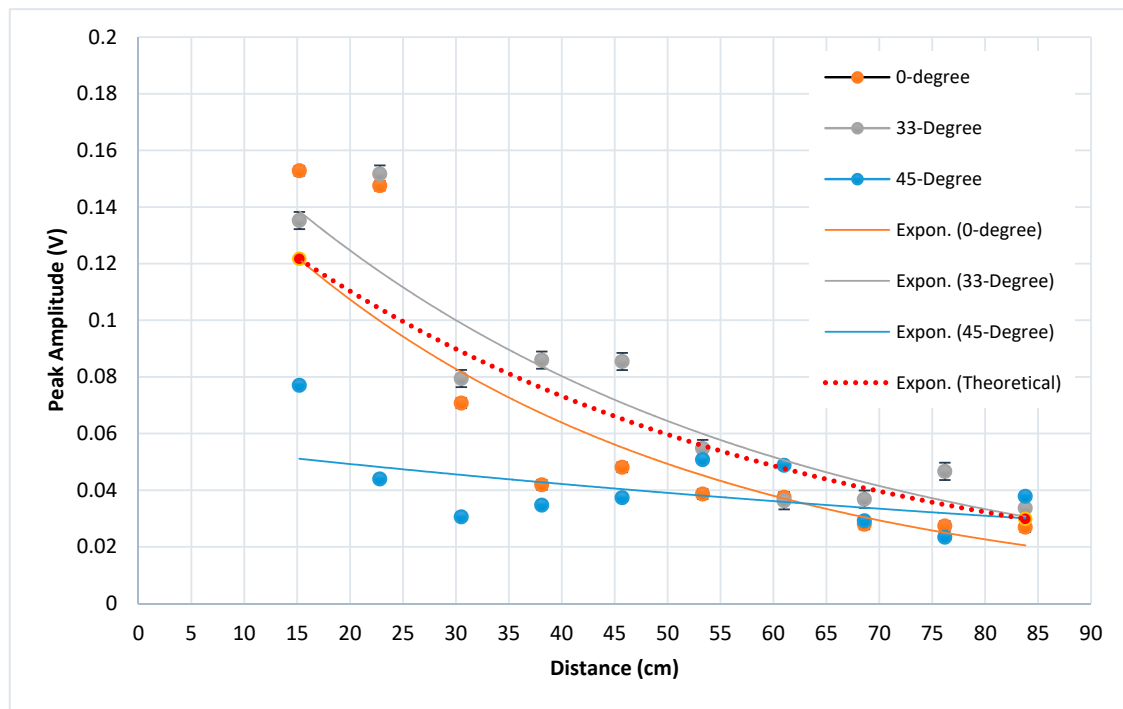
As expected, maximum energy transfer was achieved with the 0 degree specimen with a peak amplitude around 0.15 V. The 33 degree specimen provided comparable peak amplitudes (around 0.14 V) but greater scatter due to the fact that additional modes of ultrasonic waves were excited that led to additional reflections of the leaked waves from the boundaries of the wave guide. In the case of the 45 degree specimen, much less energy was transmitted longitudinally, resulting in much lower amplitudes detected from the concrete surface along the array. Given the significant loss of energy in

this setup along with highly scattered data, this angle of attachment (45 degrees) was concluded to be infeasible for field applications. A 33 degree angle or lower appears to be optimal—a compromise between feasible attachment on a horizontal rebar and maintaining most of the energy longitudinally in the wave guide. However, further work will take place in future phases of this project to investigate other angles between 0 and 33 degrees.

Figure 16. Comparison of the peak amplitudes and attenuation curves for the 0, 33, and 45 degree specimens.

- With Specimen 3, the use of different bar end angles created a practical lab experiment to test various angles for transmitter-to-rebar attachments. While a 45 degree angle resulted in amplitudes of leaked wave measurements that were too low, a 33 degree angle provided promising results for the UGWL method. It should be noted, however, that when an angled attachment is used, the data interpretation should consider variations in the ultrasonic modes excited, as well as reflections from the boundaries.

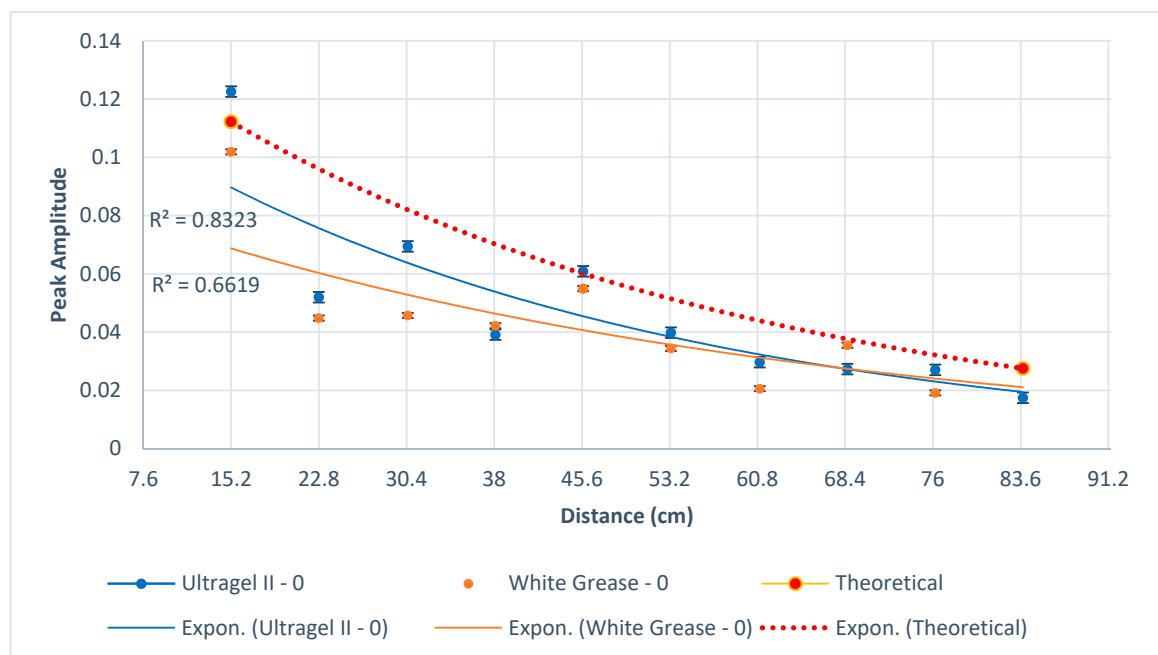
It can be seen in Figure 17 that not only are the peak amplitudes for coupling with Ultragel II slightly higher than those with WLG, but the exponential curve is also closer to the theoretical curve. Further, the R-squared value for an exponential trendline is higher for Ultragel II. Another advantage of Ultragel II is that it can be easily wiped off the surface compared to White Lithium Grease. On the other hand, each data point in Figure 17 represents 20 trials, and it should be noted that the standard deviation for each test location was slightly higher with Ultragel II (0.0018 versus 0.0008 for WLG); this is likely because it is less sticky than WLG and creates more room for user errors when measurements are repeated. Therefore, care should be taken to ensure consistent measurements with Ultragel II. In conclusion, the difference is not very significant, and either couplant can be used in this method; however, Ultragel II appears to be slightly more efficient.

Figure 17. Plot obtained from the 0 degree specimen for comparison between Ultragel II and White Lithium Grease.

- In terms of couplants, the difference between White Lithium Grease and Ultragel II is not very significant, and either couplant can be used in this method. However, Ultragel II appears to be slightly more efficient in terms of transmitting the energy into the system and receiving the leaked energy from the surface of the concrete.

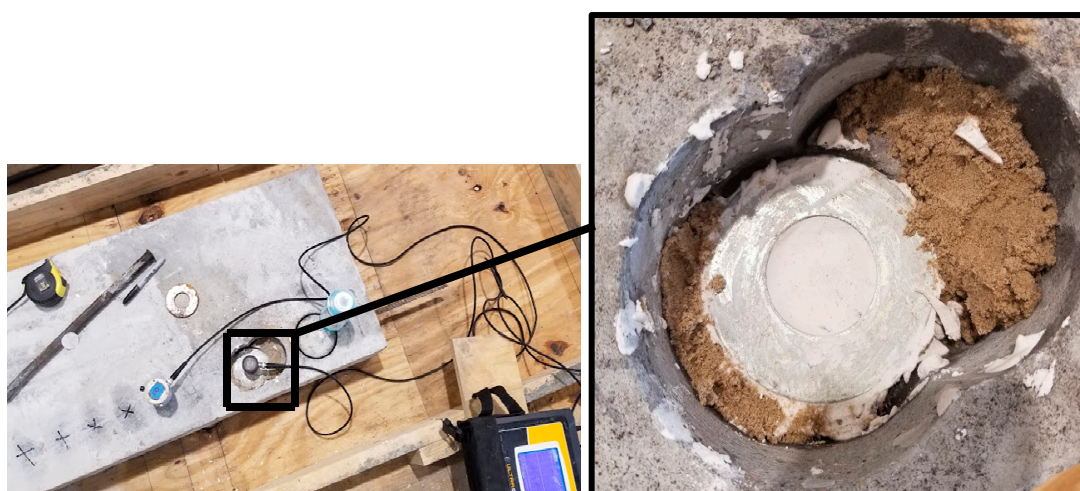
The 45 degree test specimen was cored to the rebar level using a hitch mounted core drill; then, the top surface of the rebar was ground flat and a seat was created using the Hydrocal gypsum paste to replicate the gypsum seat attachment that would be made in the field (Figure 18). The ultrasonic pulses were transmitted from this point and monitored using receivers at five equally spaced spots on the top surface of the specimen along the rebar.

Figure 18. Hydrocal gypsum cement placed on top of the rebar to improve the coupling condition.

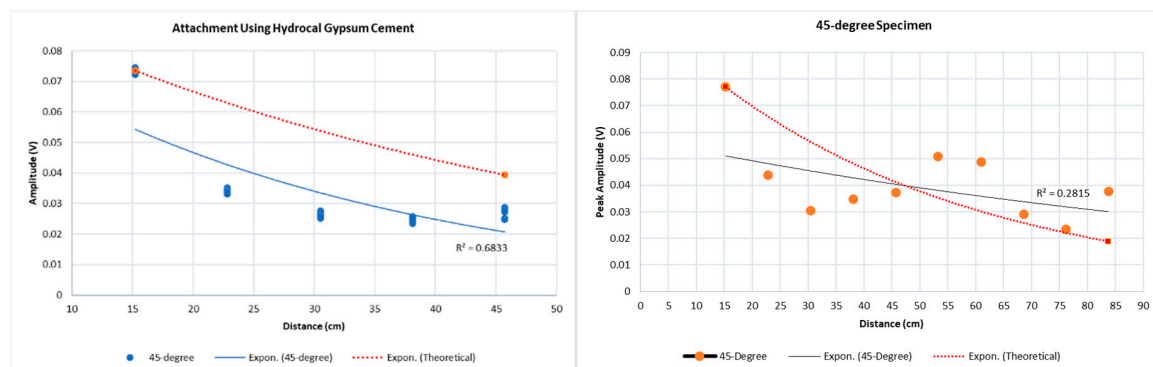
The results for this experiment are shown in Figure 19 in comparison to the original data from the 45 degree specimen. As can be seen, coupling perpendicular to the bar with gypsum (Figure 19, left) actually works better than the end of rebar with a 45 degree angle, given the better fit with an exponential curve and the theoretical curve, as well as similar peak amplitudes to those observed when sending the energy from the end of the wave guide (Figure 19, right). This is attributed to two factors: (1) it is difficult to be consistent when a larger-diameter transmitter is placed on the inclined,

smaller-diameter cross section of the rebar; and (2) Hydrocal gypsum is a very efficient couplant for ultrasonic waves.

Figure 19. Left: Measurements from the cored 45 degree specimen with transmitter attached perpendicularly to the bar with Hydrocal gypsum (as shown in Figure 18). Right: Measurements from the 45 degree specimen with transmitter coupled with WLG at a 45 degree angle to the longitudinal axis of the rebar from the end.

Based on these two stages of testing (rebar only and within concrete), the use of a Hydrocal quick-setting gypsum cement seat with an angle lower than 45 degrees is recommended for field applications.

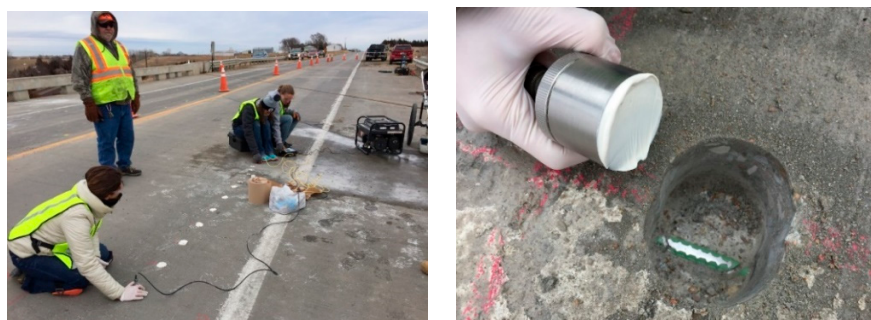
Figure 20. Images from pilot field work.

The first bridge deck trial took place in the earlier stages of the project to understand the challenges that must be researched further to implement the proposed method in the field. This pilot test was conducted on bridge S006 30574 of the Nebraska Highway System, located near the town of Emerald (henceforth referred to as the “Emerald Bridge”). There were two testing locations: one in the north lane and one in the south lane. At each location, the concrete was cored to the level of the top rebar, and the surface of the rebar was ground to create a smooth and flat surface for better coupling (Figure 20). Two types of sensors, one of 2.5 cm (1 in.) and one of 5 cm (2 in.) diameter, and WLG as couplant were used. Figure 21 shows the average results (for five readings at each point) for the 5 cm diameter sensor on the north lane. The amplitudes from the smaller sensor were too low to be useful, and it is not recommended for field use without an amplifier. The results from the south lane are very similar; thus, for brevity, they are not represented here.

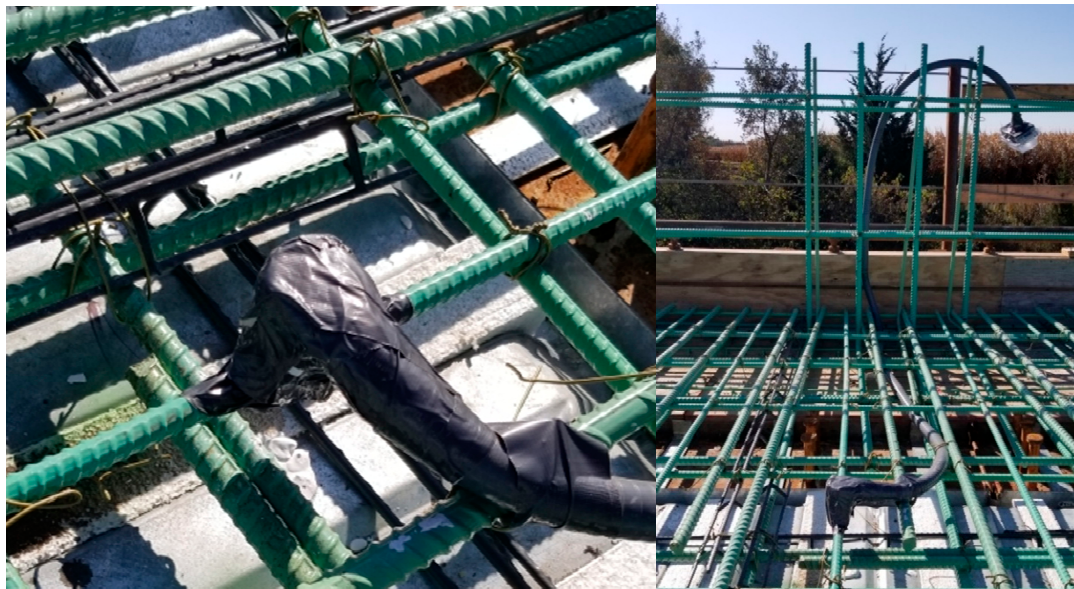
Another field study was performed on the Dwight East Bridge near Valparaiso, Nebraska (henceforth referred to as the “Valparaiso Bridge”). In this study, a sensor was attached to a Number 4 transverse, epoxy-coated rebar on the west side of the bridge deck as shown in Figure 22. Hydrocal

gypsum cement was applied onto the rebar to facilitate permanent attachment of the transmitter to the rebar at that location, and the attachment was wrapped in water-proof duct tape. A BNC RG58 coaxial cable was connected to the sensor at one end, and the other end of the cable was enclosed inside a water-proof box to stay outside on the side of the bridge as shown in Figure 22. After the arrangement was made, the concrete was poured.

Figure 22. Valparaiso Bridge instrumentation. Left: gypsum seat attachment of the ultrasonic transmitter wrapped in duct tape. Right: the sensor cable was protected in protective plastic pipe and ran to the shoulder of the bridge.

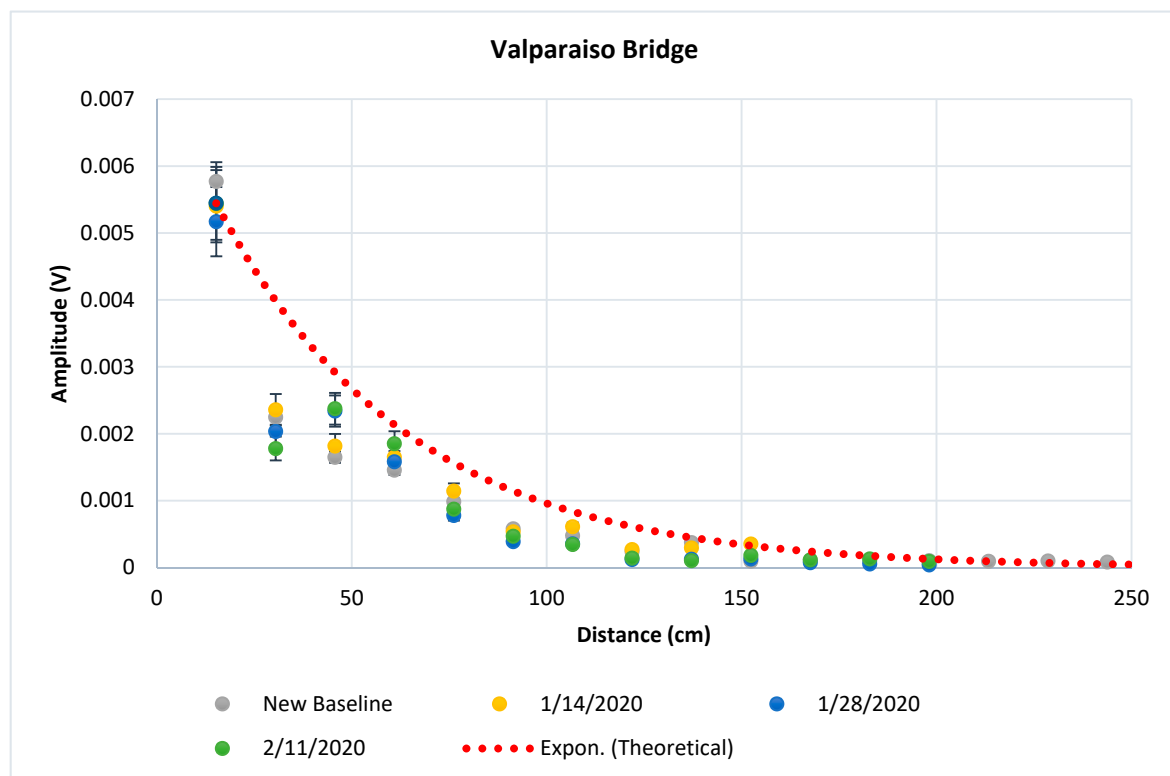
After the curing was complete and the bridge was ready for monitoring, the first set of data (baseline) was collected. The transmitter is located approximately 196 cm (77 in.) from the edge of the bridge, which is the first point for which the measurements are taken. The testing was done along the rebar on the bridge in the transverse direction, covering a full lane and part of the other lane, making a coverage length of 427 cm (14 ft.). Ten data points were collected for each test location for the first few points, where the distance between the transmitter and the receiver is less. This is because the ultrasonic measurements are more sensitive for a shorter distance of travel. For other test locations, as the distance between the transmitter and the receivers increased, five sets of readings were collected for each test location. Figure 23 shows a combined plot of the data that were collected on different dates along with the baseline data. As expected, in each set, the wave energy attenuates exponentially as the distance between the transmitter and receiver increases. The amplitudes decrease substantially after 91 cm (36 in.), rendering the remaining readings too small for monitoring for small changes. A signal amplifier, if one that matches the appropriate frequency range can be located, may help in the future to increase the gains. In addition, as can be seen in Figure 22, the transmitter is located close to the intersection of longitudinal and transverse bars, potentially attenuating some energy in both directions and causing the reduced measurement distance in comparison to the Emerald Bridge. Future studies will try to identify locations that are farther from rebar intersections, if possible.

Figure 23. Baseline data versus other days for Valparaiso Bridge.
