Article

Investigation of the Geometrical Deterioration of Paved Superstructure Tramway Tracks in Budapest (Hungary)

Keywords: tramway; deterioration; paved track; ESCRB; RAFS; TrackScan 4.01; geometrical analysis; traffic load

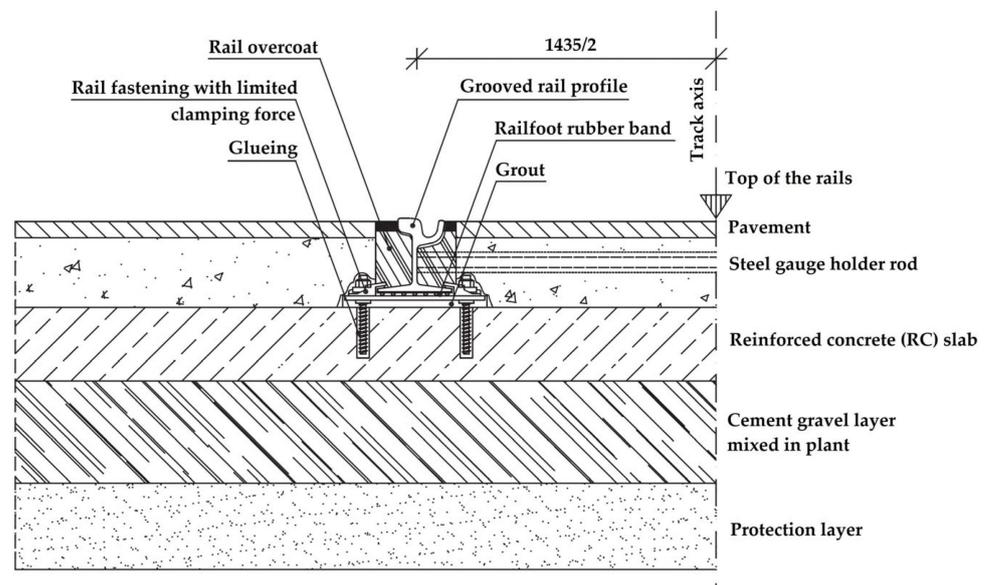
The ESCRB I superstructure system (Figure 1) has a reinforced concrete slab of 28 cm in depth. The grooved rails or flat-bottom rails (i.e., the so-called Vignole rail profiles) are built with rubber profiles and are stabilized by fastenings with limited clamping force. The fastenings are constructed as follows: the dowel screws, which are equipped with nuts and bolts, must be pressed together with the tie plates onto the rail foot rubber band. Around the tie plates and in the sections between them, formwork must be applied, and then the pour should be carried out—usually with Gantrex material. This fastening mimics the so-called Gantry rail fastening used in Hungary. Between the rails, there are steel gauge holder rods; these are present to ensure an accurate (adequate) track gauge.

Figure 1. Cross-section of the ESCRB I track system (formatted based on [60]).

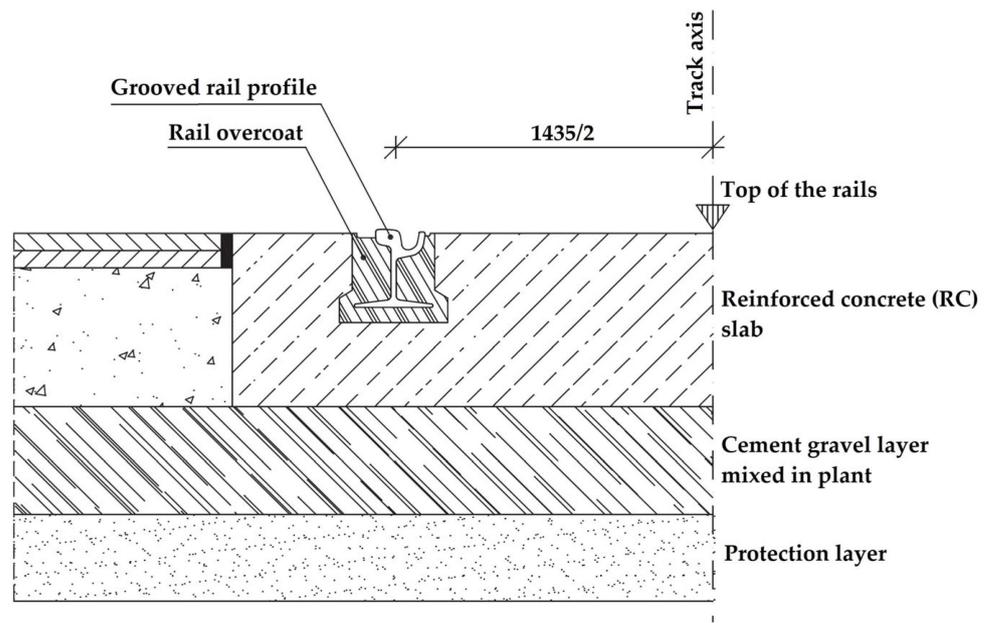
In the case of the ESCRB II superstructure system (Figure 2), steel fastenings are not installed. Similar to the ESCRB I system, the superstructure is built with rail overcoats and rail foot rubber bands. Any type of rail system can be used, but, in practice, grooved rails are used, which rest within a reinforced concrete slab. In Budapest, basalt concrete is used in most cases, which also provides supplementary bracing for the track.

Figure 2. Cross-section of the ESCRB II track system (formatted based on [60]).

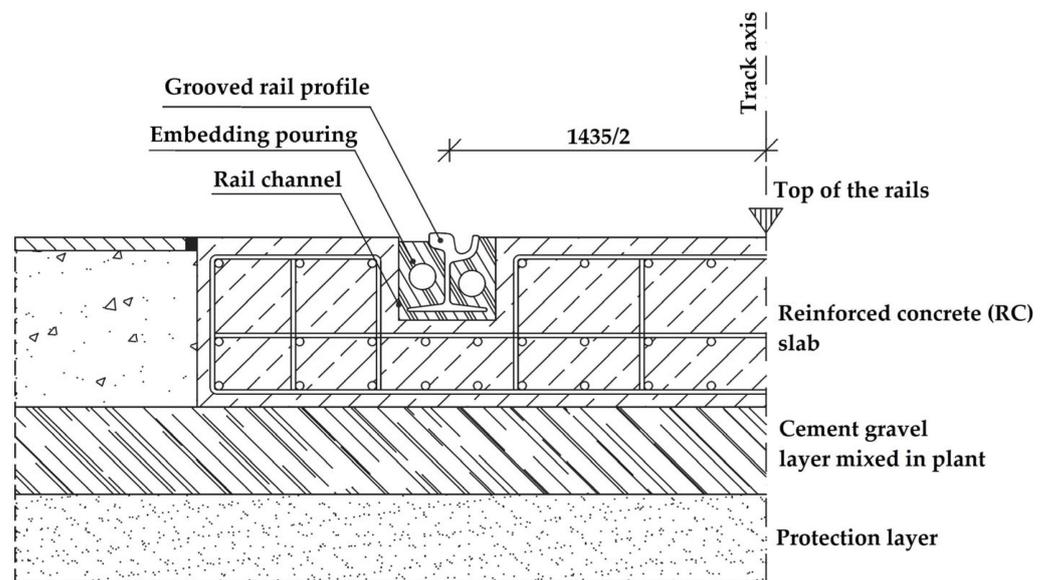
The third type of ESCRB superstructure system is ESCRB III (Figure 3). The track rests on a reinforced concrete slab or a reinforced concrete beam. Similar to the ESCRB II system, steel fastenings are not installed; instead, there is a homogenous continual elastic support along the entire length of the rail. Nowadays, the use of “filling” technology is very common in Budapest, especially in the case of extremely heavily loaded lines.

Figure 3. Cross-section of ESCRB III track system (formatted based on [60]).

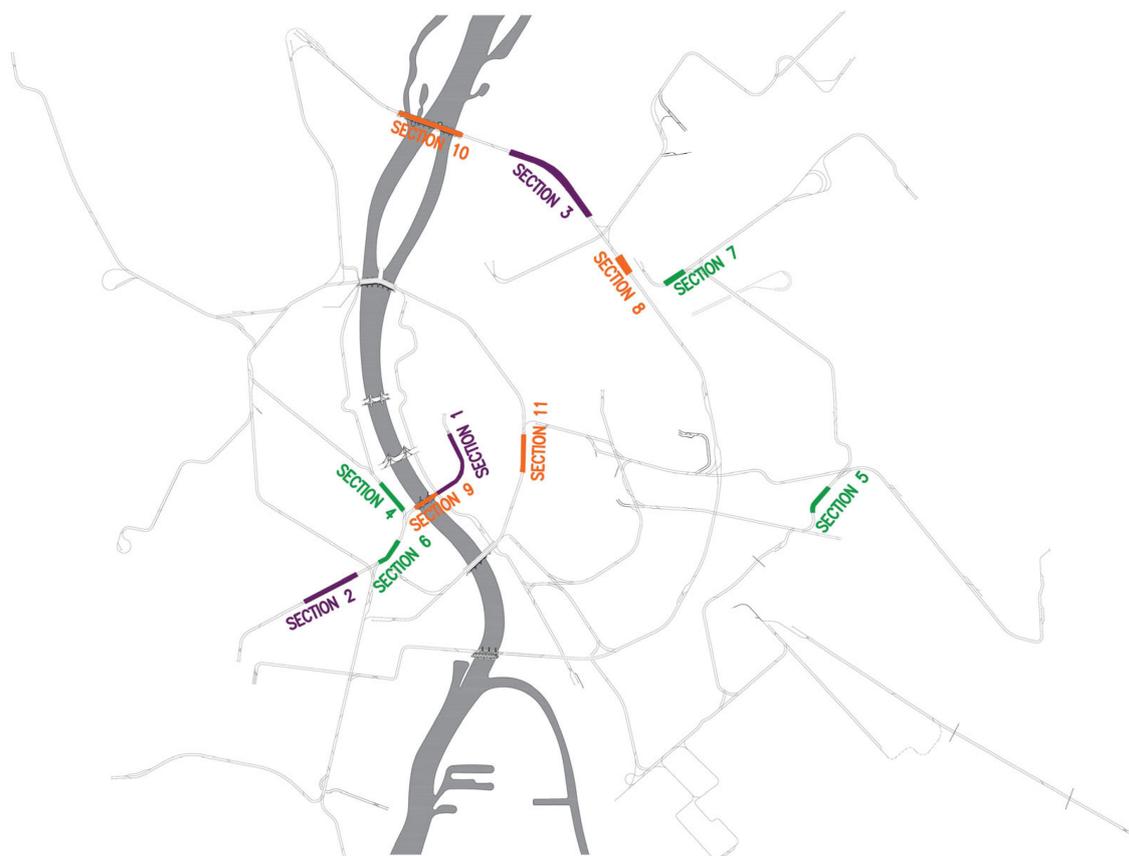
Figure 5. Tramway network of Budapest (the different analyzed sections are drawn with own labels, which can be identified by Tables 1 and 2).

Table 1 shows the general characteristics, while Table 2 represents the geometric characteristics of the reference track sections (i.e., Sections #1 to #11); additionally, Figures 4 and A1–A10 (in Appendix A) show representative photos of all the sections. Figure 5 represents a map of the tramway network of Budapest.

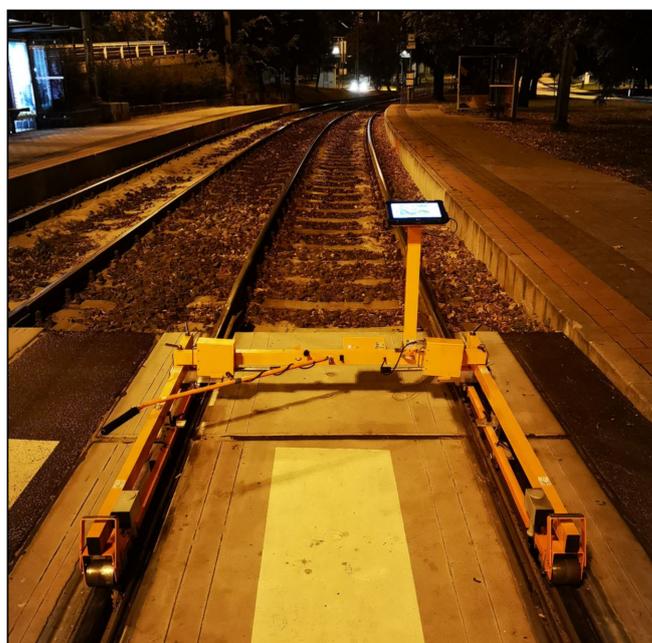
The geometrical measurements were executed, on average, every third month during a night standstill, using a TrackScan 4.01 instrument (Figure 6). Unfortunately, because of the cold weather and the dirty conditions of the tracks, there was no chance to take measurements in winter in the case of paved reference sections. For these reasons, the measurements were made in June 2021, September 2021, April 2022, September 2022, and May 2023. The examination cycle and its evaluation cover nearly two years.

Figure 6. TrackScan 4.01 instrument (author’s own photo).

The TrackScan 4.01 instrument is a complex track-measuring device; its attributes were described in the authors’ earlier article [1]. The parameters measured are the track gauge, alignment, longitudinal level, and twist; however, the twist is not taken into consideration in the current paper. The details of the data processing method are the same as those published in [1].

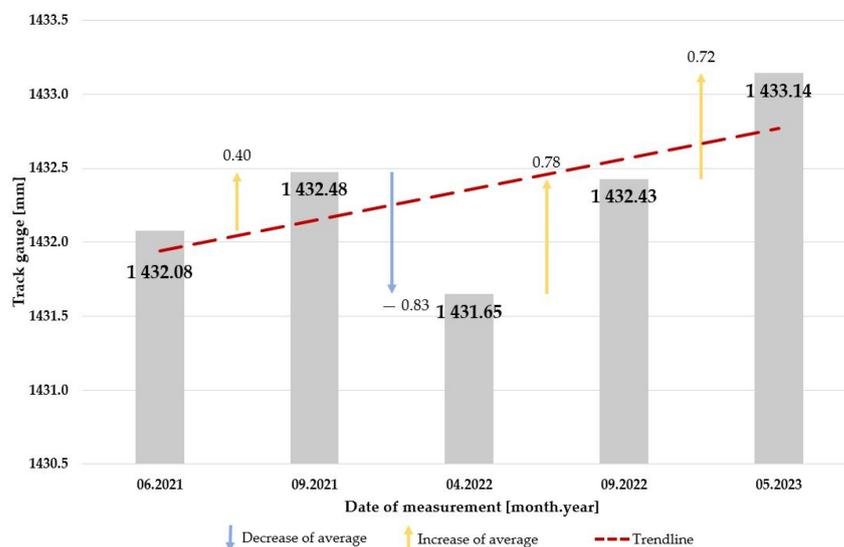
Figure 7 shows the changes in the average values of the track gauge parameter. Between the first and the second measurements, the change was almost 0.5 mm, which can be explained by the weather conditions. After a hot summer, this broadening of the track gauge is typical. The same change can be seen between the second and third measurement results; however, in this case, the narrowing of the track gauge appeared. Between the third and fourth and the fourth and fifth measurement results, there is also an increasing change, the value of which is almost as high as the previous value. In the case of changes in the average values of the track gauge parameter of Section #1, the weather conditions significantly affect the results.

Figure 7. The changes in average values of the track gauge in Section #1 (ESCRB I).

Based on the trendline of the measurement data, there is an unequivocal and moderate rise in the Section's track gauge data, which indicates a long-term widening of the track gauge.

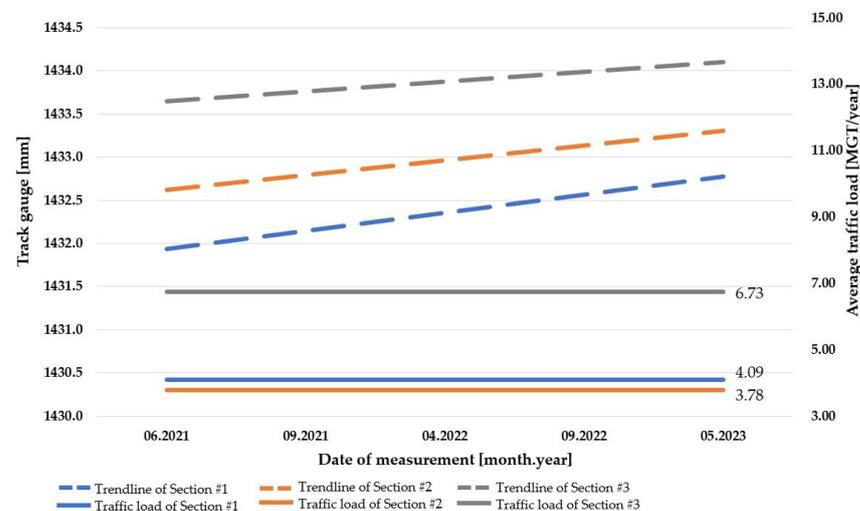
Figure 8 depicts the link between the trendlines of track gauge modifications and the average traffic load values for the analyzed ESCRB I track system.

Figure 8. The relationship between track gauge and traffic load in the ESCRB I track system.

Section #1 and Section #2 have almost the same average traffic load in a year, but Section #2 is five years older than Section #1. Both have a similar trendline with almost the same steepness.

Section #3 is the youngest ESCRB I track and has more than one and a half times the traffic load of Section #1 and Section #2. Therefore, it is to be expected that in this case as well, the trendline increases more steeply: an evaluation of the results supports this suggestion.

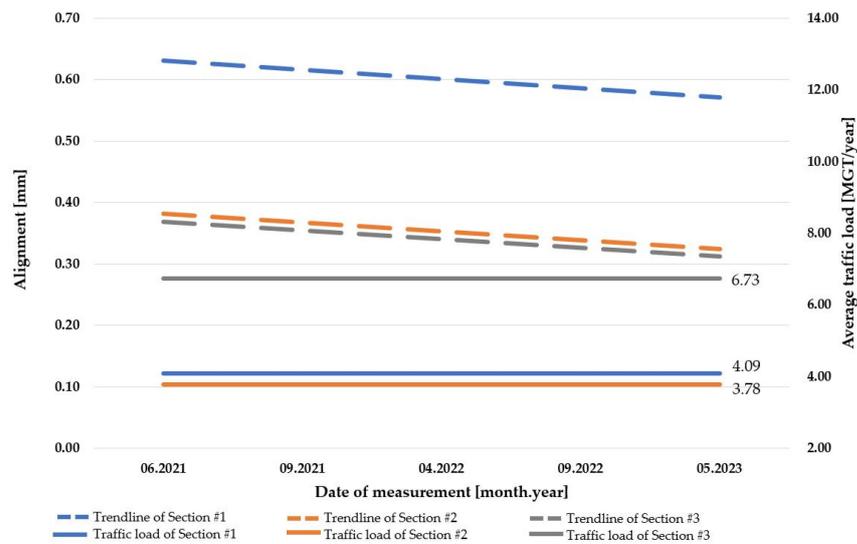
Figure 9 depicts the link between the trendlines of the alignment adjustments for the ESCRB I track system and the average traffic load values.

Figure 9. The relationship between alignment and traffic load in the ESCRB I track system.

Regardless of the traffic load level, each reference section’s trendlines decrease. It is interesting that regardless of the age or the traffic load of the selected reference section, the results of the first, the fourth, and the fifth measurements are similar, as well as the results of the second and the third measurements, resulting in a decreasing trendline.

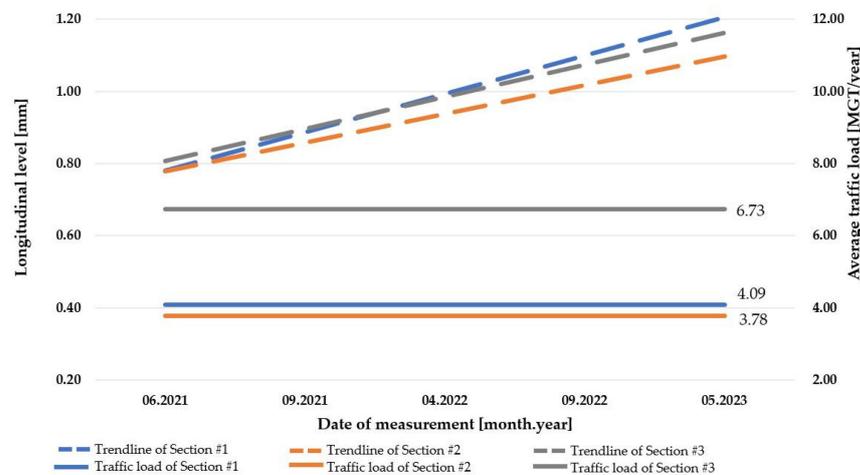
Figure 10 demonstrates the correlation between the trendlines of longitudinal level changes for the evaluated ESCRB I track system and average traffic load levels.

Figure 10. The relationship between longitudinal level and traffic load in the ESCRB I track system.

Regardless of the traffic volume or age of the chosen reference segment, the trendlines rise sharply. Section #1, which is middle-aged and has a medium traffic load value, might show a steeper trendline than the others. In general, these values are constantly increasing from year to year.

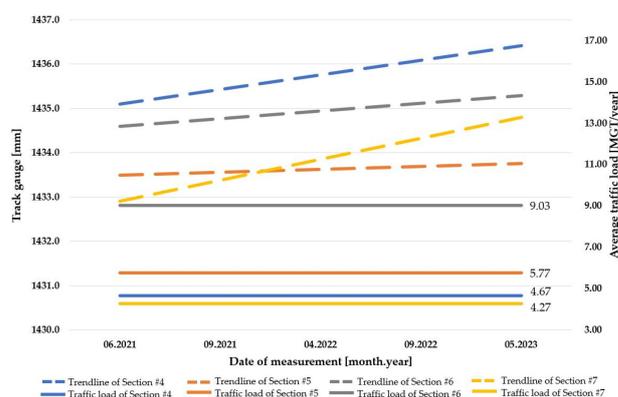
Figure 11 demonstrates the connection between the trendlines of track gauge modifications and the average traffic load values for the ESCRB II track system being evaluated.

Figure 11. The relationship between track gauge and traffic load in the ESCRB II track system.

Section #4 and Section #7 have almost the same average traffic load in a year, and Section #7 is only three years older than Section #4. As a result, both have similarly steep trendlines, which indicate the broadening of the track gauge through the years.

Section #5 and Section #6 have a slightly higher average traffic load; the change in these cases is also an increase, which also indicates the broadening of the track gauge through the years.

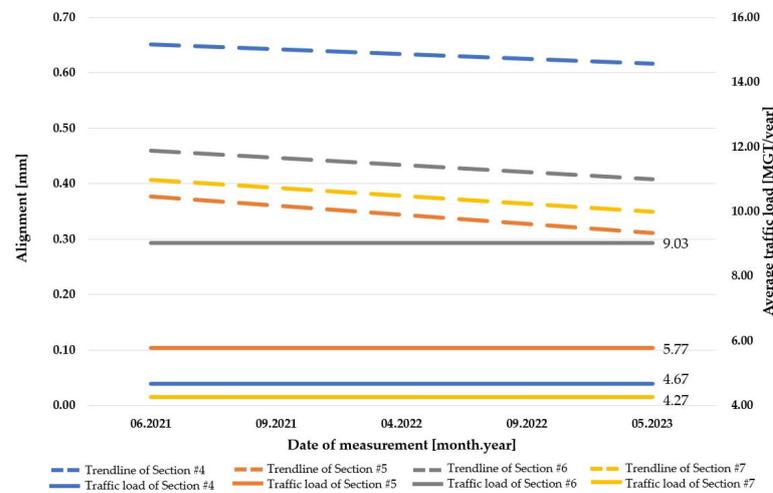
Figure 12 displays the relation between the trendlines of the alignment variations and the average traffic load values for the ESCRB II track system.

Figure 12. The relationship between alignment and traffic load in the ESCRB II track system.

For each reference section in Figure 12, the trendlines decrease. It is the same scenario as for the ESCRB I tracks; regardless of the age or traffic load of the selected reference section, the results of the first, the fourth, and the fifth measurements are similar, as well as the results of the second and third measurements.

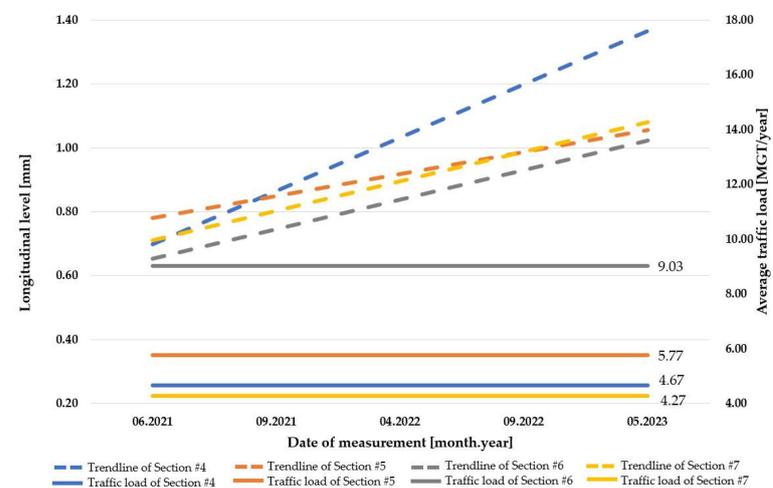
Figure 13 shows the connection between the longitudinal level change trendlines and average traffic load values for the evaluated ESCRB II track system. In every case, the trendlines are steeply increasing.

Figure 13. The relationship between longitudinal level and traffic load in the ESCRB II track system.

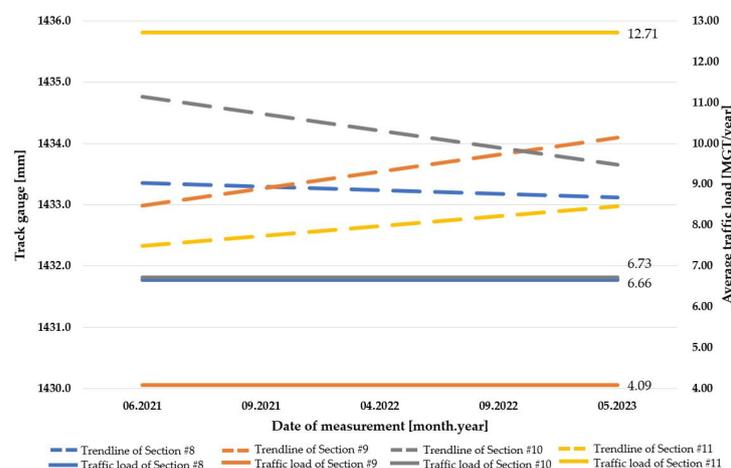
Figure 14 shows the connection between the trendlines of track gauge variations in the examined ESCRB III track system and the average traffic load values.

Figure 14. The relationship between track gauge and traffic load in the ESCRB III track system.

Section #8 and Section #10 have almost the same average traffic load in a year, but Section #8 is thirteen years older than Section #10. Both have similarly steep trendlines, which indicates the narrowing of the track gauge through the years.

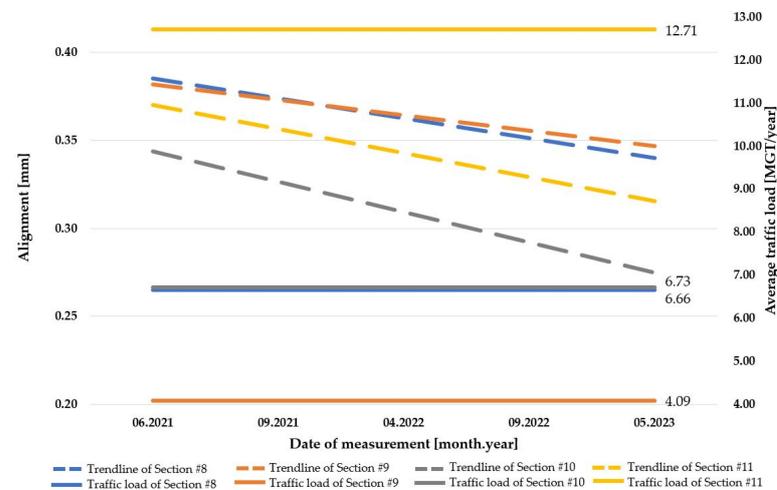
Figure 15 depicts the correlation between the trendlines of the alignment variations and the average traffic load values for the ESCRB III track system.

Figure 15. The relationship between alignment and traffic load in the ESCRB III track system.

As is the case with the ESCRB II tracks, all the trendlines decrease. It is the same scenario as for the previously discussed paved tracks: regardless of the age or traffic load of the selected reference section, the results of the first, the fourth, and the fifth measurements are similar, as well as the results of the second and third measurements.

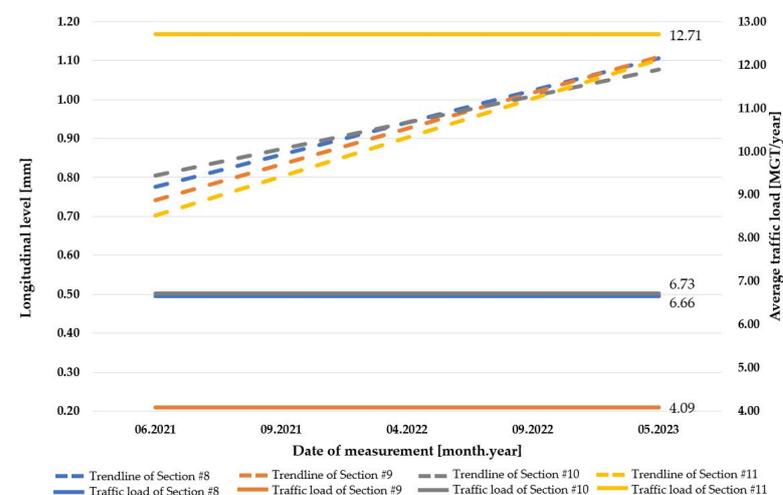
Figure 16 displays the connection between the trendlines of the longitudinal level changes for the tested ESCRB III track system and the average traffic load values.

Figure 16. The relationship between longitudinal level and traffic load in the ESCRB III track system.

The trendlines are steeply increasing, as is the case with the ESCRBI and ESCRBI II tracks. The following can be deduced about the ESCRBI III tracks, based on the results:

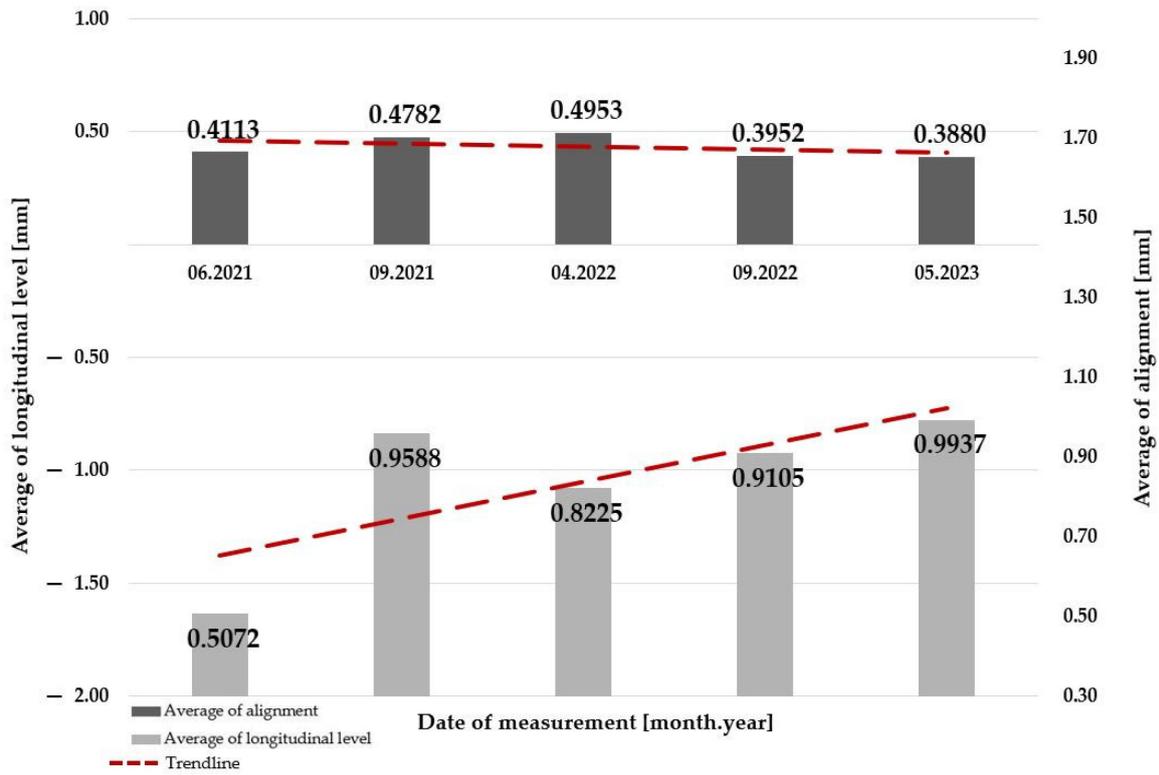
Figure A21. The change in the average values for longitudinal level and alignment in Section #6 (ESCRB II).

The change in the average values of longitudinal level and alignment does not differ from those of the previous sections (Figure A21). The trendline of alignment decreases. The results of the first, the fourth, and the fifth measurements are similar, as well as the results of the second and third measurements, and so this causes a decrease. The trendline of the longitudinal level parameter increases, just as is the case for all the reference sections.

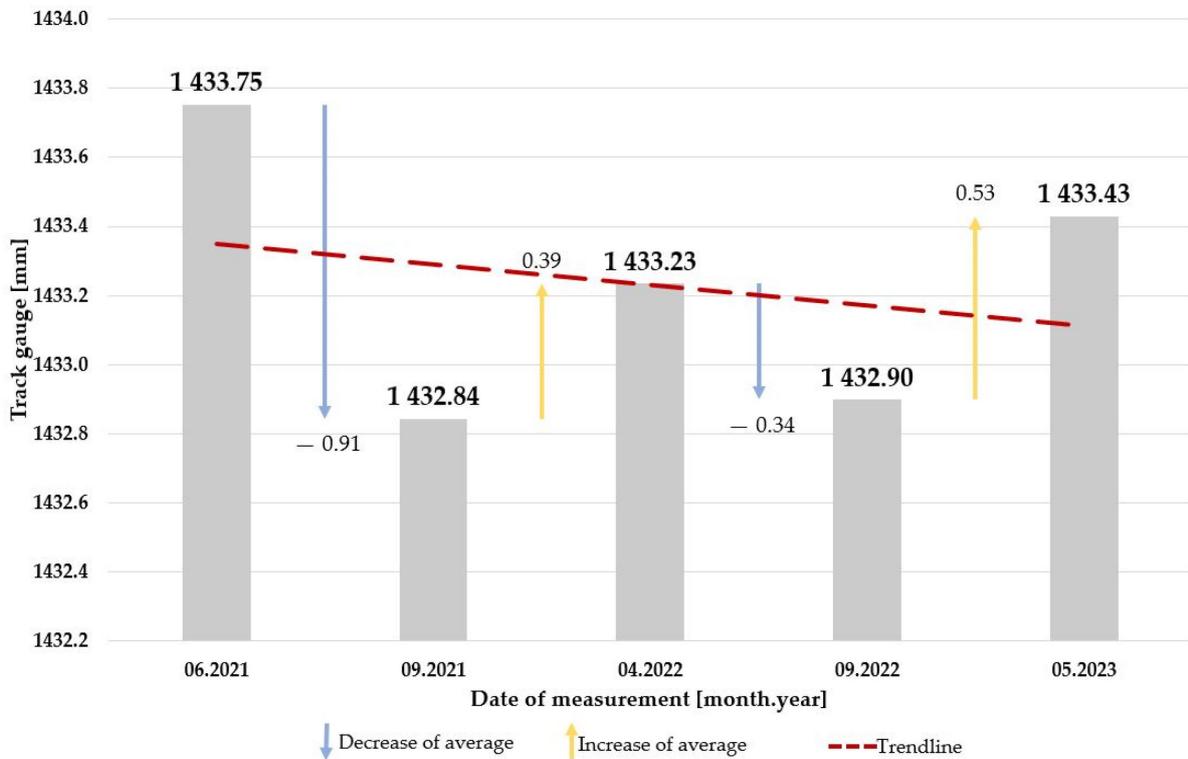
Figure A24. The change in the average values for track gauge in Section #8 (ESCRB III).

Section #8 is the oldest of the selected reference sections of the ESCRB III superstructure system; it is also a heavily loaded line. The trendline of the track gauge parameter indicates a clear drop, indicating a decreasing track gauge (Figure A24). In this case, the weather conditions cannot explain the changes since the change here is almost the opposite.

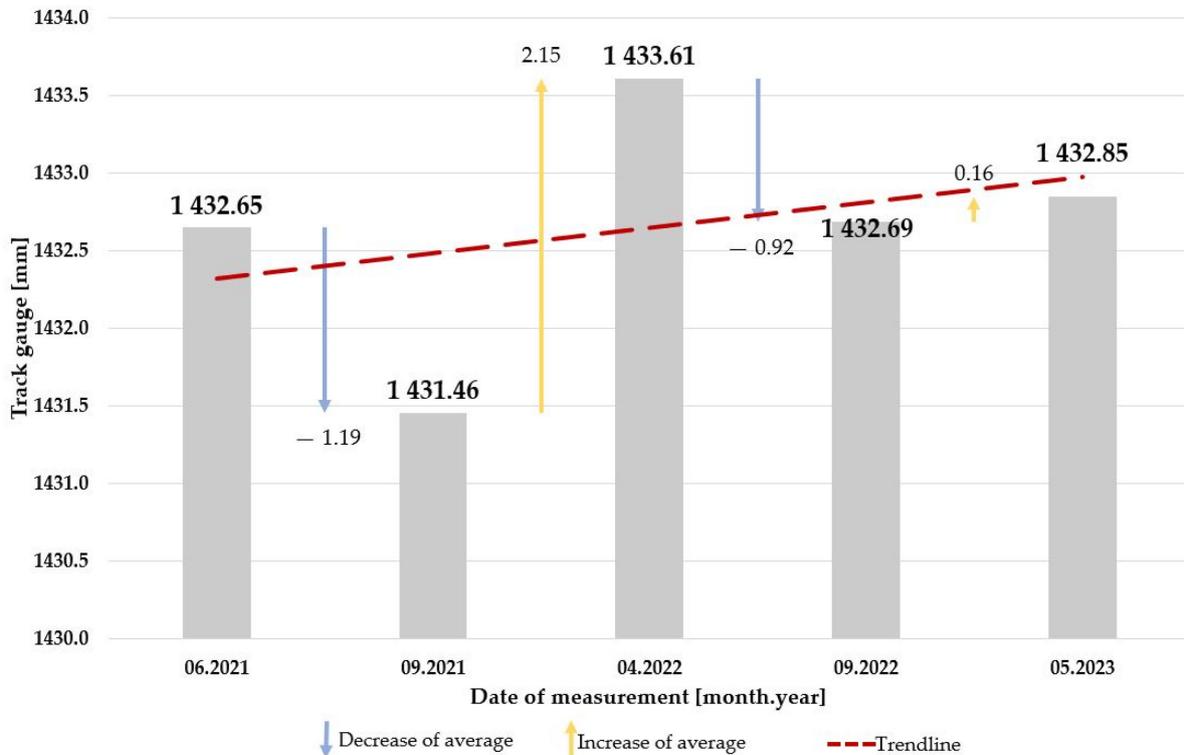
Figure A30. The change in the average values for track gauge in Section #11 (ESCRB III).

Despite this considerable traffic load, when considering the last two years, the change in the average of the track gauge parameter is very minimal overall and does not follow the pattern of change due to weather conditions. Figure A30 shows an increasing change, which indicates the broadening of the track gauge.
