Automated Pavement Construction Inspection Using Uncrewed Aerial Systems (UAS)—Hot Mixed Asphalt (HMA) Temperature Segregation

Reihaneh Samsami ^{1,*}, Amlan Mukherjee ² and Colin N. Brooks ³

Citation: Samsami, R.; Mukherjee, A.; Brooks, C.N. Automated Pavement Construction Inspection Using Uncrewed Aerial Systems (UAS)—Hot Mixed Asphalt (HMA) Temperature Segregation. *Drones* **2023**, *7*, 419. <https://doi.org/10.3390/drones7070419>

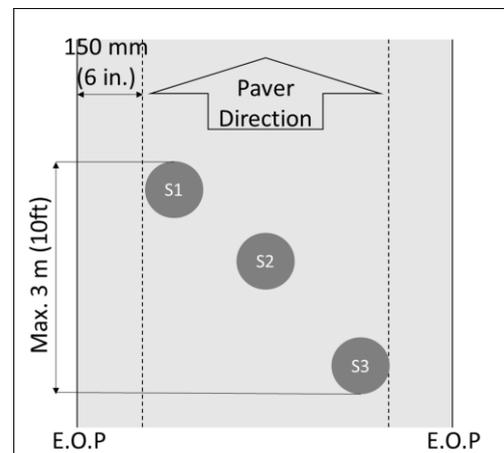
samples need to be taken. As shown by black circles in this Figure, each composite sample consists of a minimum of three samples taken within 10 ft of a longitudinal distance and across the width of the pavement.

Figure 1. Sampling pattern behind the paver [7].

MTM 324 “Sampling Behind the Paver” and MTM 313 “Sampling HMA Loose Mix from Mini-stockpile” are the two Michigan Test Methods (MTM) accepted by MDOT for the purpose of temperature testing. In MTM 324, samples are taken immediately behind the paver and before the initial roller compaction [7]. Figure 1 illustrates the pattern the

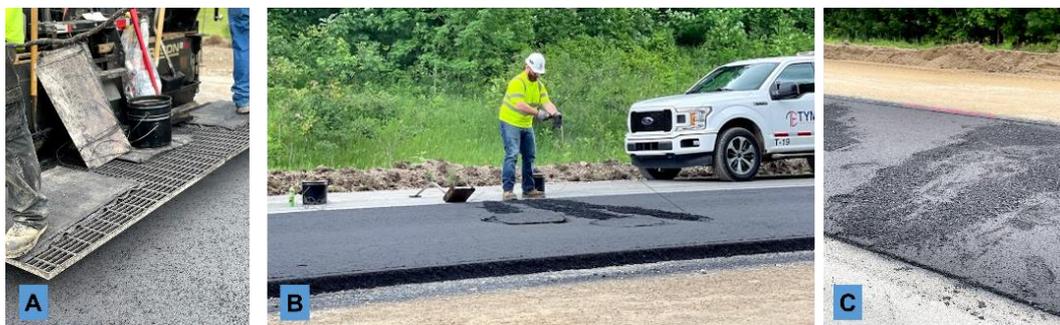
In Figure 2, the manual “Sampling HMA Paving Mixtures Behind the Paver” is illustrated. As shown, the inspector uses sampling plates and wires, a non-absorbent container, an MDOT approved shovel, and an MDOT-approved splitter to conduct the test (Figure 2A). A minimum of three samples are taken immediately behind the paver, at random locations. For this purpose, plates with wire leads are placed ahead of the paver, and the wire lead is extended beyond the edge of pavement. The wired leads are used to locate the wire leads (Figure 2B) and then dig the pavement above the plate, using shovel. This material is placed in the container, and the voids are filled/levelled by the contractor afterwards (Figure 2C).

Figure 2. MTM 324 inspection for I-69 project (A: Sampling plates and wires, B: Taking samples, C: Filling the voids).

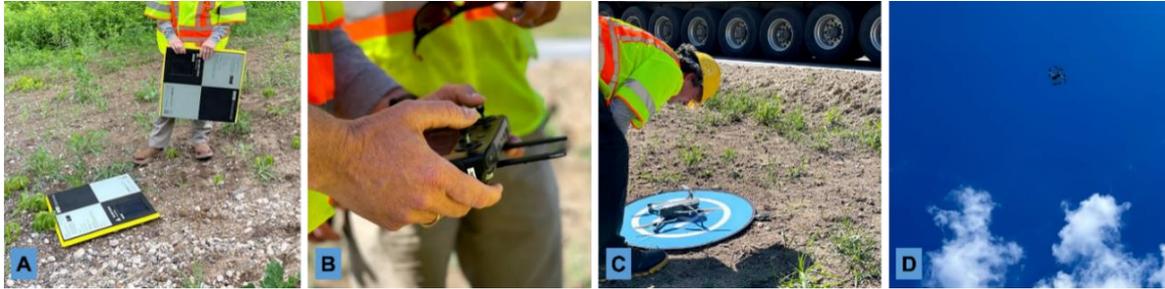
Figure 3 captures the thermal data collection by MTRI at I-69 project. Before flying, the process starts with placing ground control points (GCPs) (Figure 3A) to provide high-accuracy georeferencing information for the collected imagery. The GCPs used here were

Figure 3. UAS thermal imaging set up on I-69 (A: Placing GCPs, B,C: Pilot flying the UAS, D: UAS flying at about 24m (80 ft)).

Aeropoint units from Propeller, which provided approximately 3 cm positional accuracy for the center of each target using built-in GPS and post-processing capabilities. This positional information improves the output quality of registered and merged images.

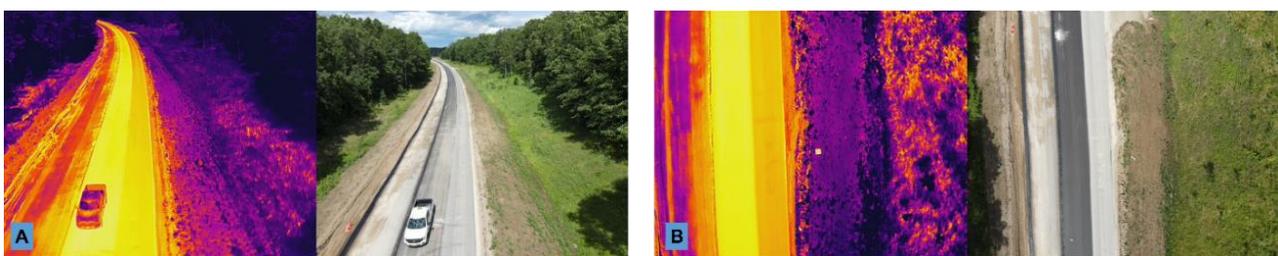
The M2EA UAS has the Multiple Display Mode technology to display both infrared and visible light images while collecting data. Figure 4 is an example of the data collected in Multiple Display Mode (infrared and visible) and then stored as a side-by-side comparison image when using this UAS. Thermal images recorded by the M2EA are 640×512 pixels and can be converted to per-pixel temperature values as this is a radiometric thermal camera. Visible light images are collected with a quad-Bayer filter camera that interpolates 12 mp images into 48 mp outputs. The already-paved shoulder and mainline (shown in yellow) is compared with the existing pavement (shown in orange/red) in the captured thermal and visible light images.

Figure 4. Thermal profile of already-paved shoulder/mainline vs. existing pavement (A: Side View Images, B: Top-Down Images).

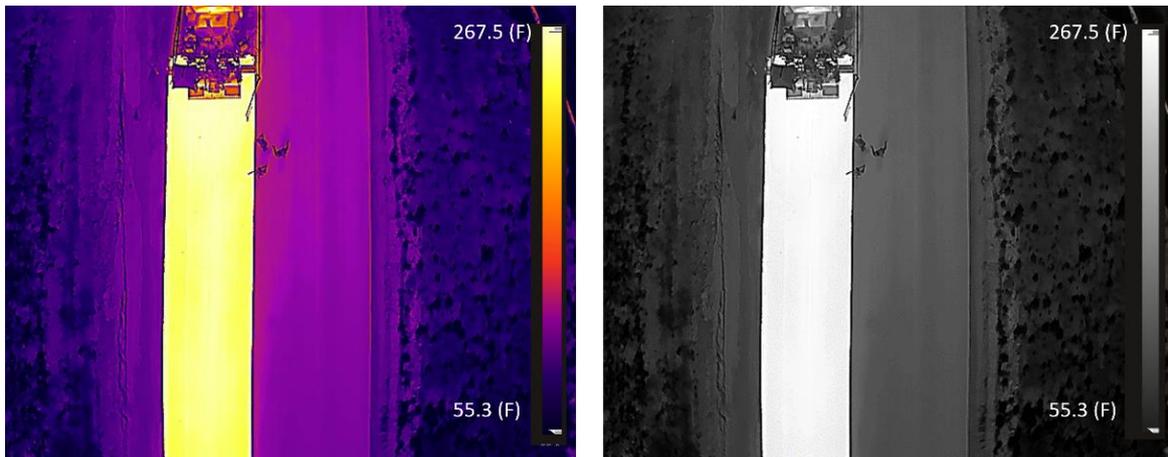
Image processing is used as a tool to automatically identify the thermal differences in the HMA mat. Thermal images in the RJPG format are the output of the data collection procedure. Each image is a collection of pixels with three red, green, and blue intensities (IR, IG, and IB) that vary between 0 and 255. The first step is to process these images in the DJI Thermal Analysis Tool 2 application and create grayscale images. In a grayscale image, $IR = IG = IB = I$. Figure 5 is an example of this grayscale conversion for image DJI_0040.

Figure 5. Grayscale image from regular RJPG.

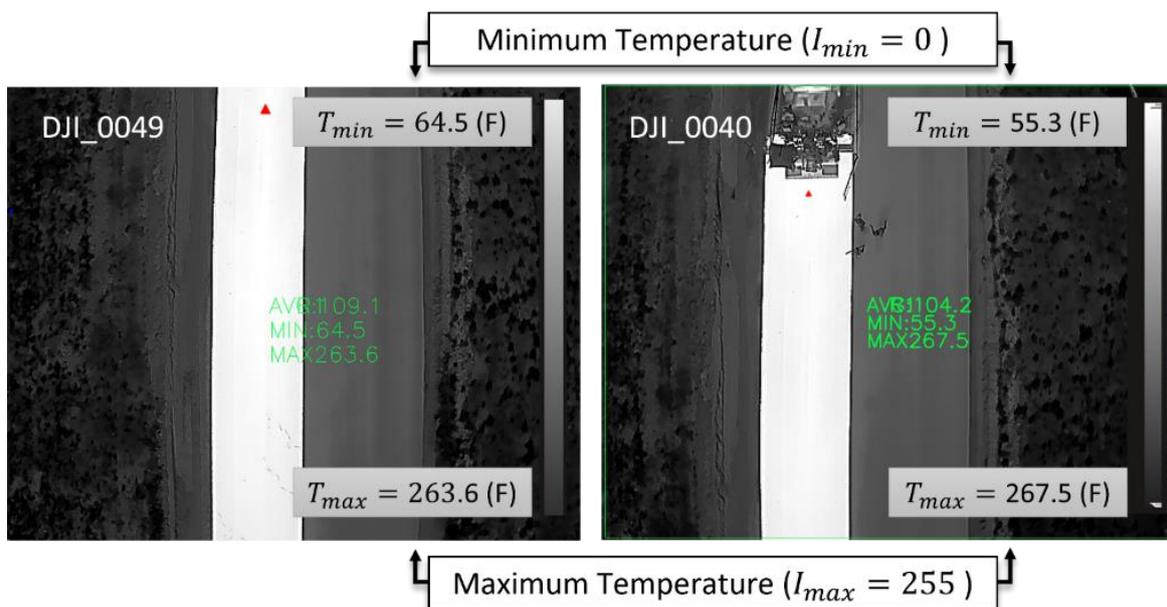
The second step is to identify the thermal ranges on each image and associated color intensities. This requires using the DJI Thermal Analysis Tool 2 application to find the maximum and minimum temperatures on each grayscale image. Figure 6 captures this comparison between the two DJI_0049 and DJI_0040 images. Temperature ranges are (64.5 °F, 263.6 °F) and (55.3 °F, 267.5 °F) for these two images, respectively. As illustrated, the coldest spot on each image is associated with $I = 0$ (black), and the warmest spot with $I = 255$ (white). Different temperature ranges on each image make it difficult to compare images with each other.

Figure 6. Comparison between temperature ranges (Red triangle locates the maximum temperature on each pavement image).

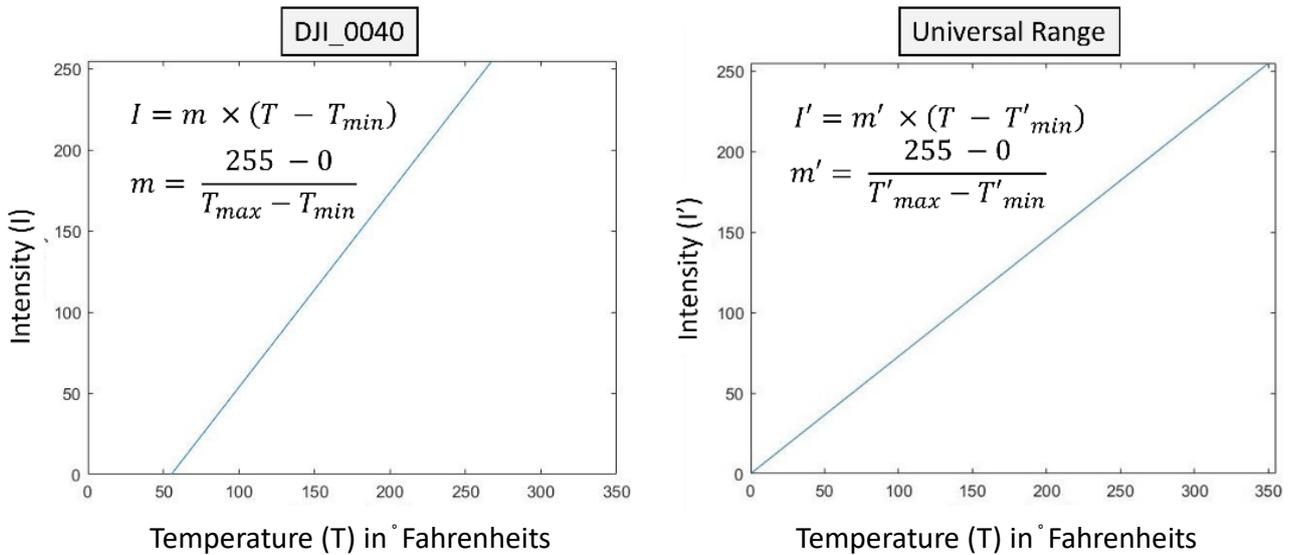
Therefore, the third step is to define a universal range and correct intensities considering that range (Equation (1)). All images are studied to find the minimum (T_{min}) and maximum temperatures (T_{max}). The highest maximum temperature among all images ($T'_{max} = \text{Max}(T_{max})$) is defined as the highest limit of the universal range. The lowest minimum temperature among all images ($T'_{min} = \text{Min}(T_{min})$) is defined as lowest limit of the universal range. The universal range is defined as (0 °F, 355 °F) for this set of collected data. It can be different for other data sets, based on the T'_{max} and T'_{min} . Figure 7 illustrates the intensity–temperature graphs for DJI_0040 (as an example) and the newly defined universal range.

$$T = \frac{I'}{m'} + T'_{min} \quad \text{Where } m' = \frac{255 - 0}{355 - 0} \quad (1)$$

Figure 7. Intensity–temperature relationship for DJI_0040 and universal range.

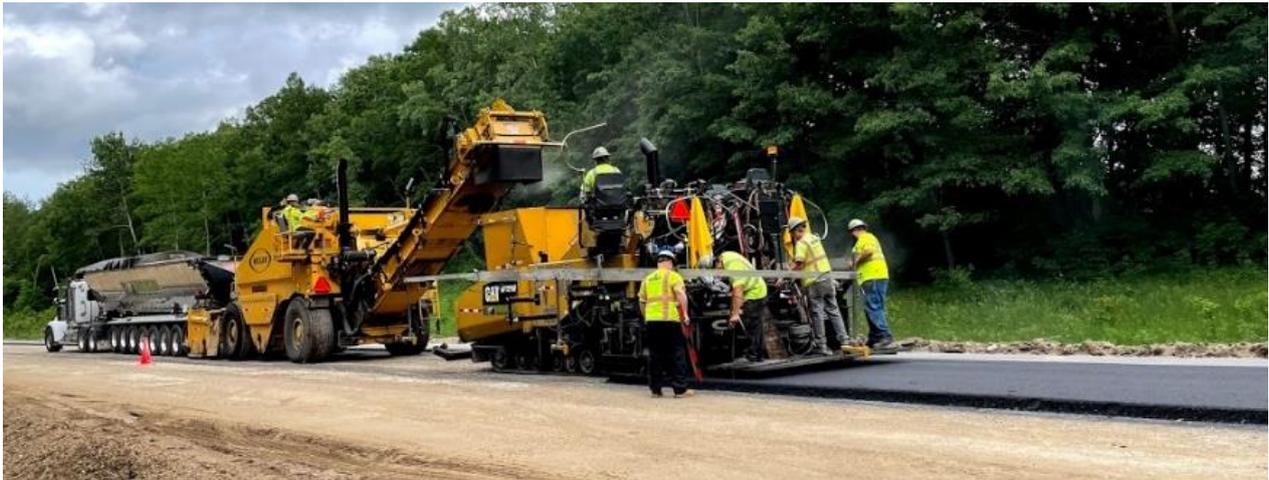
During site visits, the authors had an opportunity to become familiarized with the ongoing paving operation and shadow the project inspectors to understand the current state of practice. Figure 8 illustrates the HMA paving operation, where the HMA is transferred from truck to paver, using a Material Transfer Vehicle (MTV).

Figure 8. I-69 HMA pavement construction operation.

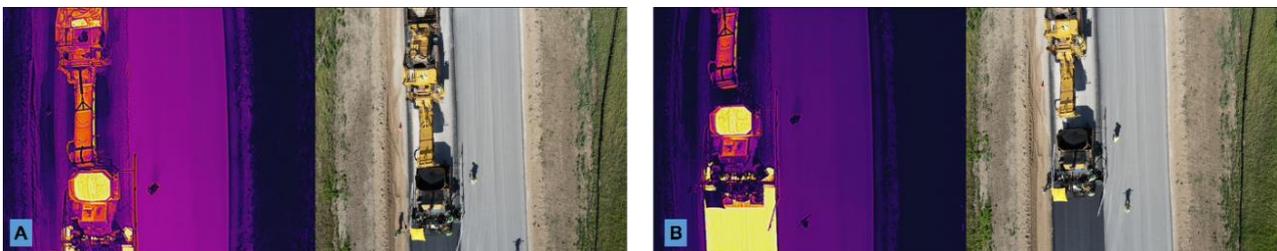
Figure 9 is an example of the dual images collected from the HMA in the hopper (Figure 9A) and HMA behind the paver (Figure 9B). Figure 10 is also an example of the dual image collected from the freshly placed HMA at the very beginning of the paved mat (Figure 10A) and along the roller tracks (Figure 10B). In these images, cold areas are shown in blue/purple hues, while warmer areas are in orange/yellow hues. For example, the HMA in the hopper has a high temperature and is shown in yellow. The existing pavement has a lower temperature and is shown in purple.

Figure 9. Thermal profile of HMA in the hopper (A) and behind the paver (B).

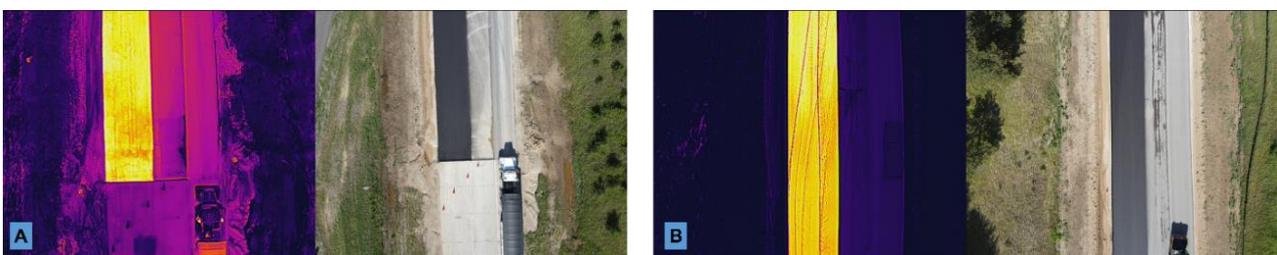
Figure 10. Differential cooling on the freshly placed HMA at the very beginning of the paving (A) and along the roller tracks (B).

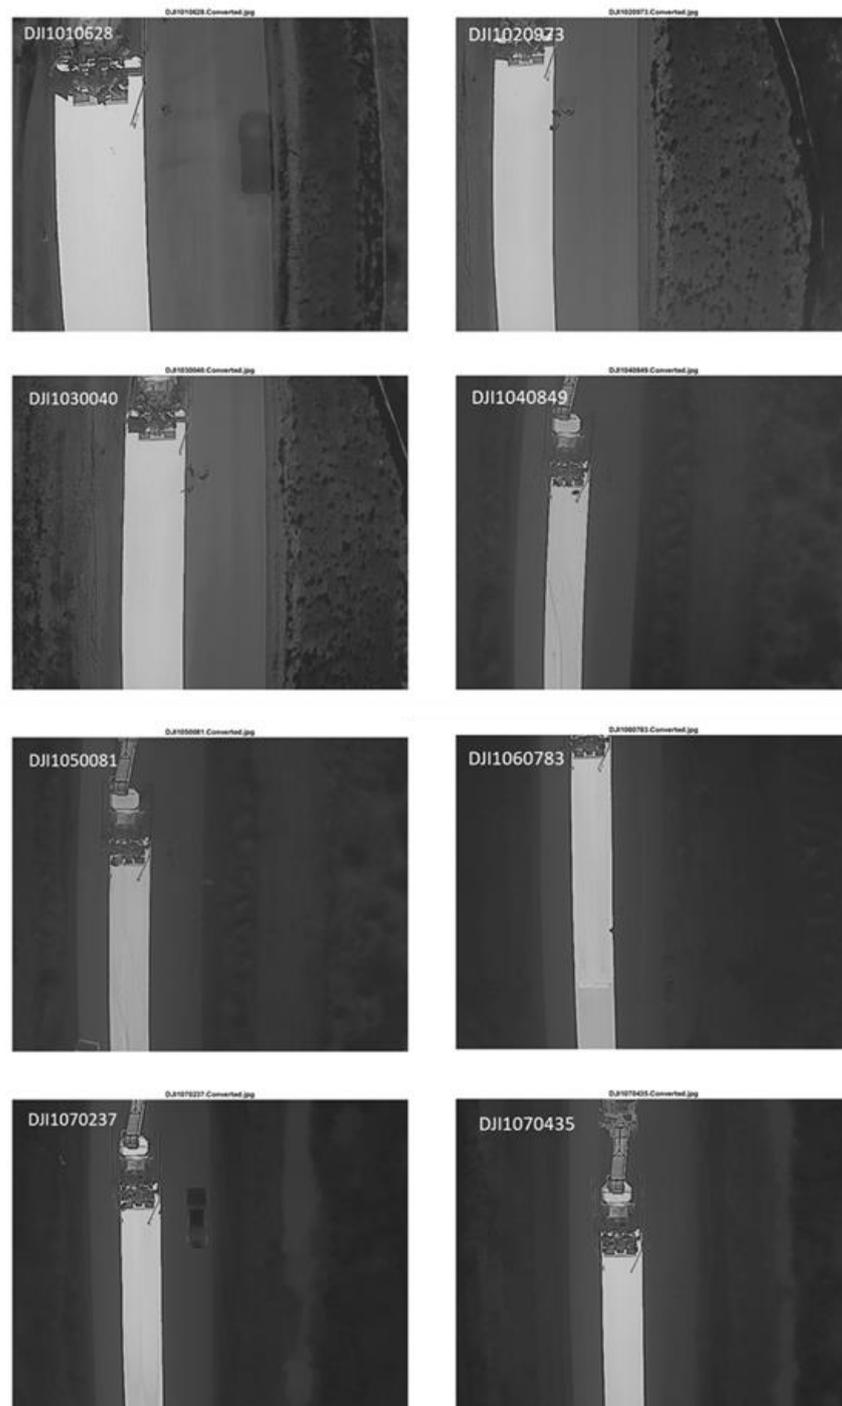
Eight images are selected from the data pool (containing 2000 images) to investigate the proposed methodology. These images captured the newly placed HMA mat immediately behind the paver, at different locations. They are processed through the steps discussed in the Methodology section (Figure 11). Figure 12 presents these selected images, after they are scaled to the universal scale and contoured. To understand the contours better, consider the color bar in Figure 13. This color bar maps colors to temperature values in

Figure 11. Selected images after scale conversion.

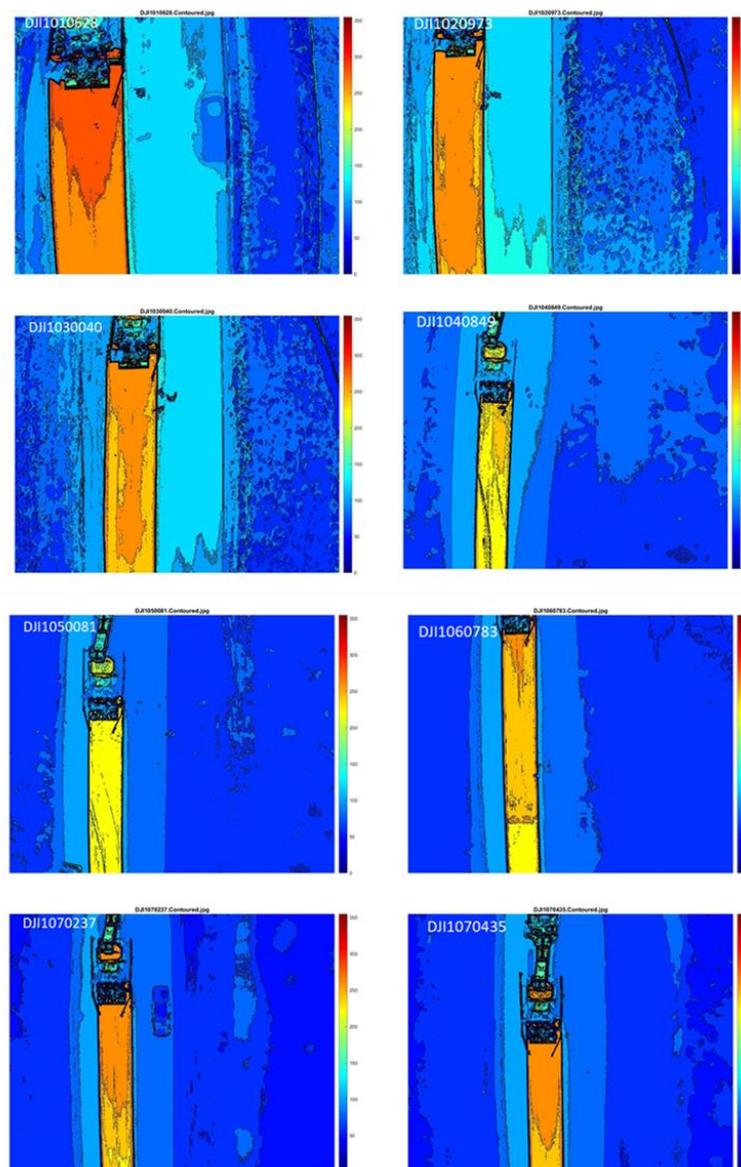
the range (0 °F, 350 °F). The low temperatures in this range are shown in a blue color, while the moderate temperatures are shown in green-yellow, and the high temperatures are presented by red. As illustrated in Figure 12, the mat temperature is generally in the range of (200 °F, 300 °F), while the daylighting and the unpaved shoulder are in the range of (20 °F, 100 °F). There were some points on the collected images with extremely low or high temperatures. These points were resulted from cooling/heating system components of the equipment in the images. There are no such extreme points in any of the selected images in Figure 12.

Figure 12. Selected contoured images.

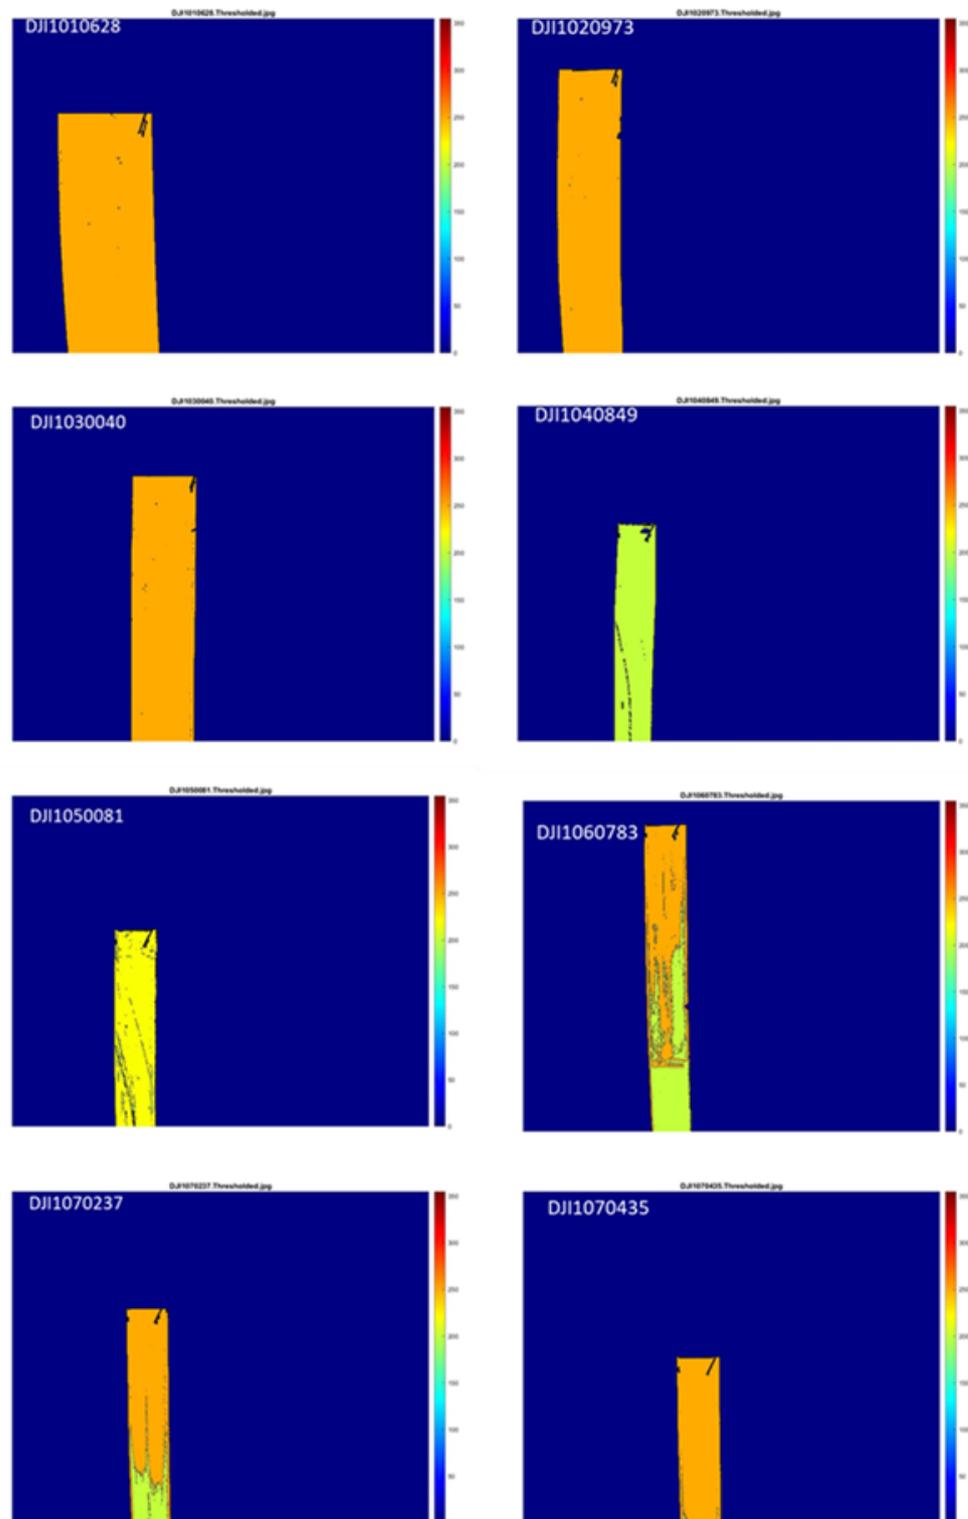
After processing the images, they can be studied closely to estimate the thermal parameters and compare them with the manual inspection results. Figure 14 presents the

images with thermal values within the range of 185 °F (85 °C) to 293 °F (145 °C) as an acceptable temperature range (parameter 1 in Table 1). This parameter is visualized on each image, aiming to assist in estimating the value of the first parameter, R_c . Equation (2) is used to estimate R_c for each selected image, and the results are summarized in Table 5. The next step is to find the temperature differentials and to estimate the second and third parameters, R_{ps} and R_{hs} , as in Equations (3) and (4), respectively.

Figure 14. Thresholded images within 185 °F (85 °C) to 293 °F (145 °C).

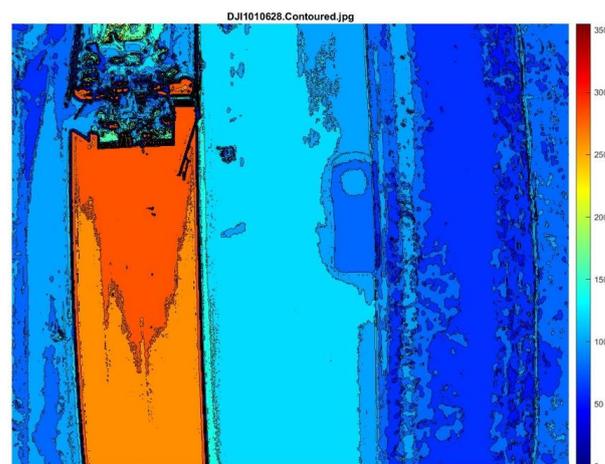
The first image (DJI1010628) has the highest cool area ratio of 5.3% (Figure 15). This image can be analyzed in detail to find the most problematic locations. For this purpose, R_c is calculated for all cross-sections across the road in Image DJI1010628. To visually represent the results, a contour is applied showing the most problematic cross-sections in “red” and the least problematic in “blue”. Figure 16 illustrates these cross-sections across the road. Cross-sections shown in red on the image are the most critical ones, with R_c about 13%.

**Figure 15.** Image DJI1010628 with highest cool area ratio.

In the presence of a threshold for any of these metrics, MDOT could use these numbers to accept/reject the work. For example, if the MDOT specification indicates a 5% limit for ratio of cool areas (R_c), Image DJI1010628 falls into the unacceptable range, and the contractor will be asked to repeat the work (stations associated with flight DJI101) to satisfy the temperature requirements of the mat.

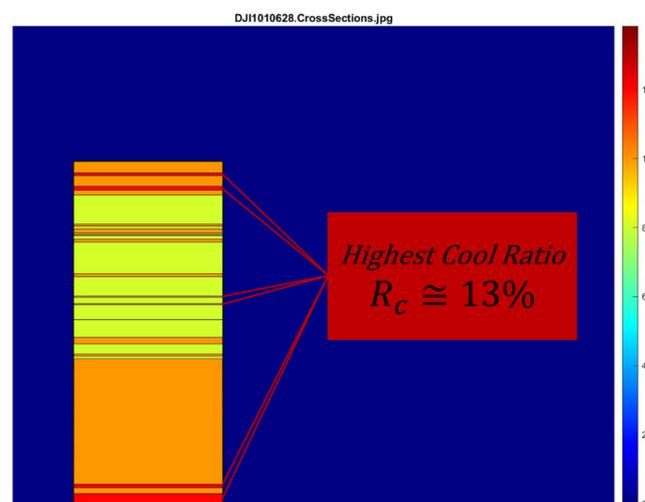
**Figure 16.** Cross-section analysis on Image DJI1010628.
