Article

Feature-Based Point Cloud-Based Assessment of Heritage Structures for Nondestructive and Noncontact Surface Damage Detection

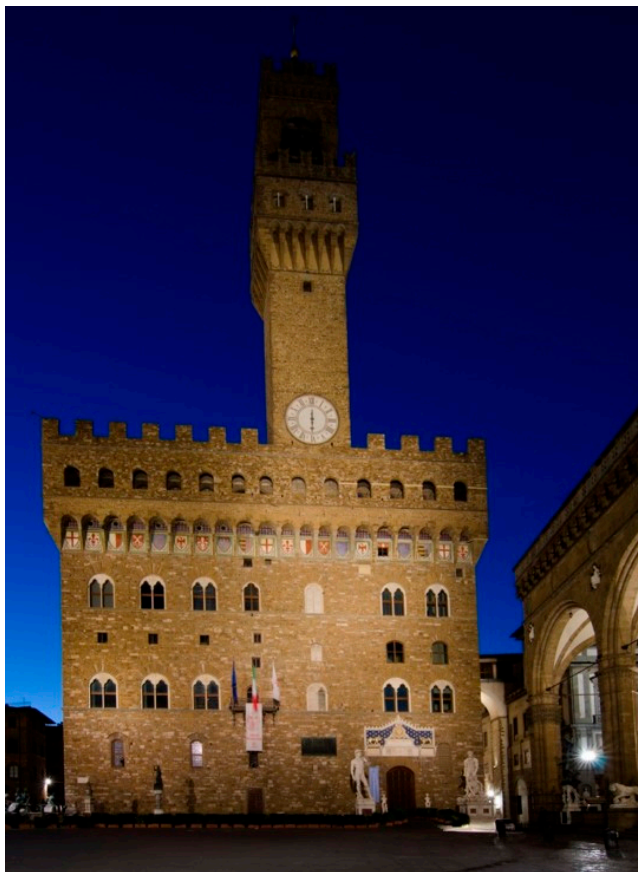
(a) Front façade from Piazza della Signoria

Figure 1. Palazzo Vecchio's structure as located in the city of Florence, Tuscany, Italy.

This study aims to analyze the point cloud representation of the walls of a culturally prominent structure, namely *Palazzo Vecchio*, which is located in the city of Florence, Tuscany, Italy (Figure 1). *Palazzo Vecchio* is a historical building where many of the interior

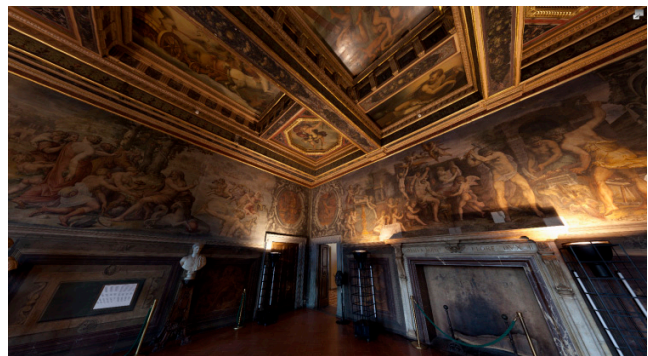
(b) Interior view of Sala degli Elementi

walls contain culturally important frescos (paintings with waterborne colors). The analyzed wall segment is located in a room at the southeast corner structure, known as *Sala degli Elementi*. The analyzed wall segment sustained significant cracking on its interior walls, where a single point cloud data of the wall segment is processed using an extension of the method introduced by Mohammadi et al. [9]. Single point cloud data here emphasizes that the analysis is performed without relying on comparison between two or more datasets collected at different times. The developed method relies on the local geometric variations that are not affected by color, which is essential for heritage structures due to color nonuniformities introduced by anthropologic and environmental effects. The damage detection and results using remote sensing point cloud data enable objective damage detection analysis, provide immediate guidance for in-person condition assessment, can be used as a baseline to monitor the damage and its progress. These are essential tools for heritage structure evaluations by providing insight into understanding the potential damage mechanisms and identifying potential rehabilitation. Lastly, it provides digital documentation of the scene in case of an emergency or unforeseen events to rehabilitate the damaged areas of cultural importance [10].

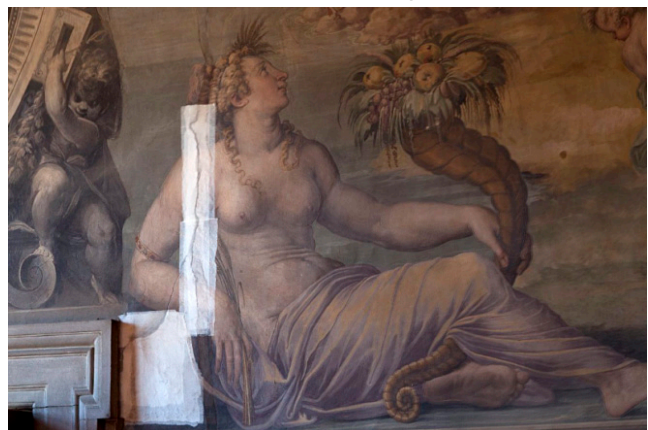
(c) Detailed view of cracking and repair area

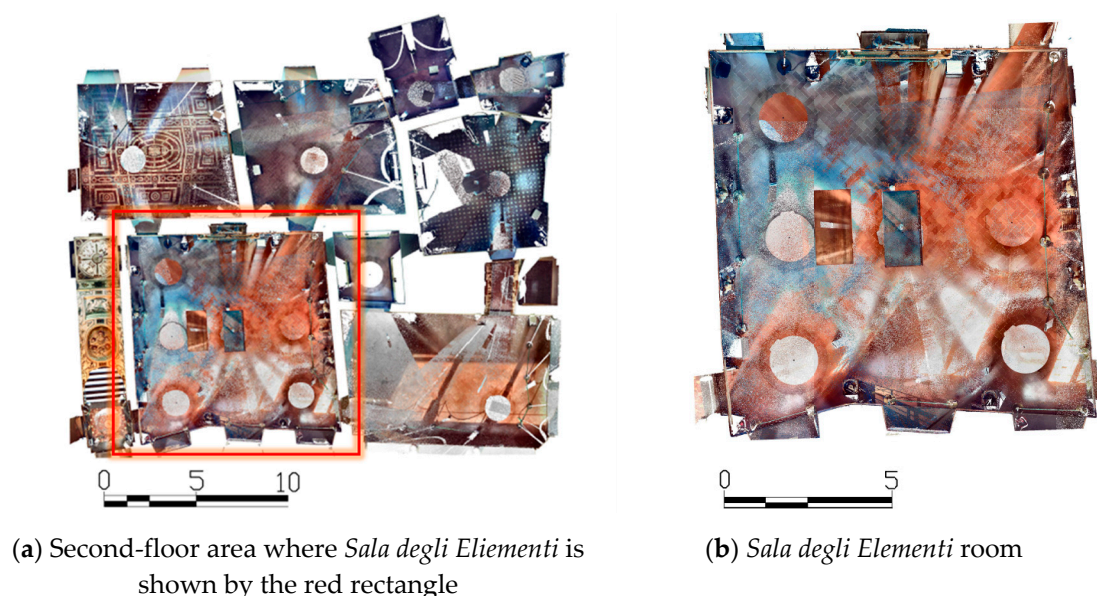
Figure 2. RGB point cloud plan view of the southeast corner of *Palazzo Vecchio* (units in meters).

The dataset used within this study to introduce the developed method is comprised of GBL data collected from the town hall of Florence, in the province of Tuscany, Italy, known as *Palazzo Vecchio*. *Palazzo Vecchio* is a prominent Romanesque town hall and was originally constructed in 1299. However, the structure was expanded in the following centuries. The structure consists of a chamber with a length of 52 m and a width of 23 m known as *Salone dei Cinquecento*, three courtyards, and three apartments on the second floor, including *Sala degli Elementi* or Room of the Elements. Figure 2 shows the planar view of the second floor. The *Sala degli Elementi*, which is located at the southeast corner of the structure (Figure 2b), sustained significant cracking on its interior walls. Various studies have investigated the application of different sensors for Italy's cultural heritage sites. For example, Ottoni and Blasi performed a statistical analysis based on data of various sensors to monitor crack widths and horizontal and vertical displacements [27]. However, Alessandri et al. focused on *Palazzo Vecchio*. The authors have investigated the deterioration and concluded that the sustained damage in the *Sala degli Elementi* is due to structural changes made to the building [28].

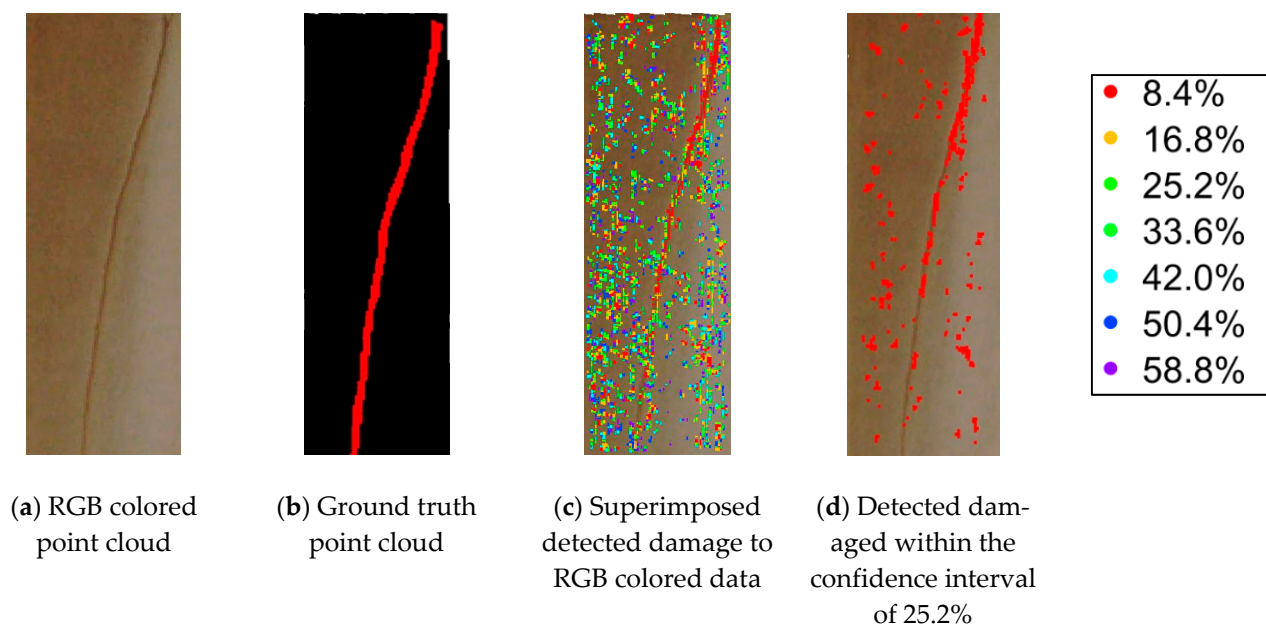
Figure 5. Point cloud representation of the test specimen used for the evaluation study.

The dataset was collected using a Faro Focus S350 GBL platform, and the laser scanner was placed at a distance of fewer than 4 meters from the cracking. The team minimized the offset angle between the GBL platform and the ROI. The scanner setting chosen to collect data was 1:4—4 \times , which resulted in a point cloud with a point-to-point spacing of less than 5 mm. Note that the parameter 4 \times within the scanner setting controls the number of measurements (oversampling) and does not contribute to the collected point cloud dataset point density. The selected segment is shown in Figure 5a. The chosen segment consisted of 11,600 points and was chosen as it demonstrates cracking damage similar to that observed within the *Sala degli Elementi*. The cracking had a varied width of approximately 1.5 cm at the top to 0.60 cm at the bottom. To analyze this dataset, initially, the data were voxelated with a grid step of 5.0 mm. It was then analyzed based on the eight closest points for surface variation, normal vector variation based on local reference planes (as the selected segment was curved surface), and curvature-based damage-sensitive features. As demonstrated in Figure 5c,d, the method could detect cracking of the selected segment. The precision for all confidence intervals was approximately 20 percent, while the recall value was 100 percent, where the precision for the cracked area was 70 percent.

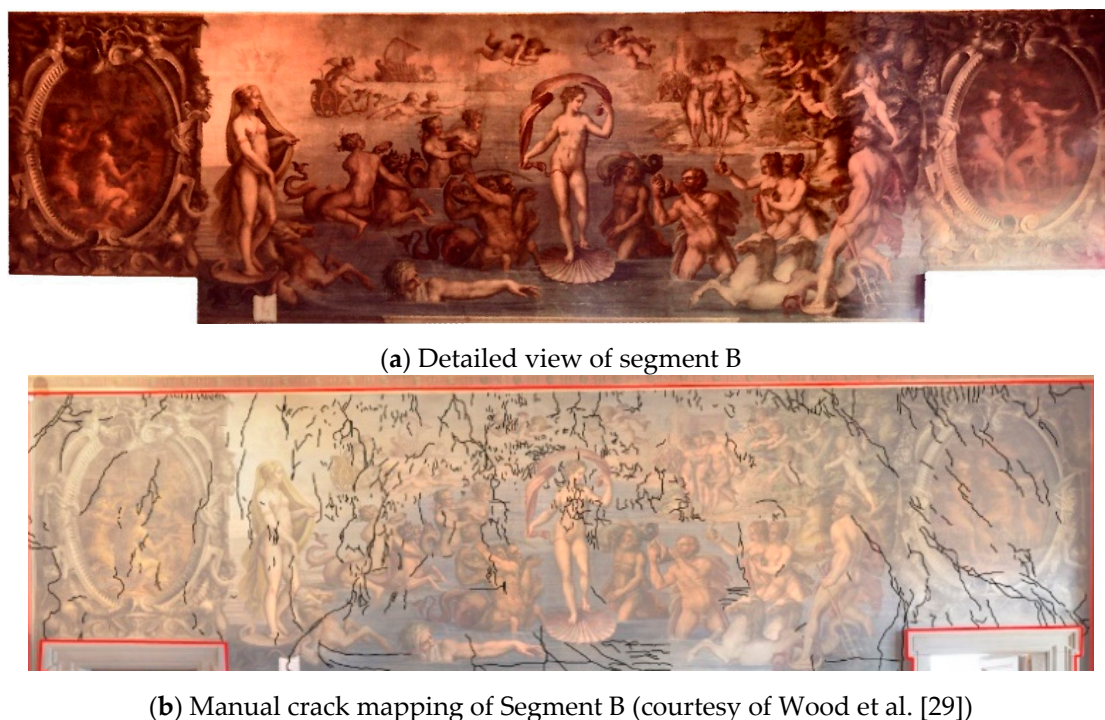
Figure 7. Details of the selected second segment for analysis.

To assess the workflow performance in detecting and segmenting the cracks, defects, and other surface anomalies, two segments of the *Sala degli Elementi*'s east wall are selected and analyzed in this manuscript (Figures 6 and 7). The selected ROIs were extracted from the single high-resolution scan that was collected at the center of the room with the resolution setting of 1:2 and quality of 4 \times to eliminate inaccurate detections due to registration error. The ROIs are comprised of a predominantly planar surface, but this wall does contain local nonplanar deformities. Segment A is close to the southeast corner of the room, and segment B represents the entire top portion of the wall [28,29]. As illustrated in Figure 3b, Figure 6c, and Figure 7b, the selected ROIs sustained multiple cracking at centimeter and millimeter levels, identified through manual crack analysis of the images. In addition, it was noted that the walls represented many nonuniformities in out-of-plane protuberances at various locations.

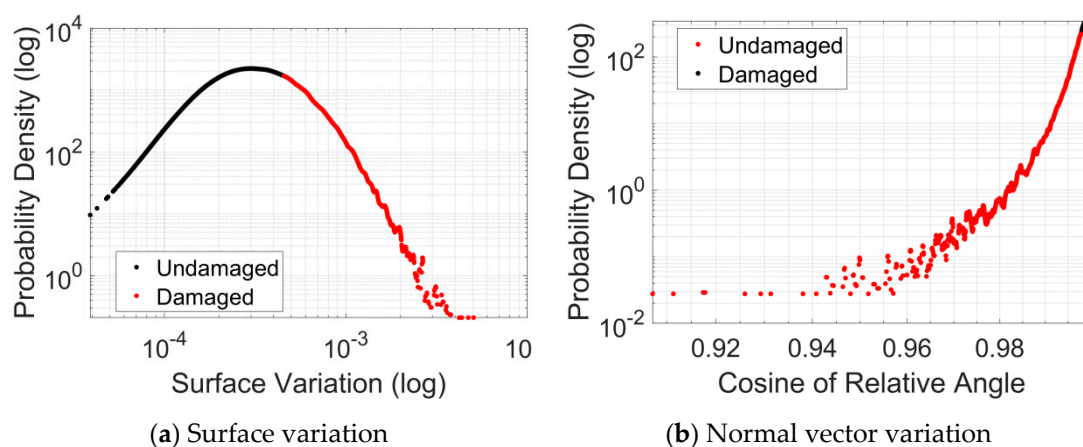
Figure 8. Example log-log scaled PDF identifying undamaged and damaged points.

damage-sensitive features resulted during the point cloud analysis with 5 mm resolution. Once the features were computed, the damage evaluation and reevaluation steps identified the potentially damaged areas. The identified damaged points were then classified into 11 intervals. The analysis results for segment A based on three damage-sensitive features are shown in Figure 9a,b. After evaluating the damage detection results based on each damage-sensitive feature, it was observed that surface variation-based and curvature-based features are predominately able to detect surface imperfections and nonuniformities.

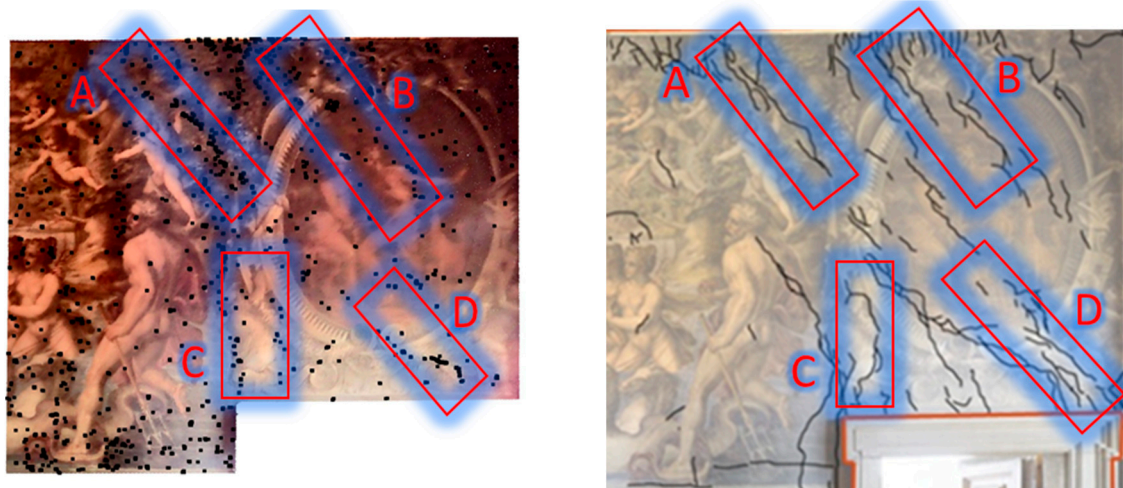
(a) Identified cracks in the confidence interval of 11.8% shown by the color black (b) Crack mapping of Segment A (after Wood et al. [29])

Figure 12. Comparison of detected damaged areas with the manual crack mapping.

Following identifying the detected cracking areas, various damage confidence intervals are evaluated for the 5 mm and 10 mm segments. As each of these intervals essentially captures similar spatial distributions, the goal here is to identify the confidence interval that captures the spatial distribution of the points that correspond to the cracking. The goal of evaluating these intervals is to identify the confidence interval that represents the cracking while minimizing the presence of surface anomalies and bulges, which allows comparing the detected damaged regions with manual crack mapping results, as shown in Figures 6c and 7b. Figure 9d, Figure 10b, and Figure 11b show superimposed detected damaged regions of the first three confidence intervals into the colored point cloud, representing the significant diagonal cracking identified from the images based on manual analysis. Moreover, it was noted that the selected confidence intervals for the spatial resolutions of 5 mm also represent major surface defects and localized bulges, potentially due to humidity or construction style, within the bottom of the selected ROI. However, by comparing Figure 9c,d, Figure 10a,b, and Figure 11a,b, it can be observed that the majority of the minor surface defects and anomalies, shown by the other confidence intervals, can be distinguished and eliminated as large cracks. Based on the detailed comparison for segment A analysis results at 5 mm, it was observed that the developed method was able to identify two of the diagonal shear cracking at the top of the segment (shown by A and B in Figure 12) as well as vertical cracking at the top left of the doorway (shown by C in Figure 12) and shear cracking at the right of the entrance (shown by D in Figure 12). Additionally, it was noted that some of the smaller cracks at the middle of the segment were identified.

cracks that result in local geometry change of 10 mm or larger. This includes the significant shear cracking at the top right of the wall (shown by A in Figure 12), highlighted by cluster 7 in Figure 10c and cluster 12 in Figure 11c. Furthermore, only a section of the vertical cracking (shown by C in Figure 12), the shear cracking on the top right of the doorway (crack D in Figure 12), and a portion of the cracking at the left and middle walls (clusters 1, 5, and 6 in Figure 11c) were detected. While other studies, such as Valenca et al. or Hou et al. [7,16], demonstrate workflows that can detect cracking with a higher level of accuracy, these methods rely on crack detection based on intensity or color information, which is not ideal for fresco walls, particularly within *Sala degli Elementi*.
