# The Voyatzis Mansion in Aegina, Greece: A Historical and Architectural Approach and Physicochemical Documentation of the Wall Painting Decoration

**Abstract:** This paper refers to the study of the Voyatzis mansion, in the port of Aegina, Greece. The building complex consists of two discrete structures, which were built at different times (before 1830, 1880 and 1890) and have housed either the Voyatzis family home or its business and work premises. The present research is focused on the documentation of the building, which was never published, and combines the architectural form and elements within its historical context as well as the physicochemical analysis of the painted decoration. The key hypothesis investigated is whether Konstantinos Voyatzis transferred the aesthetic approach and application techniques from Symi to Aegina, when he emigrated from his birthplace. The documentation of the ceiling decoration as well as the physicochemical study of the second floor's internal wall painting decoration in the main rooms was carried out using in situ modern hyperspectral imaging in specific wavelengths of the visible and near-infrared region, as well as in false color infrared

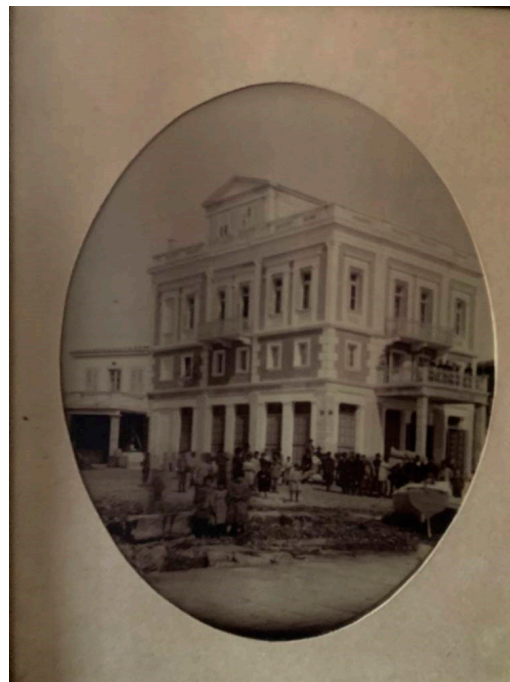
**Figure 1.** Building A (pre-existing single-storey) appears at the left part of the photograph, the three-storey main building B appears at the right part of the photograph and the building C at the left part, which consists of the first floor as an extension of the original building A and a two-storey part in the middle. Archival photograph, around 1890. In Dimitrios Moraitis' archives. © Ref. [4].

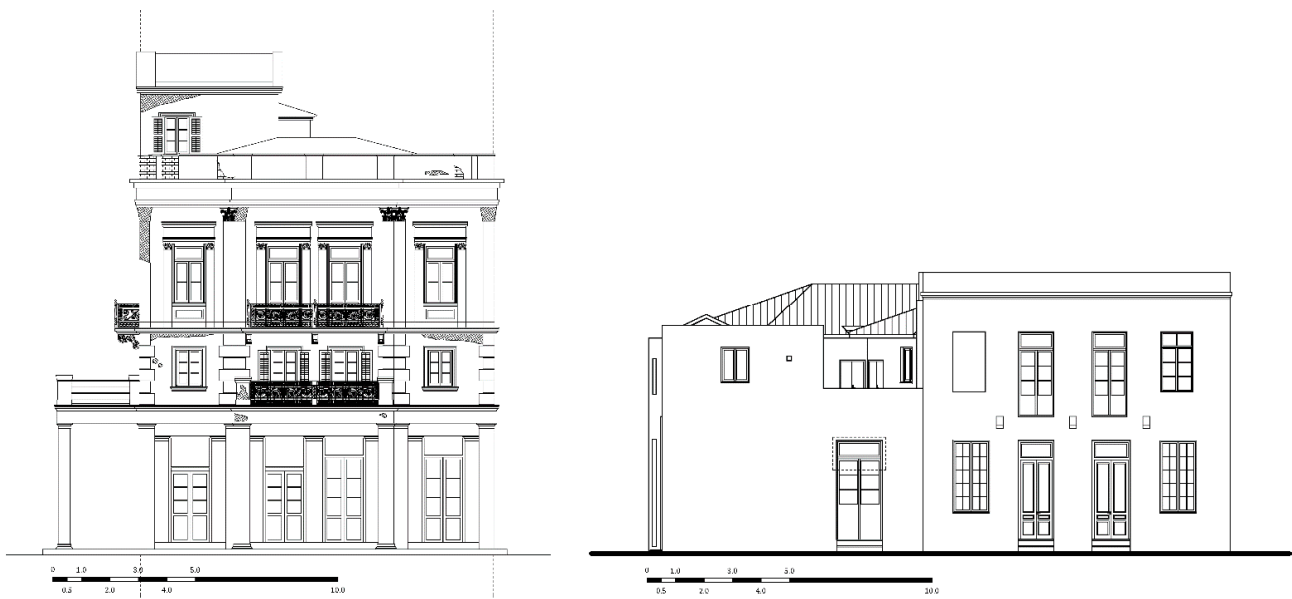
**Figure 5.** South (right) and north (left) facades—Dimokratias Avenue—port and Kanari street. Source: Architectural Office “Jacotey-Voyiatzis, Architectes Associés” (2004). © Ref. [6].

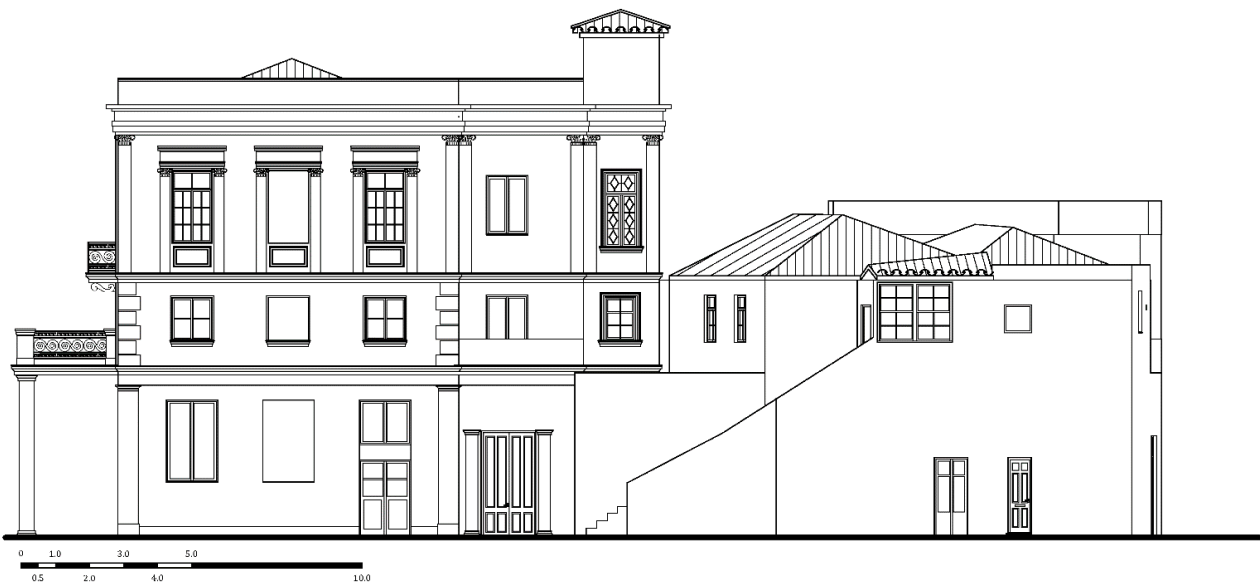
**Figure 6.** East façade—Irioti str. Source: Architectural Office “Jacotey-Voyiatzis, Architectes Associés” (2004). © Ref. [6].

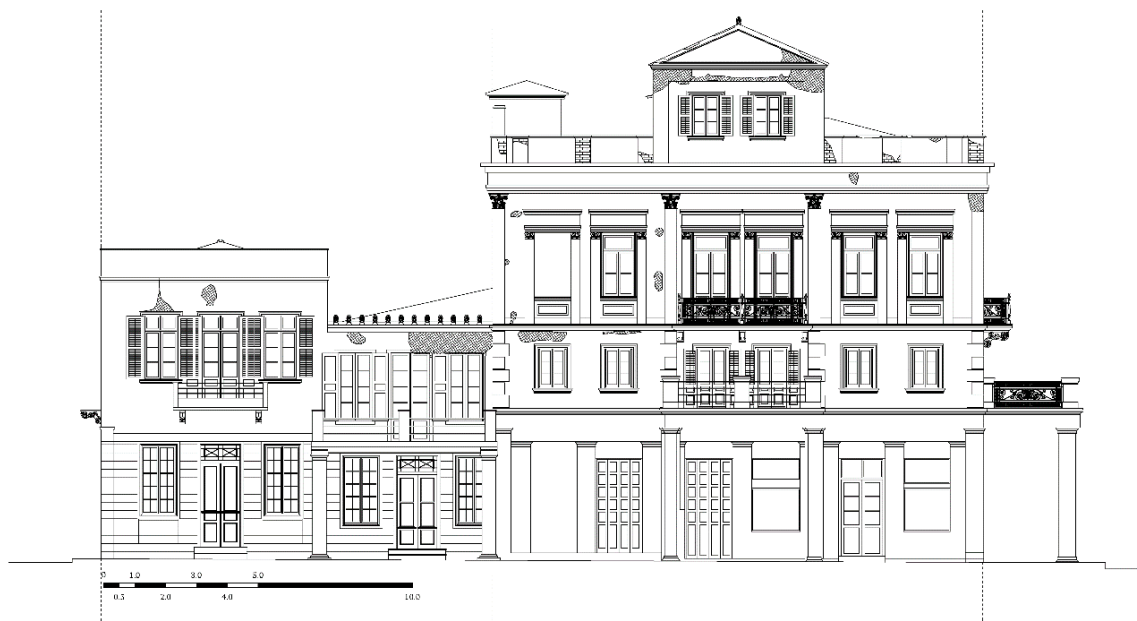
**Figure 7.** West facade Dimokratias Avenue—port. Source: Architectural Office “Jacotey-Voyiatzis, Architectes Associés” (2004). © Ref. [6].

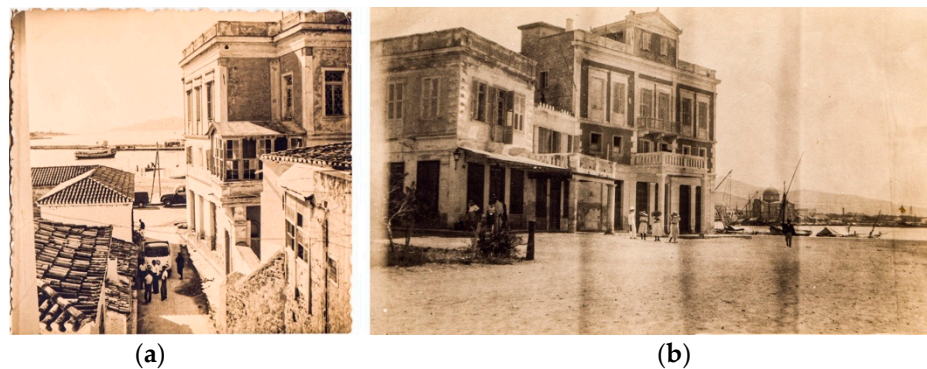
**Figure 8.** The additional balcony with balusters (b). Archival photograph around 1905–1907. The conservatory of the first floor (a) Kanari str. Archival photograph around 1962–1967. Both in Dimitrios Moraitis' archives. © Ref. [4].

Ornate cast-iron railings are used on the balconies, except on the addition, where a built wall with balusters is used, as in the second building. This has been damaged and replaced [4].

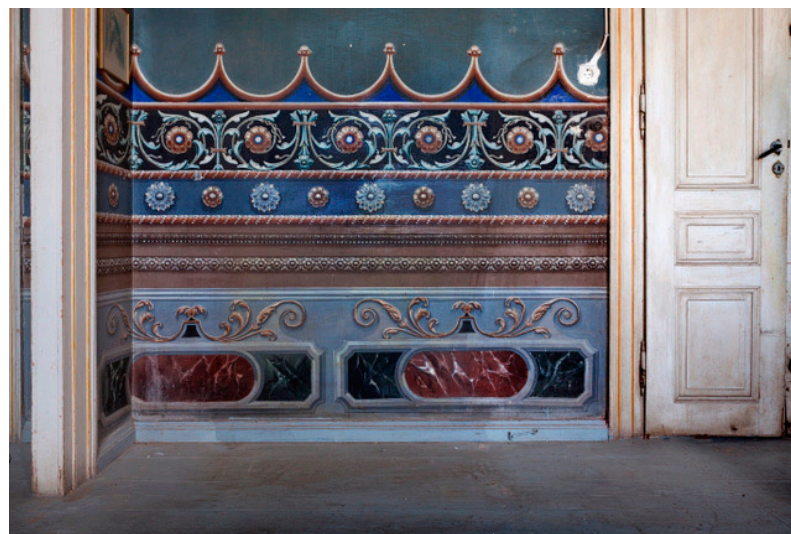
In the main reception room (Figures 9 and 10), the wall painting decoration covers the bottom of the walls up to a height of 1.5 m. The painting can be divided into four distinct zones. The lower zone depicts a painted representation of marble tablets in grey-black and dark red colors, each of them surrounded by a whitish frame, similar to the ones observed in the entrance hall of this floor. On their top, the faux marble plaques are adorned with gold painted plant decoration. They are both laid on a light grey background. The second zone, above the plant decoration, includes only garnished horizontal stripes. The third zone consists of plant decoration namely single red and white alternating roses above which there is a more elaborate green leaf with red roses synthesis. Finally, a vivid blue

**Figure 10.** Wall paintings in the main reception room. Photograph by Panagiotis Ilias ©.

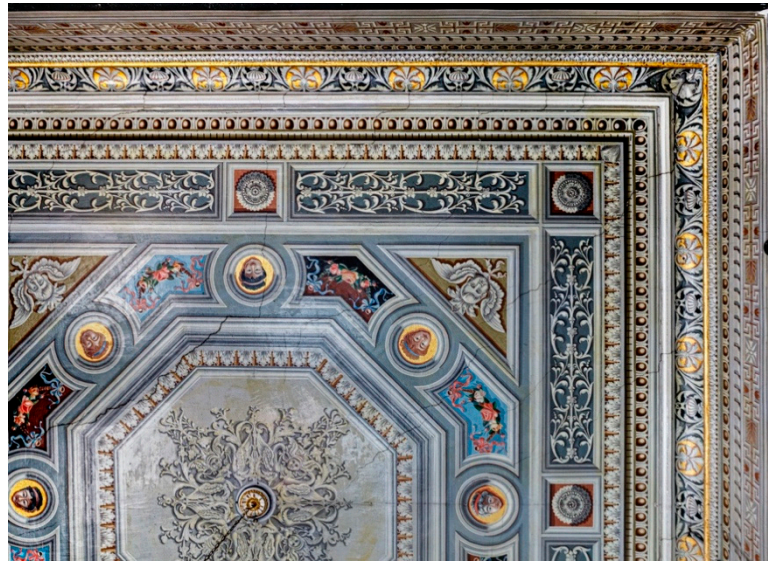
**Figure 11.** Ceiling paintings in the main reception room. Photograph by Panagiotis Ilias ©.

Regarding the ceiling decoration, it must be noted that all ceilings are decorated, no matter if they belong to primary or secondary areas of the house. However, the ceiling decoration of the main reception room is richer, more elaborate and more luxurious compared to the others, therefore it will be dealt with separately. The ceiling of all the other rooms is painted with roses and/or plant decoration, with marble strips, giving out the sense of relief. As the main reception area comprises two rooms, both of them have the same ceiling decoration (Figures 11 and 12). This can be divided in at least four different zones. The outer zone includes roughly 30cm of the upper part of the wall, which merges to the ceiling in a curved inner bas-relief painting. The second part is composed of straight-lined plant decoration divided into sections by marble-like roses. The inner part of the ceiling consists of an octahedron. Its outer ring bears the faces of ancient men alternating with flower bouquets, while the inner painting comprises a detailed plant-shaped marble relief.

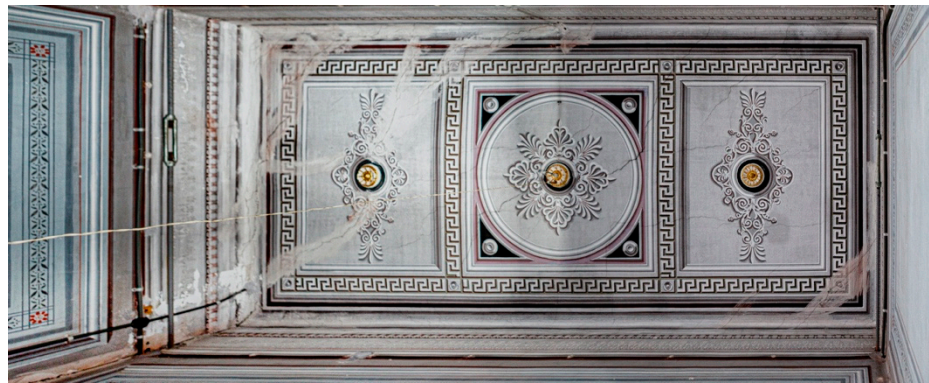
**Figure 13.** Ceiling paintings and stencil work in the walls of the corridor. Photograph by Panagiotis Ilias ©.

Of special significance is the category of ceiling paintings where square, octagonal and circular panels were depicted (Figures 13–16), usually with a central star, rose or other decorative pattern painted on a bright background according to the ancient standard, something that we find in vestibule stairwells in galleries and loggias [17]. Furthermore, simple rooms were usually decorated with a central rosette surrounded by symmetrical arrangements with thin floral garlands. The margins were decorated with similar shapes with helical stems and flowers that had a specific axial relation to the central theme.

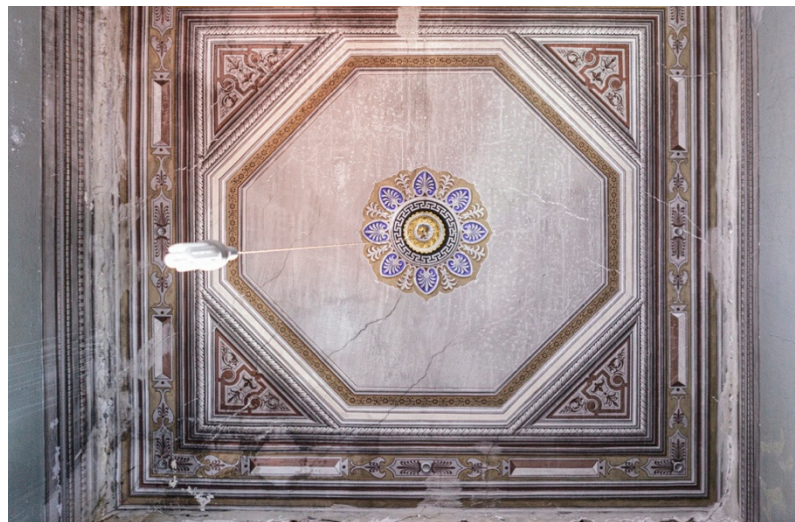
**Figure 14.** Ceiling paintings in a bedroom. Photograph by Panagiotis Ilias ©.

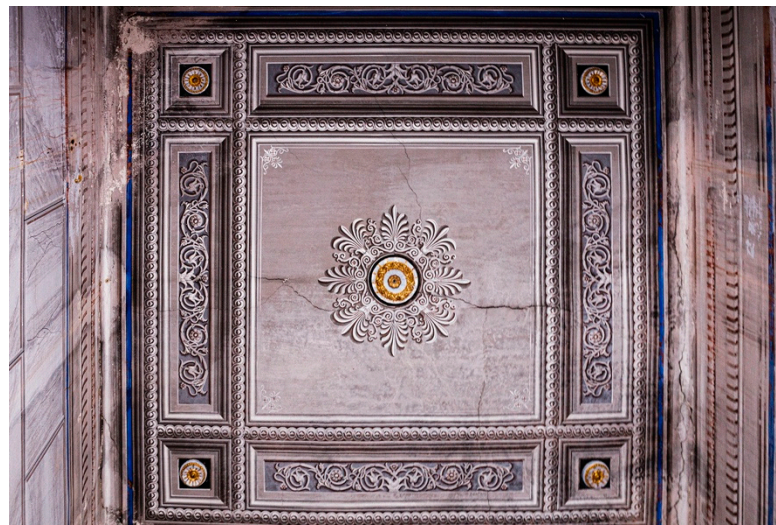
**Figure 16.** Ceiling and wall paintings in the staircase. Photograph by Panagiotis Ilias ©.

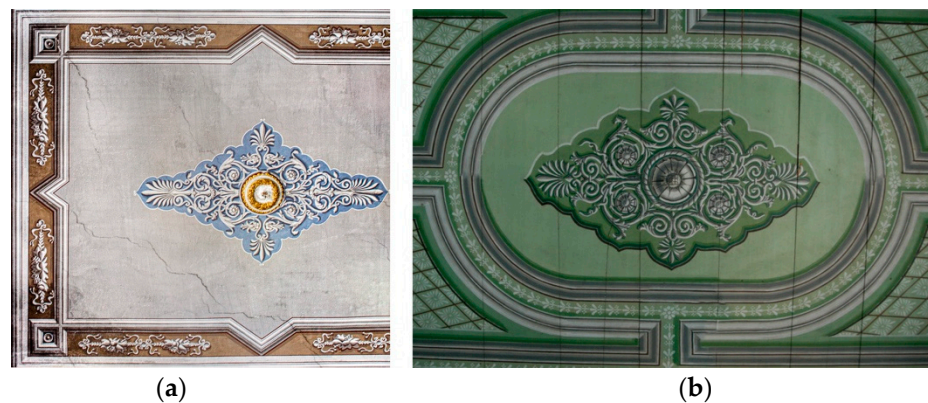
**Figure 18.** Bedroom's ceiling decoration in Voyatzis mansion, (a). Photograph by Panagiotis Ilias ©. Ceiling decoration in a mansion in Symi (b). Source: [18] Chiotinis N, Xanthis S, Chiotinis M (2008). The Architecture of Symi. In: Apostolopoulos N (ed) *Symi* (in Greek). New Media Art, Athens, p. 138. ©.

The contact of the Symian merchants with the big urban centers at the end of the 19th century and the first half of the 20th century, such as Syros, Genoa, Konstantinople, Izmir, Trieste, Alexandria, Paris, London and Brussels brought the Symians in contact with new images, and ideas and new ways of life, so the effects from European neoclassical architecture are clear. The Symians devoted much of their money from trade and the sea to building their own homes, which thus projected personal and family prestige [1,19]. This can be seen in the way the interiors of these buildings are decorated. In addition to the expensive furniture and wood-carved elements of the spaces, the colors and paintings on the walls and ceilings present expressions of high aesthetic perfection and symbolism [19]. So, ceilings completely covered by painting can be seen, while it is not usual for the walls to be covered. The ceiling was usually wooden and at the top of the walls there was a narrow-painted frieze with anthems and other decorative elements. The variety of themes is also important as the artists were inspired by Greek history, ancient and modern, by mythology and nature [18]. The coffered ceilings were decorated with designs such as anthems, rosettes and other plant decorations that can usually be found in rooms, hallways and utility rooms, which are evidently similar to those found in the Voyatzis mansion (Figures 17 and 18).

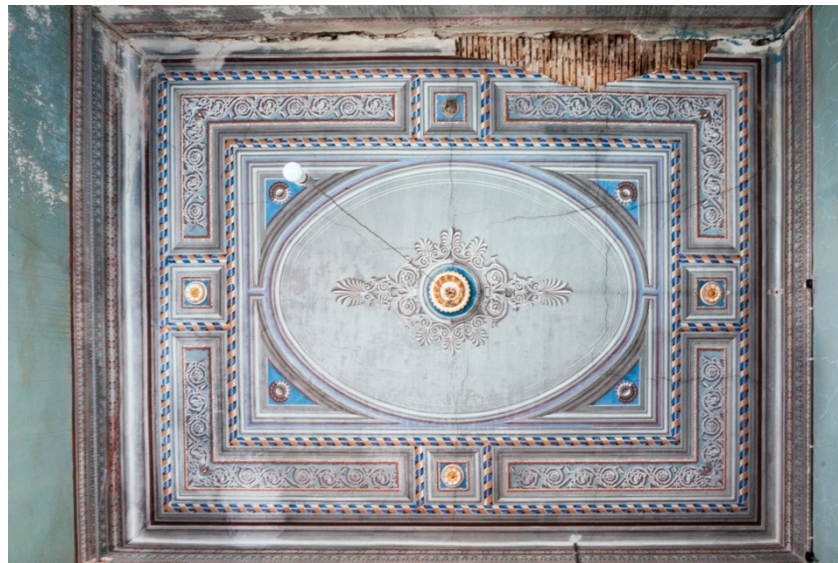
The support of the roof paintings are the wooden laths that constitute the *bagdati* construction [20,21] (Figure 19). This element becomes apparent at first glance as both in the ceiling painting of the central reception area and in the ceiling painting of the bedroom, parts of the ceiling paintings have collapsed, most likely due to the humidity, as a result of which the wooden beams that characterize the *bagdati* are visible.

This construction method is used in the period of neoclassicism [20,21]. According to this method, this is a construction made of wooden beams, which have a small cross-section and are fixed on top of square beams, also of a small cross-section. They are usually 50cm apart [20,21]. All this timber construction, which is usually made of hewn spruce wood, is fixed to the roof beams that are a large cross-section and are usually about 1m apart [20,21]. Short boards are placed on the bars in order to fill the gaps between the beams, thus creating the so-called false floor. Finally, for the best sound and thermal insulation of the floor, a layer of mortar reinforced with lime and hair or straw is applied to the entire surface, for the best sound and thermal insulation of the floor. On the wooden substrate were placed three successive layers of lime mortar in different thickness and texture (fine-grained ~2mm, coarse-grained ~3 mm and fine-grained ~2mm) to eliminate structural irregularities of the roof surface and to form the solid, smooth, clean and appropriately textured substrate.

**Figure 19.** Ceiling paintings in the dining-room, where the bagdati construction is visible. Photograph by Panagiotis Ilias ©.

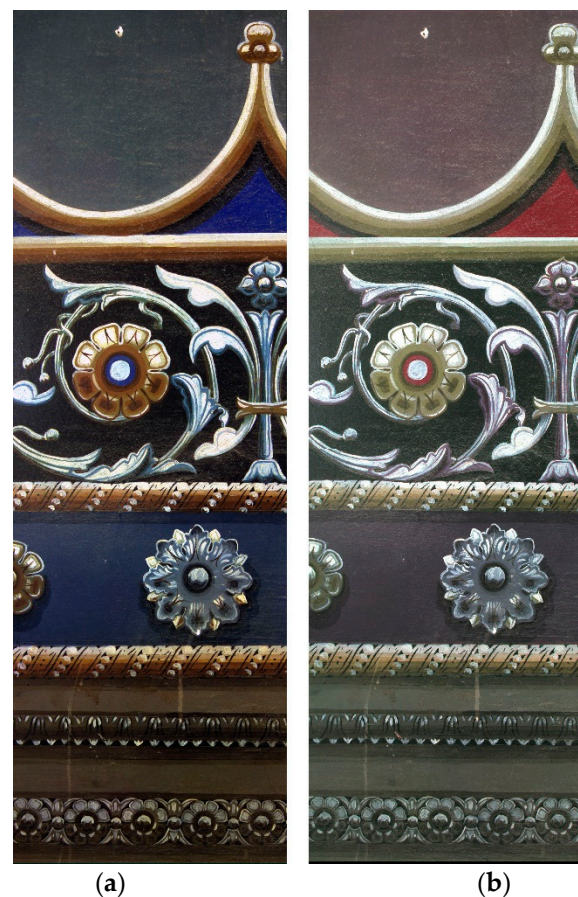
The recording of the images in true and false colour mode (Figure 20) has given many interesting results regarding the nature of the pigments employed by the artist as well as the painting technique. The main hues used were yellow, red, brown, green and blue, but not in clear form, rather in admixtures with white or black or some other color. The colors are very well mixed. The surface of the background is fine grained and smooth, the brushstroke not being distinguishable. The relief of the preparation can be distinguished at 1000nm due the penetrating ability of the infrared, by both MuSIS and SWIR. Tone differentiations are better distinguished in FCIR rather than in the visible.

**Figure 20.** Detail of the wall painting in the main reception room in the visible (a) and FCIR (b). Photograph by ARTICON Lab ©.

The comparison of the false color infrared images showed that the artist used two different blue pigments for the wall paintings. The blue pigment employed for the roses' internal ring and the crown filling shows a bright red false color, while the intense blue of the background produces a black greyish false color. According to the hue in the visible,

The brown pigment of the stripes and garland is the same as the one used for the rose (Figure 20). It is recorded by an olive false color, which suggests the use of earth pigments and especially burnt sienna, perhaps in admixture with a white pigment depending on the tone the artist wanted to express [22,28].

In all areas with a white hue, such as in the leaves, the brush stroke is clearly depicted in both FCIR and SWIR images; color layer is not uniform either. Judging from the transparency it presents, it is assumed that the white pigment could be lime ( $\text{CaCO}_3$ ), as lead white ( $2\text{PbCO}_3 \cdot \text{Pb}(\text{OH})_2$ ) gives out the feeling of impasto.

Yellow areas could have been executed with yellow ochres, as they present the typical green-olive false color [28] (Figure 20).

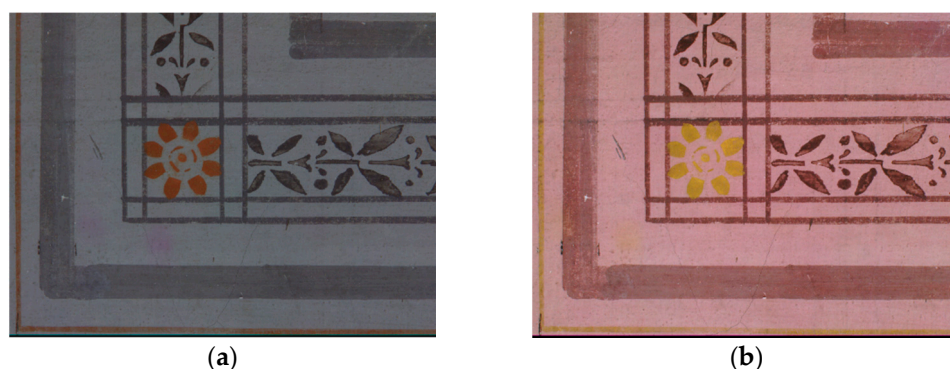
In the faux marbles in the reception room, the red turns into a yellow-olive false color, which indicates the presence of iron oxide pigments [28]. In the hallway, the orangey red presents a bright yellow false color (Figure 21) which suggests the use of either minium ( $\text{Pb}_3\text{O}_4$ ) or artificial vermillion (art.  $\text{HgS}$ ) [28]. However, since minium has not been widely used in wall paintings [37,38] and the fact that it has a slightly more orangey tone than vermillion, it might indicate the use of the latter.

**Figure 21.** Detail of the wall painting in the hallway in the visible (a) and FCIR (b). Photograph by ARTICON Lab ©.

Furthermore, it is worth noting that in the wall decoration of the hallway area, the gray lines observed in the visible become gray in false color infrared, which could indicate that they were made of a mixture of black and white pigment. However, the gray background

presents a pinkish false color, and this might indicate the addition of a blue pigment in the mixture, probably cobalt blue.

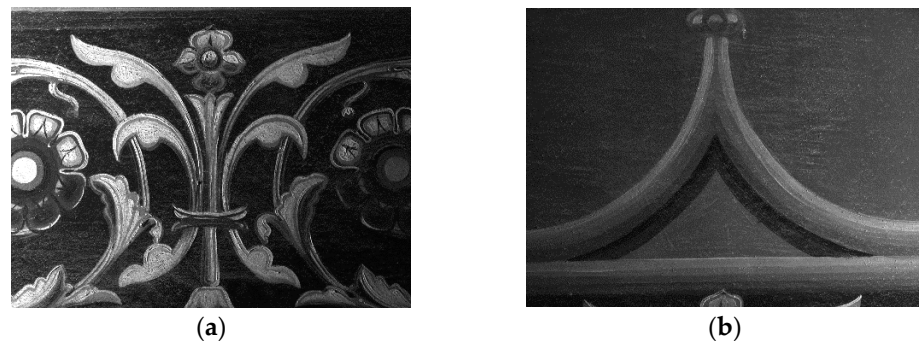
Comparing the images of the wall paintings at 420 nm and 1000 nm as well as in false color infrared mode, the paintings in the main reception room appear free from a preliminary sketch or guidelines. At 1000 nm, the brush strokes can be easily observed and appreciated, as every single one can be distinguished. It is a painting created by hand, without any external use such as a stencil. Moreover, no underdrawings could be observed even with the SWIR camera that extends up to 1700 nm. To further investigate the artist's technique, raking light illumination was employed. Images at 500 nm, 700 nm and 1000 nm were acquired (Figure 22) and enabled the distinction of the relief caused by the brushstrokes. While in the visible, the background looks uniform, examination with the SWIR camera revealed brush strokes and highlighted the existence of the shadow under the roses (Figure 23). It should be reminded that pseudo colors in this case depict different tones of grey.

**Figure 22.** Details of the wall decoration in the main reception room in 500 nm (a) and 1000 nm (b). Photograph by ARTICON Lab ©.

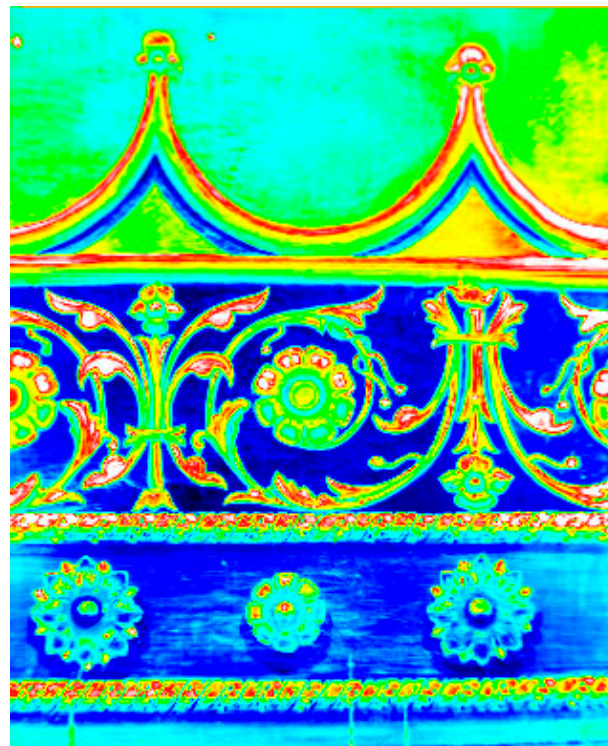
**Figure 23.** Pseudo color image of the wall in the main reception room. Photograph by ARTICON Lab ©.

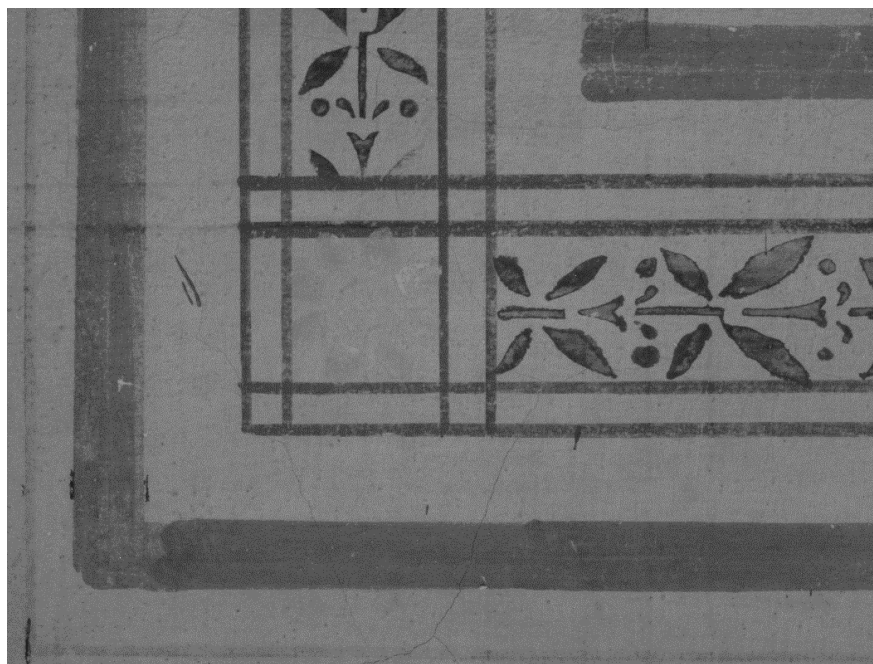
On the contrary, in the corridor/entrance hall, the stripes that form the frames were carried out on guidelines that can be observed at 1000 nm (Figure 24) and in the SWIR images because of the penetrating ability of the infrared radiation. Furthermore, in the infrared images, the floral motifs present a waterfront at their edges, which could indicate that they were painted using a stencil. There is a possibility of the use of carved wooden stamps, but they usually had more detailed sketches, which is not the case here.

**Figure 24.** Detail of the wall painting in the hallway at 1000nm. Photograph by ARTICON Lab ©.

In the reception room, the painting seems more solid, while in the corridor it looks more fluid. This might have happened because of the different style of execution of the wall paintings, which might relate to the existence of two different artists who painted the walls.
