Article

Modeling Earthen Treatments for Climate Change Effects

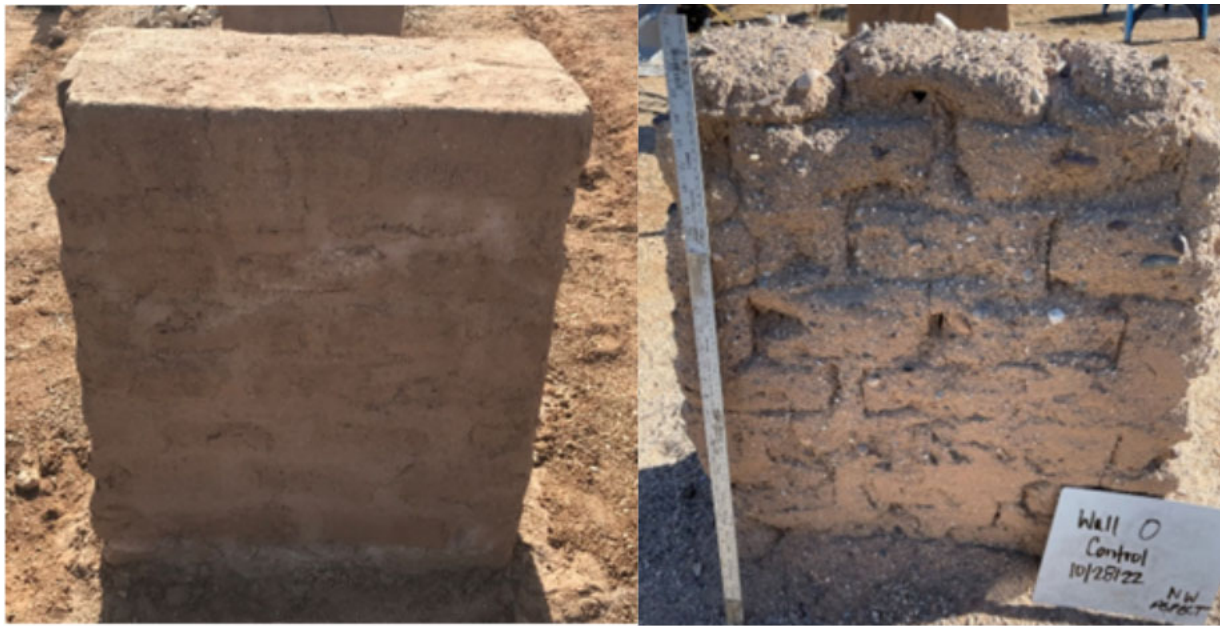
Figure 1. Wall O when newly constructed in 2018 (left) and before rain simulation in 2022 (right).

Since their original construction, the test walls have experienced variable amounts of erosion in response to both ambient weather and the applied rainfall events [9]. As detailed above, in November 2018, rainfall simulators were used to apply one of four high-intensity rain treatments to each test wall. Additionally in that study, subsequent additional low-intensity rainfall simulation experiments were conducted in May–June 2019 on a subset of walls applying 0.97 cm h^{-1} of rainfall in either a single event (1 event, 240 min) or two events (2 event, 80 min and 160 min events separated by a 48 h hiatus) to assess the effects of prolonged low-intensity rainfall on wall degradation. Untreated walls (control treatment) for the low-intensity simulations utilized the same original five control test walls from the previous high-intensity rainfall simulations. The walls received no preservation treatments or amendments after the high- or low-intensity experiments. After these two experiments, all the walls were primarily exposed to ambient weather conditions. By Autumn of 2022, the walls' erosional state had visually appeared as “melted adobe ruins” (Figure 1).

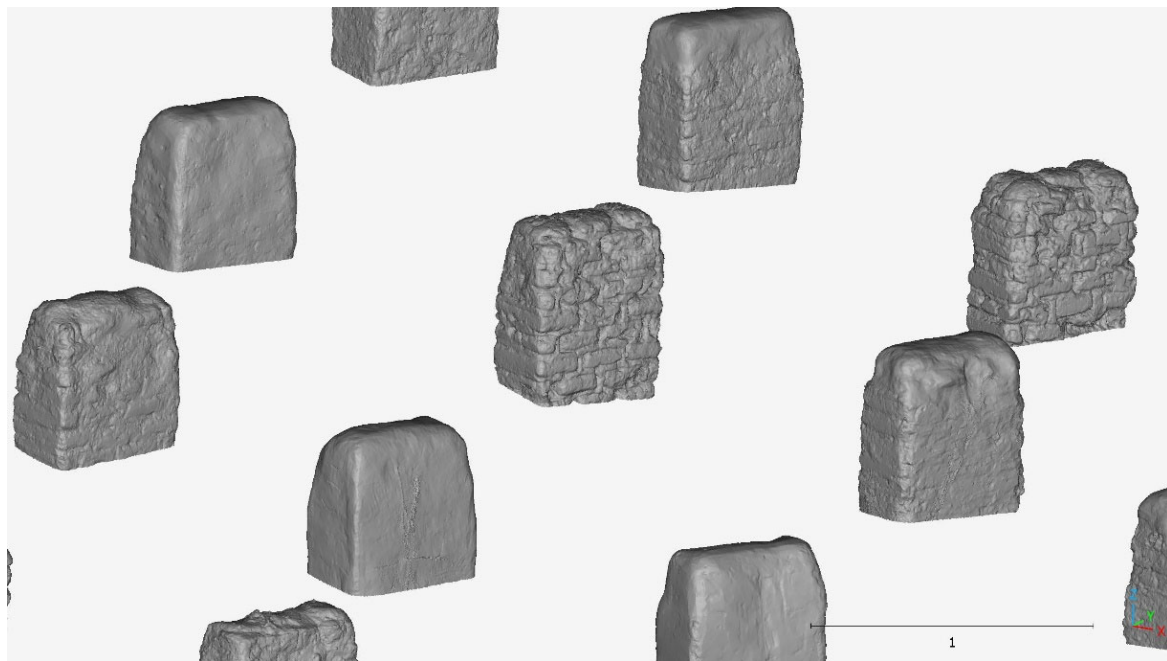
Figure 2. Lidar scan/wall models of treated walls prior to 100-year (10.6 cm h^{-1}) rainfall event application.

While the previous study [9] used rainfall intensities to correlate the precipitation and material loss, this study sought to investigate the effectiveness of common treatments under one future rainfall intensity. In this case, all the walls, including the test locations originally classified as control walls, were subjected to 100-year rainfall intensity (10.6 cm h^{-1}) for 30 min. This scenario was intended to test the effectiveness of three common types of treatments. Each treatment used unamended earthen material, consisting of the same locally-sourced soil with clay content and sand as the previous study [9]. Unamended earthen material is defined as having no chemical additives such as polymer adhesives to help with water shedding. As each locally-procured soil will have distinct characteristics, there is no one formula for mixing the clay, sand, and water, and studies and guides on adobe give a range of 0 to 30% clay content [15–18]. However, a certain consistency is desirable and was reached, namely, one where the wet material stayed adhered to a trowel when inverted and spread easily on the wall surfaces. All the treatments were hand applied with trowels. The treatments were applied to 5 walls each in the following configurations (see also Figure 2):

- Epoch IX: immediately prior to treatment application; 6 September 2022,
- Epoch X: after treatment application and before the rain simulation; 28 September 2022 (Figure 2),
- Epoch XI: after the rain simulation; 3 November 2022.

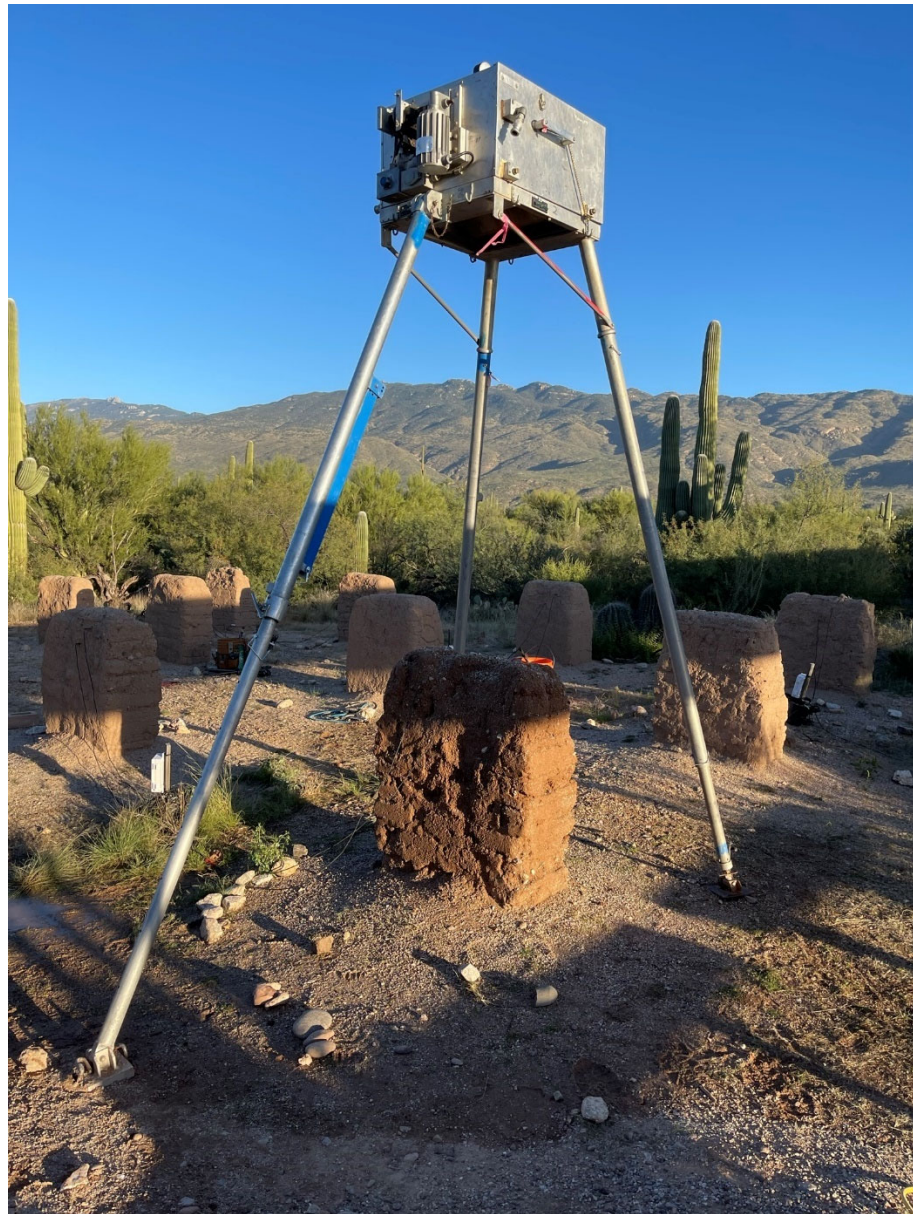
Figure 3. Rainfall simulator with tarps removed, October 2022.

Rainfall simulations were conducted over the period of 25 October–1 November 2022 with consistent daily ambient weather conditions without natural rainfall. Rainfall simulations employed the same portable single-nozzle, Meyer and Harmon-type, oscillating-arm rainfall simulator [19–21] used in earlier high- and low-intensity rainfall studies on the test walls [9]. The rainfall simulator (Figure 3) was fitted with a VeeJet 80–100 nozzle raised 3 m above the ground surface and supplied with water pressurized at 41 N m^{-2} . The raindrop size and kinetic energy of the simulated rainfall was within 1 mm and

70 kJ ha⁻¹ mm⁻¹, respectively, of the values reported for natural convective rainfall [19,22,23]. Tarps were applied to the rainfall simulator prior to the experiments to prevent wind effects on rainfall and to ensure consistency in the rainfall application rate. Specifically, the simulator configuration described above applies rainfall with a kinetic energy at the ground surface of approximately 200 kJ ha⁻¹ mm⁻¹ and about 2 mm average drop size [19]. The simulator was calibrated multiple times daily for the target intensity (10.6 cm h⁻¹) by simulating rainfall over a calibration pan for five minutes [20,21]. The calibrations resulted in an average application rate of 10.57 cm h⁻¹ (applied for a 30 min duration) with a standard deviation of 0.01 cm h⁻¹ across all the simulations. All the calibration runs and wall simulations were controlled for wind by tarping around the simulator and respective test wall.

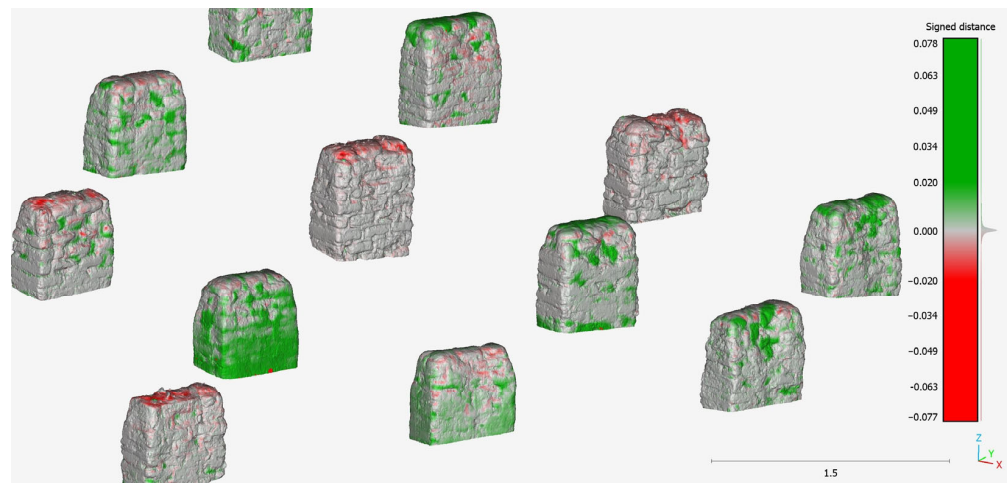
Figure 4. Epoch XI walls compared to Epoch IX showing positive signed areas representing additions (green) and negative signed areas representing loss (red).

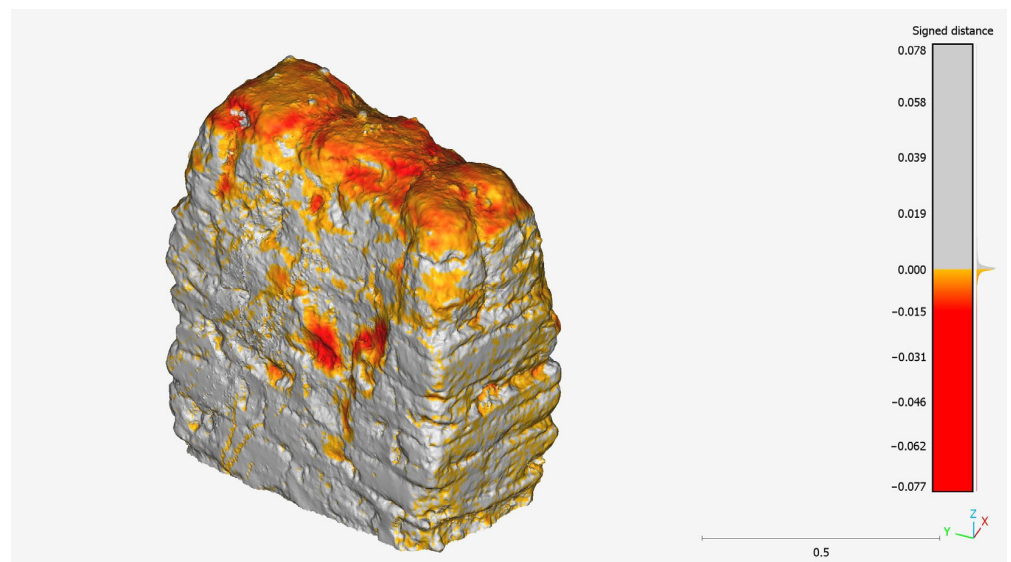
Figure 5. Affected area and negative signed values (in orange-red) used to calculate original material loss on Wall C.
