Article

Early Detection of Corrosion-Induced Concrete Micro-cracking by Using Nonlinear Ultrasonic Techniques: Possible Influence of Mass Transport Processes

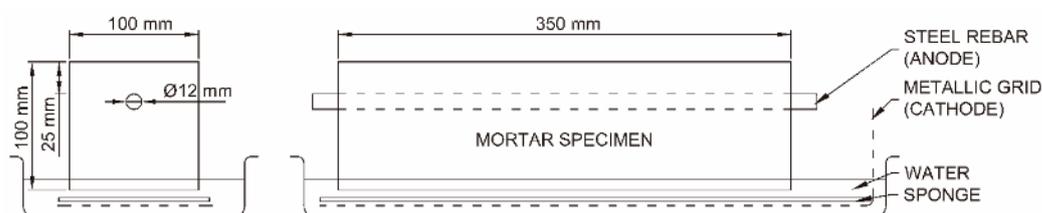
Figure 1. Mortar-specimen dimensions corresponding to the second set of experiments (specimens M0, M1, M2, M3, and M4) and the anode/cathode disposition. In the case of the first set of experiments (specimens 1, 2, and 3), the mortar cover depth over steel was 10 mm instead of 25 mm. Figure adapted from [48].

The molds allowed for the center crossing of a smooth steel rebar of a 12 mm diameter along each sample. The cement-mortar cover depths over the steel bar were 10 mm and 25 mm for the first and second sets of experiments, respectively (see Figure 1). This layout was chosen to promote the appearance of the first visible crack on top of the upper surface of the RCM specimens, thus allowing for the monitoring of the evolution of crack width with time. The steel bars were previously cleaned from native corrosion products following a recommended procedure [58] and weighted, covering the ends with vinyl electric tape to avoid the steel–mortar–air contact.

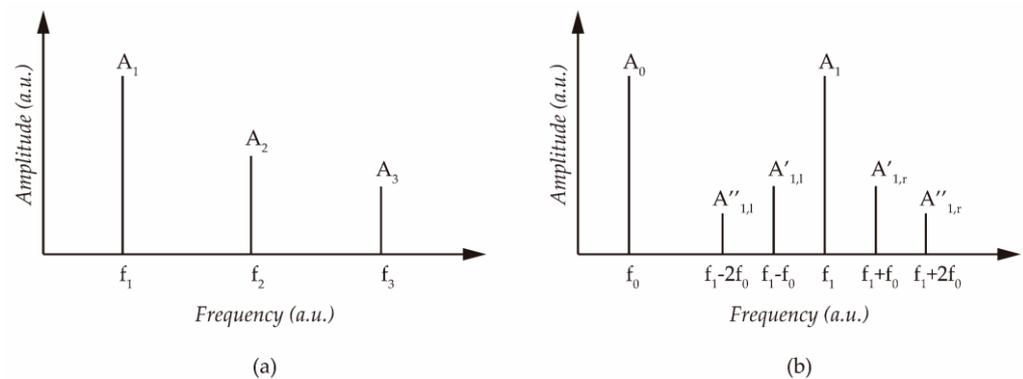
Figure 2. Frequency spectrum: (a) harmonic distortion (HD) and (b) intermodulation distortion (IMD). Figure adapted from [47].

The degradation of a material, for instance, due to cracking, is linked to a nonlinear mechanical behavior [59]. When an ultrasonic wave propagates through the material and interacts with the microstructural defects, nonlinear terms should appear as linked to these elastic waves. As the micro-damage increases, nonlinearity should increase. In this work, the NLU measurements were obtained through techniques based on higher harmonic generation, here termed as harmonic distortion (HD), and frequency wave modulation, here termed as intermodulation distortion (IMD) [60] (see Figure 2). HD takes place when a nonlinear system is excited by a signal of frequency f_1 . In this case, higher-order frequencies appear at the output ($f_2 = 2f_1, f_3 = 3f_1$, and so on), Figure 2a. Regarding IMD, if a nonlinear system is excited by two signals of frequencies f_0 and f_1 , referred to as pump (f_0) and probe (f_1) waves, being $f_1 \gg f_0$, the mechanical nonlinearity produces additional output-frequency components as sum and difference as $f_1 \pm n \cdot f_0$ (for $n = 1, 2, \dots, N$) (see Figure 2b). Otherwise, if the system behaves linearly, the sideband frequencies are not generated.

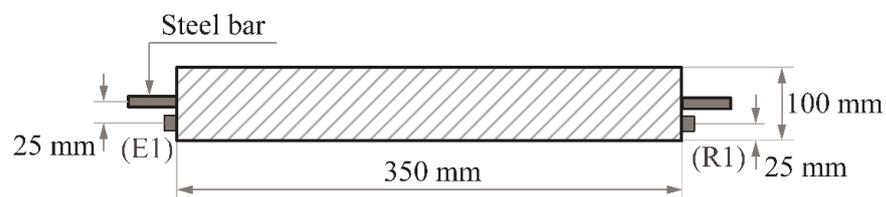
Figure 3. Positions of the transducers in the first series of experiments (top view of the RCM specimen). E1: emitter and R1: receiver. Figure adapted from [47].

In the first series of experiments (specimens 1, 2, and 3), both HD and IMD measurements were performed with a “direct-transmission” mode, i.e., with ultrasonic transducers located at opposite faces of the RCM specimen. The positions of the transducers were equidistant to the rebar axis and to the specimen’s lateral surface (same height from the specimen’s bottom) (see Figure 3). Both transducers were permanently glued (at the beginning of the NLU measurement series) to the RCM specimen, using a quick-setting Cyanoacrylate glue as the coupling agent. The tests were conducted with an NI-USB 6361 multifunction I/O device with a sampling frequency of 2 MHz and an ACD resolution of 16 bits. For the HD experiments, a 30 kHz sinusoidal signal with a length of 10,000 cycles was sent to an FS WMA-100 voltage amplifier and then to the emitter transducer. Amplitudes between 120 to 200 V in 10 V steps were used for the excitation signal. The received signal was amplified using a signal conditioner 2693-A (Brüel & Kjaer, Naerum, Denmark) and then sent to the acquisition platform. For the IMD experiments, the emitter transducer was supplied with two tones at the same time: $f_1 = 30$ kHz (probe wave) and $f_0 = 2$ kHz (pump wave). IDK09 transducers [66] with an isolated contact membrane (Al_2O_3 pure ceramic) and piezoelectric ceramic active element PbZrTiO_3 (PZT)—modified ceramic class 200—were used for both the emitter and receiver elements. A rectangular window was applied to the steady-state interval of the received signal. The frequency spectrum of the windowed signal was obtained using the Fast Fourier Transform method. Then, the amplitudes of the fundamental (corresponding to 30 kHz), second- (60 kHz), and third-harmonic (90 kHz) waves were determined. A similar process was performed for the intermodulation products (first-order-intermodulation products are expected at 28 and 32 kHz and second-order products near 34 and 26 kHz). Further details of the experimental procedure can be found in the previous publications [47,67].

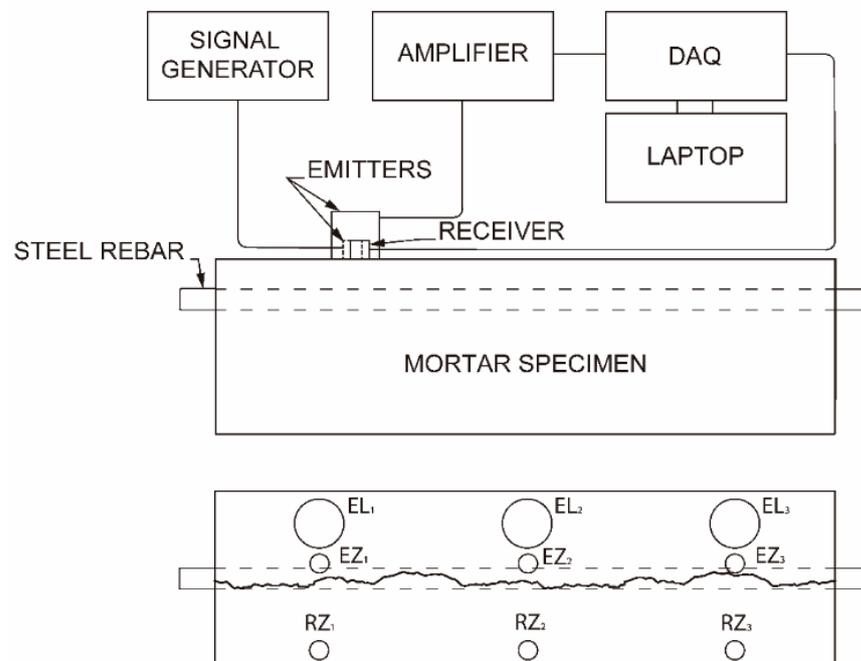
Figure 4. Experimental setup used in the second series of experiments, and relative positions of the transducers: Langevin emitter (EL), IDK emitter (EZ), and IDK receiver (RZ). Figure adapted from [48].

tive positions of the emitting (EL and EZ) and receiving (RZ) transducers. The test was repeated at the three different positions shown in Figure 4. Two transducers were used to simultaneously supply two pure tones: $f_0 = 20$ kHz (pump wave) and $f_1 = 200$ kHz (probe wave). The high-frequency probe signal was emitted with a signal generator (SONY AFG310) at an amplitude of 5 V. The same 16 bit ADC resolution I/O device described in the preceding paragraph was used for the generation of the low-frequency pump and the acquisition of the frequency-modulated signal with a sampling frequency of 2 MHz. The acquisition length was set to 50 ms. The pump wave signal was fed through an amplifier FS WMA-100 and then transmitted through a specially designed and manufactured Langevin transducer [48]. These devices have a very narrow bandwidth, making them suitable for providing the needed frequency and energy of the pump wave [48]. The input voltage was set to 130 V (after amplification). Two broadband ultrasonic transducers IDK09 [66] were used for emitting and receiving the high-frequency signal. White soft paraffin (Acofarma) was used as a coupling agent. Further details of the experimental procedure can be found in the previous publications [48,67].

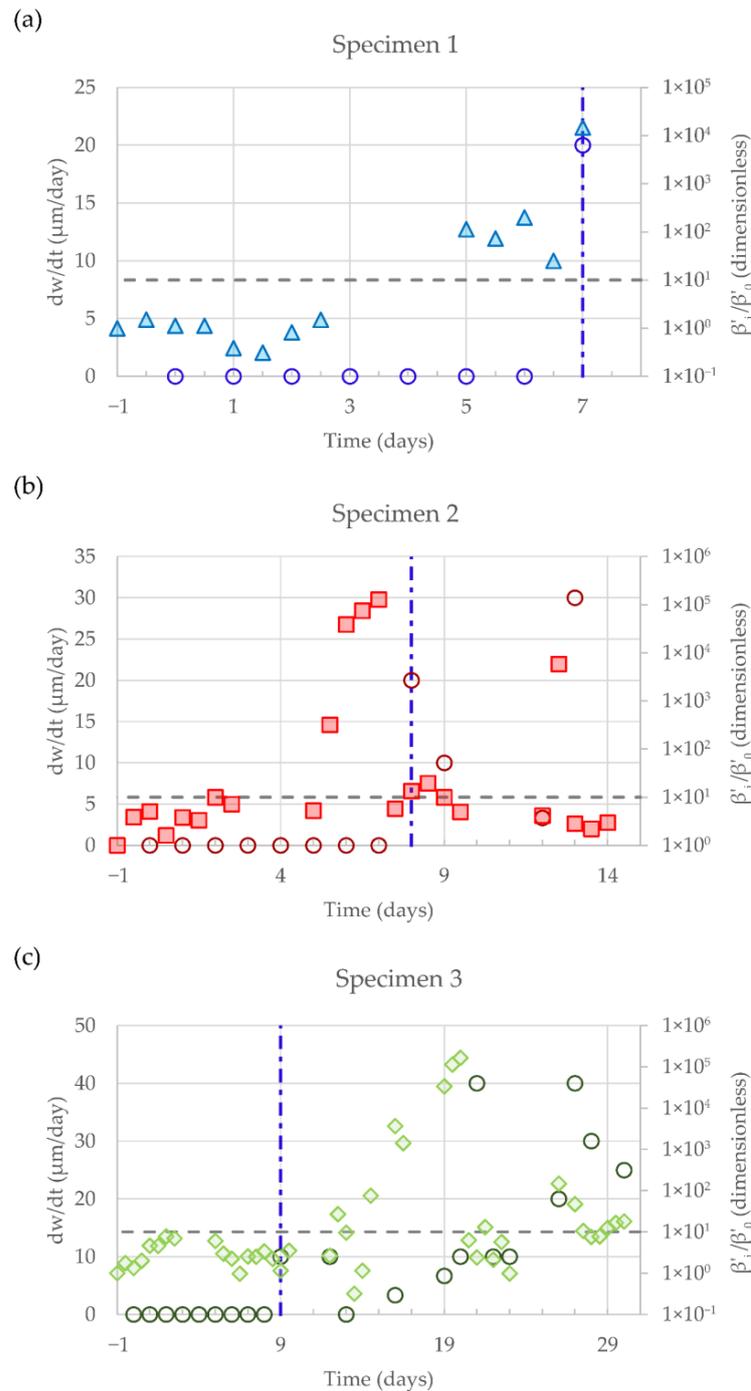
Figure 5. Correlation between the evolutions with time of dw/dt (circle symbols) and those of the third harmonic ratio β^l : Δ , \square , \diamond . (a) Specimen 1; (b) specimen 2; and (c) specimen 3. The vertical line indicates the time of observation of the first surface crack. The dotted horizontal line represents the arbitrary threshold considered as indicative of a critical increase in the nonlinear elastic features (see text for details).

It is apparent from Figure 5 that the harmonic ratio β' starts to reach values over the threshold considered as indicative of critical nonlinear features, a few days before the first appearance of a surface crack (Figure 5a,b). In these cases, the first crack observed had an initial width of 20 μm . The situation is slightly different in Figure 5c, where the initial crack width measured is about 10 μm , and its appearance is not preceded by an increase in β' over the threshold. Instead, the values of the harmonic ratio started to exceed the threshold about four days before the sudden increase in the crack width recorded on the 20th day ($dw/dt = 40 \mu\text{m}/\text{day}$). These observations clearly point to an excellent correlation between the increases in the harmonic ratio and the relevant events of the corrosion-induced cracking. Furthermore, the results also indicate the capability of the NLU technique for providing an early detection of the corrosion-induced damage of mortar and concrete: the non-elastic features can be detected well before the observation of any open surface crack.

It is easily appreciable from Figures 5–8 that, typically, after a clear increase in the nonlinear parameters (or decrease in the case of *DIFA*), the values return to values characteristic of the initial undamaged state (see Figures 5b,c, 6c, 7b,c and 8d,e). This observation was previously pointed out [46–48]. An explanation was hypothetically proposed considering the possible effect of the filling of the void space by liquid containing steel corrosion products after the formation of new cracks or the enlargement of its width [47]. This filling process might be enhanced particularly by the net convective transport of liquid (wick action) in the experimental conditions of this work [47,70]. A recent publication presenting the results obtained during accelerated corrosion tests performed with an experimental setup similar to that used in this work, and using a different NLU technique based on the determination of the sideband peak count-index [71], also concluded that the returning of the nonlinear parameters to values typical of the undamaged state, after the critical events of the micro-cracking phenomena, may be due to the filling of the void space created with liquid containing steel corrosion products. Another possible effect that might contribute to these shifts in the nonlinear parameter values is the fact that the opening of micro-cracks (when reaching the surface) may reduce the overall nonlinearity [71]. However, a careful observation of the results presented in the precedent subsection allow us to appreciate that the abovementioned shifting of the nonlinear parameters is observed not only after the appearance (opening) of the first surface crack, but also after sudden increases in the width of a previously existing crack (see Figures 5c, 6c, 7b,c and 8d,e).

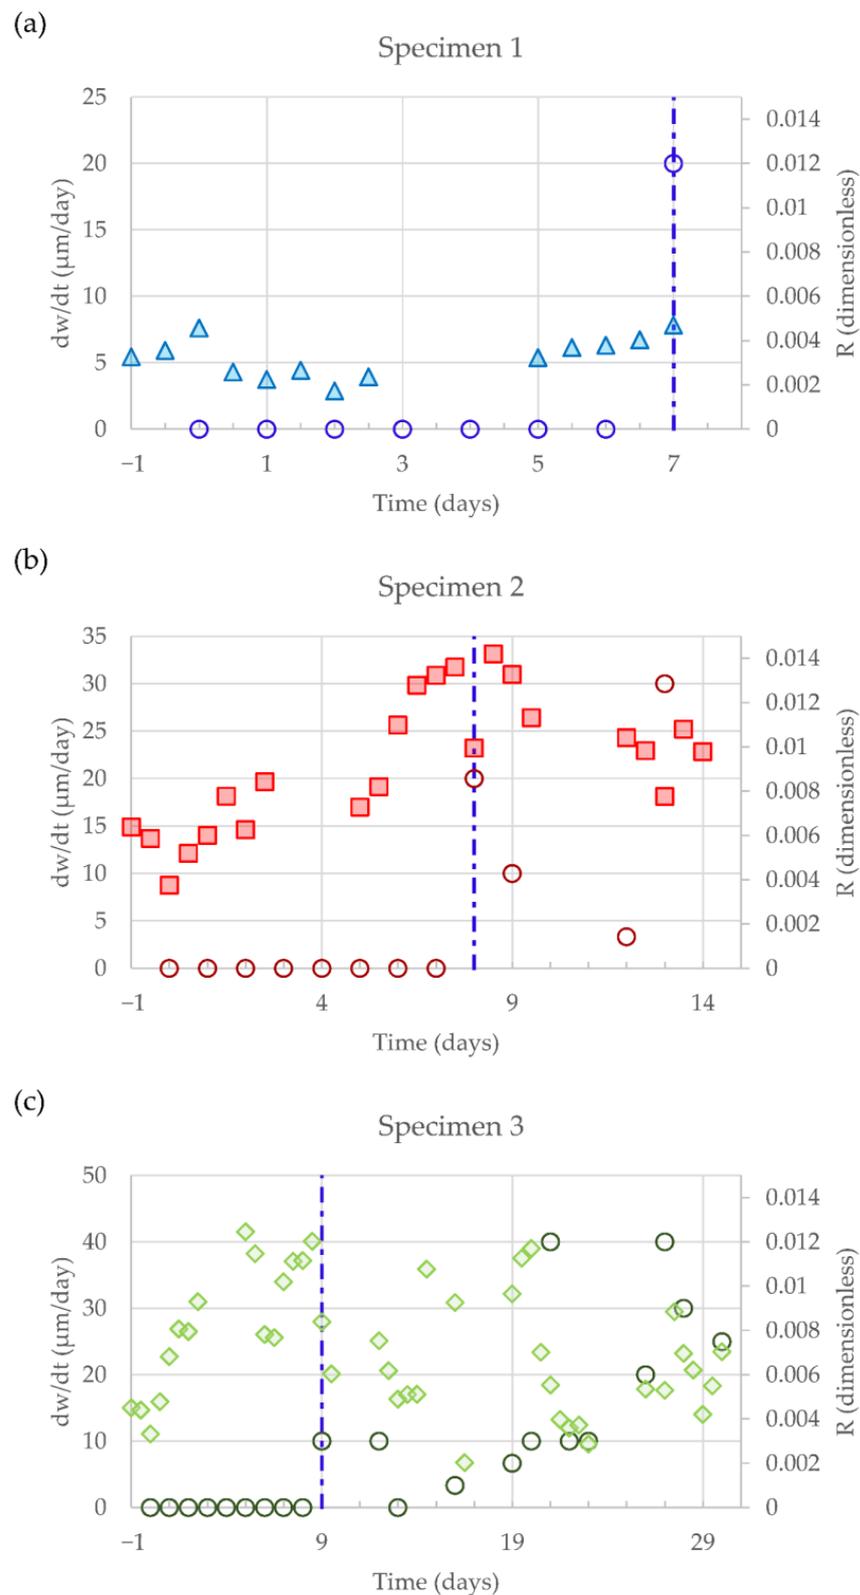
Figure 6. Correlation between the evolutions with time of dw/dt (circle symbols) and those of the intensity modulation ratio R : Δ , \square , \diamond . (a) Specimen 1; (b) specimen 2; and (c) specimen 3. The vertical line indicates the time of observation of the first surface crack.

The observations of Figures 6 and 7 are also in line with that of Figure 5. The intensity modulation ratio R also clearly starts showing increased values before the first appearance of a surface crack (Figure 6b,c) and before the sudden increases in the crack width observed, for instance, on the 20th day in Figure 6c. The only exception is represented by the behavior observed in Figure 6a. However, it needs to be taken into consideration that the experiment corresponding to Figure 6a was interrupted on the 7th day, just after the observation of the first surface crack and the specimen was broken to observe the incipient crack [47]. Hence, we do not have enough data allowing us to clearly establish the evolution of R in the case of specimen 1. A parallel discussion can be developed on the basis of data in Figure 7a–c. The *DIFA* parameter, defined in Equation (2), starts to decrease its recordings and reaches values close to zero a few days before the first appearance of a surface crack or before the sudden enlargements of the recorded crack width.

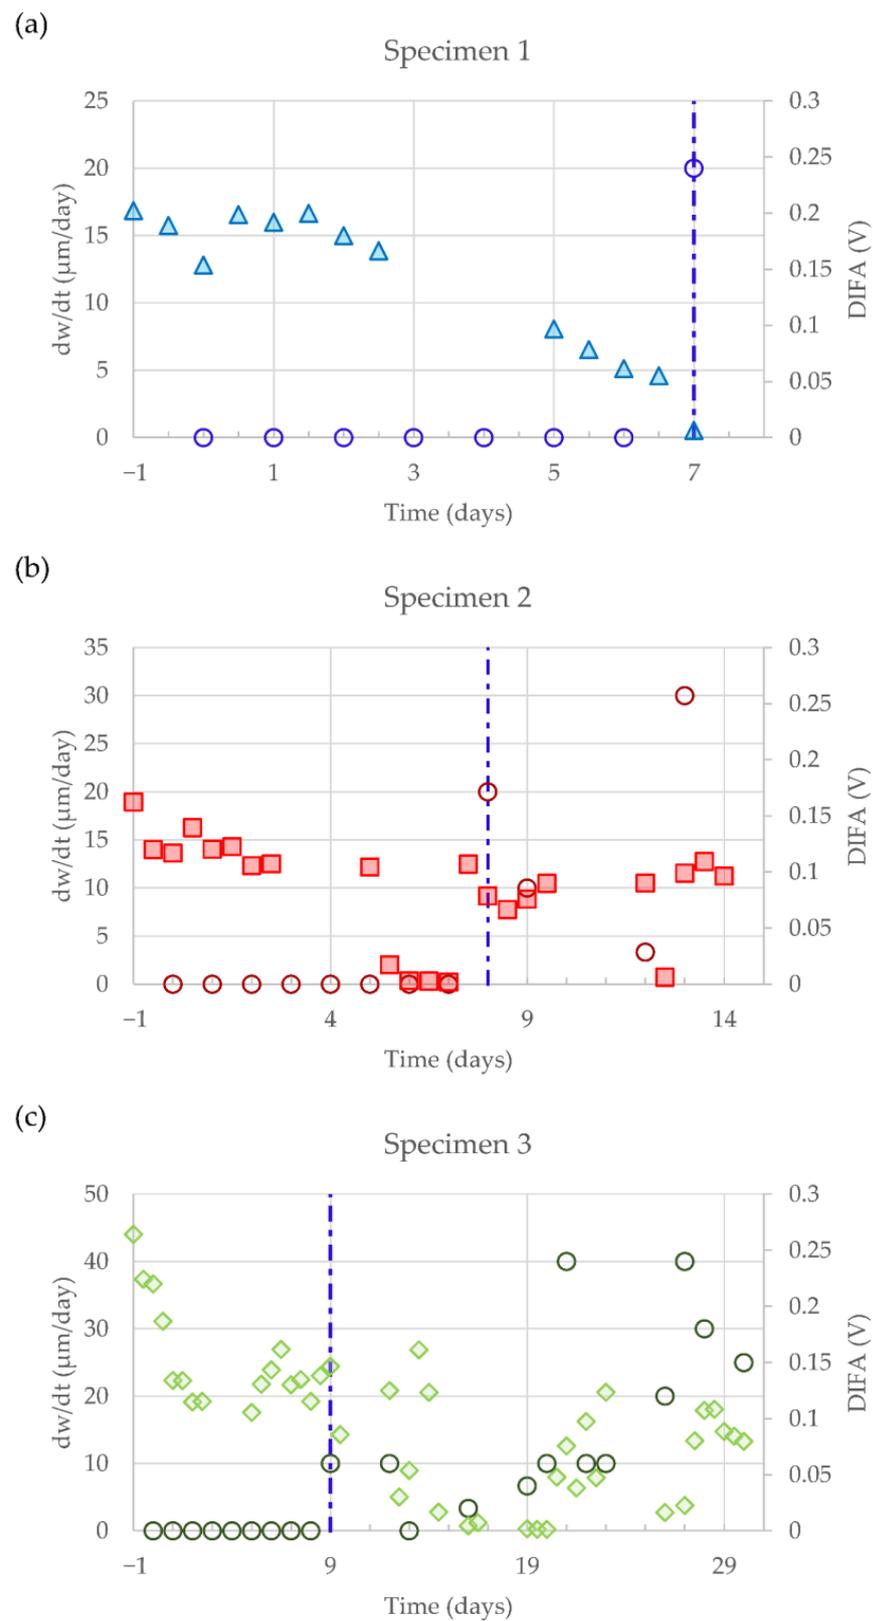
Figure 7. Correlation between the evolutions with time of dw/dt (circle symbols) and those of the DIFA parameter: Δ , \square , \diamond . (a) Specimen 1; (b) specimen 2; and (c) specimen 3. See Section 2.3. The vertical line indicates the time of observation of the first surface crack.

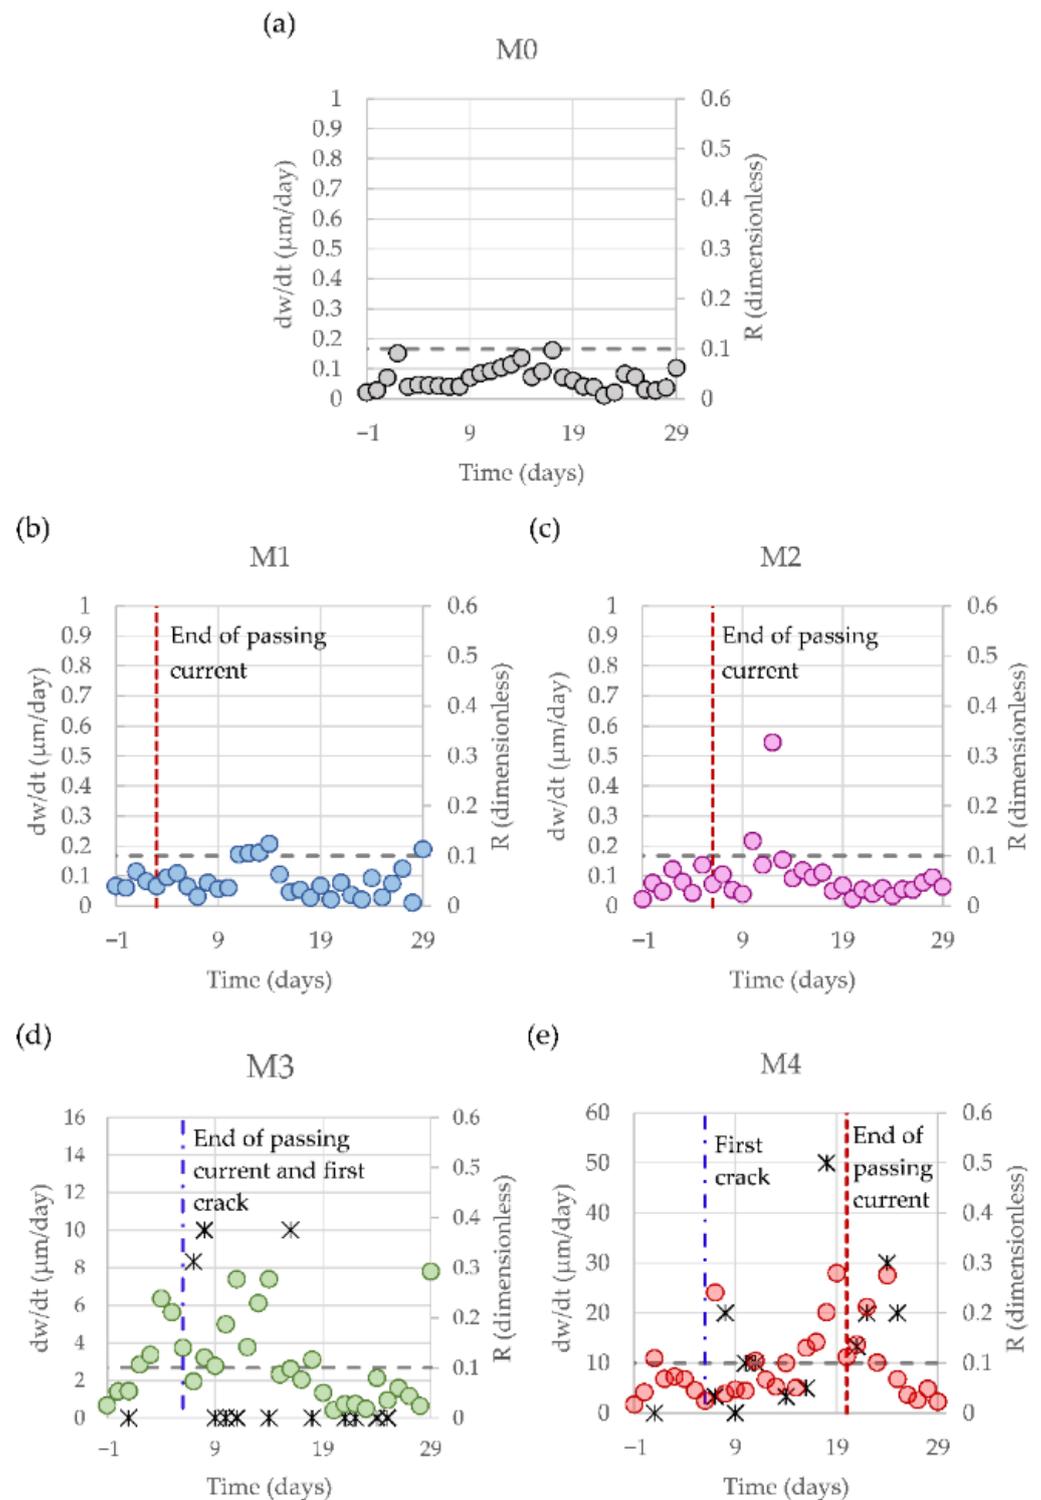
Figure 8. Correlation between the evolutions with time of dw/dt (* symbols) and those of the intensity modulation ratio R (circle symbols). (a) Specimen M0; (b) specimen M1; (c) specimen M2; (d) specimen M3; and (e) specimen M4. The vertical lines indicate the time of the end of passing current, and the time of observation of the first surface crack, which coincide in the case of specimen M3. The dotted horizontal lines correspond to a statistically established upper control limit for the initial (undamaged) R values [48].

Regarding the tests corresponding to specimens M0, M1, M2, M3, and M4 (second series of experiments), Figure 8 shows that their results are also in line with the observations of Figures 5–7. It must be taken into account that the data of Figure 8 correspond only to the central part of the tested specimens (see Figure 4). This means that the NLU data have been obtained with the transducers located in the middle part of the specimen (position 2 in Figure 4), and the crack width measurements have been performed just in this central zone. The rationale behind this decision is to avoid the unavoidable dispersion of results expected, if we mix in the same Figure the results corresponding to the three measuring areas in Figure 4. This dispersion would most probably hide any existing correlation between the evolutions of dw/dt and R . The dotted horizontal lines in Figure 8 correspond to a statistically established upper control limit (UCL) for the initial (undamaged) R values [48].

It is appreciable from Figure 8 that the values of R hardly obtained values over the UCL in the cases of the specimens that did not show any surface cracks during the tests (specimens M0, M1, and M2). On the other hand, for specimens M3 and M4, R values clearly exceeded the UCL a few days before the appearance of the first surface crack, or before any sudden enlargement of the crack width in the central part of the specimens.

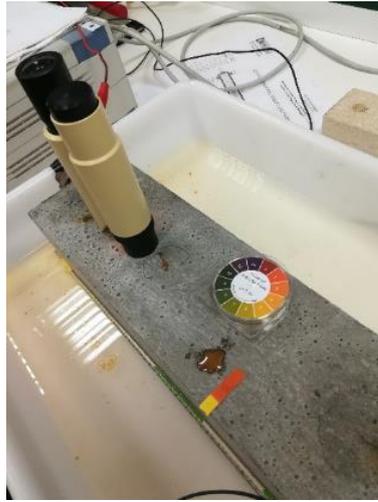
Figure 9. Photo showing the liquid leached out through the surface open crack in the course of the accelerated corrosion test. pH value of the liquid: 2 to 3.

One of the noteworthy observations obtained during the accelerated corrosion tests of the RCM specimens was the leaching out of a reddish liquid through the surface open cracks, Figure 9. The measured pH value of this liquid was about 2 to 3, in agreement with previous findings [46,49]. The only possible origin of the strong acidity of the leachate was the hydrolysis reaction of the main product of the anodic electrochemical reaction, i.e., the hydrolysis caused by the Fe^{2+} ions [72]:

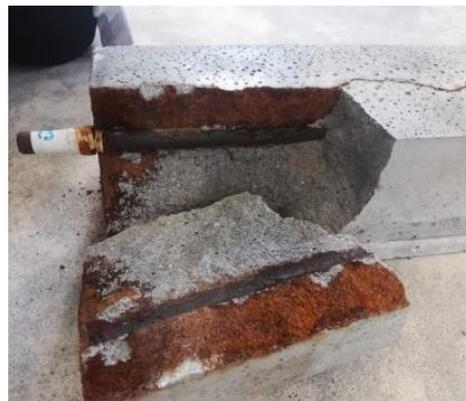
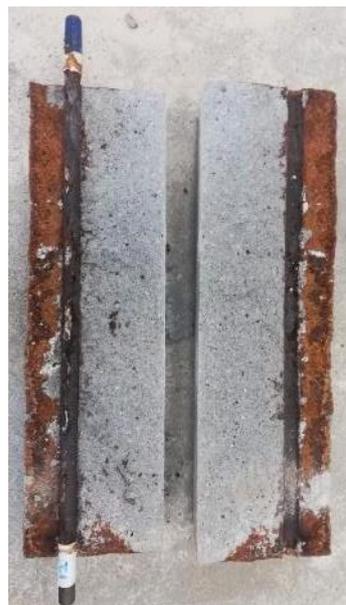
Figure 10. Photos showing the appearance of the split parts of an RCM specimen broken after finishing the accelerated corrosion test. The surfaces of the open crack reaching the upper surface are fully coated with the typical reddish-brown corrosion products of steel, while the region below the steel bar is free from corrosion products.

The images in Figure 10 clearly demonstrate the existence of a net mass transport of liquid from the bottom of the RCM specimen in contact with water to the upper surface (see Section 2.2). This net transport, which efficiently drags the steel corrosion products away from the rebar, is probably due to wick action [70]. Additional evidence of the mass transport process is the video produced by collecting photos taken by a webcam system focusing on the upper surface of one of the RCM specimens during some part of the accelerated corrosion test: the images were taken during a period of 39 h after the appearance of the first corrosion-induced surface crack, at a rate of one image every ten minutes (see Supplementary Materials [Video S1]).

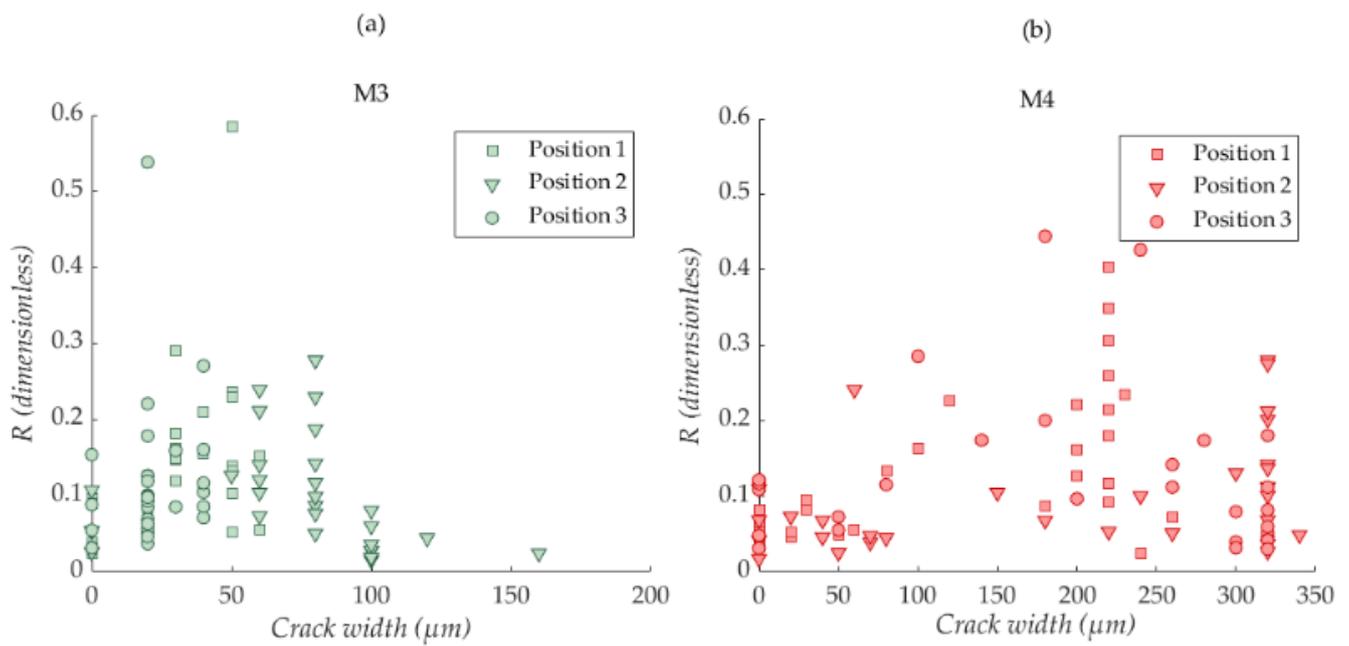
Figure 11. Correlations between the values of the R parameter and the crack-width measurements obtained during the accelerated corrosion tests. (a) M3 specimen and (b) M4 specimen. The results correspond to the three positions of testing on the upper surface of the specimens (see Figure 4).

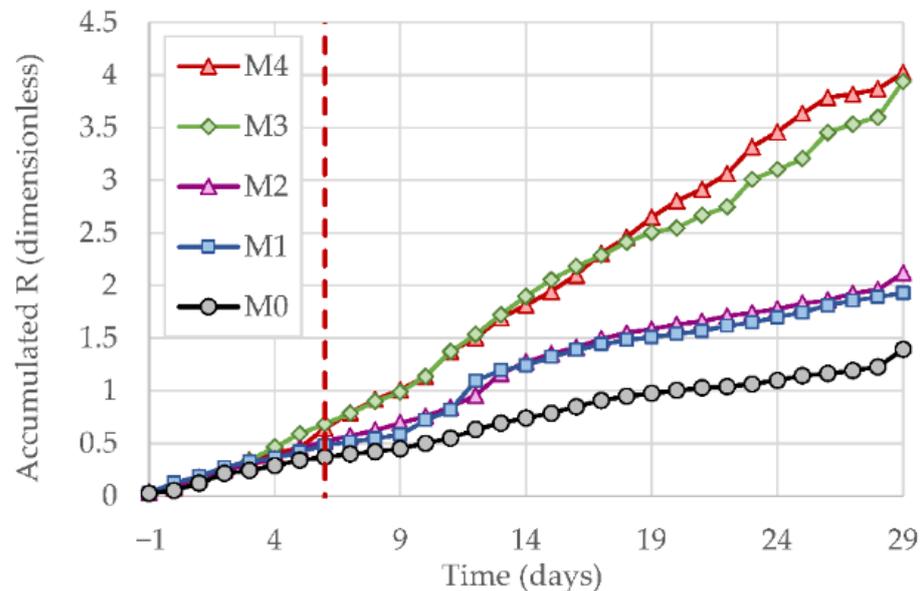
Figure 12. Accumulated values of the R parameter for the accelerated corrosion tests of the M0, M1, M2, M3, and M4 RCM specimens. The vertical line indicates the time of surface cracking for the M3 and M4 specimens; the rest of the specimens did not show any surface cracks.
