# Concrete Alkali–Aggregate-Reactivity-Induced Steel Reinforcement Corrosion

Robert E. Melchers \* and Henry Humphrey

**Abstract:** The alkali–aggregate reactivity (AAR) of concrete, long known for mass concrete, can also induce corrosion of steel in reinforced concrete structures. Several examples are given for which the origin of observed reinforcement corrosion and loss of concrete cover originally was attributed to chloride-induced or to carbonation-induced reinforcement corrosion. Critical reviews of these cases, using available information, suggest that, more likely, the observed crack patterns and concrete deterioration are the result of long-term AAR-induced concrete matrix expansion and loss of concrete strength and that these effects occurred prior to the eventual initiation of reinforcement corrosion. This proposition is supported by finite element and other stress analyses of various concrete–steel ensembles. They show that concrete expansion produces tensile stresses localised at and near exterior concrete surfaces or relative to the reinforcement. The locations of high-stress and -strain zones so produced correlate with field observations of long-term concrete crack

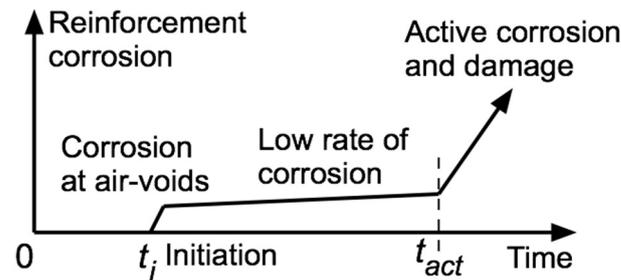
**Figure 1.** Typical development of reinforcement corrosion showing the separation of corrosion initiation and the slow development of long-term corrosion for good quality concretes, with definition of  $t_i$  and  $t_{act}$  [19].

The Yucatan reinforced concretes were all made, as noted, with local limestone as aggregate. As seen in Figure 1, provided the aggregates are not reactive, the use of limestone should have had the beneficial effect of extending the times to initiation ( $t_i$ ) and the time to active corrosion ( $t_{act}$ ) (Figure 2). But as noted, this does not appear to be the case both for on-land reinforced concrete structures and for the second Progreso pier. The likely reason lies with the character of the Yucatan limestones.

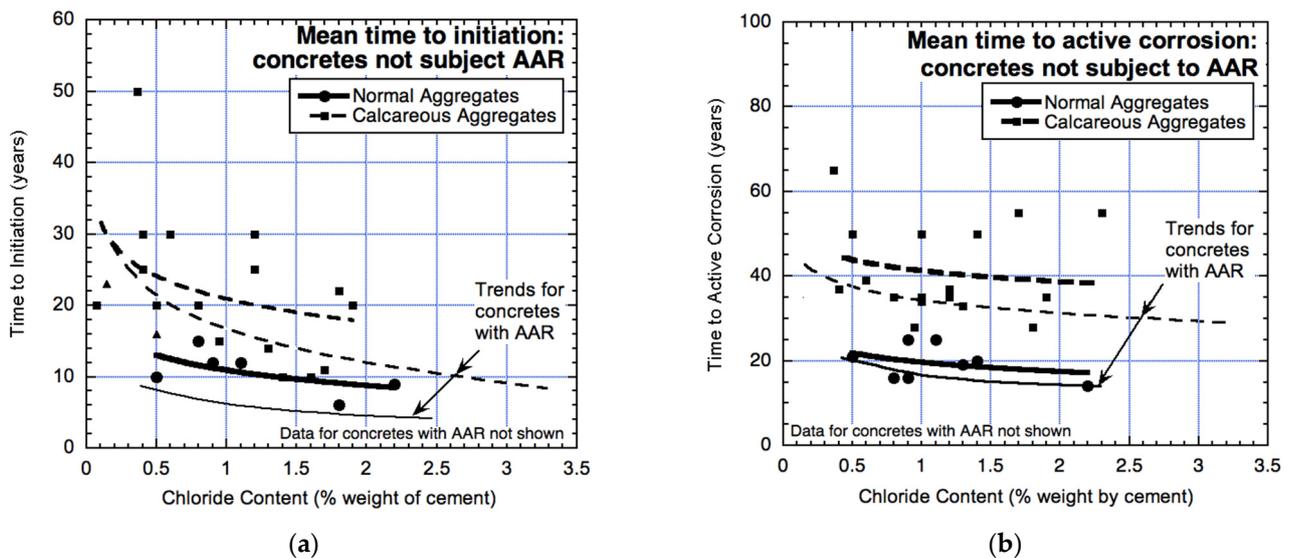
**Figure 2.** Data and trends for reinforced concrete corrosion (a) initiation time  $t_i$  and (b) time to active corrosion  $t_{act}$  for two different types of aggregate. Original data in refs. [17,20].

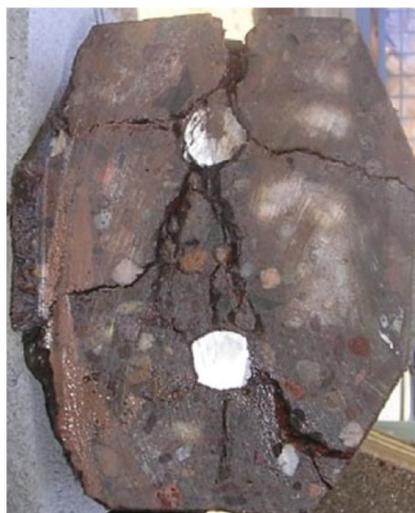
**Figure 3.** Colour-enhanced and sharpened-focus photograph in 2008 of saw-cut cross-section of reinforced concrete handrail likely made in 1968, showing very low volume of rust around the steel bars and extensive cracking [21].

Comparisons of the bridge piers in Table 1 show considerable differences in the severity of their deterioration, including when compared to the other cases, such as the second Progresso pier. Further, the deterioration at Arbroath (Figure 3) after 60 years is not unlike that of the oldest Georgia piers (50–60 years) and possibly the Sydney piers but more severe than the younger Georgia piers. More detailed comparisons between these cases is difficult owing to a lack of information about the aggregates used in each case and their reactivity. Nevertheless, the cases given above support the notion that the effect of AAR increases with longer exposures, as expected [9].

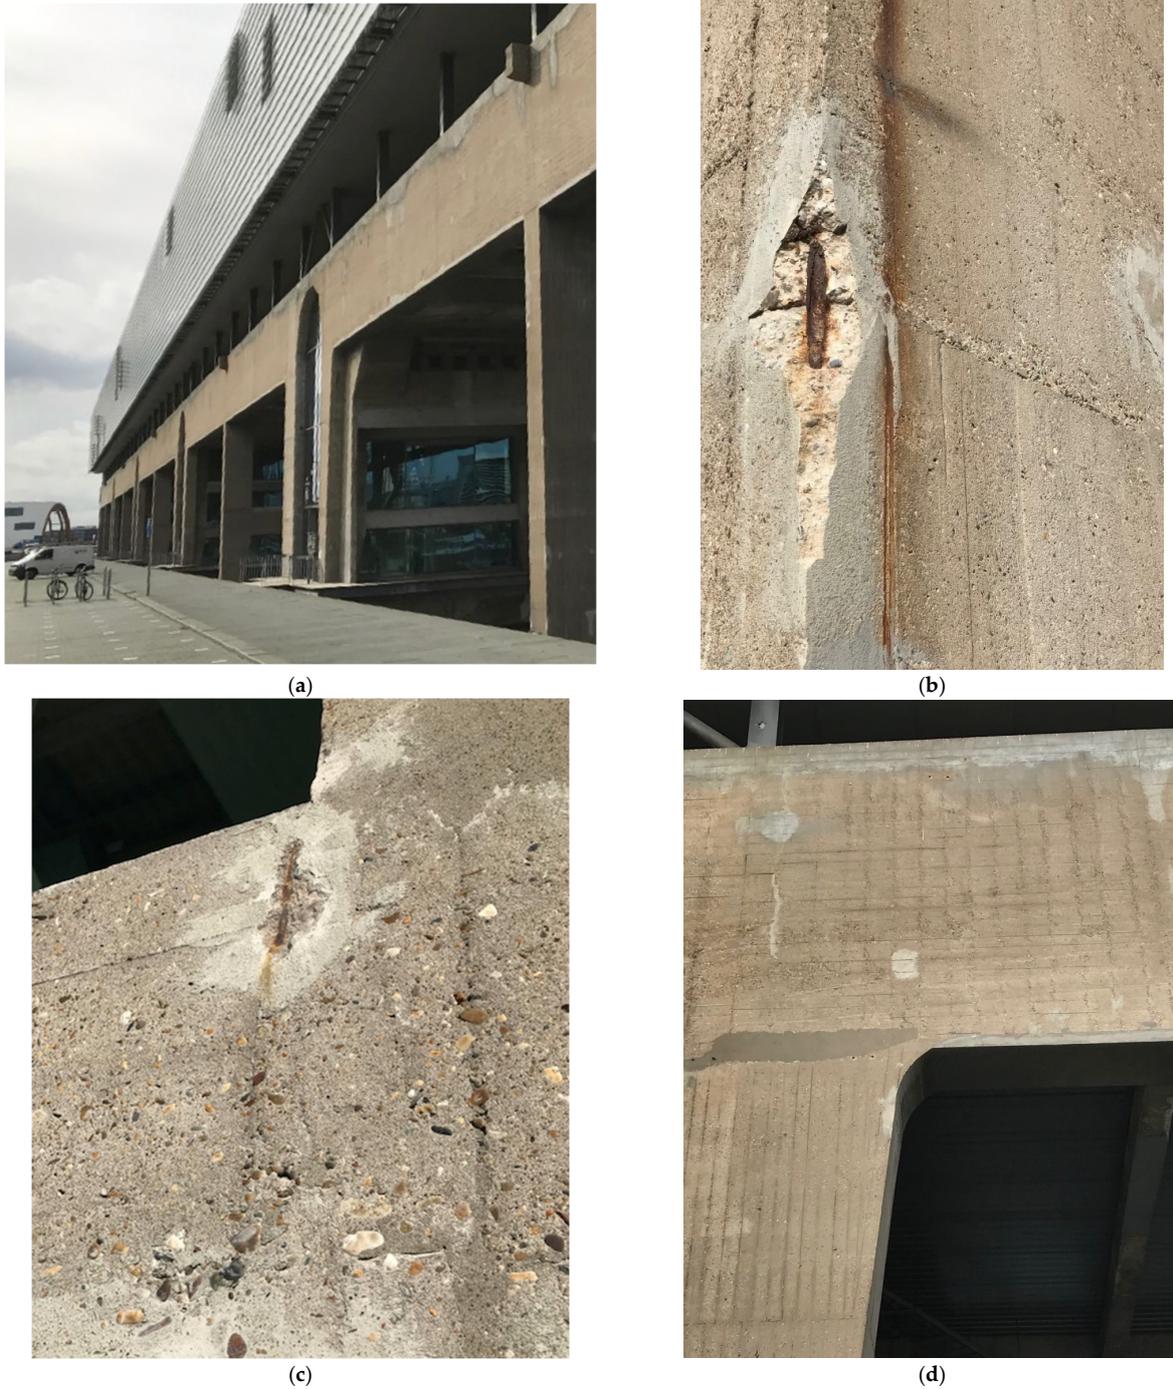
**Figure 4.** (a) Overview of 1950s Kraanspoor reinforced concrete structure with recently constructed superstructure (b,c) localised loss of concrete cover and reinforcement corrosion at corners of portal frame columns in 2019, showing some evidence of (unsuccessful) patch repair, (c,d) examples of flat off-form concrete surface showing alignment of the reinforcing bars underneath.

was forced to rely increasingly on aggregates sourced from the Ardennes in Belgium ([16], p. 26) and the North Sea and also on marine gravels such as porous chert, chalcedony, and impure sandstone sourced from the Meuse and the Rhine rivers. These aggregates all are known to be prone to AAR. It follows that almost certainly these were the aggregates used in the structural concrete of the Kraanspoor gantry and that potentially they and ASR are responsible for the observations in Figure 4.

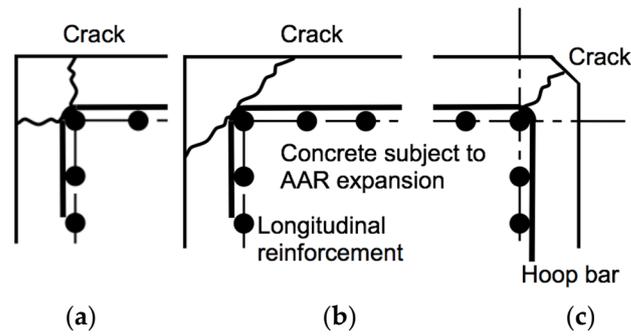
**Figure 5.** Schematic cross-section of a reinforced concrete pier with hoops showing typical field-observed longitudinal crack pattern (a) near the corners, (b) cracks causing loss of corner concrete cover, and (c) cracking through the corner chamfer.

As to why cracking of piers and other longitudinal objects affected by AAR tends to occur at and near the corners (Figure 5), it is necessary to consider differential movement between the interior of the concrete piers and that at the surface and also the effects of the reinforcement and the presence of stirrups in relation to the expanding concrete under the volumetric expansion action of AAR. The main reinforcement and the stirrups act in combination as a “cage” to offer restraint to the interior concrete. The concrete cover, on the other hand, is not restrained directly by this cage, although there could be transfer of (mainly shear) resistance between the interior and exterior concrete. Evidently, the cover concrete is able to expand laterally (as well as transversely) at a different rate to the constrained bulk concrete. To ascertain the effects of these different strain conditions, the structural response was modelled using a standard finite element analysis program. For convenience and simplicity, the expansion was modelled using an increase in temperature of the concrete (but not the reinforcement steel) to create the material expansion and the resulting stress distribution. Without considering the precise details, the overall result of the analysis, in terms of the triaxial stresses generated by the volume expansion of the concrete, are shown in Figure 6. This is for a typical pier in Table 1, with a 450 × 450 mm cross-section with 60 mm cover. It is evident that the high triaxial stresses correspond to the corner zones where the tensile cracks are observed for AAR-affected concrete.

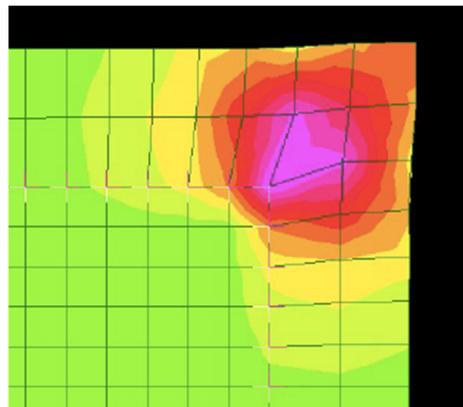
**Figure 6.** Triaxial stresses generated by the volumetric expansion of a reinforced concrete cross-section restrained by steel hoops, showing high stresses near and at the corners.

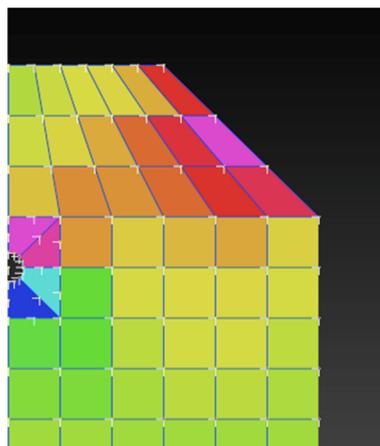
**Figure 7.** Schematic triaxial stress-state distribution for the upper right part of the reinforced concrete handrail in Figure 3 under the volumetric expansion of the concrete. The highest stresses occur at the top right quadrant surface (and at corresponding other quadrants).

A generally similar result is obtained if the cross-section is changed to that corresponding to the handrails at Arbroath. Figure 7 shows the results for the triaxial stresses generated under volumetric expansion of the concrete. In this case, there is no hoop reinforcement. Nevertheless, the regions of high triaxial stress correspond with the pattern of cracking where it reaches the surface of the handrail (cf. Figure 5).

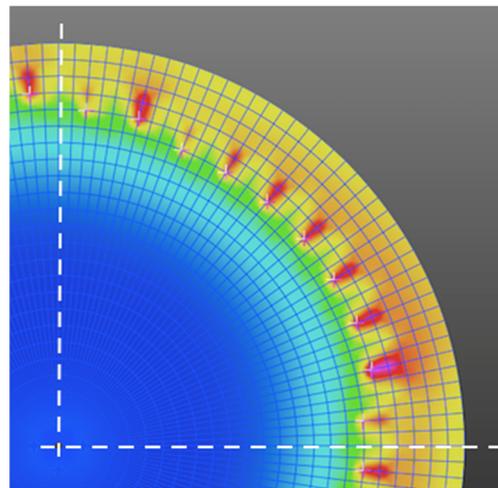
**Figure 8.** Plan section of a nominally circular reinforced concrete column or pier subject to expansion from AAR and the development of a tensile stress state (at right) resulting from non-perfect alignment of reinforcement within the circular formwork.

For circular columns, the stress analysis for volumetric expansion is elementary. It corresponds directly to that of a thin-walled pipe under internal pressure that generates a hoop (i.e., circumferential) tensile stress that, under idealised conditions, would be uniform around the circumference. In turn, for sufficient high tensile stress, this would result in fine uniform cracking all around the circumference. In practice, however, the concrete cover is unlikely to be precisely uniform around the circumference or of precisely the same tensile capacity. Thus, localisation of tensile stress and hence cracking is inevitable (Figure 8). Once commenced, such localized cracking is almost certain to extend longitudinally, causing isolated longitudinal cracking, as observed for practical circular piers, for example, those of the St. David highway bridge, Québec City, Canada [42].

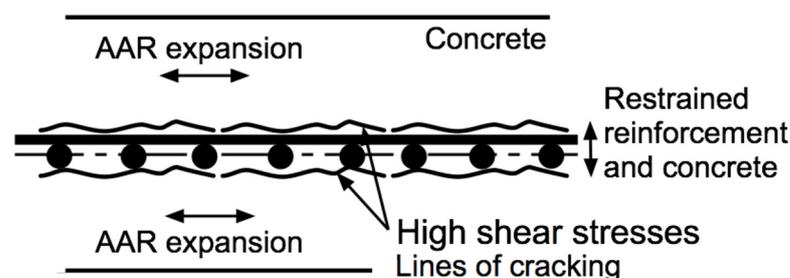
**Figure 9.** Plan section of reinforced concrete wall with centrally placed two-directional in-plane reinforcement, showing schematic strain states set up by expanding concrete enveloped by the two-way steel reinforcement and the generation of shear stresses in the concrete from the AAR-induced expansion as shown and resulting in cracking along the plane of the reinforcement.

Finally, the delamination of the concrete cover in the case of the two-way reinforced concrete walls and similar elements for Yucatan housing can be seen to follow a similar analysis, again based on concrete expansion. In this case, while the concrete will tend to expand in all directions under the influence of AAR, the steel reinforcement in contact with the concrete will tend to offer a degree of in-plane restraint to the expansion of the concrete in the direction of the reinforcement (Figure 9). If the concrete expansion is sufficient, the concrete shear capacity will be exceeded, and delamination will result. Obviously, this is an entirely different mode of delamination failure compared to that resulting from the build-up of rusts forcing the concrete laterally away from the reinforcement. The shearing pattern of failure along the plane of the reinforcement without significant build-up of rusts being required is consistent with the field observations of low to modest reinforcement corrosion [26].

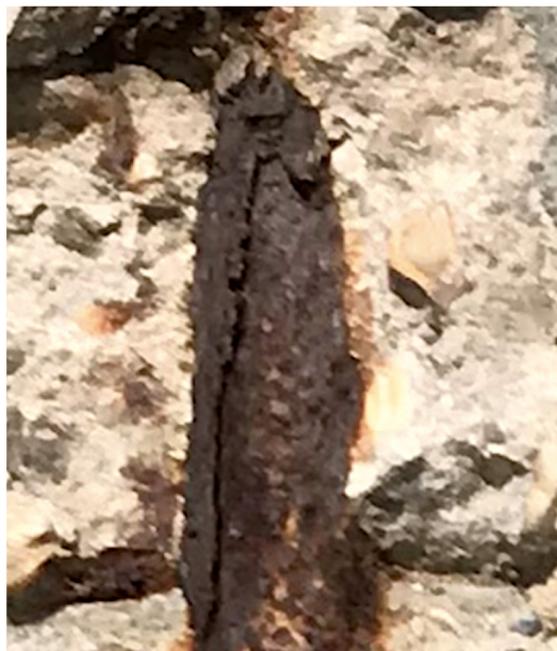
**Figure 10.** Close-up view of exposed reinforcement bar showing corrosion on the outer surface of the bar but negligible corrosion at the sides and negligible corrosion products into the concrete surrounding the bar (detailed view of bar in Figure 4b).
