Article

Archeoseismic Study of Damage in Medieval Monuments around New Delhi, India: An Approach to Understanding Paleoseismicity in an Intraplate Region

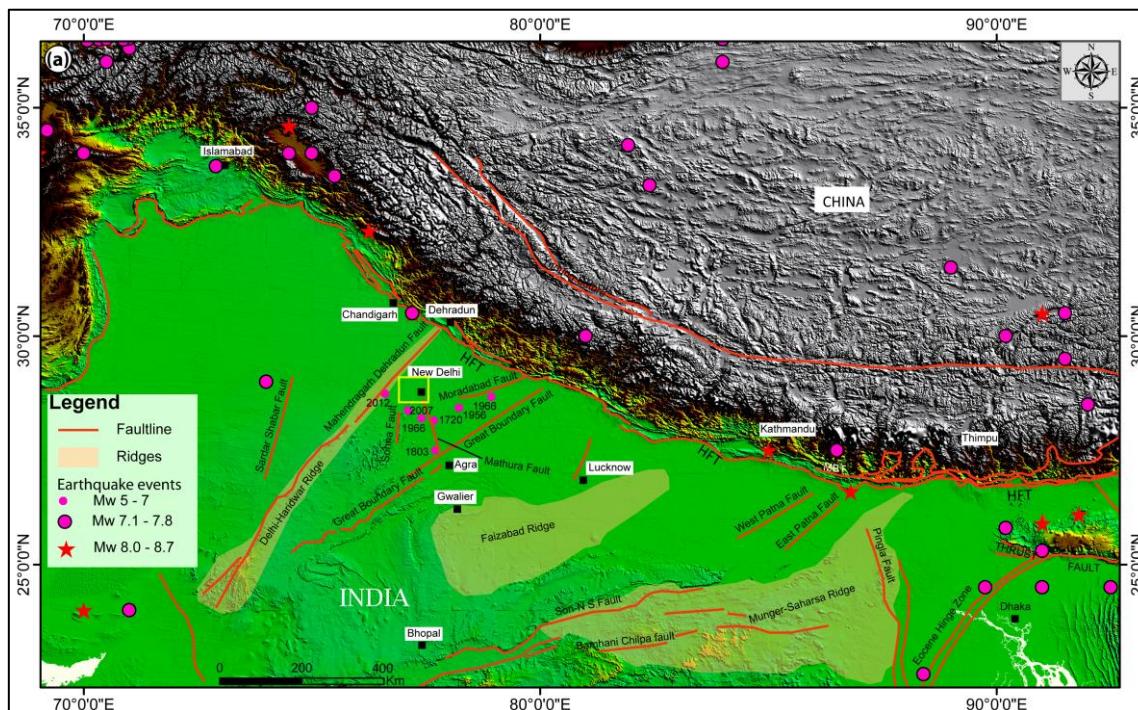
Figure 3. Seismotectonic map showing the major structural features around the Indo-Gangetic Plain, including the major structural features around Delhi. The map also shows the distribution of major earthquakes that were felt around New Delhi from near-field and far-field sources. The year mentioned in the figure indicates the timing of the earthquake [Modified from [37,89]].

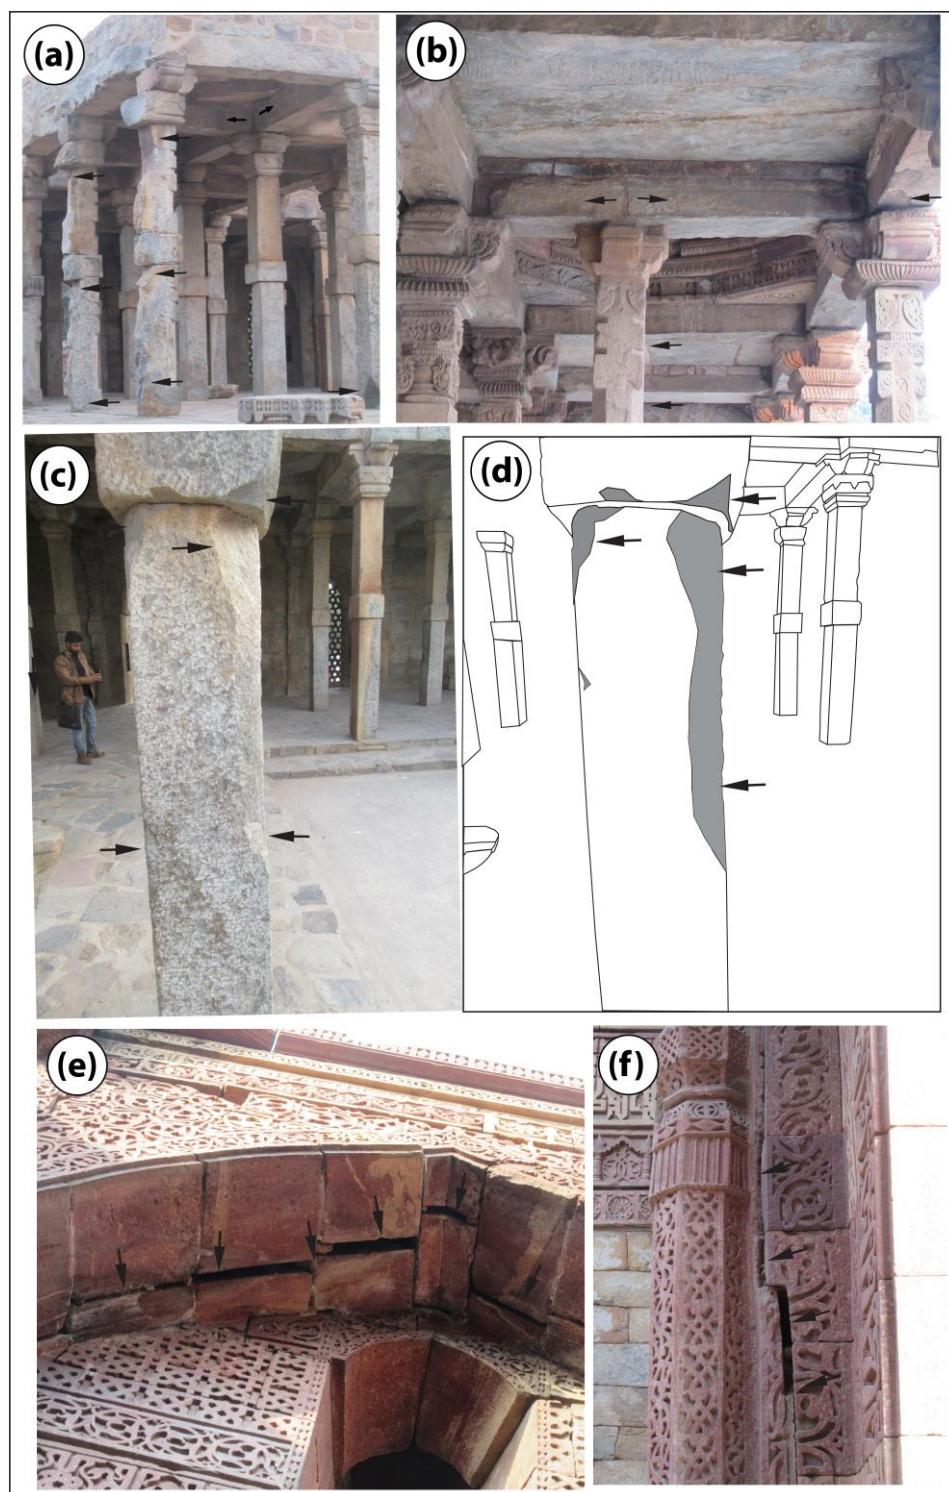
This study recorded several earthquake-induced damages around the Quwwat-ul-Islam mosque and the Iltutmish Tomb within the Qutab Minar complex (Figure 4). The Quwwat-ul-Islam mosque was erected between 1192, the conquest of Delhi, and 1198 when the building was completed by Sultan Muizuddin ibn Sam. The mosque was built upon the remains of different Hindu temples. The following ruler, Shamsuddin Iltutmish (1211–1236), doubled the size of the mosque in 1230 by extending its colonnades outside the original enclosure (photos were taken in this later part). The result was that the Qutab Minar fell within the mosque enclosure. A later Delhi sultan, Alauddin Khalji (1296–1316), again extended the mosque substantially by enlarging the enclosure. His major contribution was adding the two massive gateways. During our systematic archeoseismic damage survey around the Quwwat-ul-Islam mosque, we observed that the upper elements of two composite columns (left) bear axial fractures (Figure 4a,b).

Figure 4. Damage observed around Quwwat-ul-Islam mosque, Qutab Minar complex. (a) Upper elements of two composite columns (left) bear axial fractures; (b) stone beam connecting three columns was fractured in the middle, right above the central column; (c,d) photograph and line diagram showing the edge of column fractured parallel with the long axis, typical fracture caused by repeated hammering of the ashlar above (arrows); (e) out-of-plane shift in arch masonry blocks separated by a more than 5 cm wide gap near the top of the entrance arch of the northern gate in the Iltutmish Tomb, Qutab Minar complex in Delhi; (f) opening of wall decoration a few centimeters large at north gate in the Iltutmish Tomb, Qutab Minar complex in Delhi.

These were caused when the block above repeatedly hit the columns during earthquake-induced shaking. The lower elements of the same columns bear deeply fractured oblique edges. These were created when the rectangular block above hit them during shaking. Within the same mosque, the stone beams connecting the three columns were fractured in the middle, right above the central column. Horizontal stone beams are damaged easily, but not when right above a strong supportive pillar. This is a clear indication that the differential vibration of the central column caused the failure (Figure 4a,b). In many places, the edge of the column was fractured parallel with the long axis. This is the typical fracture caused by the repeated hammering of the ashlar above due to strong shaking (Figure 4c,d).

Iltutmish's Tomb was built by Shamsuddin Iltutmish for himself in 1235, who ruled during 1211–1236 (Figure 2). Iltutmish's Tomb is a cubic building with dimensions of about 13×13 m in plain view and with a height of 9 m in its present state. The walls are 2 m thick and made of light-brown-colored sandstone. The tomb shows evidence of major restoration, which can be observed due to the modification of the original richly carved portions with later undecorated walls. At the top of the tomb, we observed 5 cm wide gaps, which are due to the out-of-plane shift in the masonry blocks (Figure 4e,f). This kind of shifting can be observed during an earthquake of intensity IX [17]. Since both the Qutab Minar and the Tomb of Iltutmish are located within the same archeological complex and are around 500 m apart, it can be inferred that both were damaged during the 1803 CE earthquake. Similar damage features have been documented at various earthquake-hit sites worldwide (Table 2).

Therefore, the observed damage, such as dipping broken corners or chipping, broken beams, and out-of-plane shifts in the stone blocks at the Qutab Minar and Humayun's Tomb complexes, are of seismic origin. The Qutab Minar is considered a seismoscope for the Himalayan earthquakes that have affected the Indo-Gangetic Plain region.

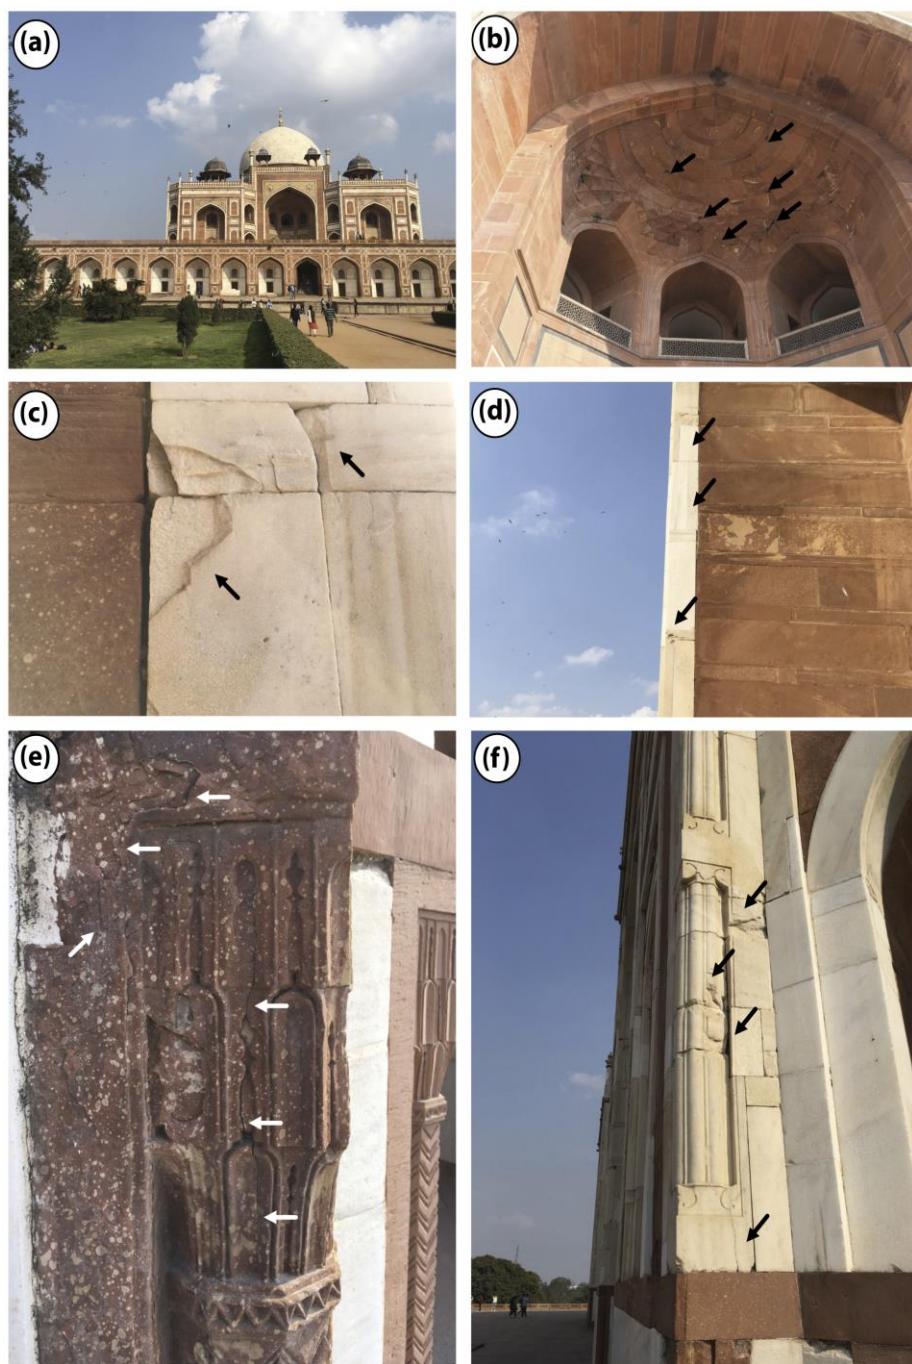
Figure 5. (a) Humayun’s Tomb (taken from <https://www.delhitourism.gov.in/> (accessed on 30 October 2023); (b) the red sandstone in the central cupola with corner break-outs indicated by black arrows; (c) marble application at main entrance has corner break-outs (black arrows); (d) chamfered marble edge on the western corner with corner break-outs (black arrows); (e) dotted red sandstone with fractures and deformation (white arrows); (f) the western corner with corner break-outs in marble (black arrows).

We noticed earthquake-induced damage to the main cupola (Figure 5b–f). The red sandstone of the main copula shows fractures along its corner. The white marble blocks used at the main entrance also show chipped corners. The corner marble pillars of the main structure show fractured edges, whereas the red dotted sandstone blocks used for the artwork on the main complex corners show differential fractures at the centers and corners. The gate artwork was made of alternate white and reddish stones. The reddish stone blocks at the edges fractured along their long axis (Figure 6a,b), which is a typical damage type observed due to the repeated hammering of the blocks during earthquakes. Similar damage features were documented at various earthquake-hit sites worldwide (Table 2).

The damage observed at Humayun's Tomb and Isa Khan's Tomb, built in the 1560s and 1547–1548 CE, could have been caused by both the 1720 and 1803 CE earthquakes. However, the damage observed in the other two monuments in Delhi is well constrained, and the 1803 CE earthquake is the main candidate earthquake for such damage. The distance between the Qutab Minar complex and Humayun's Tomb is nearly 10 km. So, if the 1720 earthquake caused seismic damage to Humayun's Tomb and Isa Khan's Tomb, why did it not cause damage to the Qutab Minar? The Jantar Mantar had not been constructed yet. Was it a local event, and did the monument face more shaking than a far-field event

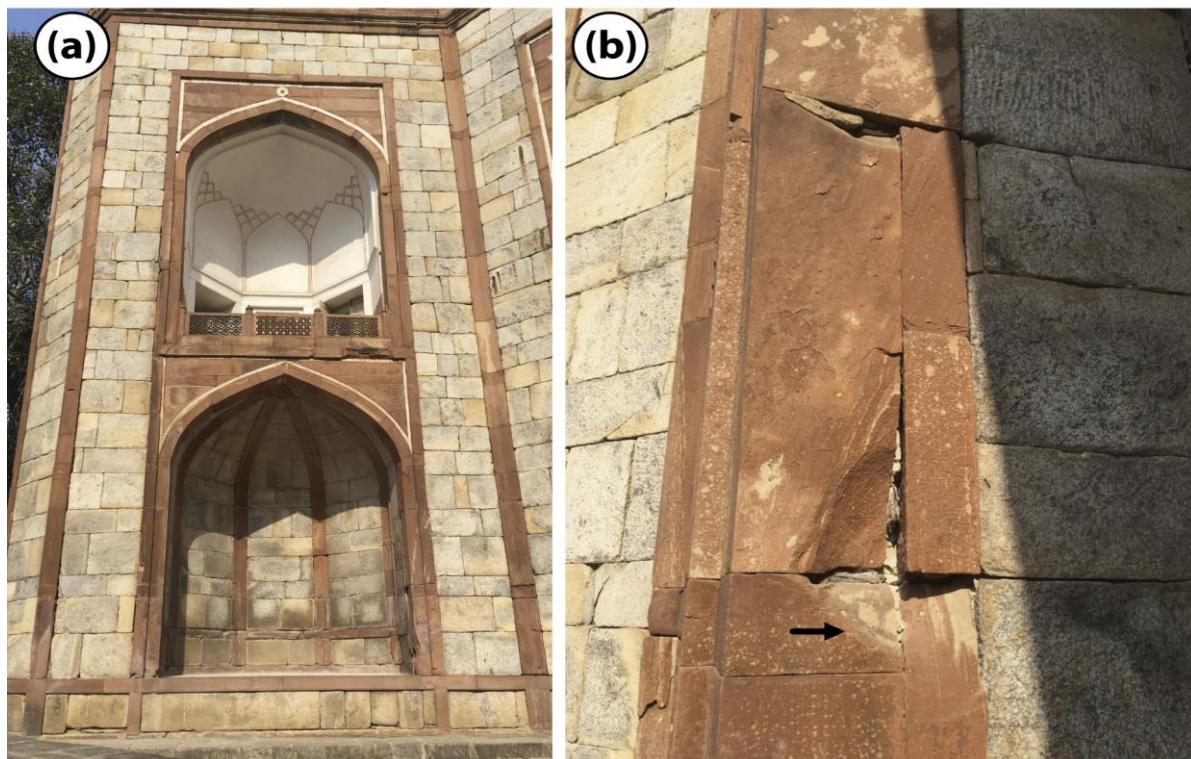
by pillared kiosks (chhatris), and the domes of the central chhatris are decorated using glazed ceramic tiles. The archeoseismic survey suggests that previous earthquakes have damaged the entrance gate of Humayun's Tomb.

Figure 6. (a) Damage to the entrance gate of Humayun's Tomb; (b) the reddish stone block fractured at the corner due to the repeated shaking, detail indicated by black arrow.

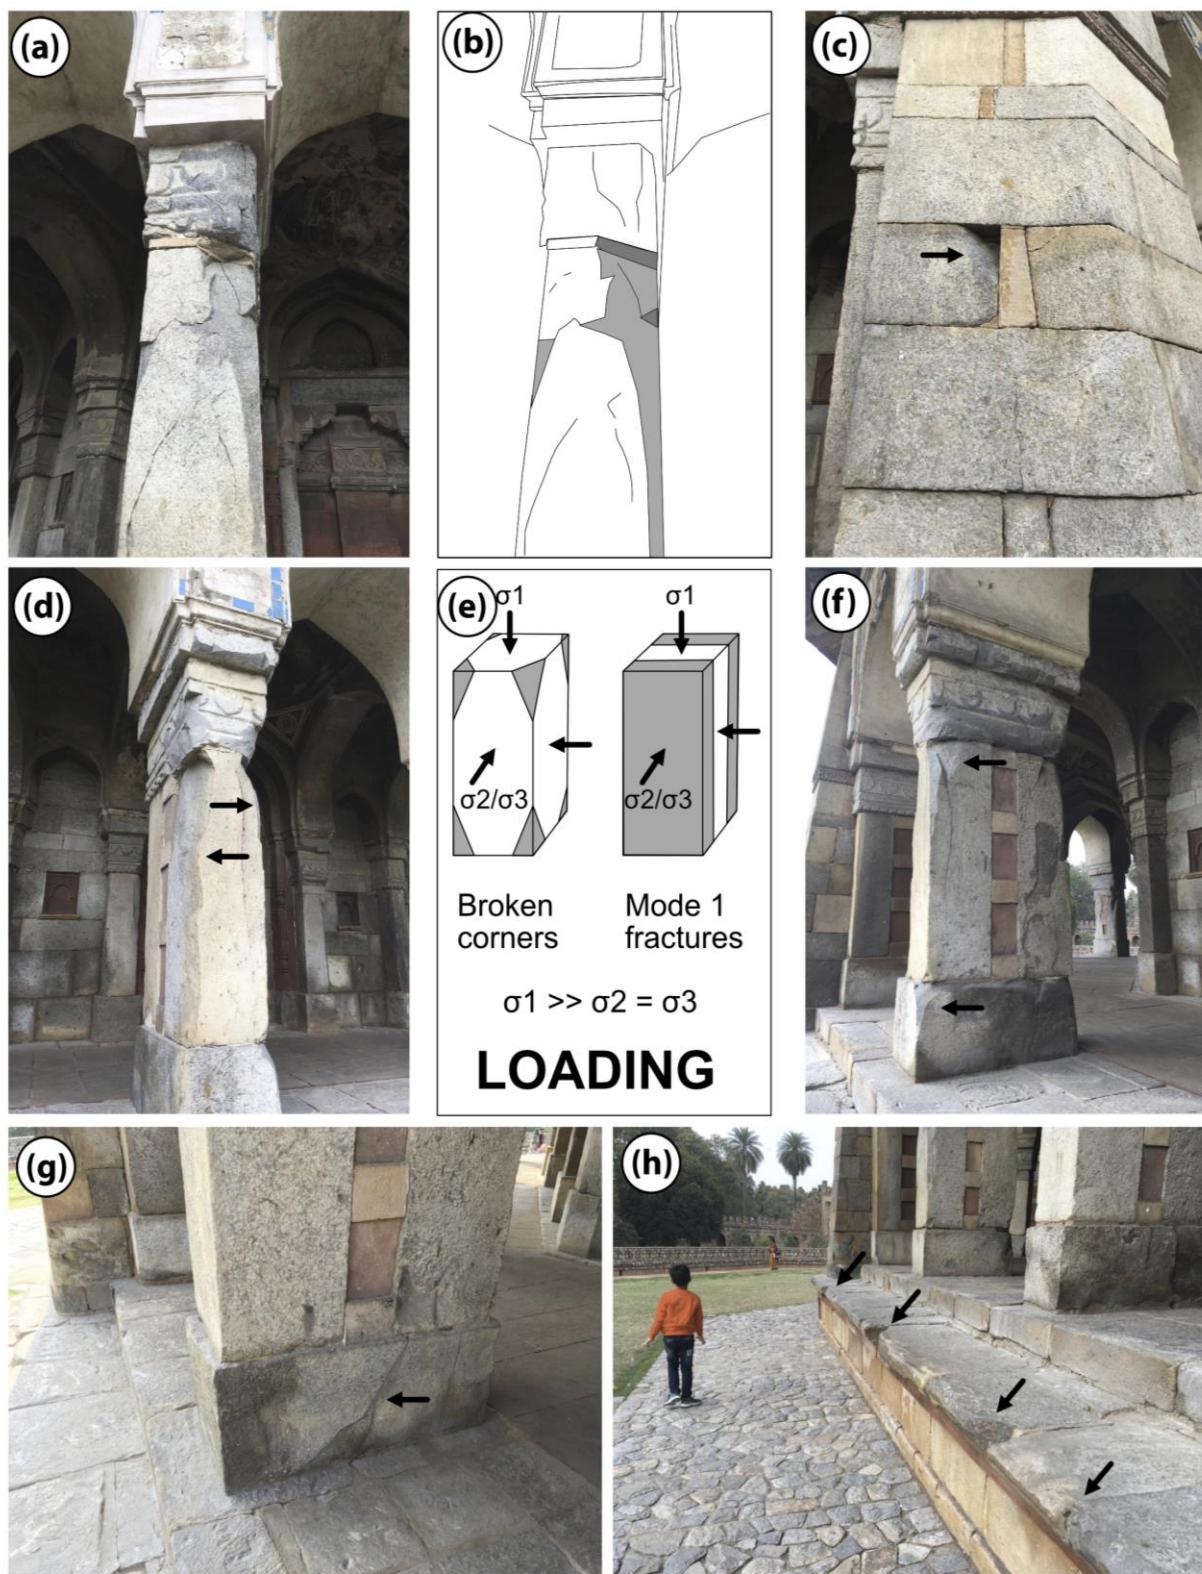
Figure 7. Archeoseismic damage observed around Isa Khan’s Tomb; (a) classical fracture pattern in a granitic column; (b) sketch of photo in (a); (c) corner break-out in a granitic block (arrow); (d) mode 1 fractures (without confining pressure) in granitic column (arrows); (e) center—explanation for the cracks; (f) mode 1 fractures in granitic column (arrow) induced by vertical loading forces; (g) crack in a granitic foundation block (arrows); (h) corner break-out in granitic block tiles (arrows).

The detailed damage survey suggested that several damages to features across the tomb are of seismic origin, such as chipped corners; displaced arches and edges of masonry blocks; tilted, broken steps; collapsed stairs; and extensional gaps (Figure 7a–h). We have interpreted that the dipping broken corners or chipping may indicate vertical or rotational motions associated with seismic waves [14,62]. The fractured walls could be the consequence of repeated shear movements due to intense shaking during an earthquake (Figure 7g). We interpreted that the broken corners of the stone columns not only in Isa Khan’s Tomb but also in the Quwwat-ul-Islam mosque, Iltutmish’s Tomb, and Humayun’s Tomb are the result of maximum compressive stress (σ_1) changes to the vertical stress at the surface due to seismic waves and repeated shaking during seismic wave amplification or passage through the ground (Figure 7b,e). Similar damage features were documented at various earthquake-hit sites worldwide (Table 2).

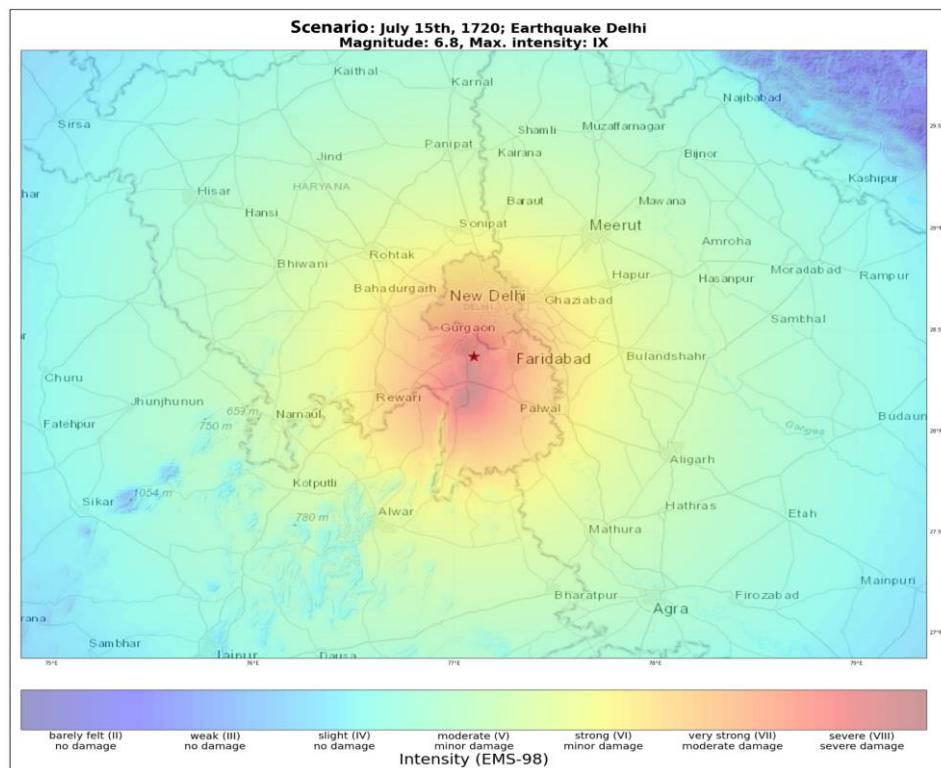
With the available information on the epicentral locations and magnitudes of these three earthquakes as documented in the literature, we created ShakeMap earthquake scenarios for the years 1720 CE, 1803 CE, and 1960 (Figures 8–10). The paleo ShakeMaps we generated illustrate the shaking intensity at various locations surrounding New Delhi. Specifically, for the 1720 CE earthquake, the ShakeMap indicates intensity values of VIII in the Gurgaon area, while New Delhi experiences intensity VII. Likewise, in the case of the 1803 CE earthquake, Mathura exhibits a higher intensity level of VIII, whereas New Delhi registers an EMS-98 intensity of V–VI. For the 1960 Gurgaon earthquake, both New Delhi and Gurgaon display EMS-98 intensity levels of VII–VIII.

Figure 8. Paleo EMS-98 ShakeMap for the 15 July 1720 Delhi earthquake, which shows higher intensity of VIII around Gurgaon and intensity of VII–VI around Delhi.

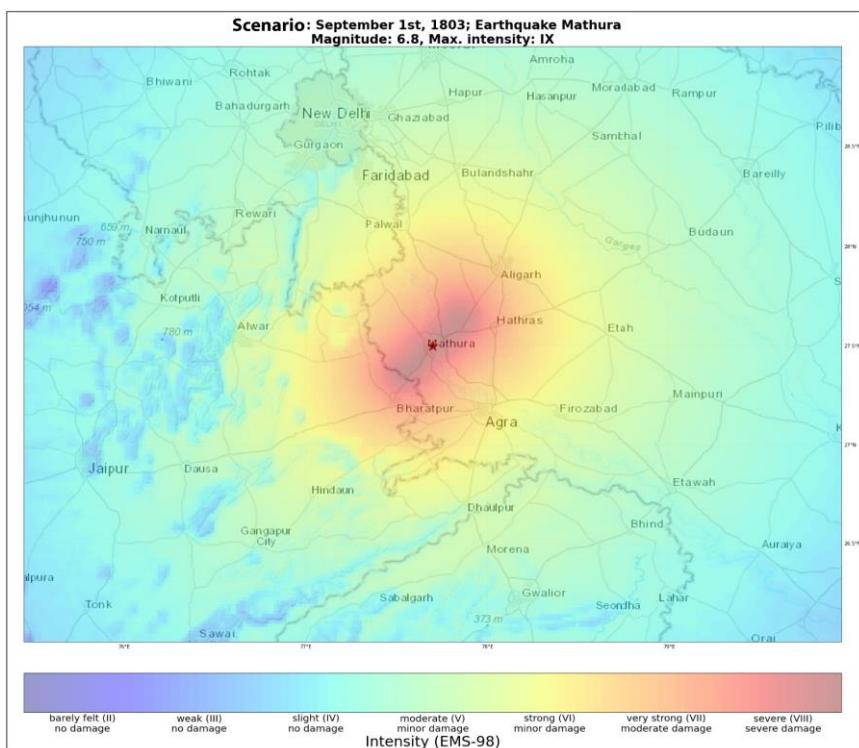
Figure 9. Paleo EMS-98 ShakeMap for the 1 September 1803 Mathura earthquake, which shows higher intensity of VIII around Mathura and Bharatpur and intensity of IV–V around Delhi.

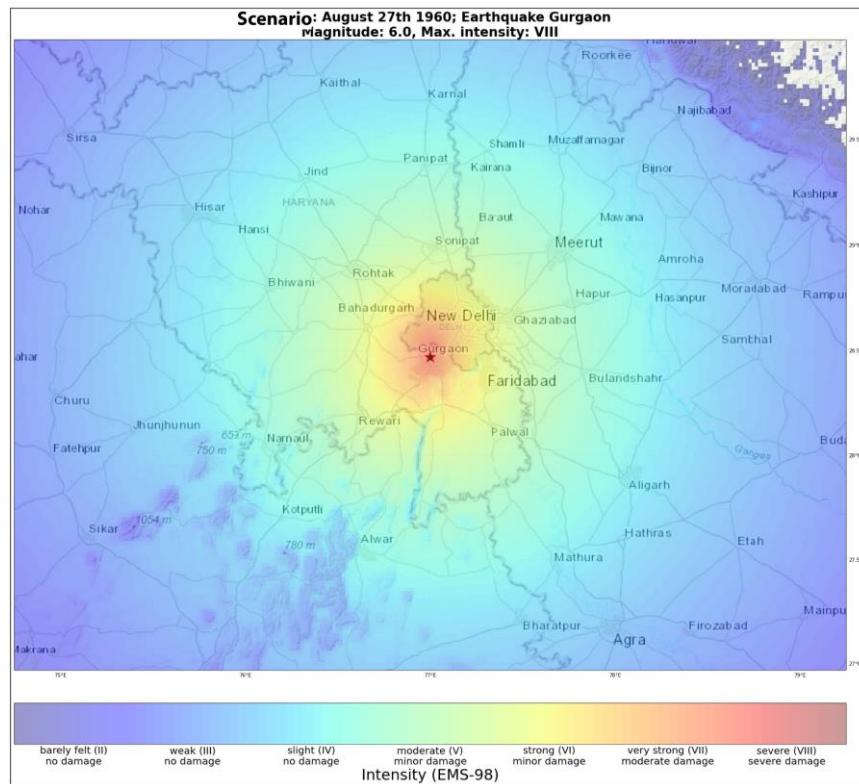
Figure 10. Paleo EMS-98 ShakeMap for the 27 August 1960 Gurgaon earthquake, which shows higher intensity of VIII–VII around Gurgaon and Delhi.
