Review

Surface Waterproofing Techniques: A Case Study in Nova Lima, Brazil

A case study was conducted in a residence located in Nova Lima, Minas Gerais State, Brazil. The construction in question comprises structural masonry, two floors, and a waterproofed slab roof. The project included solar and photovoltaic heating, air-conditioning infrastructure, a sound system, an electric car-charging point, a swimming pool, and a fireplace.

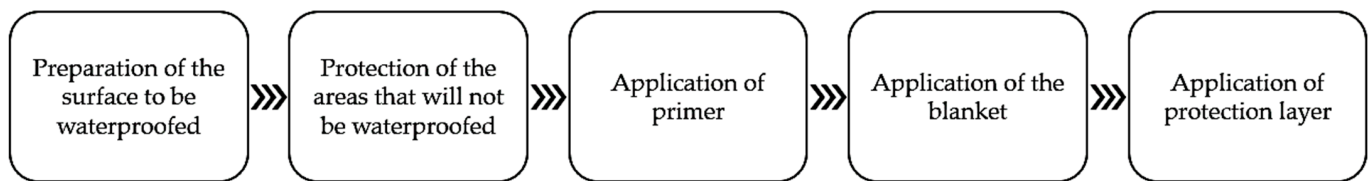
Figure 1. General stages of waterproofing with asphalt blankets.

blankets over the surface to be waterproofed, forming a continuous and water-resistant layer [4,6]. Figure 1 shows the main steps of this technique [22].

The first stage consists of the adequate preparation of the surface to ensure the adherence of the asphalt membrane. This includes cleaning the surface, removing loose or poorly adhered parts, leveling, and smoothing imperfections.

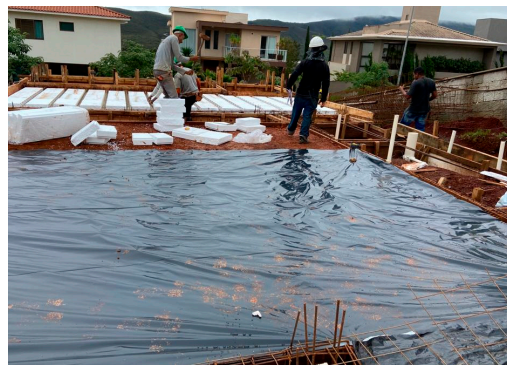
Figure 2. Application of tarp on the floor before the concreting.

When the first slab was made, supported on the ground at the beginning of the project, it was necessary to waterproof the contact between the concrete and the soil to avoid the capillarity phenomenon. The first waterproofing was conducted using a 150-micron tarp (Figure 2), thicker than an ordinary tarp, usually with 50 to 100 microns, and, therefore, offering a better performance and useful life. After applying the tarp, EPS (expanded polystyrene) sheets were placed over it (Figure 3) to increase the distance between the ground and the concrete, and to take advantage of the characteristics of EPS, which is highly resistant to mold and moisture. The tarp method was also used under the concrete ramp for vehicle access to the upper garage (Figure 4) to avoid capillarity between soil and concrete.

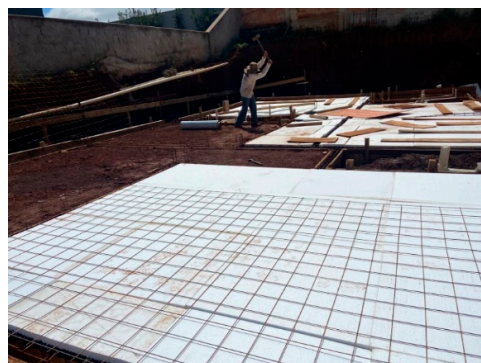
Figure 3. Positioning of EPS plates.

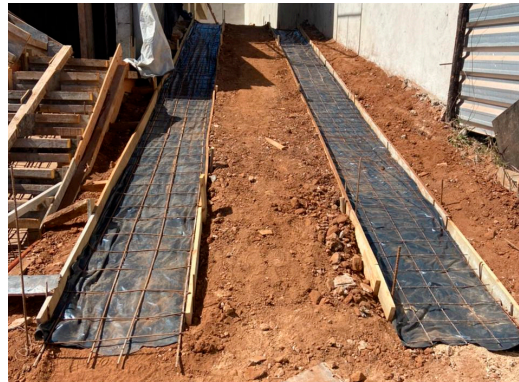
Figure 4. Application of tarp on the ramp floor before concreting.

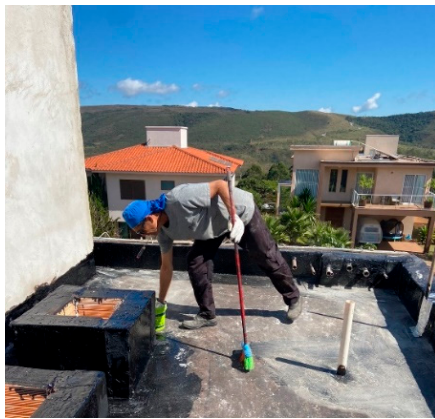
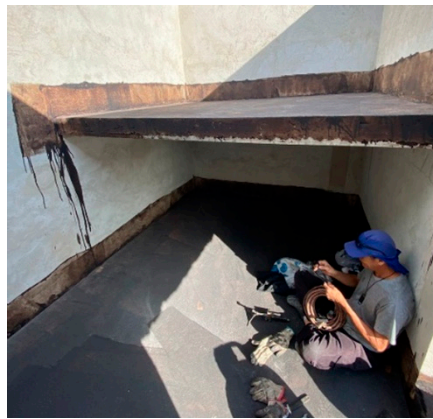
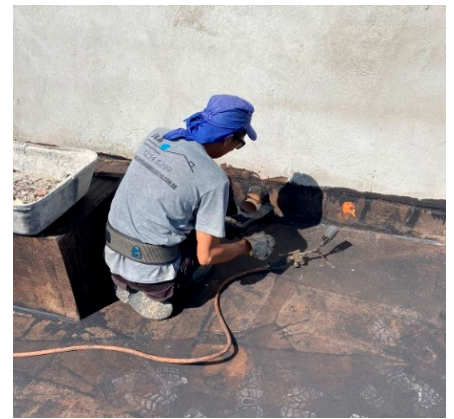
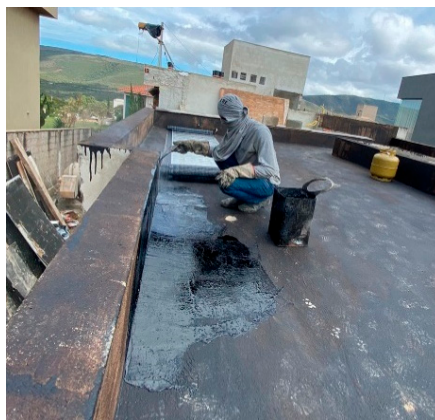
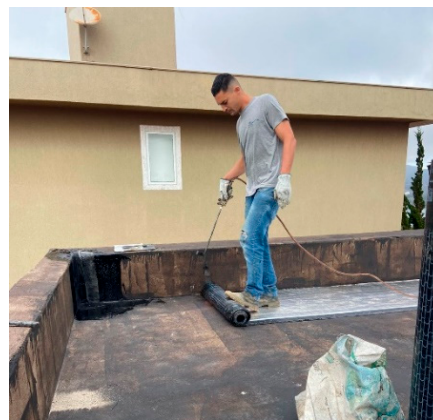
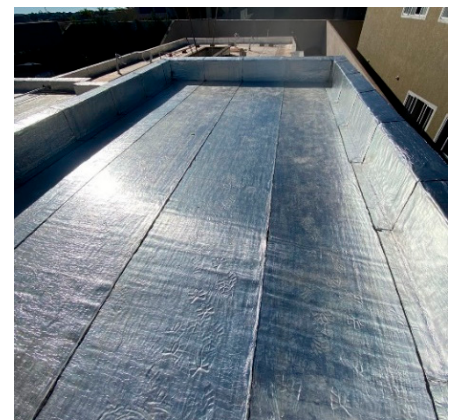
Figure 5. (a) Primer application on the slab; (b) primer application in water tank room; (c) use of a blowtorch to melt the modified asphalt; (d) application of modified asphalt to receive the blanket; (e) positioning of the blanket roll on the slab; and (f) aluminized asphalt blanket applied on the slab.

After this process, a primer composed of polycondensed asphalt cement diluted in solvents is applied (Figure 5a,b), which increases the adhesion between the asphalt-based waterproofing system and the surface. With the primer applied, modified asphalt sheets are heated to dissolve and apply them, thus, beginning the process of adherence of the asphalt mats to the surface (Figure 5c,d)—although not detailed above, applying a hot layer is usually required for the blanket application. The professional distributes the roll of the mat on the slab and uses a blowtorch to ensure the adherence of the mat and the modified asphalt to the surface (Figure 5e).

After the blanket application is completed on the entire slab (Figure 5f), it is necessary to wait for drying time and perform the water-tightness test. This test aims to verify the effectiveness of the blanket applied and correct any details, if necessary. In the water-tightness test, the slab is completely flooded with water to a certain height, usually above the finished floor level. It is then observed whether leaks or seepage occur over a certain time, usually 24 h. If any leakage is found by the inspection in the lower floor below the slab, it will be evident by moisture stains under the slab, and the responsible team must correct this failure and perform the test again, ensuring no more leaks. It is essential to mention that no standards exist for performing this test. It is conducted based on the experience of the professionals when dealing with these waterproofing materials.

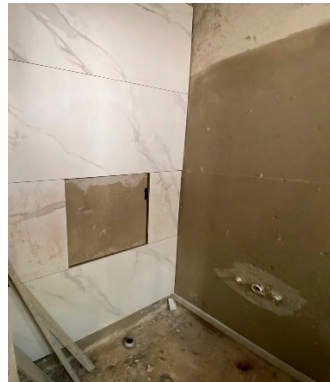
Figure 6. Bathroom after applying waterproofing.

Applying the waterproofing material followed the manufacturer’s recommendations and the NBR 9574 standard [21]. First, the liquid component was mixed with the powder component using a metal rod attached to a drill. Then, using a brush, the first layer of the mixture was applied on the floors and walls (up to a height of approximately 1.80 m) of the bathrooms (Figure 6) and then reapplied after drying in the opposite direction to the application of the first coat. This way, the bathrooms were released for the finishing stage, covering floors and walls with ceramic tiles and protecting them from humidity.

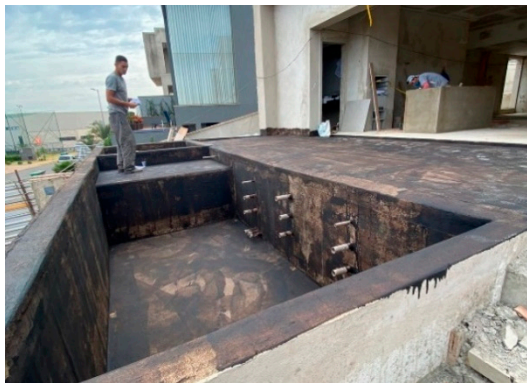
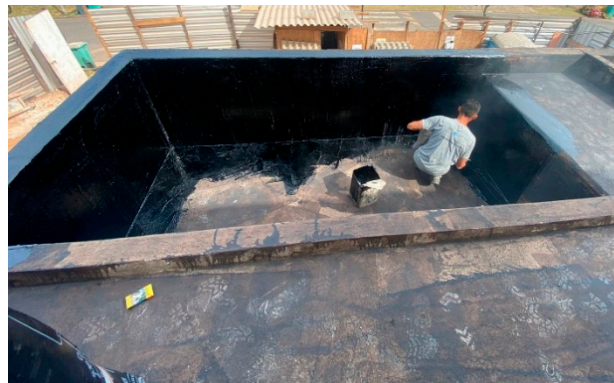
Figure 7. (a) Pool with primer applied; and (b) use of modified asphalt on the pool surface.

The waterproofing process of the deck, pool, and fireplace surfaces started with verifying the drainage system and testing the water flow toward the area's drains. After this verification, these areas were cleaned using brooms and vacuum cleaners. Then, the primer was applied to the pool, fireplace, and deck surfaces (Figure 7a), preparing them to receive the asphalt. Then, a layer of modified asphalt was applied and melted with a blowtorch to adhere the mat to the surface (Figure 7b)—while it was not explicitly mentioned earlier, it is typically necessary to apply a layer of hot material when using the blanket application method.

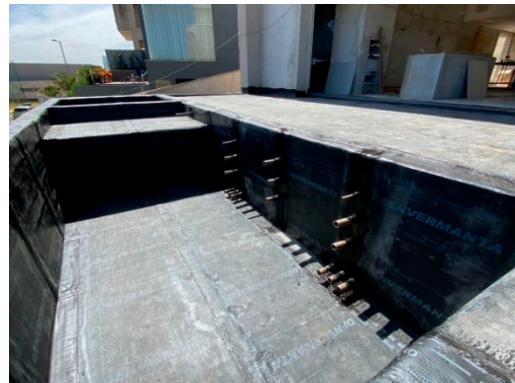
Figure 8. Swimming pool with polyethylene asphalt blanket applied.

Then, applying the polyethylene asphalt blanket on the surfaces was started, using a blowtorch to melt the modified asphalt and ensure the adherence of the blanket. After finishing the application of the blanket on the pool surfaces (Figure 8), deck, and fireplace, the water-tightness test was performed, as was conducted on the slab, to verify the waterproofing guarantee. Next, the pool, fireplace, and deck were filled with water up to the limit of the edges (Figure 9).

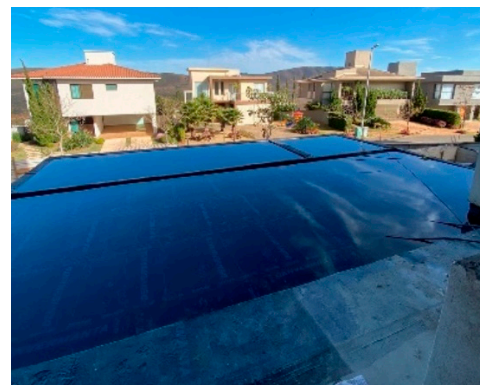
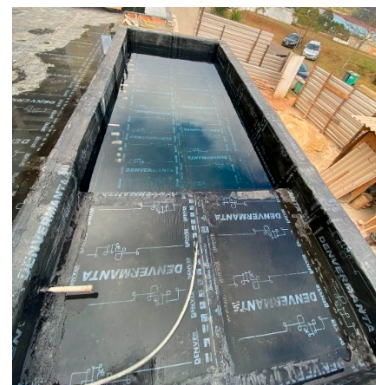
Figure 9. (a) Pool, fireplace, and deck in the water-tightness test; and (b) pool in the water-tightness test.

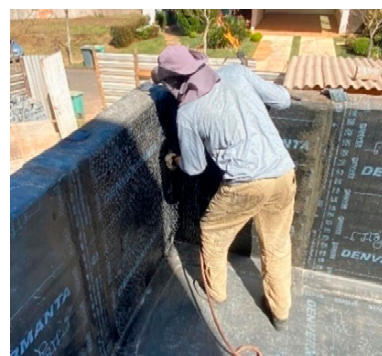
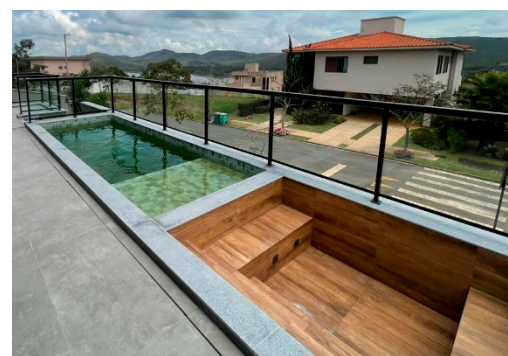
Figure 10. (a) Application of chicken wire over pool blanket; and (b) pool, fireplace, and deck.

As proven to be water-tight after the test, the next step would be plastering the pool and fireplace and the counter flooring of the deck to apply the lining later. For this type of blanket used, before receiving the lining, chicken wire was applied to the entire surface of the pool and fireplace (Figure 10a) using mortar to facilitate the adherence of the plaster to the blanket and prevent future detachment of the ceramic linings. After the preparation with the chicken wire and the mortar on the polyurethane asphalt blanket, the pool and the fireplace were plastered, and the counter-flooring was added to the deck. Then, these surfaces were covered with porcelain tiles or ceramic pieces (Figure 10b).
