Problematic Perspectives of Units of Military Fortification in Landscape Management (Teschen Silesia, Czech Republic) [†]

[†] Presented at the 4th International Conference on Advances in Environmental Engineering, Ostrava, Czech Republic, 20–22 November 2023.

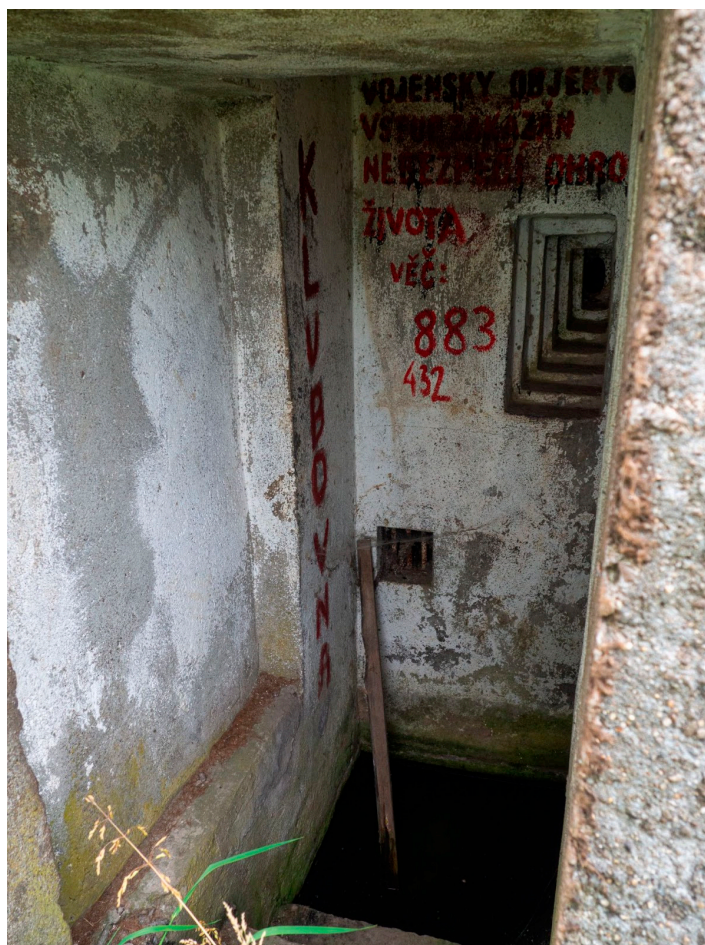
Figure A2. Inscriptions “Klubovna” (“Clubhouse”) next to the warning sign “Vstup zakázán, nebezpečí ohrožení života” (“Entry forbidden, danger to life”) can be seen like UMF-C’s “hidden curriculum”. Author: Adéla Brázdová.

At the same time, during the survey of UMF-C no. XIX/432, signs were also found of non-military use of the building, i.e., not as part of the history of the site but activities related to the use of the genius loci. These included the inscription "Klubovna" ("Clubhouse") next to the warning sign "Vstup zakázán, nebezpečí ohrožení života" ("Entry forbidden, danger to life"), "TGM" (an abbreviation of the name of the first Czechoslovak president Tomáš Garrigue Masaryk) or the remains of simple furniture with which the "Clubhouse" was probably equipped (some of the inscriptions are shown on Appendix C. There is also rubbish inside the building.

Based on the on-site investigations realized on the UMF-C No. XIX/432 and from the guided interviews, there were signs found of human use of the property (see Appendix B), and by securing the statements of the respondents, it can be concluded that the property is or has been used as part of a hidden curriculum of land use (clubhouse) (see Appendix C) [1]. From this point of view, although this property can be considered as a brownfield site, it
