Article

Stabilization of Shallow Landslides Induced by Rainwater Infiltration—A Case Study from Northern Croatia

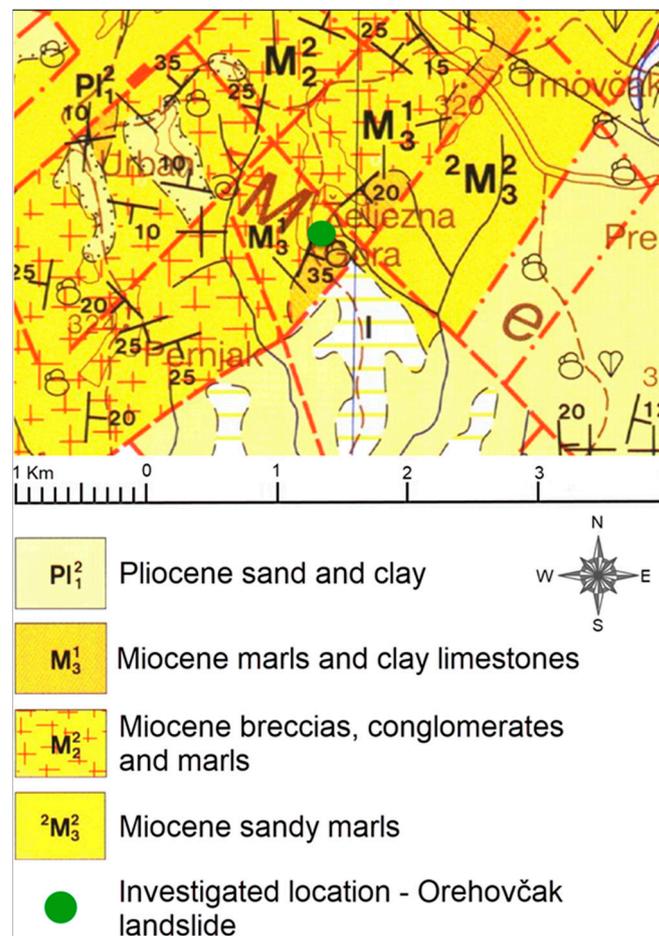
Figure 2. Geological map for the wider area of Orehovčak (adapted according to [20]).

Geological materials marked M_3^1 in Figures 2 and 9 are continuously deposited on carbonates and clasts. They are represented by thin-layered and plate-to-laminar marls of grey to yellow color. In addition to marl, clayey marls and clays are also present. Thicknesses of these deposits from 20 to 40 m were measured on open outcrops.

In the landslide zone, deposits M_3^2 in Figures 2 and 9 are represented by materials such as marls and sandy marls. These greenish marls are followed by varieties of clastic sediments from clay to marl. The thickness of these layers varies from 100 to 200 m, and lithologically, they are very similar to Pliocene deposits $Pl_1^{1,2}$. These are thinly layered sandy marls and marly clays, grey to grey-green, and can be found southeast of the landslide.

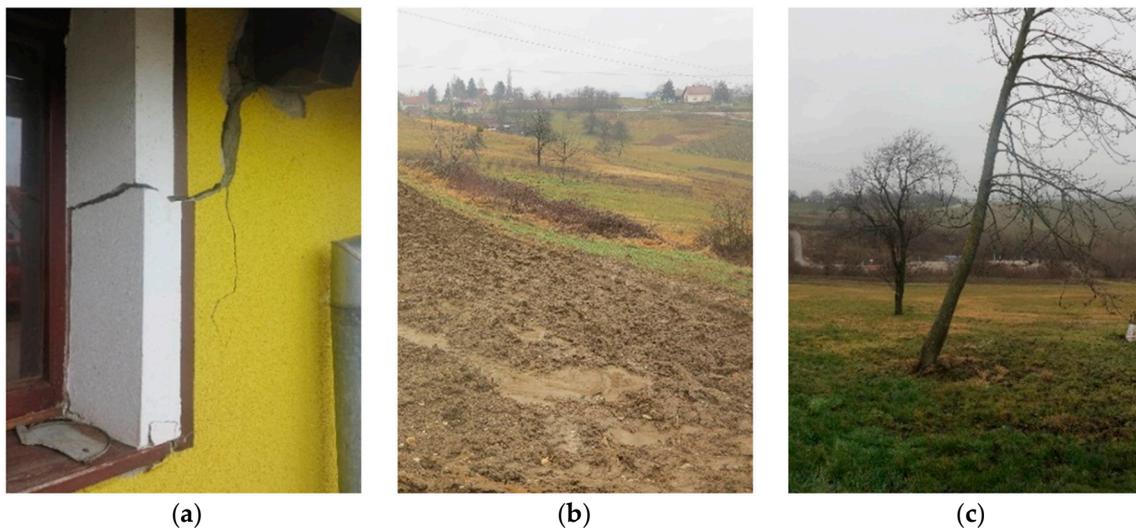
In parts of the slope, intensive soil moisture was noticed, which in those parts turns the agricultural area into a muddy mass (Figure 3b) and causes tilting of trees (Figure 3c).

Figure 3. Visible occurrences on the landslide: (a) building damage that resulted in the emigration of residents, (b) muddy mass that made agricultural production impossible, (c) tilted trees that had to be cut down.

Geotechnical reconnaissance of the unstable area was conducted in order to determine the character, intensity and coverage of the unstable slope zone. Visible occurrences and reported information of local residents were carefully recorded. The consequences of soil movement were clearly visible on the buildings located at the top of the slope (Figure 3a).

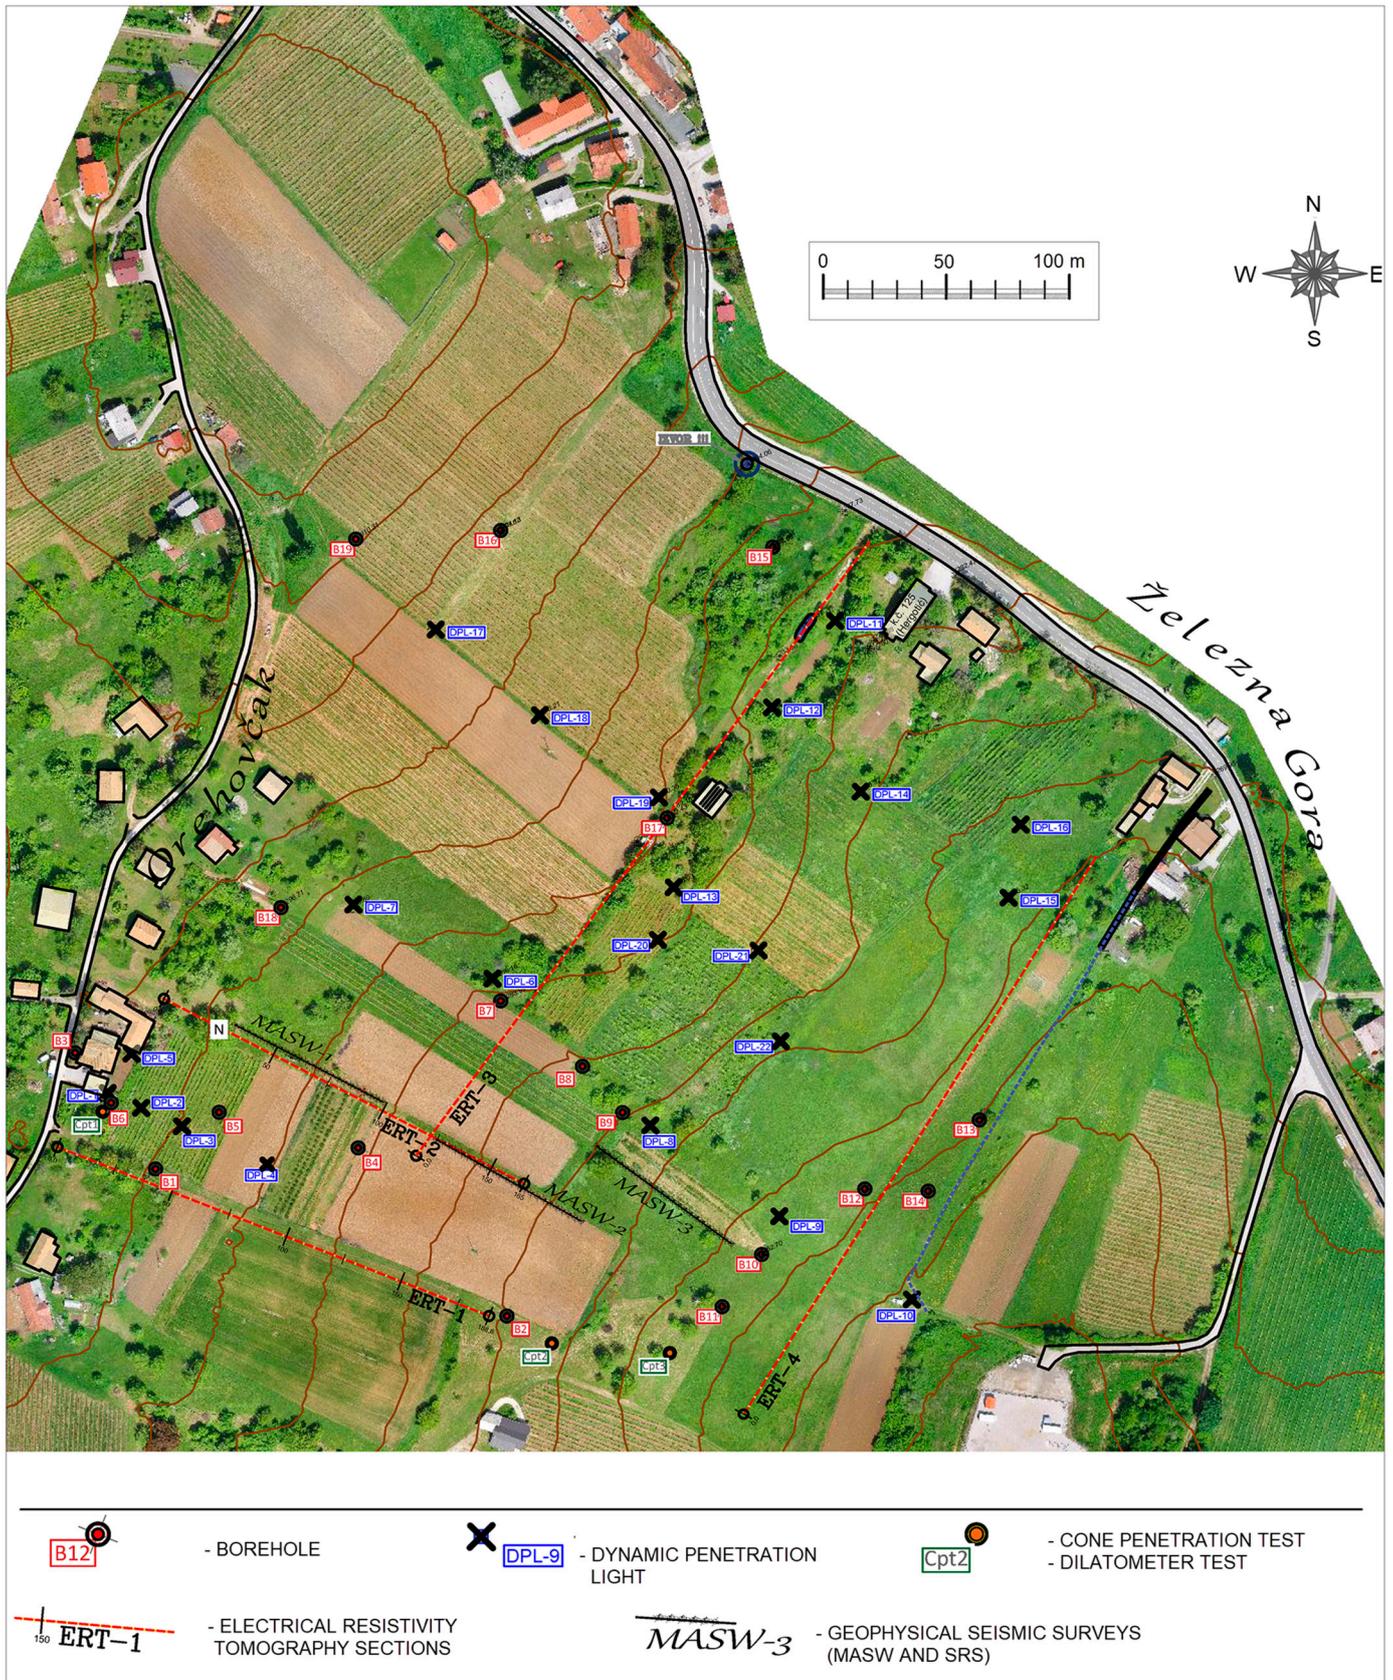
Figure 4. Locations of field investigations at the landslide Orehovčak, adapted according to [20].

The geophysical investigations were performed utilizing three techniques: Electrical Resistivity Tomography (ERT), Shallow Seismic Refraction Survey (SRS) and Multichannel Analysis of Surface Waves (MASW). The position of geophysical surveys is shown in Figure 4.

The position of geotechnical surveys is also shown in Figure 4. Nineteen boreholes (a total of 100 m of drilling) were carried out using the rig boring machine Comacchio Geo 205 (Figure 6a), completed by laboratory testing soil samples from the boreholes. To supplement the information obtained from exploratory core drilling, additional in situ tests were carried out. In situ geotechnical testing is a rapid and uninterrupted process that yields instant data, which can be quickly utilized for analysis purposes.

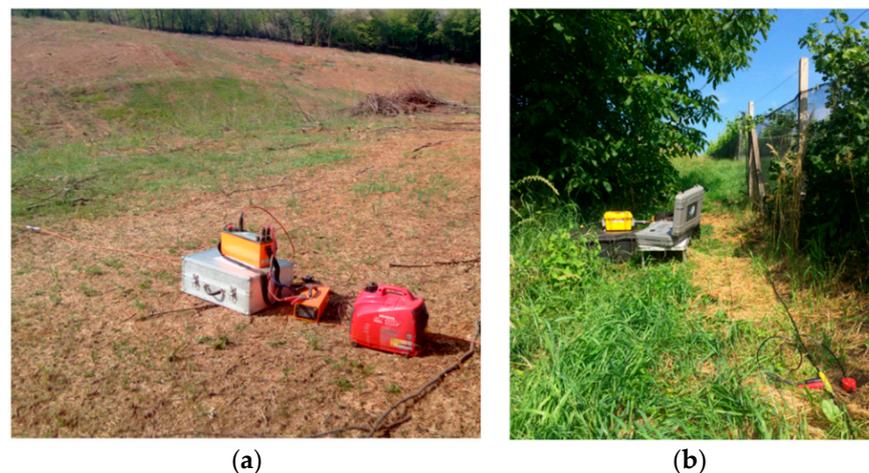
Figure 5. Geophysical investigation equipment: (a) ARES for ERT; (b) GEODE for SRS and MASW.

ERT is a geophysical technique that generates 2D pictures depicting the distribution of electrical resistivity in the subsurface [12]. Figure 5a displays the ARES system (Czech manufacturer GF Instruments), which is a multi-electrode system used for 2D electric study. This technique utilizes an array of electrodes interconnected by multicore cable to generate a linear depth profile, or pseudo section, of the resistivity variation along the survey line and at different depths. This procedure is well described in [25]. The analysis and interpretation of tomograms enable the detection of variations in resistivity, which can be caused by differences in lithological material or changes in water content within certain areas [12]. The inversion of the resistivity profile was successfully performed via the RES2DINV version 4.02 software, which is based on the methodology given by Loke [26].

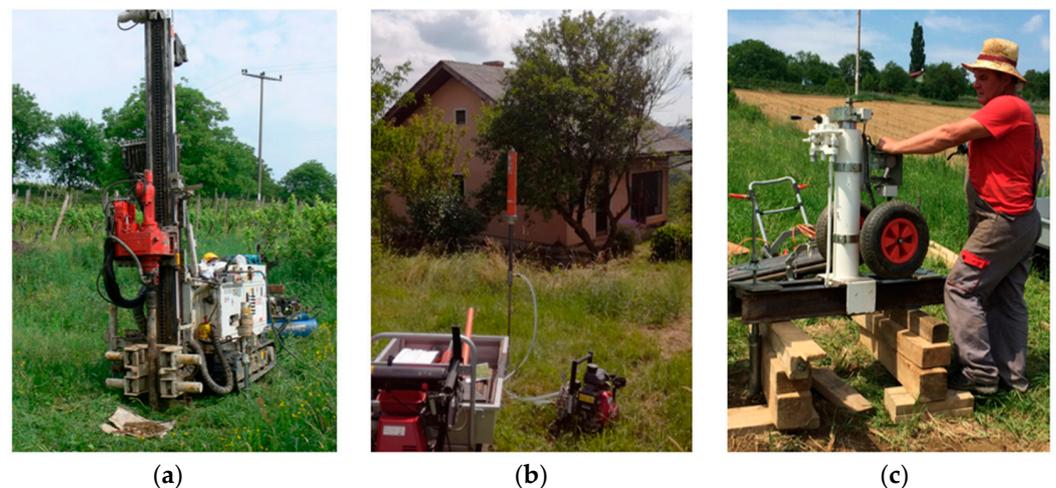
Figure 6. Geotechnical in situ investigation equipment: (a) boring machine Comacchio Geo 205; (b) DPL Nordmeyer Geotool PR 30; (c) Hydraulic embossing equipment Hyson LW100.

The initial step involved soil testing using the Dynamic Probe Light (DPL) method, where a probe cone was forcefully driven into the ground by a 10 kg hammer dropped from a height of 50 cm. Dynamic penetration resistance is defined as the number of blows to penetrate 10 cm. Dynamic probe testing was modified in [30]. On the landslide Orehovčak, 22 dynamic probes were made with Nordmeyer Geotool PR 30 (Figure 6b) up to a maximum depth of 7.5 m.

speed to measure the total cone resistance (q_t), friction ratio (R_f), and pore pressure (u). The geotechnical parameters were estimated based on the data acquired from CPTu using the expression provided by Robertson [34]. Hydraulic embossing equipment, Van Den Berg, model Hyson LW100 (Figure 6c), was used for CPT and DMT in situ investigations.

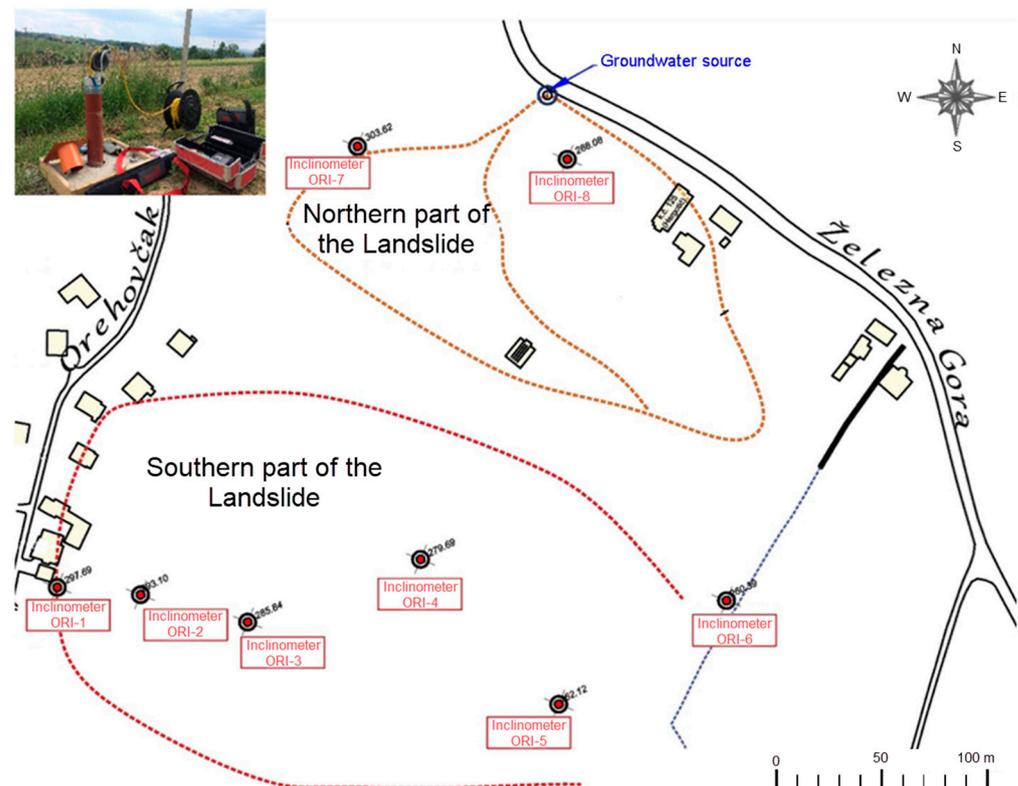
Figure 7. Locations of eight vertical inclinometers at the Landslide Orehovčak, together with the display of the monitoring equipment in the upper right corner.

Eight of the eighteen drilled exploratory holes were equipped with inclinometer tubes for geotechnical monitoring (Figure 7). ABS inclinometer tubes manufactured by SISGEO (Milano, Italy) were used, with an outer diameter of 71 mm and an inner diameter of 60 mm. The vertical inclinometer network was installed to observe horizontal movements and model control. The vertical inclinometer is the primary monitoring instrument used to measure the horizontal subsurface deformation in a borehole.

Measurements were performed using a digital inclinometer system using the biaxial digital MEMS measuring probe. The equipment for inclinometer observations consisted of the Archimede CDL300INCL registration unit, manufactured by SISGEO, and digital inclinometer measuring probe S242DV3000 (in the upper right corner of Figure 7).

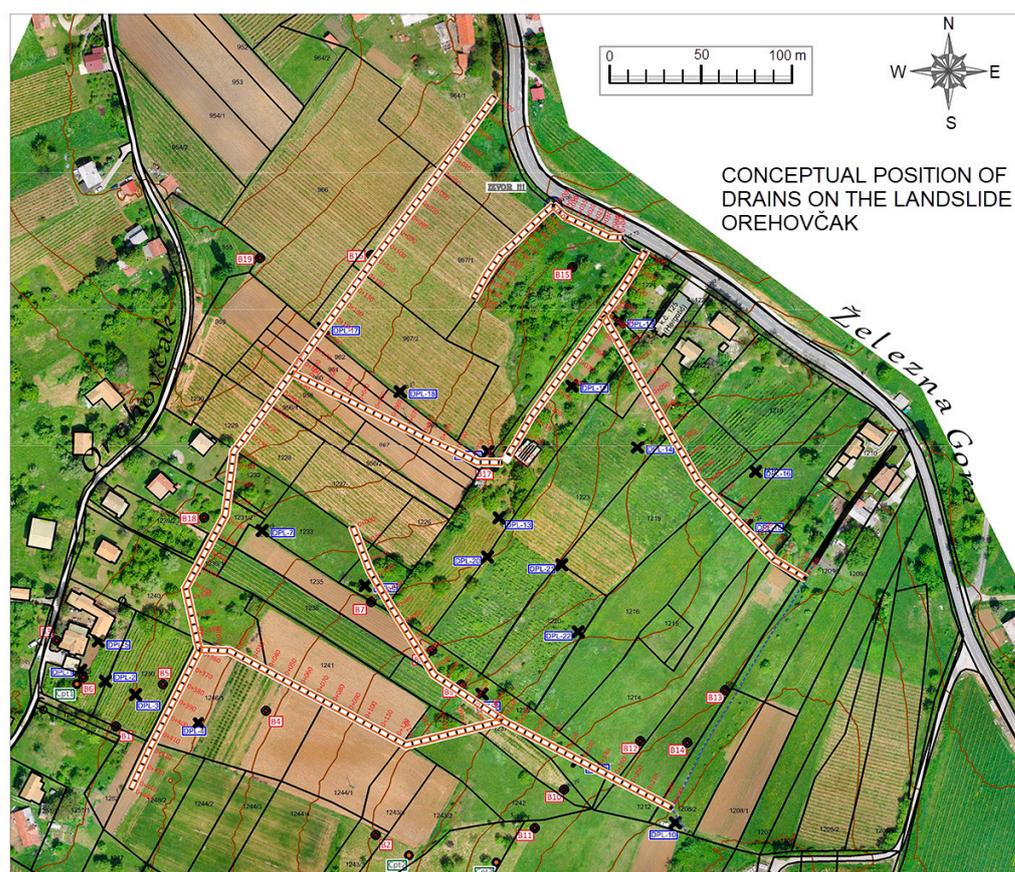
Figure 8. The conceptual position of the planned drains.

For the purpose of landslide remediation in Železna Gora, below the village Orehovčak, the conceptual project foresees the remediation of unstable space with deep dug drains and arrangement of surface drainage. A total of three drains have first been designed to drain the landslide body. Drains 1 and 3 are placed in the main directions of leachate and represent the backbone of drainage of the northern and southern parts of the landslide. Drain 2 is an extended branch of drain 1 for additional collection of leachate from the southern part of the landslide. The conceptual position of the planned drains before all research results were taken into account is shown in Figure 8.

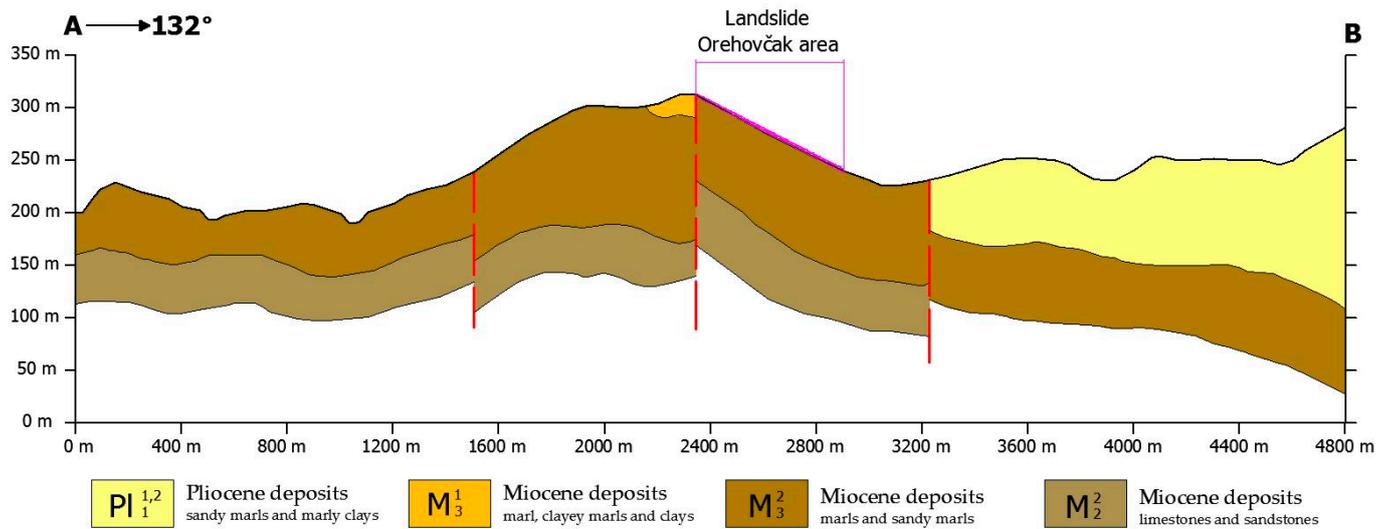
Figure 9. Geological profile that crosses the area of the Orehovčak landslide.

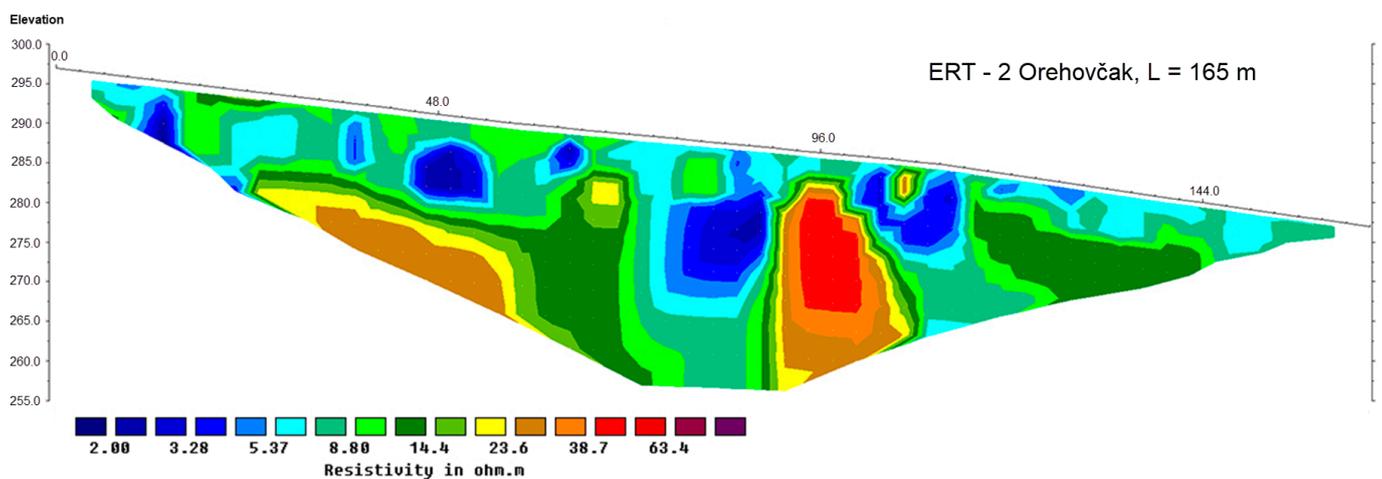
Figure 10. Two-dimensional model of soil electrical resistivity at the section ERT-2.

The interpreted results of the ERT are displayed as a graphical representation of the resistivity profile with depth. The profile is displayed in colors, where different colors, according to the legend, show different resistance zones. The soil types are distinguished according to the electrical tomography profile recorded at the location. The electrical tomography (ERT) profile identified that the sliding surface was formed within the clayey materials towards the subsoil of the marly clays. The results of ERT research in Orehovčak (Figure 10) show that the sliding surface was formed within clay materials (<10 ohmmeters), according to the subsoil of marly clays and marls (10–25 ohmmeters).

From the measurements, a clear boundary between the clay roof and the base of marly clays and marl is not visible because these materials can have similar electrical resistance values. In addition, it is difficult to detect the line of the saturated zone because in clayey materials, a classic water face is not formed, but areas of greater and lesser water saturation appear. Therefore, it is impossible to distinguish the characteristics mentioned in detail within the electrical resistance profile.

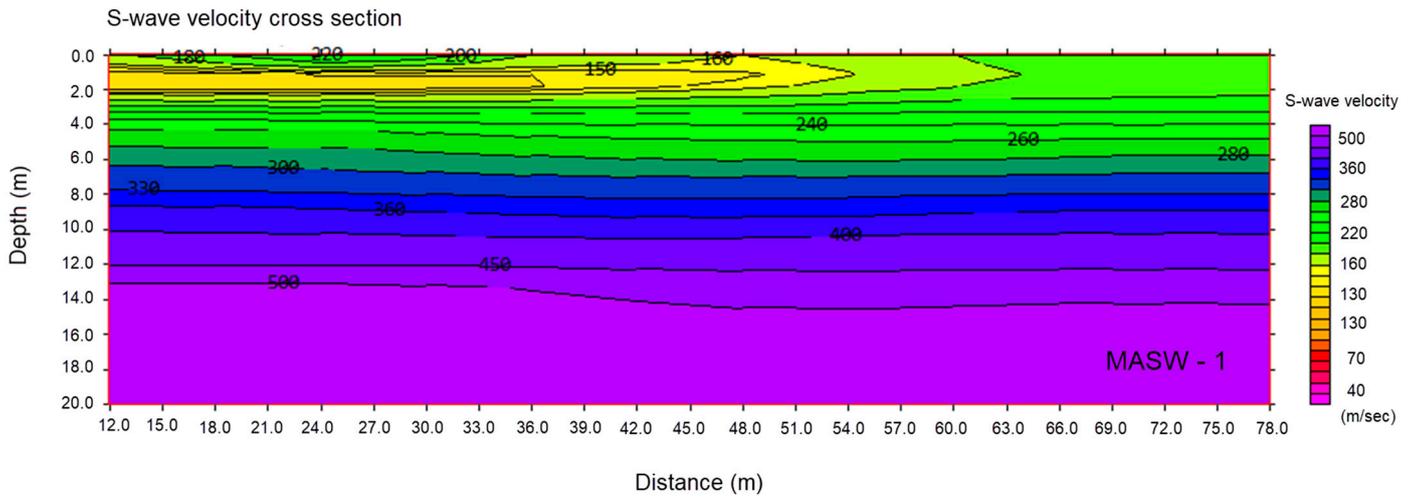
V_S information obtained by section MASW-1 is shown in Figure 11. Lower velocities of S waves indicate clayey materials (<260 m/s), and higher velocities (260–500 m/s) indicate subsoil (marly clays and marls).

Figure 11. Two-dimensional model of S-waves velocities at the section MASW-1.

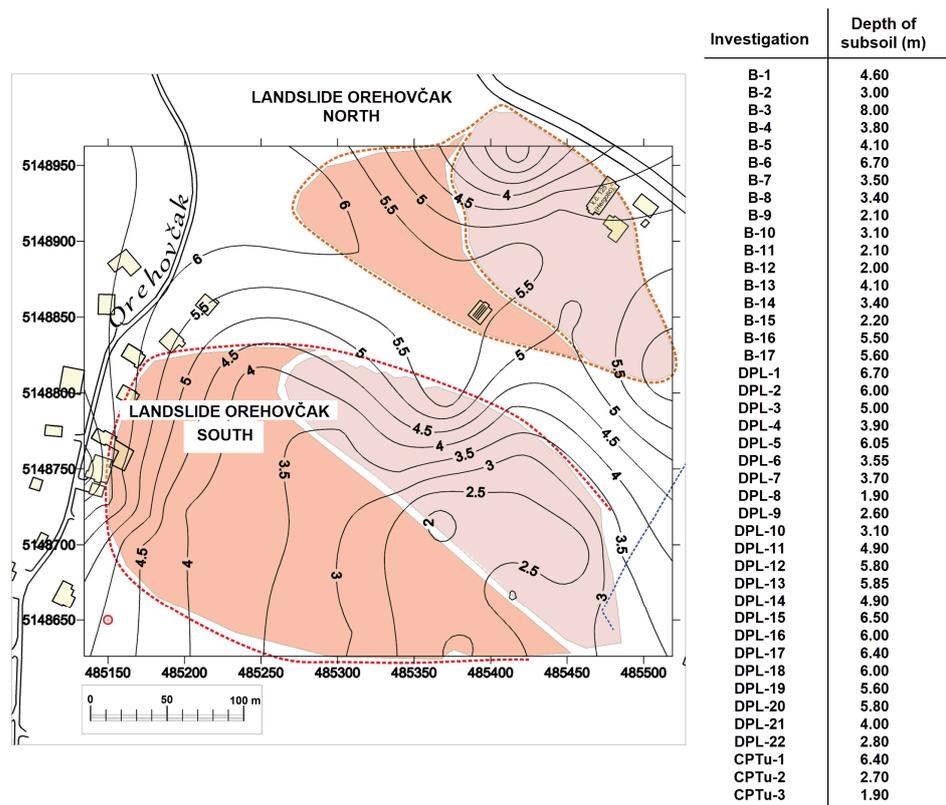
Figure 14. Isobaths of solid subsoil (marl and marl clays) measured in meters.

A large number of point data on the depth of the solid marl subsoil were obtained through investigative works, and for the purpose of systematizing the results, the subsoil (marly clays and marl) map shown in Figure 14 was created.

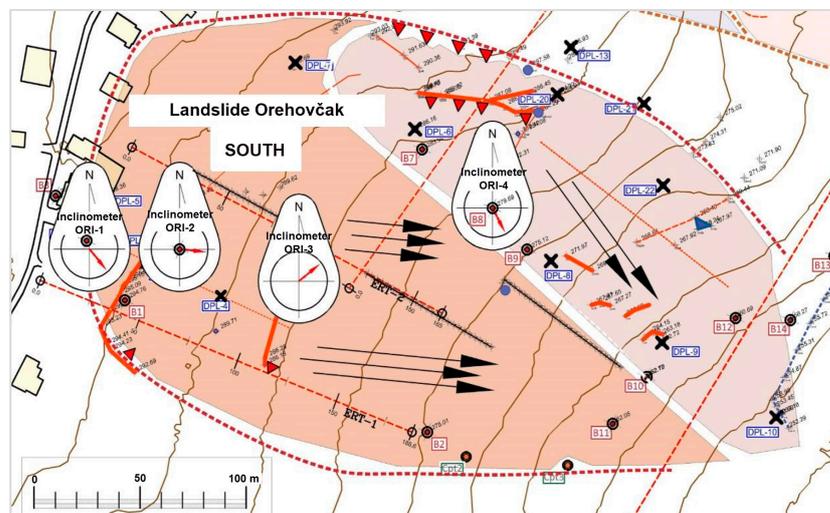
Figure 15. Movement directions read on inclinometers of ORI-1 to ORI-4.

Before establishing the inclinometer network in the middle of 2016, there was no topographic monitoring on the Orehovčak landslide that would have provided input data on trends in the slope velocity movement. The results of inclinometer observations show the measured deviations of individual points of the inclinometer tube from the zero line measured at the zero reading. The orientation of the displayed displacements is in accordance with the conventional representation (convention) in the polar diagram in the counterclockwise direction where the north direction is indicated by 90°. The results of the first reading on the four inclinometers installed in the first phase are shown in the situation in Figure 15.

The displacement directions read on the inclinometers of the southern part of the landslide coincide with the predicted kinematics of the ground movement, and the displacement depths correspond to other results. The size of the displacement is up to 2 mm and was measured over a period of 20 days.

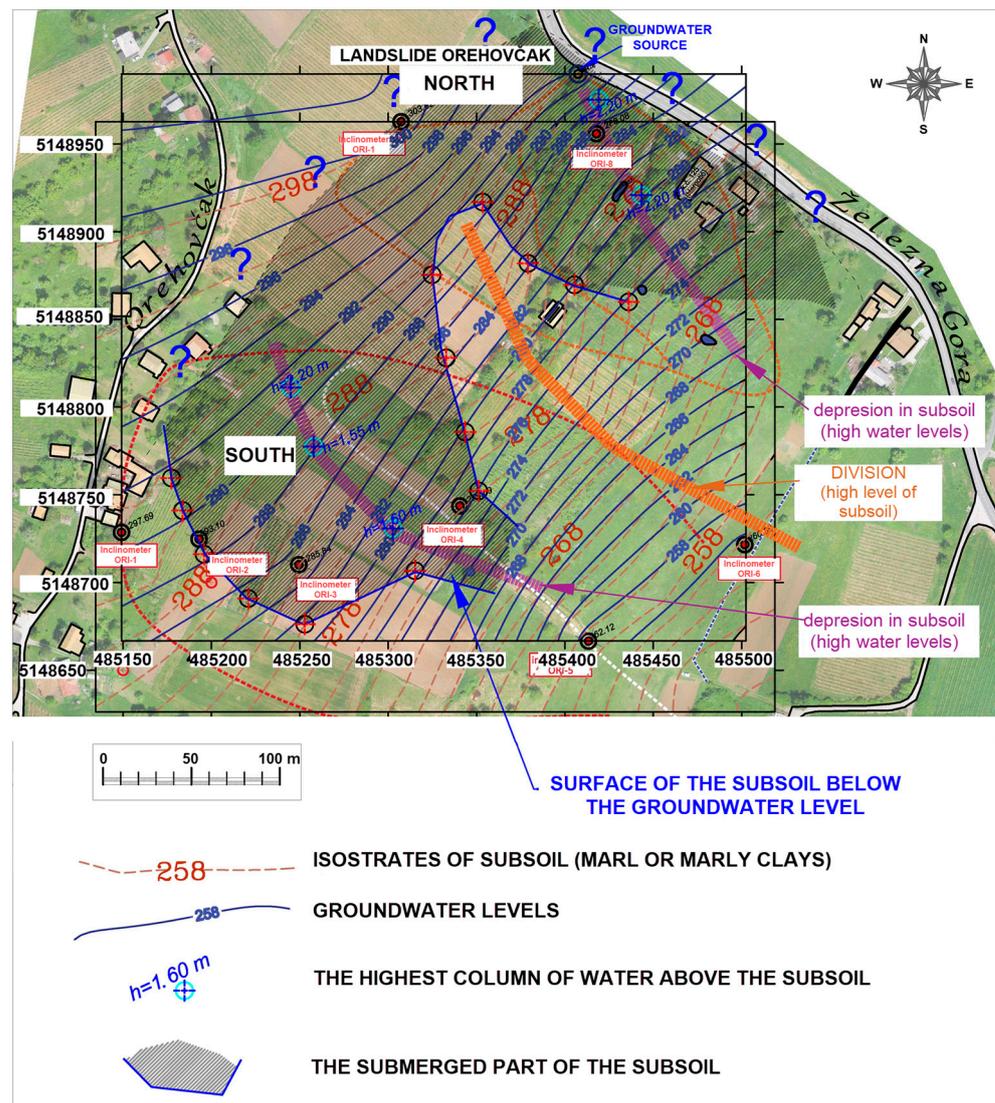
Figure 16. Hydrogeological map—state of groundwater levels.

The main reason for the resulting displacements and the development of landslides is the accumulation, i.e., the high level of leachate in the zone of depression in the subsoil, and the “filling” of the slope is connected to the water source along the D227 State Road, where the water levels are always almost up to the surface of the terrain. The scheme of the above is shown in Figure 16.

Figure 16 shows that the greatest fluctuations in groundwater levels are realized precisely in the area of the landslide. From the analysis, it is evident that the landslide consists of a sliding surface in contact with a solid subsoil. The landslide has a delapsive character, which is fast according to the speed of movement.

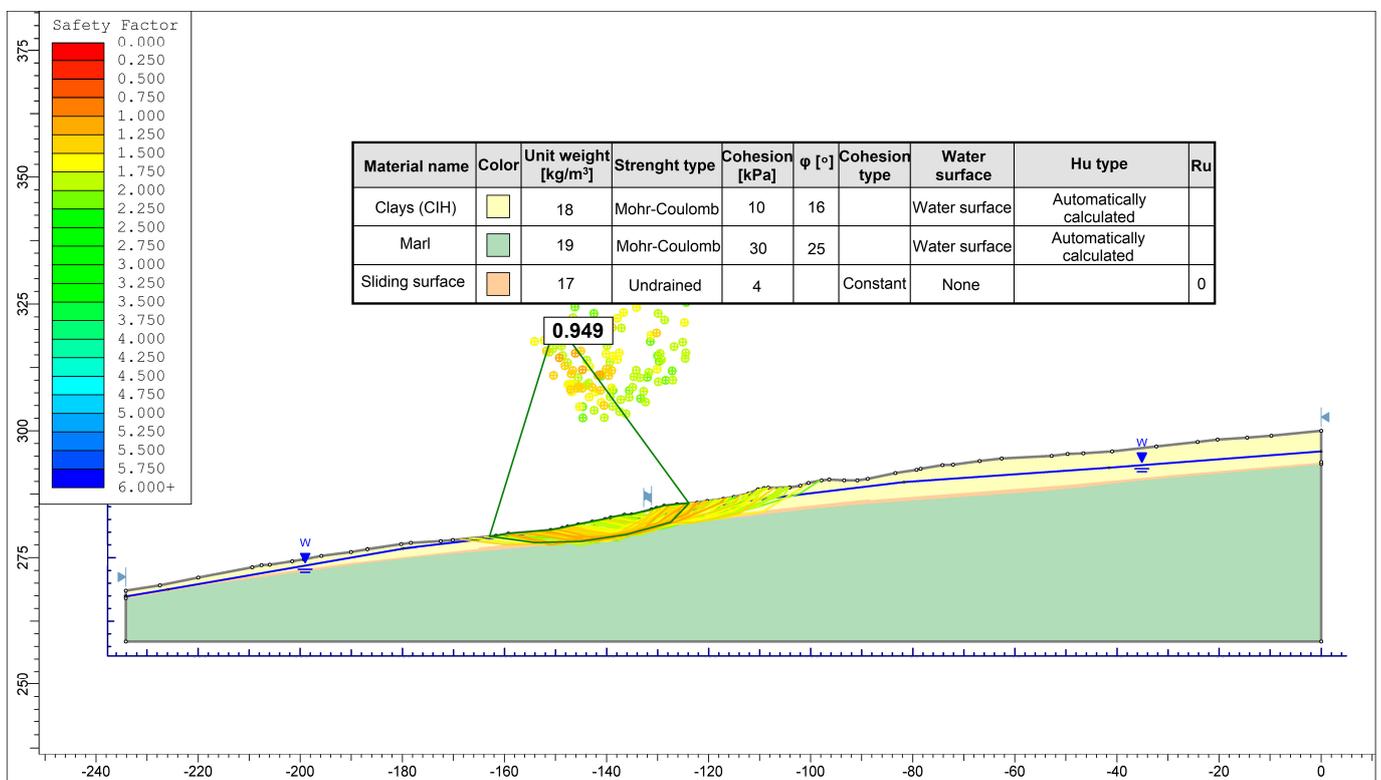
Figure 17. Characteristic profile and soil model used in the calculation of safety factors before rehabilitation (back analysis).

The slope stability analysis was performed for the most unfavorable case so that the shear strength on the sliding surface $c_u = 18$ kPa was taken into account. Other established conditions on the slope were also taken into account. The model with the used soil input parameters and loads is shown in Figure 17.

The realized safety factor is slightly less than 1, which means that the slope is unstable for the selected model parameters. In this reverse analysis, no partial factors were applied, so the characteristic values equal the design values. The result $F_s < 1$ indicates that the destabilizing action of the forces is greater than the stabilizing action.

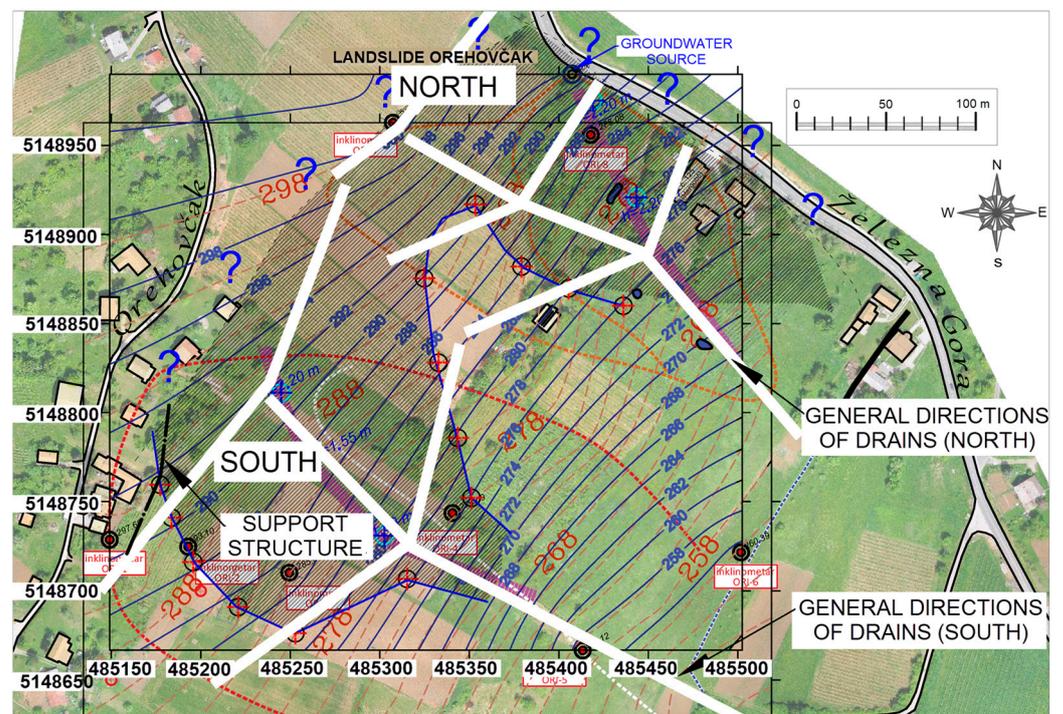
Figure 18. Drainage directions of the slope and position of the supporting structure.

After conducting research and analyzing the obtained results, in combination with the hydrogeological conditions in the soil, the final position of the drains was determined. The general positions of the deep drains in the northern and southern parts of the landslide are shown in Figure 18. In the same figure, it is also possible to see the position of the support

Drainage of the body of the landslide was carried out with a total of three drains, of which drains 1 and 3 are placed in the main directions of seepage waters and represent the backbone of the drainage of the area of southern and northern parts of the landslide. Drain 2 is an extended branch of drain 1 for additional leachate collecting from the southern part of the landslide. The drain routes were established based on the results of recorded groundwater levels in the piezometer system created during the investigation phase (boreholes and inclinometers).

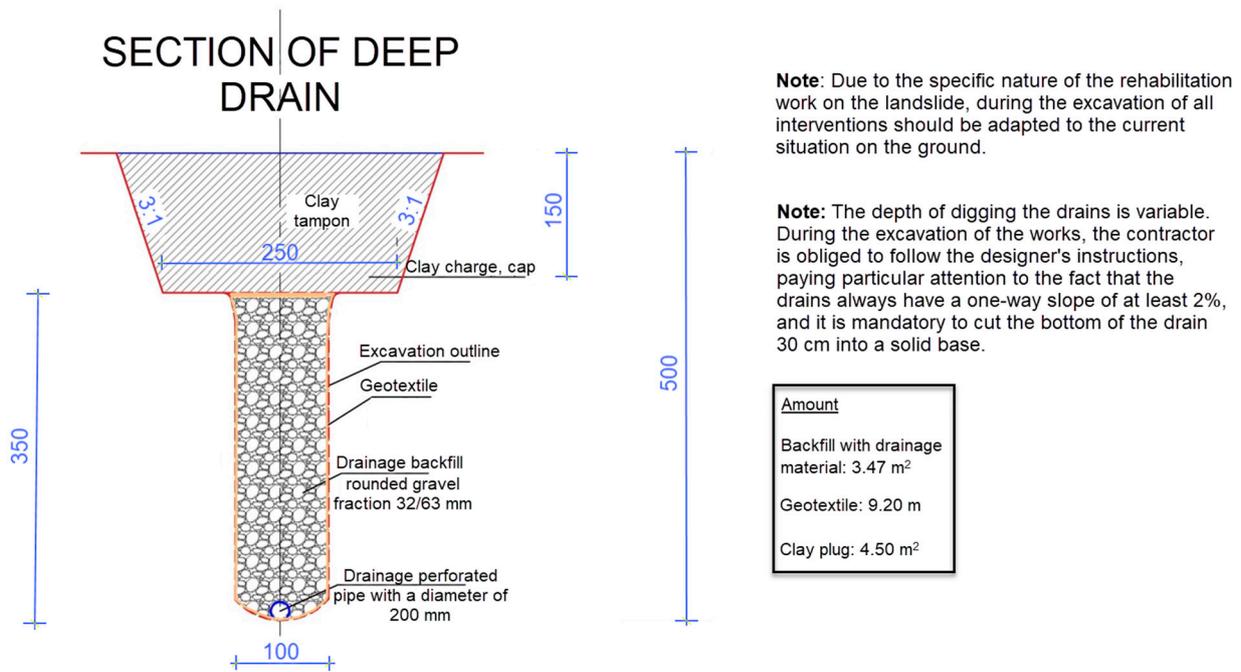
Figure 19. Characteristic cross-section of the deep drain.

Drainage flexible PVC pipes with a diameter of 20 cm were laid in the channels excavated to the marly substrate (even deeper up to 20 cm). PVC D200/184 mm, TS360° (Pipelife DX) was used for the drainage pipes.

The filter material installation began after the drainage was completed in each section. Natural gravel or crushed stone with a 30–60 mm fraction was used as drainage material.

The installation was carried out in layers with the compaction of each individual embedded layer. The drainage material was poured onto the drainage pipe, taking care not to damage the pipe. A geotextile was placed on top of the trench filled with filter stone. After that, a plug was made from a poorly permeable material (clay) that would prevent the uncontrolled entry of rainwater into the soil. The surface of the trench excavation for the drain is levelled after installation and compaction. The detail of the deep drain cross-section is shown in Figure 19, and the drain construction at the location of the Orehovčak landslide is shown in Figure 20.

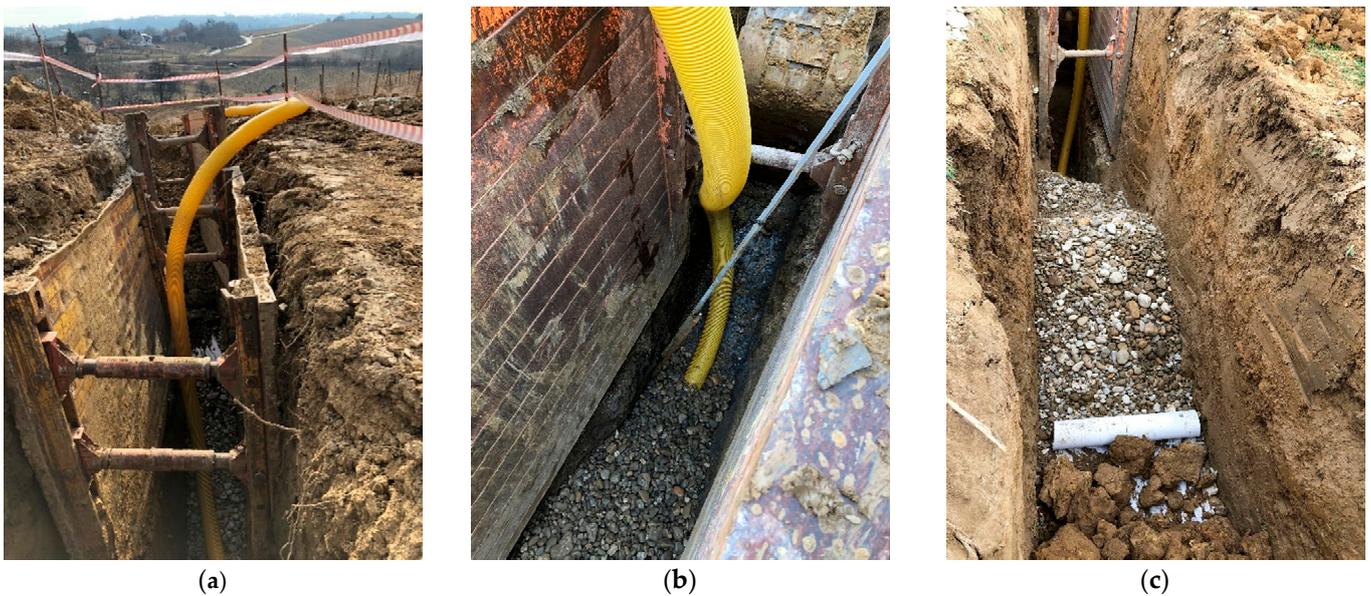
Figure 20. Building of the deep drain on the Orehovčak landslide: (a) excavation protection; (b) installation of perforated drainage pipe; (c) backfilling drain with drainage material.

Before the excavation of the drains, rough levelling of the slope was carried out, followed by the excavation of preparatory plateaus on the routes of the deep drains. The total length of the excavated drains was 980 m. Excavation and installation of the filter material were performed in stages, according to the order of work and given technical conditions. Excavation of trenches for deep drains was carried out on two levels. The first part of the excavation was carried out as a wide excavation in sections up to 20 m long, up to the elevation of the deep (second) level. The lower level of excavation to the final depth was also carried out in sections up to 5 m long.

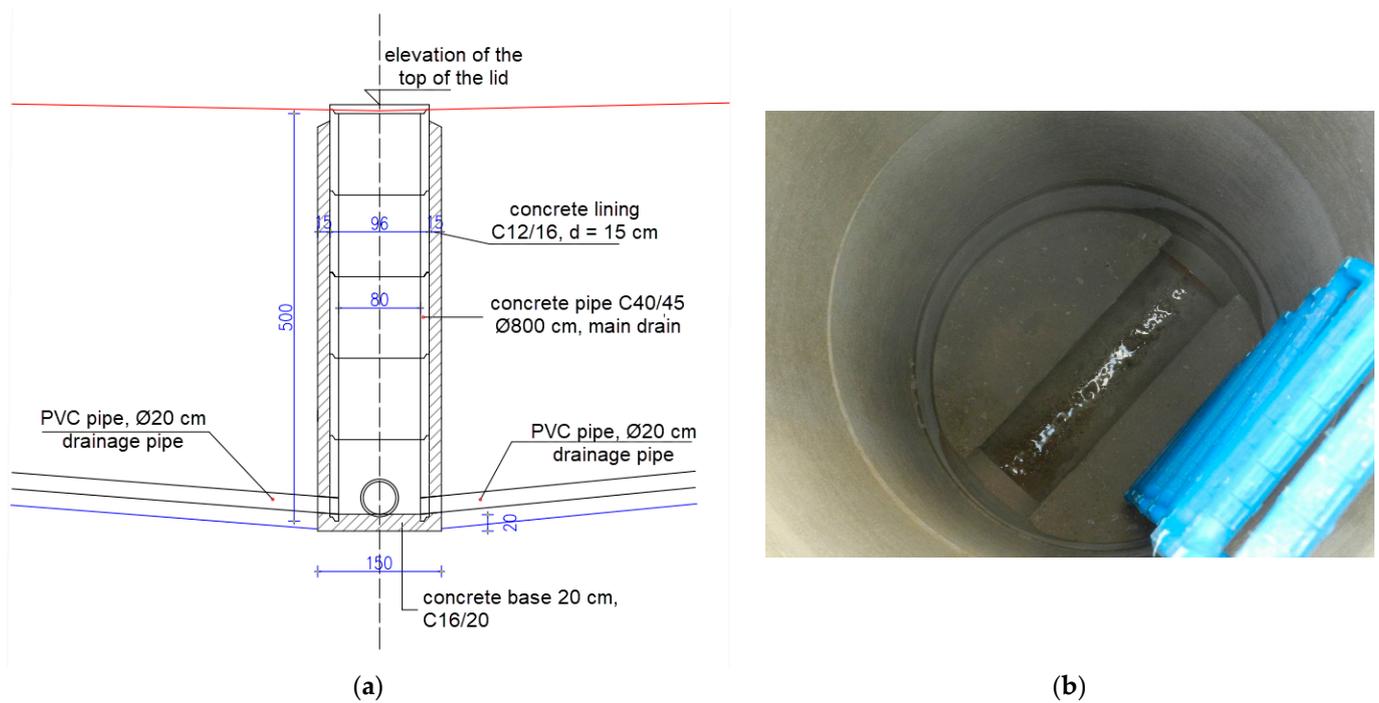
Figure 21. Audit shafts: (a) characteristic section; (b) view of the drain through the drainage audit shaft.

Inspection manholes (audit shafts) for drainage were built at the junctions and breaks of the drainage route (Figure 21) for the purpose of maintenance and control of the func-

tioning of the drainage. Inspection shafts are made of concrete sewer pipes with a diameter of 80 cm with a concrete cover. The windows were placed on a concrete base, and the concrete lining was installed along the entire height.

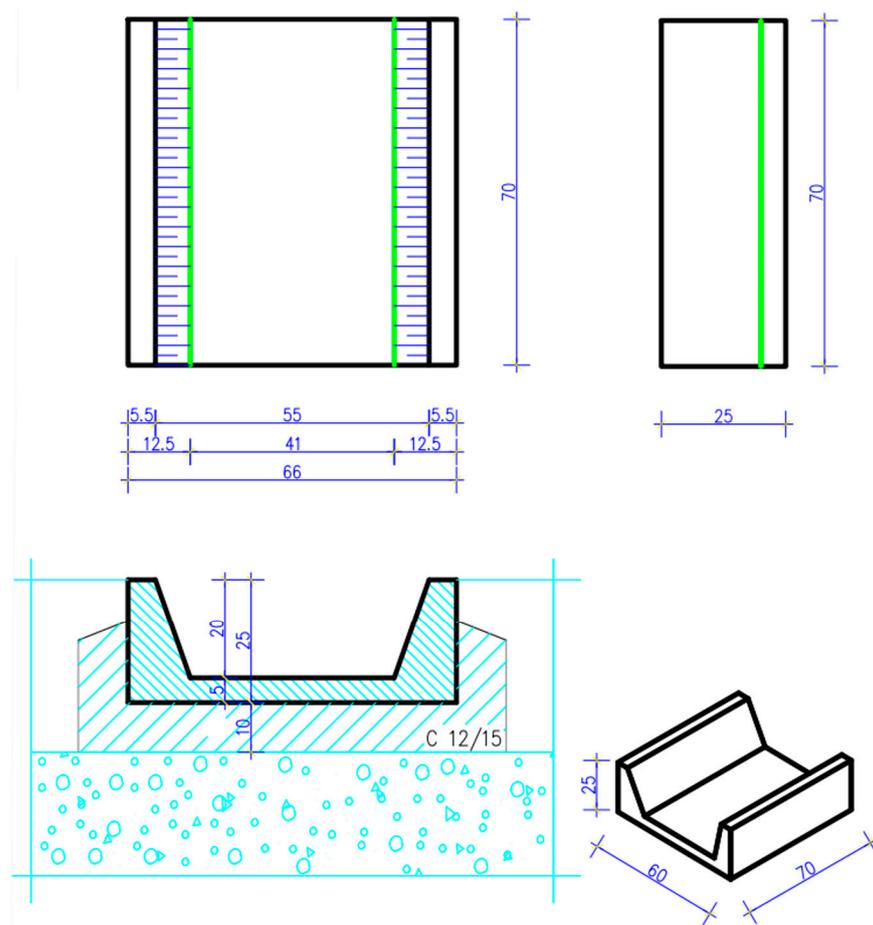
Figure 22. A characteristic section of a concrete trapezoidal channel. Dimensions in the figure are in centimeters (cm).

Other elements of the rehabilitation were related to the arrangement of storm surface drainage using concrete trapezoidal channels with dimensions of 66/25/70 cm (Figures 22 and 23), anti-erosion protection of the slope of the main drainage channel with concrete grass grates, expansion of the existing drainage ditch and the construction of a tubular culvert under the access road. Existing rainwater drainage channels, which are made of concrete trapezoidal-conical channels, are used to drain water from the drainage system.

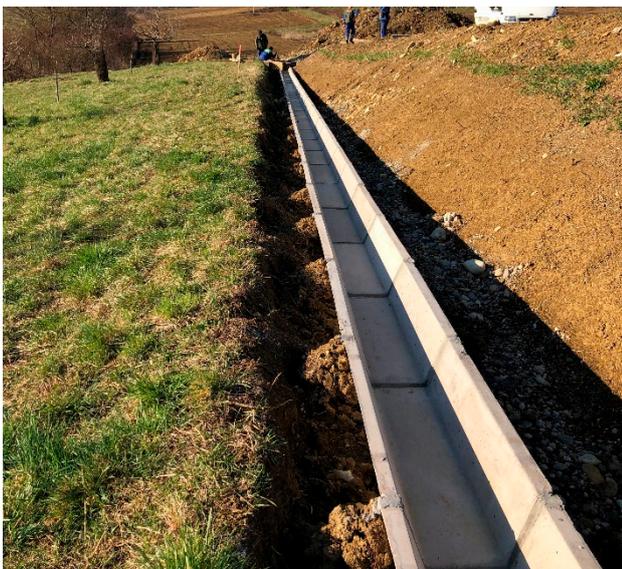
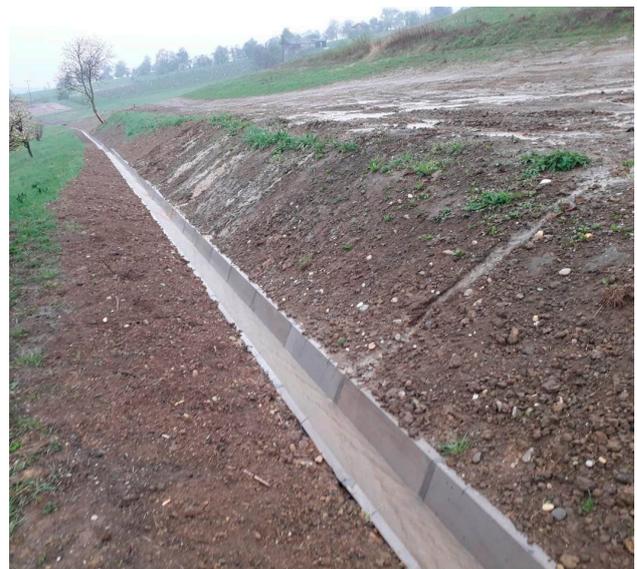
Figure 23. Concrete trapezoidal channel: (a) during the building; (b) completed.

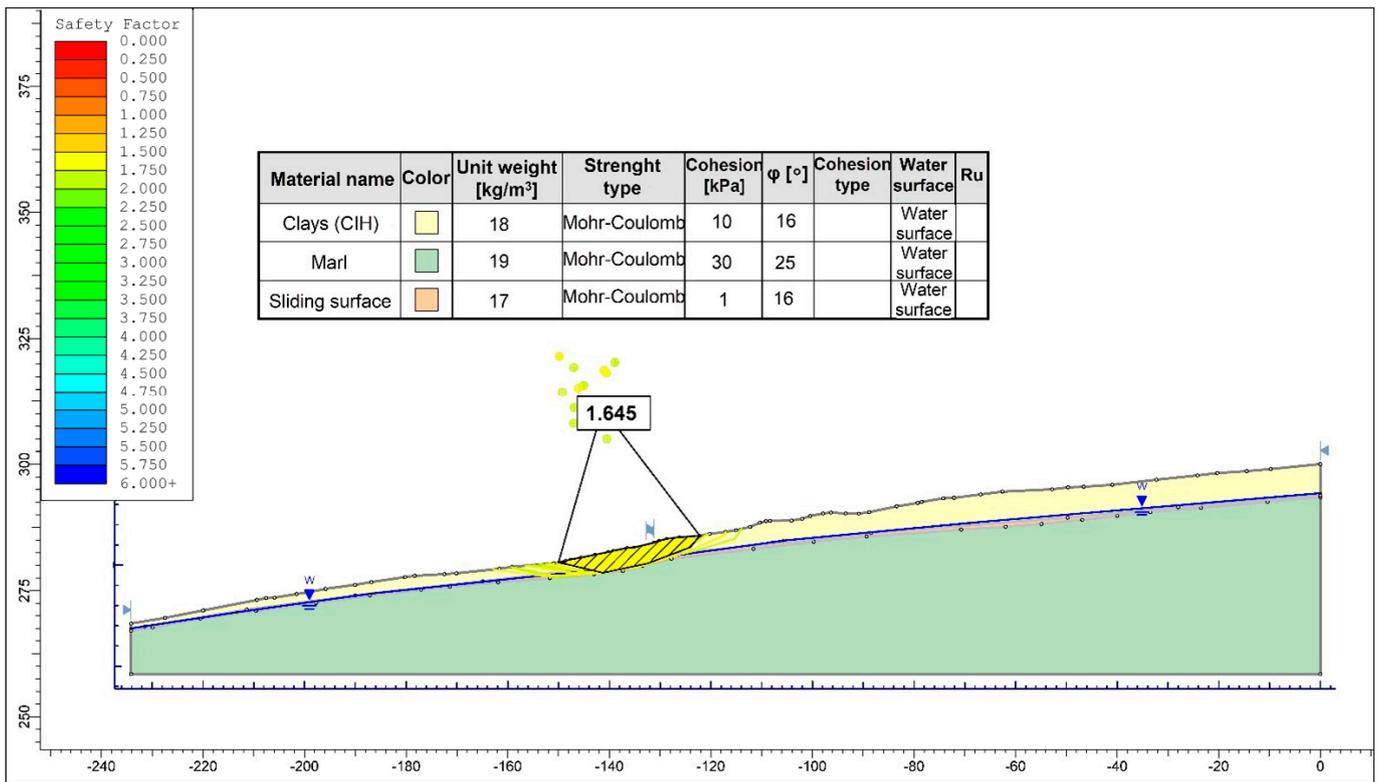
Figure 24. Characteristic profile and soil model used in the calculation of safety factors after the rehabilitation of the landslide.

An analysis of slope stability was performed in all conditions on the slope that were achieved after the landslide rehabilitation by installing deep drains. The obtained safety factor was greater than 1.5 (Figure 24), which proves that the stability of the landslide is achieved by the performance of the designed rehabilitation solution.

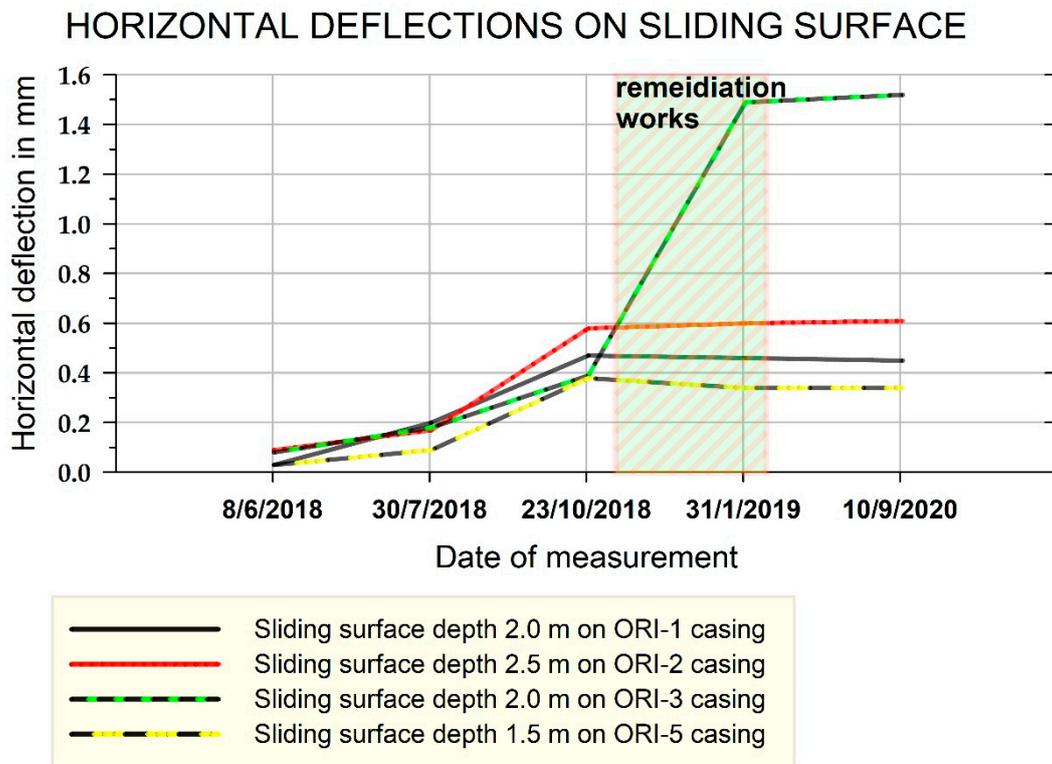
Figure 25. Observation results of selected inclinometers where the most significant horizontal deflections were recorded.

After the rehabilitation, observations were made again on the inclinometers. The measurement results show that there are no new movements after remediation and that the landslide has calmed down (Figure 25).
