Identification of the Effects of Fire-Wave Propagation through the Power Unit's Boiler Island

Michał Paduchowicz * and Artur Górski

Department of Machine and Vehicle Design and Research, Faculty of Mechanical Engineering, Wrocław University of Science and Technology, 27 Wybrzeże Wyspiańskiego, 50-370 Wrocław, Poland; artur.gorski@pwr.edu.pl

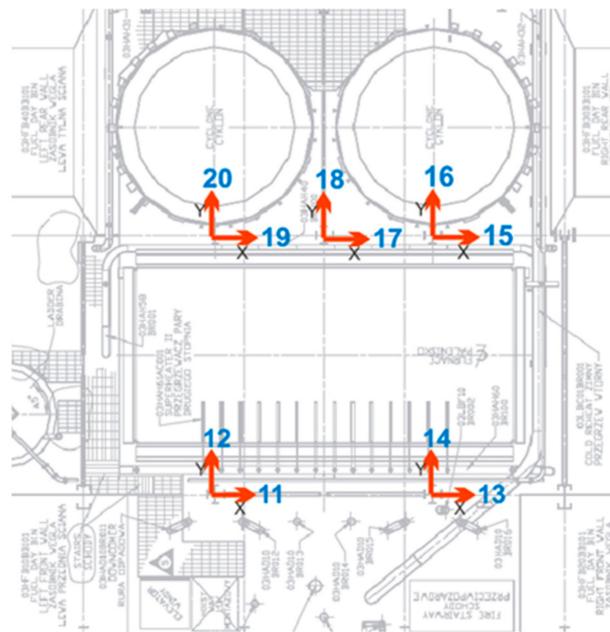
Figure 6. Diagram of measurement points on units 1, 2, and 3—the 32-m level.

The planned scope of research also included measurements of vibrations that occur in the combustion chamber's load-bearing (support) structure, on its individual height levels, between 5 and 50 m. Figure 6 shows a general diagram of measurement points arrangement for the 32-m level [14].

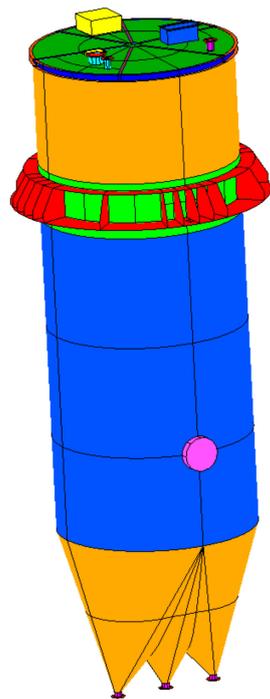
Figure 13. View of the container's complete geometric model.

In order to determine the reasons for the container's damage, a series of strength analyses was performed, with consideration paid to several factors that accompanied the fire and could cause a crack in the area of dumping hoppers and complete damage of the container's upper part. The rising temperature inside the boiler hall, which was the result of the fire, led to uneven heating of the boiler's surface. The thermal gradient of the boiler's casing that occurred in consequence, as well as the rise in air temperature inside the container—which translated into the rise in air pressure—both contributed to the emergence of cracks in the area of weld lines on the fuel hopper and sudden damage of its upper part that followed. Strength analysis was performed for the following air pressure values: 5 kPa, 10 kPa, 15 kPa, . . . , 50 kPa (values increased by 5 kPa). Impact strength of approximately 200 MPa was assumed for the observed low quality of weld lines on the fuel hoppers. The strength analysis showed that at air pressure inside the container equal to 50 kPa and at uneven thermal impact that occurred simultaneously, reduced stress in the area of hopper weld lines reached approximately 270 MPa (Figure 14). This contributed to the breaking of the discussed area of the container 8z.
