Article Chlorine Corrosion in a Low-Power Boiler Fired with Agricultural Biomass

Abstract: The selection of appropriate heat-resistant materials which are at the same time resistant to atmospheres rich in chlorine and its compounds is one of the most important current construction problems in steel boiler elements when using biomass fuels of agricultural origin. In the research presented here, an area was identified in the furnace of a 10 kW boiler where there was a potential risk of chlorine corrosion. This zone was determined based on numerical analysis of the combustion process; it is the zone with the highest temperatures and where the gas atmosphere conducive to the formation of chlorine corrosion centers. Subsequently, tests were carried out in the process environment of the combustion chamber of a 10 kW boiler (the fuel was barley straw) by placing samples of eight construction materials in a numerically-designated zone. These included samples of steel (coal boiler St41K, heat-resistant H25T and H24JS, and heat-resistant valve 50H21G9N4) as well as intermetallic materials based on phases (FeAl, Fe₃Al, NiAl, and Ni₃Al). The samples remained in the atmosphere of the boiler fu

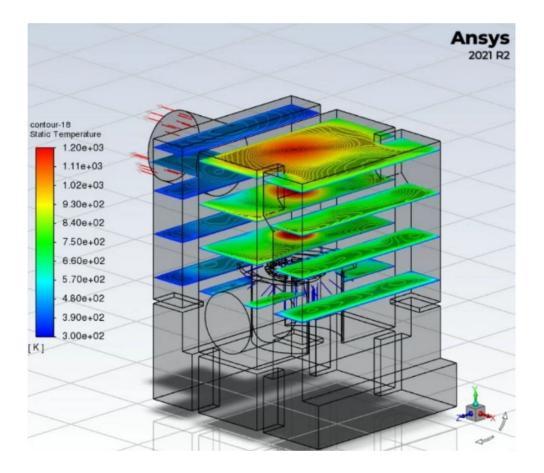
Figure 2. Temperature distribution [K].

Figures 2–5 show the temperature distribution and the O₂ and CO concentration. The structure of the combustion chamber (Figure 6), as well as the type of burner used, favor the lifting of the hot gas stream towards the upper wall of the boiler. In Figure 2, a temperature zone of 1000–1200 K can be observed in the central part of the top wall, along with a gradual decrease in temperature towards the side walls of the combustion chamber. The resulting swirl of gases in the combustion chamber promotes an even distribution of oxygen, the average values of which are in the range of 10–11% (Figures 3a and 5a). The combustion process with excess air ($\lambda = 2$), as well as the aforementioned swirling and mixing of the exhaust gases in the combustion chamber, favor a low CO content (<0.02%) both in the upper part of the combustion chamber (Figures 3b and 5b) and at the shaft through which the exhaust gases are directed to the convection line (Figure 6b).

In the zone of the highest temperature of the boiler furnace determined in the numerical analysis (red areas in Figures 2 and 4), where chlorine corrosion may appear and lead to the destruction of the boiler construction material (Figure 6), samples of various grades of steel (carbon steel, heat-resistant, creep-resistant and intermetallic samples) as well as alloys based on aluminum intermetallic phases of the FeAl and NiAl system were placed. Then, for 48 days (1152 h), fuel (barley straw pellets, as described in point Section 3.1) were dosed to the boiler during the combustion process. The average temperature in the combustion chamber had a range of 750–900 °C (1023–1173 K). After this time, samples of steels and intermetallic materials were taken out and their surface conditions were analyzed. The annealing time of the samples is justified by the fact that the observations of corrosion damage under the conditions of the described experiment were previously carried out for a period of one week to three months, and on this basis it was established that within 48 days there were significant changes on the surface of the samples.
