# Failure Analysis of a Flare Tip Used in Offshore Production Platform in Qatar

**Abstract:** An immature failure of a gas flare tip used in Qatar oil and gas offshore industry was investigated throughout this study. The design lifetime of the flare was fifteen years; however, it manifested immature failure resulting in a reduction of its lifetime to ten years. The flare is composed of different parts where the upper flare body and wind deflector showed failure while other components were still healthy. The material used for the aforementioned failed parts was Incoloy 800H, which is a highly corrosion and high-temperature resistant steel alloy. The material was rolled up and welded together with different welding joints. The root cause of failure was identified by using chemical analysis and microstructural and mechanical characterizations. For the mechanical characterization, an optical microscope (OM) and scanning electron microscope (SEM) equipped with energy dispersive spectroscopy (EDS) analyses were used for the specimen extracted from the failed part in order to ensure that the material mentioned by the manufacturer demonstrated the same metallurgical properties. For the me

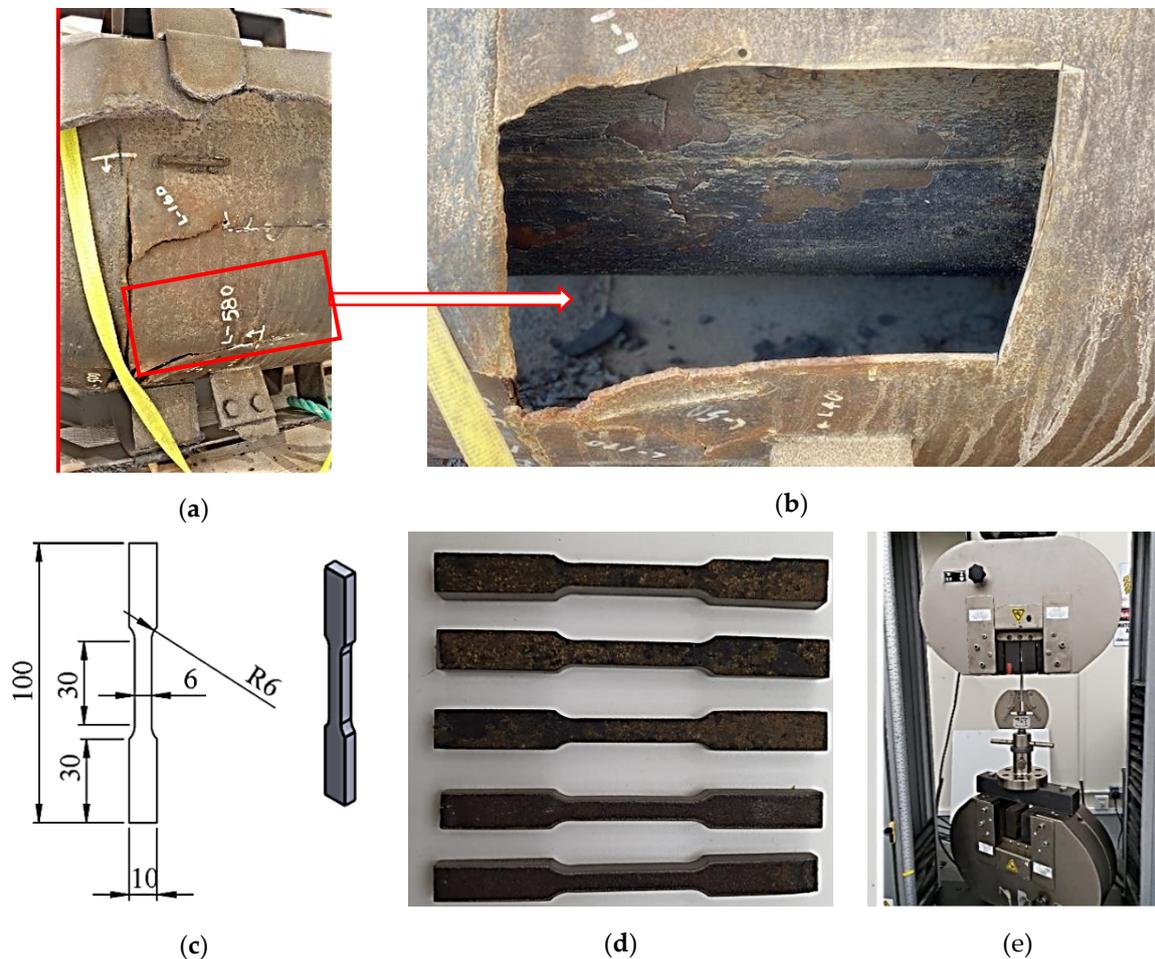
**Figure 4.** Specimen preparation for tensile test: (a) The flare tip region where the plate was cut. (b) The flare tip after the plate was removed. (c) The dimensions of the tensile test specimen. (d) The machined tensile test specimens. (e) Tensile test setup.

Five specimens were prepared for the tensile test, three specimens for a region near to the cracks and two specimens for a region far from the cracks. A crosshead speed of 2 mm/min was used for the tensile test. Brinell hardness test (HB) was also conducted at at least ten different points on each specimen. Table 1 shows the materials used for different components of the flare.

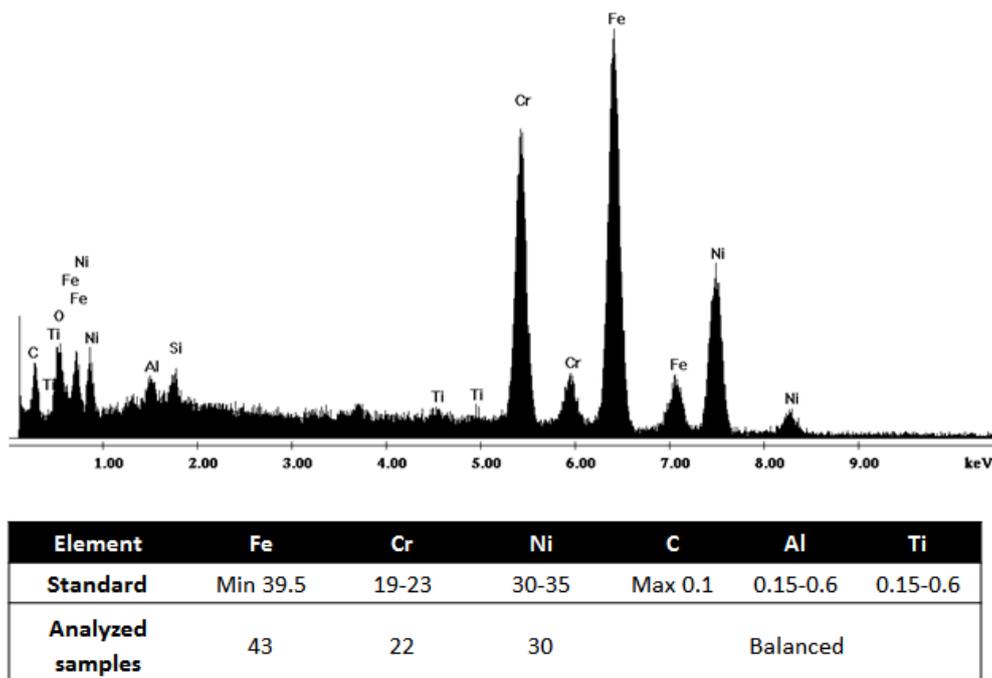
Figure 5 shows the chemical composition of the Incoloy 800H based on the standard and the analysis performed on the samples in this study. The chemical composition of the flare upper body and wind deflector was analyzed using EDS, and the results are compared with the chemical composition of the Incoloy 800H (based on the standard) for comparison. From the EDS analysis, the main elements of Incoloy 800H, i.e., Fe, Cr and Ni, can be detected, as shown in Figure 5, which is in accordance with the weight concentrations based on the standard. It is worth noting that the presence of other elements such as Al, Ti and C can also be detected by EDS analysis, as shown in Figure 5, though their weight concentration cannot be identified correctly using EDS due to the semi-quantitative analysis of EDS. Meanwhile, from the EDS analysis, the presence of oxygen can be attributed to surface oxidation of the materials, which might be one of the possibilities of failure.

Figure 5. Chemical composition of the reference material as well as the samples using EDS analysis.

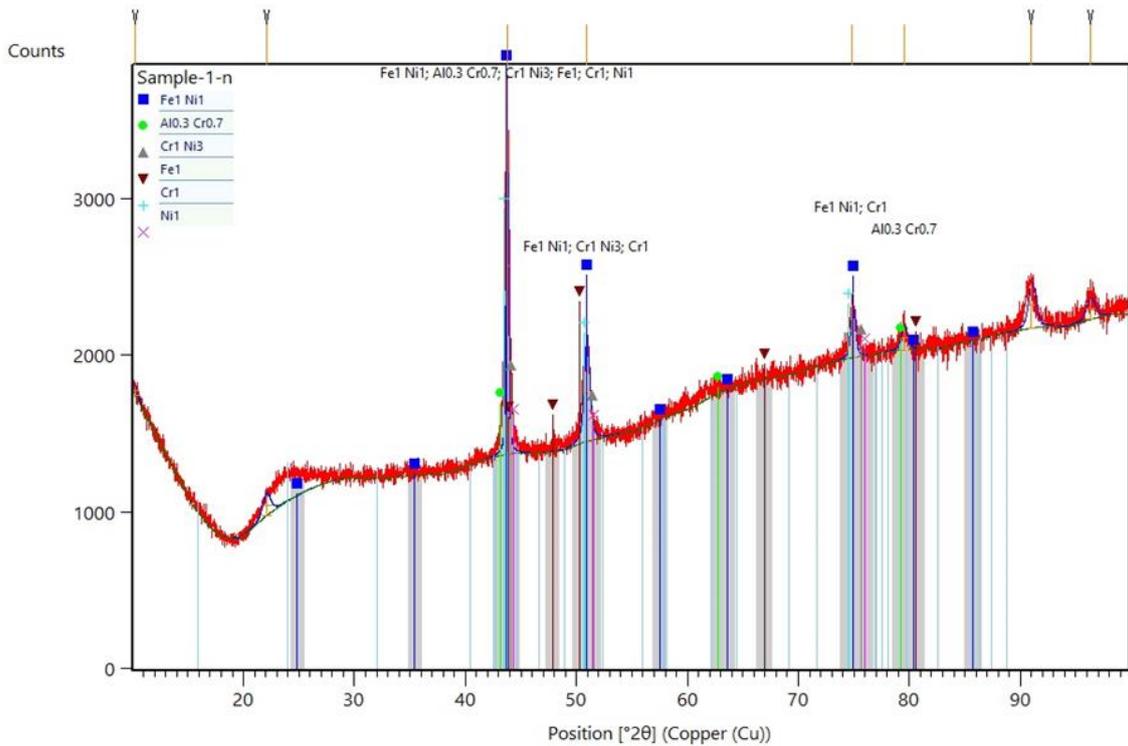
Figure 7 shows the XRD analysis performed on the samples. Not only was the presence of main phases probed, including Ti, Cr and Ni, but some other intermetallic compounds such as FeNi,  $\text{Al}_0.3\text{Cr}_0.7$  and  $\text{CrNi}_3$  can also be traced from the XRD results. By taking into account the microstructural characterizations made in this study, it can be concluded that the material used in this study truthfully manifested the same microstructural properties as the reference material. Thus, the

possible reason for the failure might be related to the operation condition of the flare as well as an improper selection of the materials used for flare parts, which will be discussed later.

**Figure 7.** XRD analysis of the samples, demonstrating the presence of individual main elements including Fe, Cr, Ni and the intermetallic compounds.
