# Preliminary Studies of the Durability of Tools Used to Form Ceramic Tiles Made of Hardox 600 and NC11LV Steel

**Abstract:** The study performs a comparative analysis of the wear of tools made of two wear-resistant materials: steel Hardox 600 and NC11LV, used in the process of forming a band for roofing tiles. The analyses were to allow the assessment of the possibility of replacing the standard material for tools in this process with a much less expensive tool steel for cold work after heat treatment (with a large number of carbides), as an alternative material dedicated to tools resistant to intense abrasive wear. The performed investigations included a macroscopic and geometrical analysis with the use of 3D scanning, microstructural analyses conducted by means of a light microscope, as well as an analysis of the topography of the working areas of the tools with the use of SEM, and microhardness tests. The obtained results demonstrate that the tools made of both materials were characterized with a similar level of wear, which, in the most critical area, reached over 4 mm, while the tools made of steel NC11LV worked over a much longer period of time without regeneration, equalin

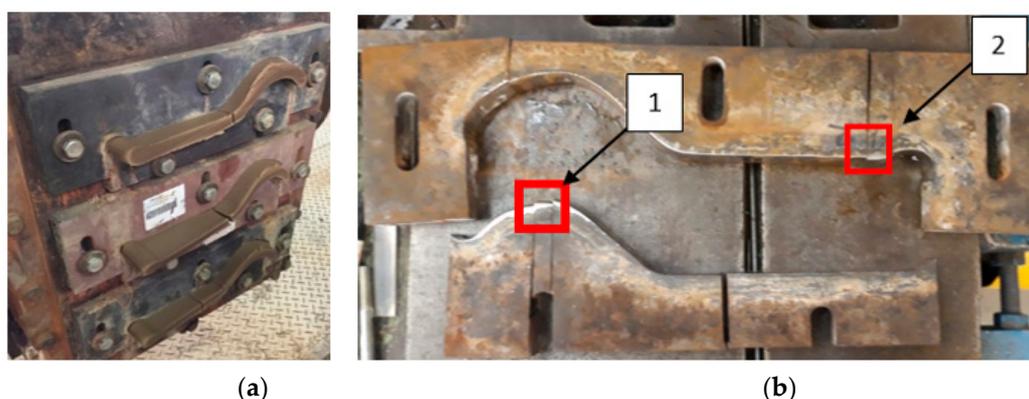
Figure 1 shows a photograph of tools used to form a clay band in the process of manufacturing ceramic tiles. The inserts are elements which are especially problematic due to the intensive wear of their working areas, which are in contact with the band of the formed clay. The materials used for the tools are characterized by high abrasion wear.

**Figure 1.** Photographs of: (a) inserts forming the clay band during operation; (b) upper and lower tools with marked areas from where test samples made of steel NC11LV were collected.

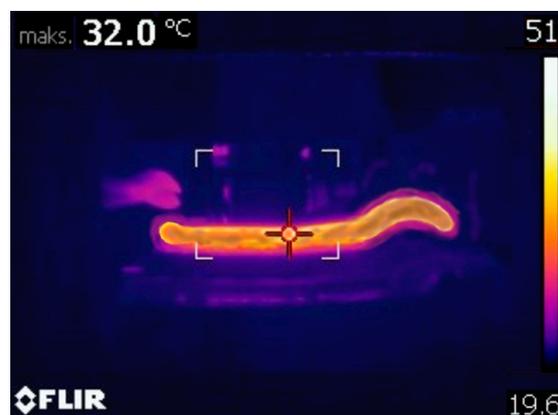
**Figure 3.** Thermovision analysis of the clay band and tool set.

This temperature is caused by friction as a result of its being compressed in the band stamping press and in the pug mill, while, on the surface of the edges of the inserts, the temperature is several degrees higher as a result of additional friction and amounts to over 40 °C. This temperature was observed during the entire production for both tool sets. The higher temperature on the tools should positively influence the impact strength, which, in this type of process, can increase the tool life.

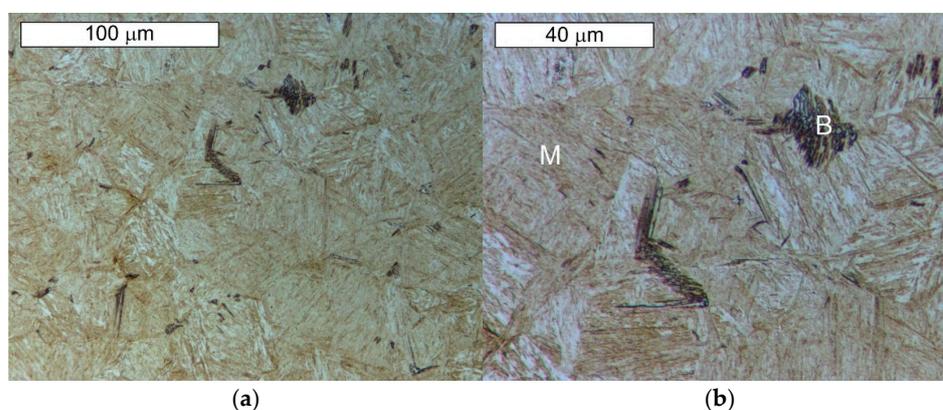
**Figure 7.** Microstructure of the examined Hardox steel obtained from sample 1: (a) visible tempered martensite (M) with locally occurring bainite (B); (b) magnified fragment of the area from Figure 7a. Light microscopy, etched state.

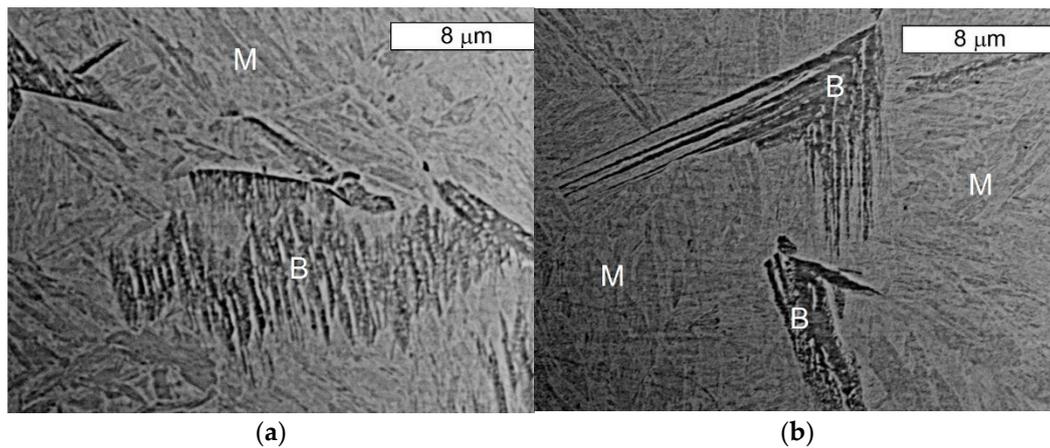
**Figure 8.** Microstructure of the Hardox steel obtained from sample 1: (a) visible bainite (B) with features typical for lower bainite on the tempered martensite matrix (M); (b) visible bainite (B) with features typical for upper bainite on the tempered martensite matrix (M). SEM, etched state.

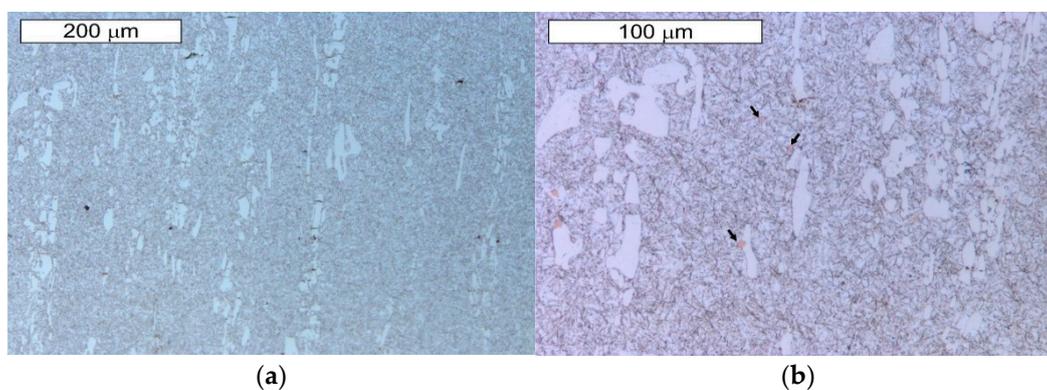
**Figure 11.** Microstructure of the examined steel X153CrMoV12 obtained from sample 1: (a) visible primary carbide precipitations arranged according to the plastic working direction in the martensitic matrix; (b) magnified fragment of the area from Figure 11a. Visible single nitride precipitations in the microstructure of the material (marked with an arrow). Light microscopy, etched state.

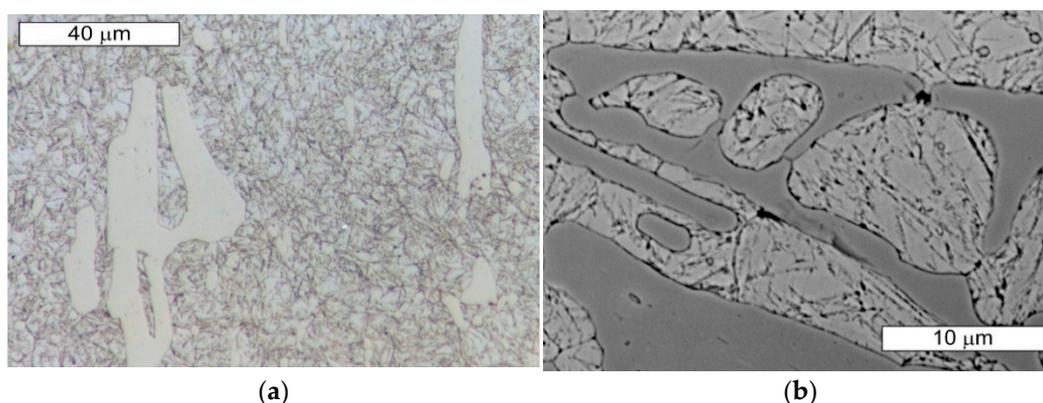
**Figure 12.** Magnified fragment of the area from Figure 11. Visible large primary carbide precipitations in the tempered martensite matrix; etched state: (a) light microscopy; (b) SEM.

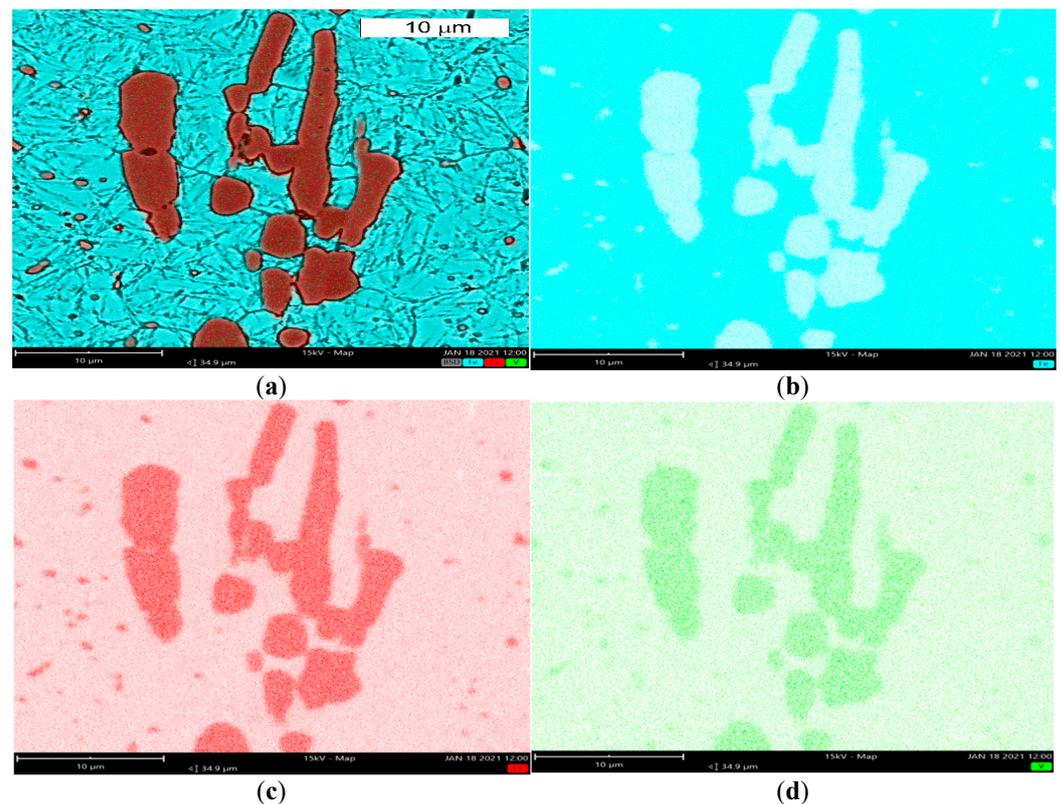
**Figure 13.** Element distribution in the microstructure area: (a) microscopic image with Fe, Cr and V distribution, (b) iron distribution, (c) chromium distribution, (d) vanadium distribution. SEM/EDX.

Chromium and vanadium were identified in the chemical composition of primary carbides. Another factor which ensures high hardness and abrasive wear resistance for these materials is their matrix.

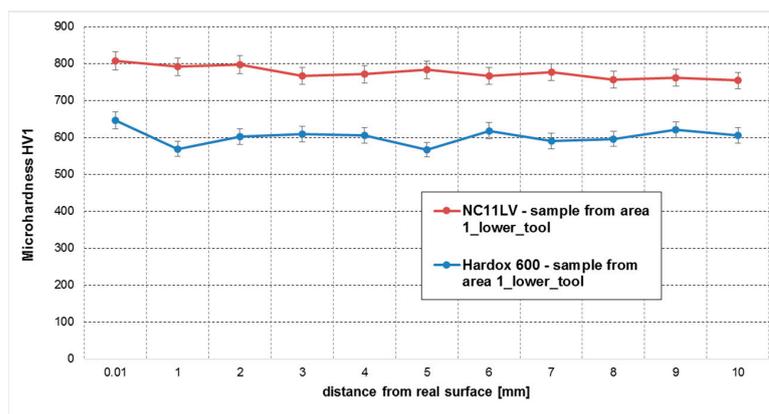
Figure 18. Hardness measurements at a distance from the working surface for area 1 (steels NC111LV and Hardox).

In the case of hardened NC11LV steel, we can observe that the material's hardness drops slightly with the increasing distance of the measurement points from the edges of the insert. The hardness in the surface layer of the inserts reaches the level of 807 HV, which can point to reinforcement of this steel as a result of high pressures coming from abrasion. We also have to consider the possibility that a slightly higher hardness is connected with a higher value of internal stresses occurring after hardening, which result from a more rapid quenching taking place in the surface areas. Further into the material, the hardness stabilizes at the level of about 770 HV. A sample collected from the lower part of the insert made of Hardox 600 steel is also characterized by a stabilized hardness, regardless of the distance from the edge shaping the band. In the examined sample, the hardness oscillates in the range from 566 to 646 HV1. In the case of the insert from this material (Hardox), the obtained results are in accordance with the data provided by the manufacturer.

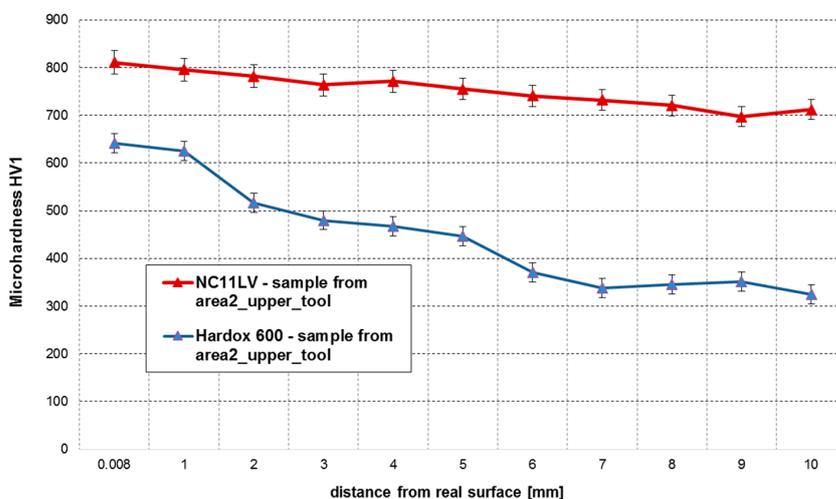
Figure 19. Hardness measurements at a distance from the working surface for area 2 (NC111LV and Hardox 600 steels).

In the analysis of the results obtained for the upper tools (Figure 10), we can notice that, in the case of the insert made of NC11LV steel, again, the maximal hardness reaches the level of over 800 HV1. The hardness of this insert, starting from the working surface, begins to drop to 700 HV1 towards its inside. In the case of Hardox 600, very big discrepancies between the particular hardness measurements were observed in a sample collected from the upper half of the insert. In the layer by the shaping area, the recorded hardness values were at the level of 641 HV1, and they gradually dropped with the increasing depth of the material to the level of 325 HV1.
