Evaluation of the Effectiveness of Trail Repair Works Based on Three-Dimensional Monitoring around Mount Kurodake, Daisetsuzan National Park, Japan

Yusuke Kobayashi ¹ and Teiji Watanabe ^{2,*}

Citation: Kobayashi, Y.; Watanabe, T. Evaluation of the Effectiveness of Trail Repair Works Based on Three-Dimensional Monitoring around Mount Kurodake, Daisetsuzan National Park, Japan. *Sustainability* **2023**, *15*, 12794. <https://doi.org/10.3390/su151712794>

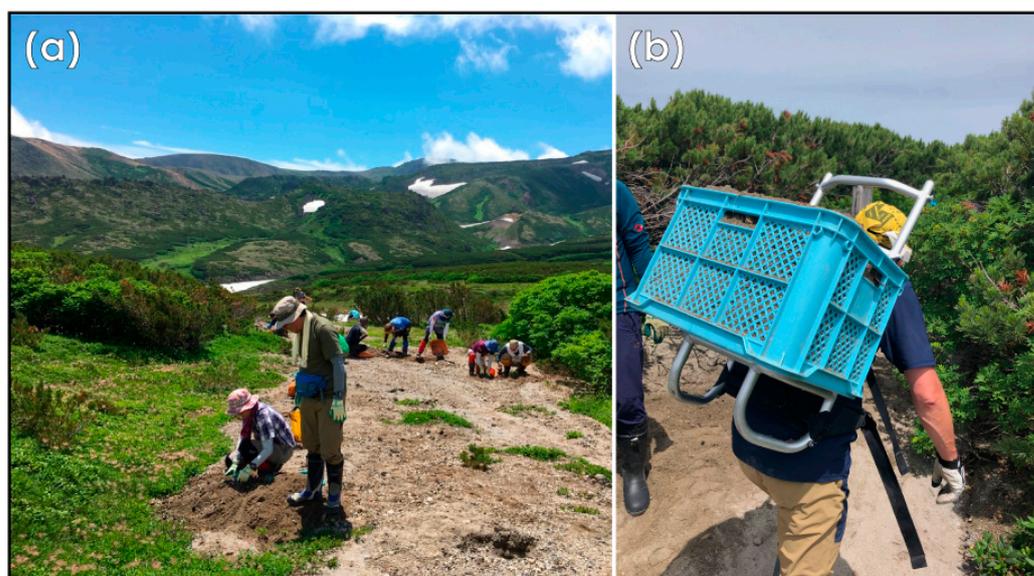
The eroded soil flowed 50–60 m downward and covered the alpine vegetation, as previously stated (Figures 2 and 3). The first repair in 2017 involved removing the sediment from the deposited area (Figures 2a and 6a) and transporting it back to the eroded section (Figures 2a and 6b). The volunteers were briefed by a technical specialist belonging to *Yamamoritai* before work began. The technical specialist not only explained the workflow, but also explained why serious erosion occurred in Daisetsuzan National Park. The technical specialists emphasized the importance of observing the volunteers. The volunteers were divided into three teams based on their roles. The first team packed the sediment into palm-fiber bags (Figure 6a). Attention was paid to the alpine vegetation buried by the sediment flowing from the upper section of the trail and not to include the vegetation under the sediment in the palm-fiber bags. The second team transported the palm bags filled with soil to the upper section (Figure 6b), and the third team placed the soil-filled palm-fiber bags in the upper section (Figure 5). Volunteers from the trailhead carried out the palm-fiber bags used for the repairs. Palm-fiber bags are lightweight and easy to carry. Because the site is in the special protection zone of the national park (Figure 1a), as well as in the Daisetsuzan Grade 3 section, only the minimum necessary repairs were performed to protect the pristine natural landscape. Therefore, no materials from the outside were used, except for the natural palm-fiber bags.

Figure 6. Involvement of volunteers: (a) volunteers packed the sediment into palm-fiber bags in the sedimented area and (b) volunteers transported the soil-filled palm bags to the upper section in the plastic case.
