# Article Construction Techniques and Detailing for Romanian *Paiantă* Houses: An Engineering Perspective

# 1. Introduction

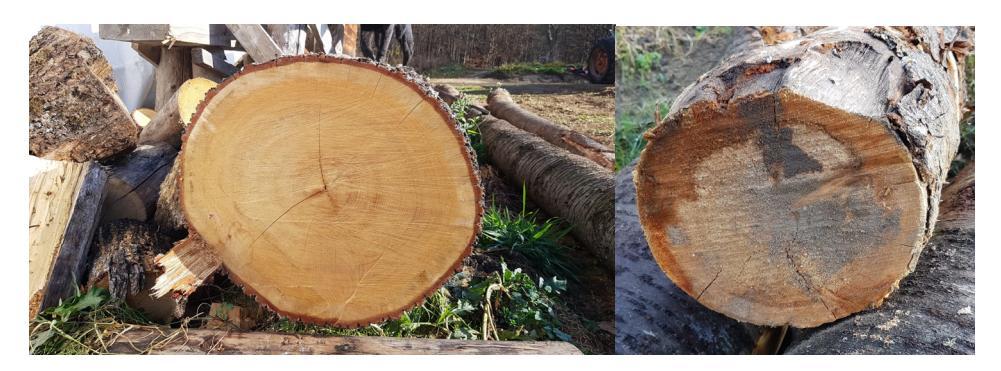
the trees on the top of the hills, the most exposed to wind, growing slower than the other, had the densest fiber. The timber was cut in the winter, when the trees have less sap. If the cut is made in the summer, the timber cracks significantly and this later facilitates the occurrence of biological decay [20]. The bark should be removed soon after cutting, so that the wood would dry faster and not rot. Figure 9 shows a good quality wood tree (left) and a bad quality one, showing rotten areas (right).

Figure 9. Wood for construction, good quality (left) and bad quality-for fire (right).

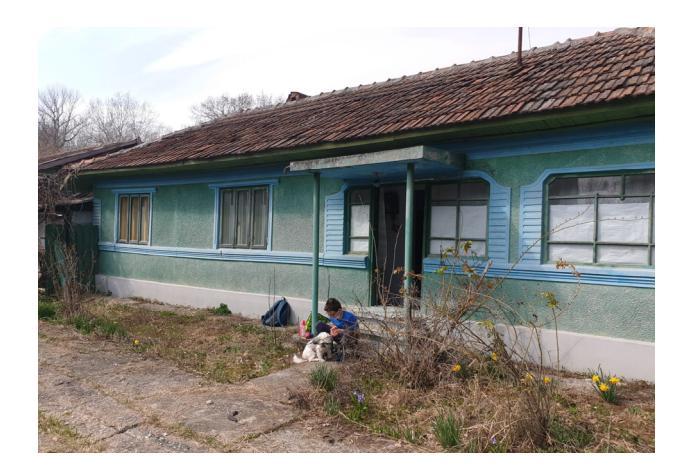
Figure 24. House 1, Tufani Village, Prahova County.

The configuration of the structure showed a ductile behavior in previous seismic events. No typical seismic damage was observed, but only degradations due to water infiltrations and lack of maintenance. Even with the timber skeleton partially degraded and the brick masonry infill also partially damaged, the house is still able to withstand seismic motions. The key feature of this type of *paianta* is the timber frame flexibility, and the infills capacity to prevent excessive deformation of the frame. The two component materials are generally not tightly interconnected; thus, through the cracks in the mortar joints of the infills and by the deformations of the timber connections (which usually have gaps from the poor execution), the earthquake energy is dissipated and the house resists seismic actions. Another very important structural feature is the presence of the braces, which have a significant contribution to the overall capacity (almost doubling it, as it resulted from experimental tests [40]), although they are connected below the upper corner joint of the timber frame.

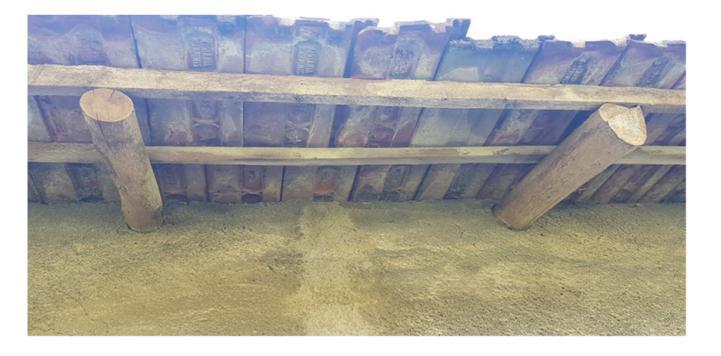
The house has a hip **roof**, made up of rounded and peeled timber elements, joined by means of clamps and nails. The rafters of the roof truss are made of 12 cm-diameter round timber, spaced at about 90–100 cm (Figure 25). On the rafters there are battens with a section of  $3.8 \times 5.8$  cm, spaced at about 25–30 cm apart, which support the tile covering of the roof. The tile covering consists of ceramic tiles, about  $40 \times 22$  cm in size, produced at Cărpiniş Brick Factory.

Figure 25. Roof cover supported on the batten network that transmits loads to the rafters.

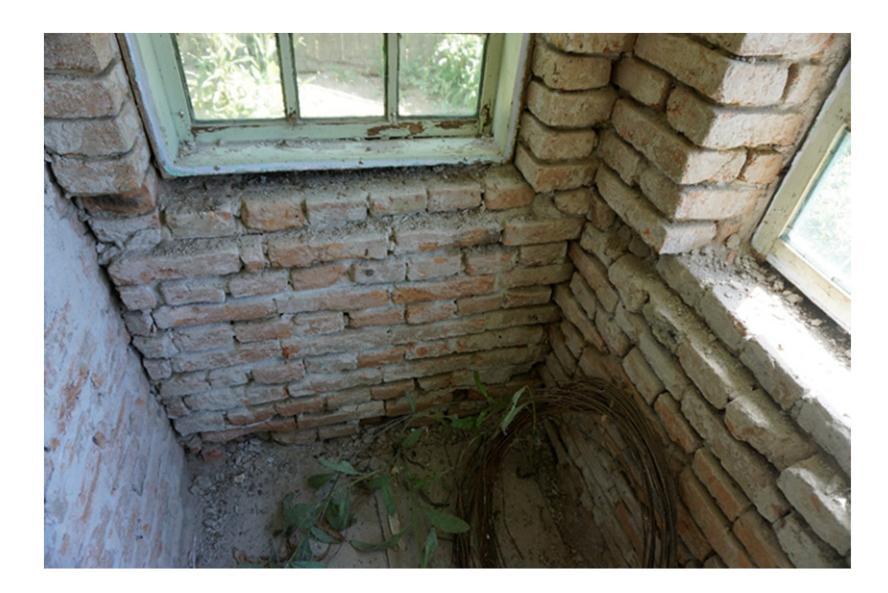
The envelope walls in axis A and between axes 4 and 5, respectively in axis 5 and between axes A and B, are made of plain burned clay solid brickwork ( $240 \times 115 \times 63$  mm) with a thickness of one brick (Figure 30). The rest of the walls of the house (placed on both directions) have a mixed structure, consisting of timber frames with braces (made of  $8 \times 8$  cm pieces of squared timber) and infilled with solid clay brick masonry ( $240 \times 115 \times 63$  mm) with a thickness of  $\frac{1}{2}$  brick (Figure 31).

Figure 30. Envelope walls of one-brick thick masonry.

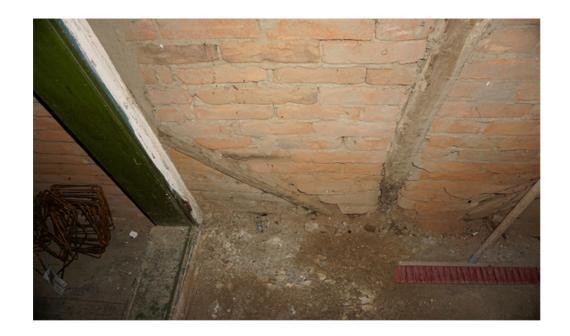
**Figure 31.** Walls with mixed composition, having a frame structure made of pieces of squared timber, braced, and  $\frac{1}{2}$  brick masonry infill.

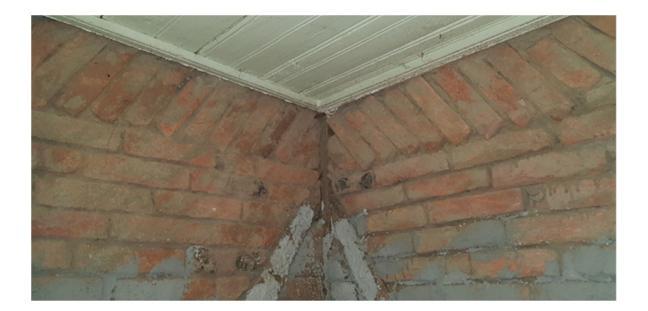
In the case of walls with timber frame, the infill masonry is laid along the height of the panels, with the exception of the last portion under the top plate, where the ceramic elements are arranged in an inclined position (Figure 33).

Figure 33. Arrangement of bricks at the top of the masonry panels.

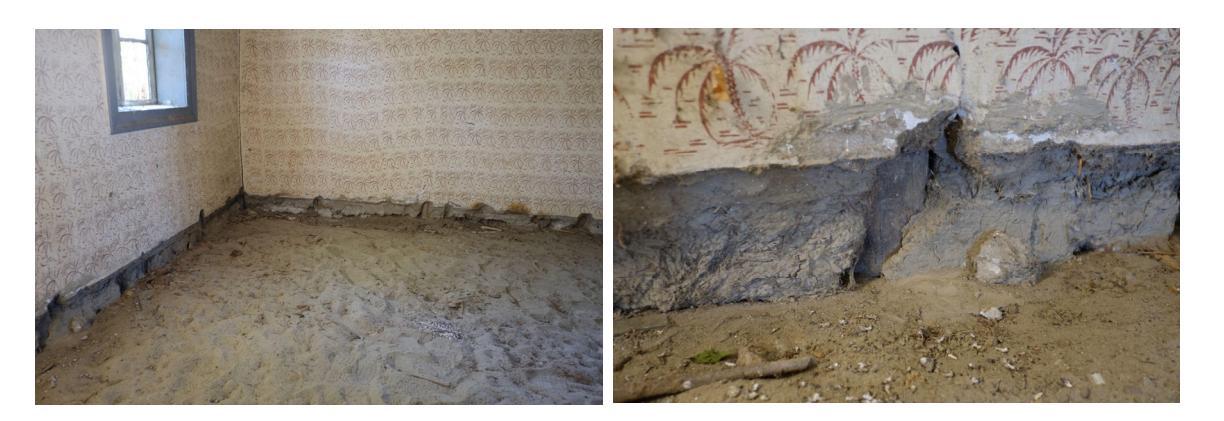
Inside the building, the **finishing** is original, made of mud and straw mortar (Figure 47). The floor decking was laid directly on the sandy soil specific to the area. In the same figure, the soil is visible, since the floor was removed in an attempt to retrofit the house.

**Figure 47.** The missing floor decking reveals the earth and straw infill between the posts at the bottom part of the wall plaster.

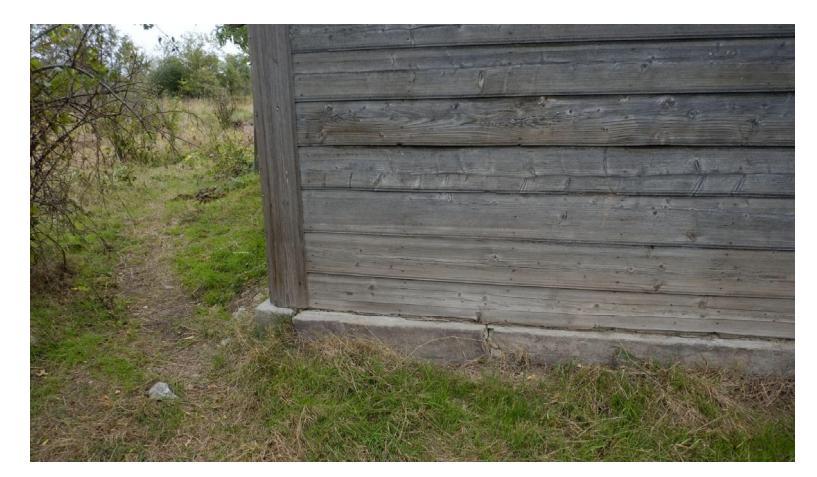
However, for this house, it seems that a concrete socle was added later on the outside part of the house, in an attempt to strengthen the structure (Figure 48). In fact, this was an inappropriate intervention, enhancing the capillary action, which further damaged the planks of the facade and the bottom of the posts.

Figure 48. Concrete socle (retrofitting tentative).

The repairing process proposed for House 3 aims to restore the house to its initial structural state by removing the inappropriate additions and replacing the deteriorated parts. According to [20], the restauration works will consist of giving the structural elements their original strength, within the prevention and conservation objective. The restoration process allows structural additions, such as timber braces, when proved necessary by the structural evaluation done by an expert. Some of the most common works will be replacing the roof cover, repairing the affected post and the façade in the corresponding area, removing the concrete socle, creating a sidewalk and adding gutters continued by downspouts to drain the water away from the bottom part of the house.

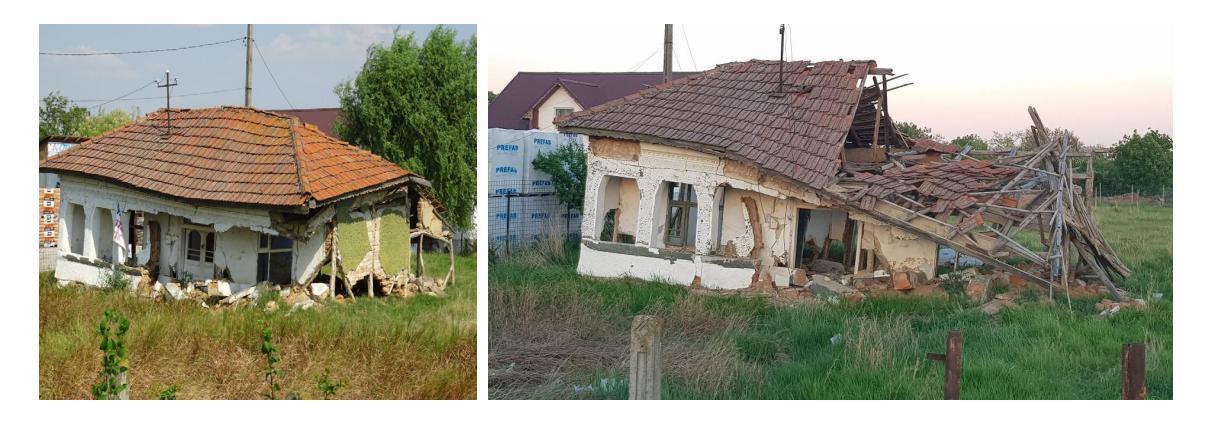
Unfortunately, more and more traditional houses are abandoned in Romania nowadays, for various reasons. Often, after local owners have passed away, their inheritors, having moved a long time ago to urban areas, either disregard the houses for their obsolescence, or they completely ignore the way of retrofitting them (or do not afford to do it), in order to provide the comfort and safety according to modern needs (indoor bathroom, thermal efficiency, water and sewage facilities, non-conventional sources of energy etc.). An example of what happens to abandoned houses is shown in Figure 68, where the same house was photographed five years apart, in 2017 and 2022. The front right corner of the house failed, dragging the roof with it, which led to a general collapse. The failure reasons may be either the biological decay of the mudsill or of the bottom of the corner post, or some differential settlements of the foundation. Whichever the case, this collapse could have been avoided by timely retrofitting measures.

Figure 68. Costești, Buzău County, August 2017 (left) and August 2022 (right).
