Research on Silicone Rubber Sheds of Decay-Like Fractured Composite Insulators Based on Hardness, Hydrophobicity, NMR, and FTIR

Keywords: composite insulator; decay-like fracture; silicone rubber shed; aging

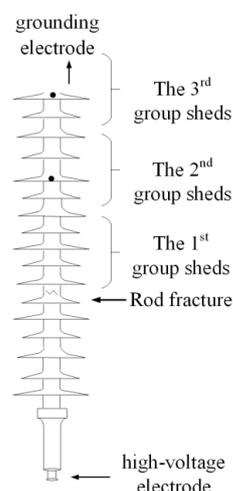
The diagram of the fractured composite insulator is shown in Figure 2. The appearances of decay-like fractured insulators are shown in Figures 3 and 4, and Figure 5 shows the appearance of 2# insulator.

Figure 2. Fracture diagram of composite insulator.
