Case Report

Bank Protection Structures along the Brahmaputra-Jamuna River, a Study of Flow Slides

Maarten van der Wal

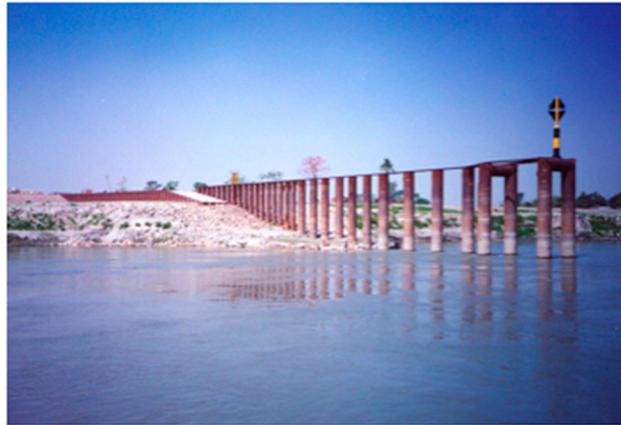
The three main, permeable groynes have tubular steel piles with a diameter ranging from 0.71 to 1.22 m, the permeability ranges in four sections from 80% at the head via adjacent sections 70% and 60% to a section with 50% permeability at the transition to an impermeable shank, see groyne G-1 in Figure 6. This variation in permeability had been designed to reduce the flow velocities from the head of a groyne to the embankment, the high permeability at the head should contribute to a shallow local scour hole. In the design of the test structure, it was decided to reduce the length of the piles by adding a falling apron and a bed protection around the pile row and the shank.

Figure 6. Kamarjani test site groyne G-1 consists of a 6-m-long steel sheet pile cofferdam protected by falling aprons and a row of 32 tubular steel piles, after completion construction during low water season in 1994/1995 (photograph: project FAP21/22).

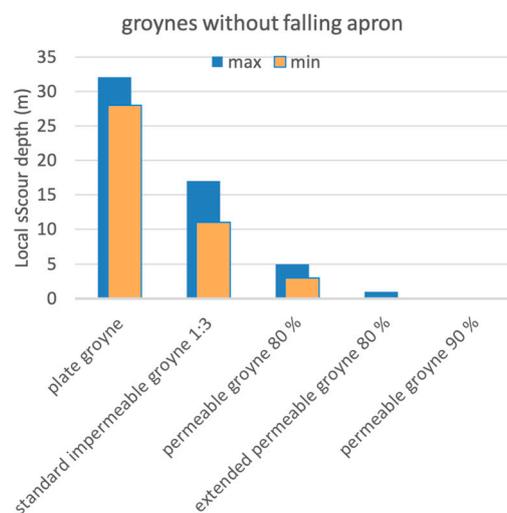
Figure 7. The maximum local scour depth near different types of groynes without falling aprons in physical model tests.

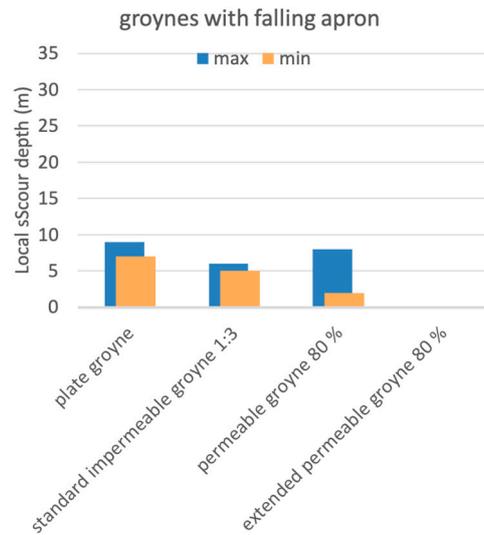
Figure 8. The maximum local scour depth near different types of groynes with various types falling aprons in physical model tests.

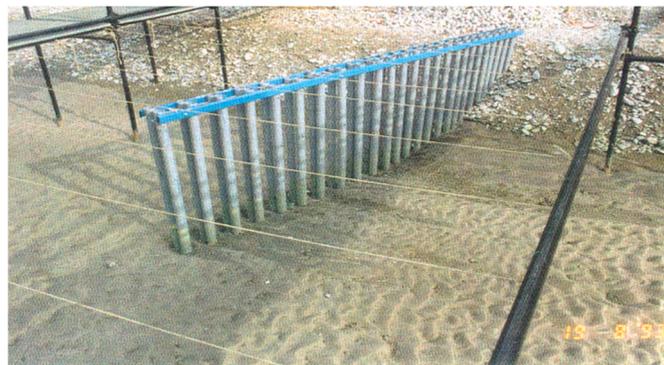
Figure 9. Small local scour hole (0 m to 1 m) near a pile row without bed protection or falling apron, only some scour around the piles, test C-T2-1 in Compagnie Nationale du Rhone (CNR), France [40], (photograph taken by CNR for project FAP 21/22).

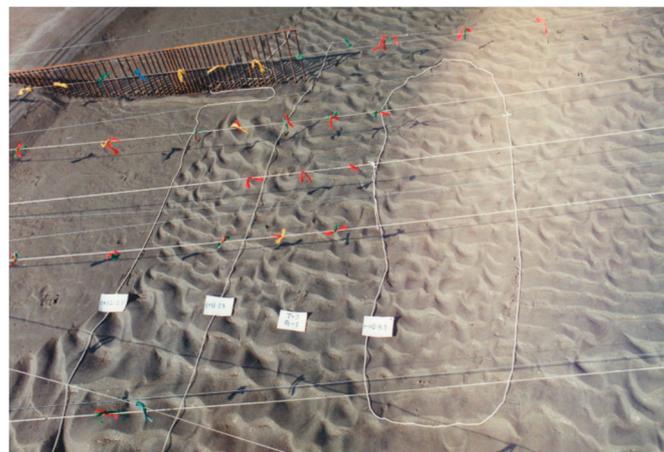
Figure 10. No local scour hole but only a shallow and wide interaction scour (about 3 to 4 m deep) due to the stopped bank erosion in the outer bend near repaired and extended pile row groynes without bed protection and without falling apron, test R-T3-2 at RRI, Bangladesh [39], (photograph taken by RRI for project FAP 21/22).
