# Damage Assessment of Road Bridges Caused by Extreme Streamflow in Montenegro: Reconstruction and Structural Upgrading

**Abstract:** The extreme river streamflow that occurred during floods in 2010 in Montenegro caused significant damage to infrastructure and road facilities. The most severe damages were located on bridges crossing the river Lim, where a rapid water level increase in several municipalities led to failure or damage of almost 20 bridges. In this paper, a damage assessment of four significantly damaged reinforced concrete (RC) bridges, located in the affected zone of 40 km, is conducted. One bridge in Berane (bridge 1) and three bridges located on roads upstream from Berane (bridges 2, 3, and 4) were analyzed. Extreme water levels and inadequate flow profiles caused great damage to the bridges of which the piers were not adequately founded. A scouring process under the foundation of piers and abutments located in the riverbed occurred due to surface erosion and degradation of alluvial sediments. Applied methods and techniques for reconstruction and structural strengthening of bridges are presented in detail as well as results of conducted analyses of the design reco

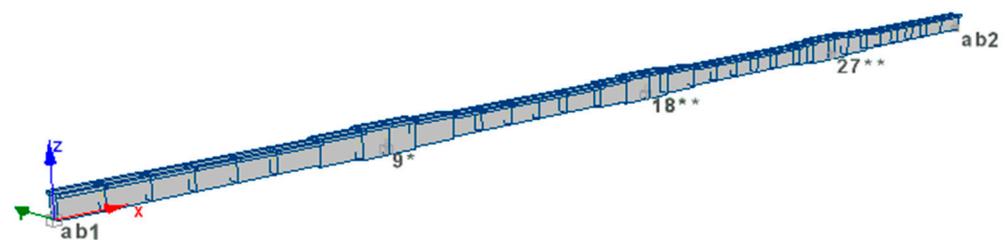
In order to design the appropriate structural strengthening of the damaged bridge 1 as well as to obtain a real distribution of action effects in the bridge 1 for the new damage state, a nonlinear analysis of the bridge 1 due to the settlement of the river pier was performed. A schematic representation of the model is shown in Figure 6.

**Figure 6.** Schematic representation of bridge 1 nonlinear model (\*, \*\* nodes at the bents).

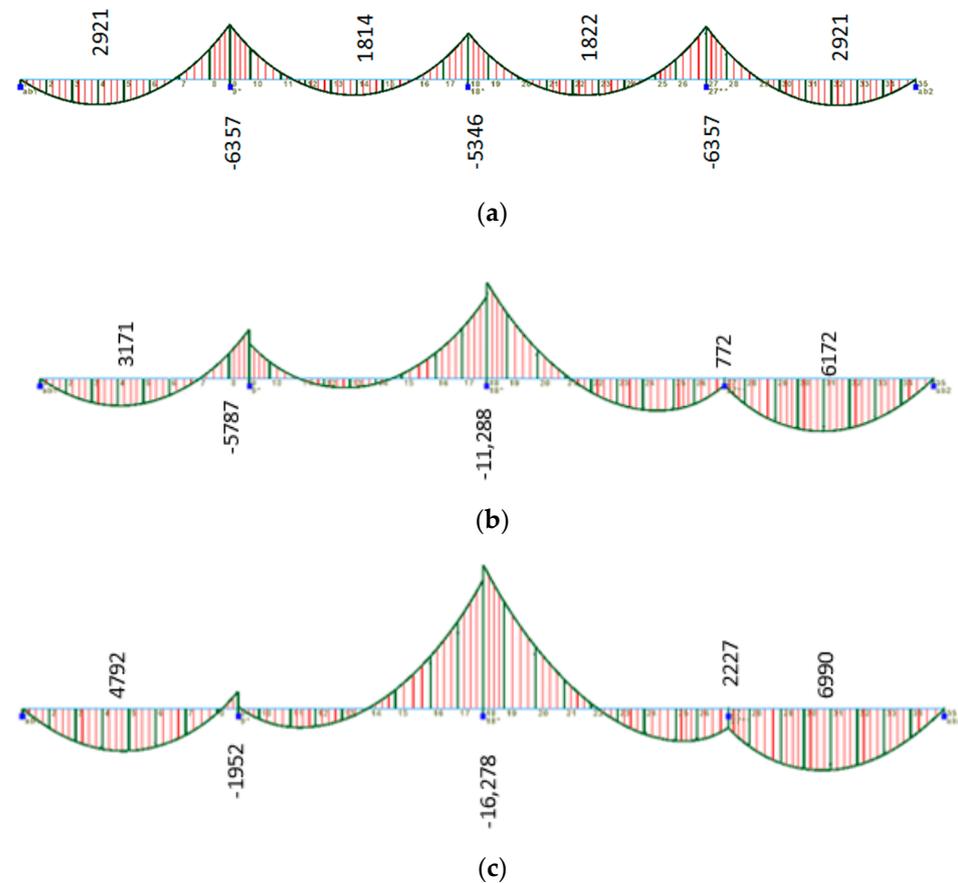
Bridge bending moment diagrams in the downstream girder for several settlement values under the pier S3, including permanent gravity loads, are presented in Figure 7b,c. The initial state shown in Figure 7a refers to permanent gravity loads acting on the deck structure.

As expected, the increase in negative bending moments at the cross-section above pier S2 up to 3 times, as well as a decrease in the negative bending moments at the sections near pier S3 and even their transformation to the positive moments for the significant values of settlement is noticed. The bending moment at the bottom edge in the last span (S3-S02) also increased up to 2.4 times.

**Figure 7.** (a) Bending moment diagram—initial state (units in  $\text{kN}\cdot\text{m}$ ). (b) Bending moment diagram—settlement of 0.14 m under S3 (units in  $\text{kN}\cdot\text{m}$ ). (c) Bending moment diagram—settlement of 0.71 m under S3 (units in  $\text{kN}\cdot\text{m}$ ). (\*, \*\* nodes at the bents).

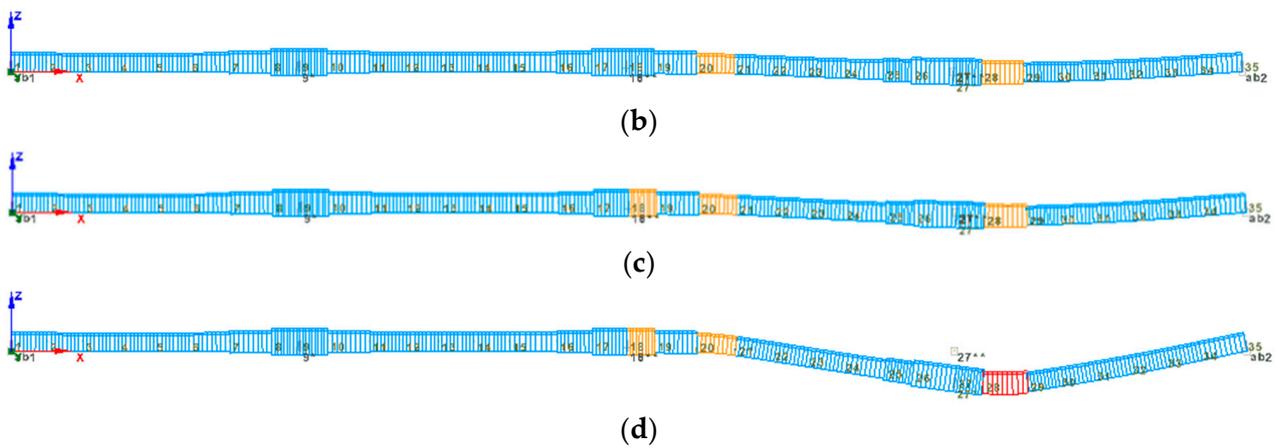
During the loading phases, two performance criteria are defined: the reinforcement yield and the chord rotation capacity. The reinforcement yield is considered to be reached when reinforcement strain exceeds the value of 0.0012. The chord rotation capacity is calculated based on EN 1998-3:2005 Annex A [52]. The load is applied as displacement below the pier S3 that simulated the foundation settlement in steps of 0.01 m. The results show that reinforcement yield occurred in the next order: (1) at node 28 located 2.35 m from pier S3, at the settlement of S3 pier of 0.14 m; (2) at node 20 located 5.9 m from pier S2, at the settlement of S3 pier of 0.48 m, and (3) at node 18 located above S2, at the settlement of S3 pier of 0.65 m. Chord rotation capacity was reached at node 28 for settlement of S3 pier equal to 0.71 m. Figure 8a–d shows a schematic bridge deformed shape at the analysis step when checked performance criteria are reached.

**Figure 8.** (a) Step 15: the reinforcement yield at 2.35 m from S3 pier for 0.14 m settlement of S3 pier. (b) Step 49: the reinforcement yield at 5.9 m from S2 pier for 0.48 m settlement of S3 pier. (c) Step 66: the reinforcement yield above S2 pier for 0.65 m settlement of S3 pier. (d) Step 72: the chord rotation capacity reached 2.35 m from S3 pier for 0.71 m settlement of S3 pier. (\*, \*\* nodes at the bents).

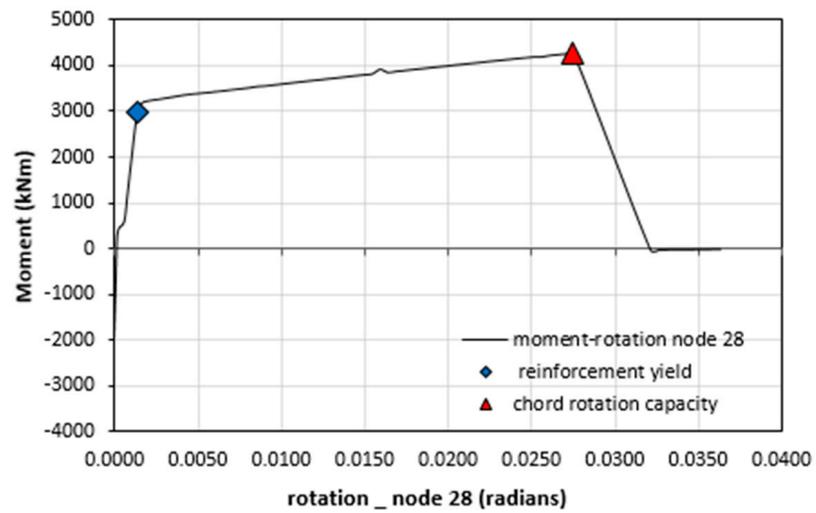
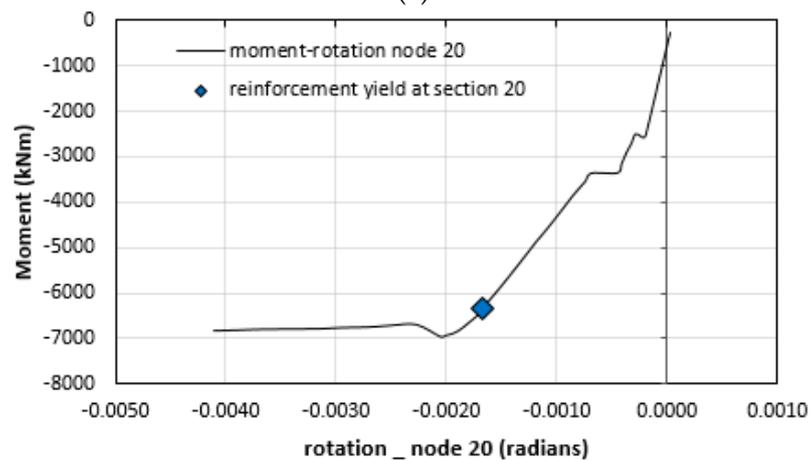
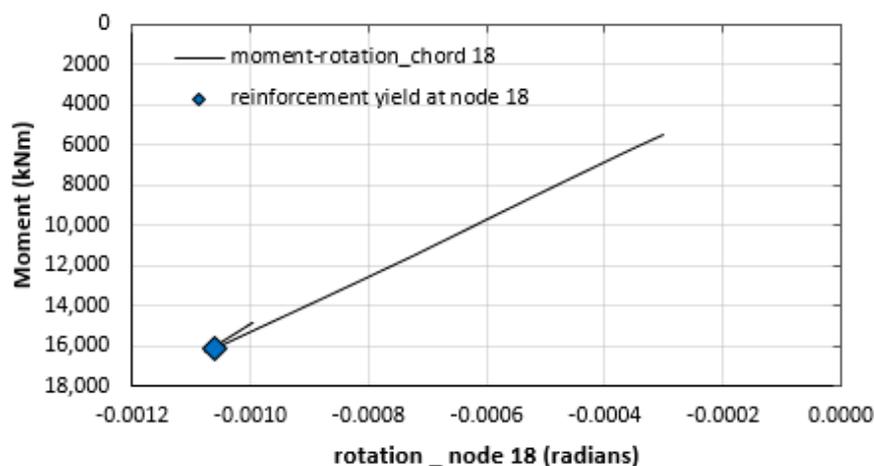
Figure 9 shows the bending moment-rotation diagrams for nodes 28, 20, and 18. The points of reaching performance criteria are marked on the charts.

**Figure 9.** Moment rotation curve for nodes (a) 28, (b) 20 and (c) 18.

It can be concluded that sections in which significant reinforcement yielding occurred in a nonlinear model (zones of nodes 28, 18, and 20) correspond to the cross-sections in which the damage occurred in the bridge (zone 1 and zone 2). In the zone of node 28 corresponding to zone 1 of bridge damage, the rotation capacity was reached, which clearly indicates the complete plastification of the plastic hinge. This was obvious from in situ bridge damage in zone 1 where the cracks about 15–20 mm wide opened in the bottom zone, while the concrete in the upper zone was crushed. In zone 2, where less damage was occurred compared to zone 1 (in the form of cracks in the upper zone, while in the bottom zone no crushing of concrete was observed in the main girders), the plastic hinge formation occurred but rotation capacity was not reached (10% of the rotation capacity was reached). This state of damage also corresponds to in situ bridge damage. Since the rotation capacities were exceeded in zone 1 and the yielding of reinforcement occurred in zone 2, the new structural system of a bridge with joints (in plastic hinge sections) should be considered for designing structural strengthening.

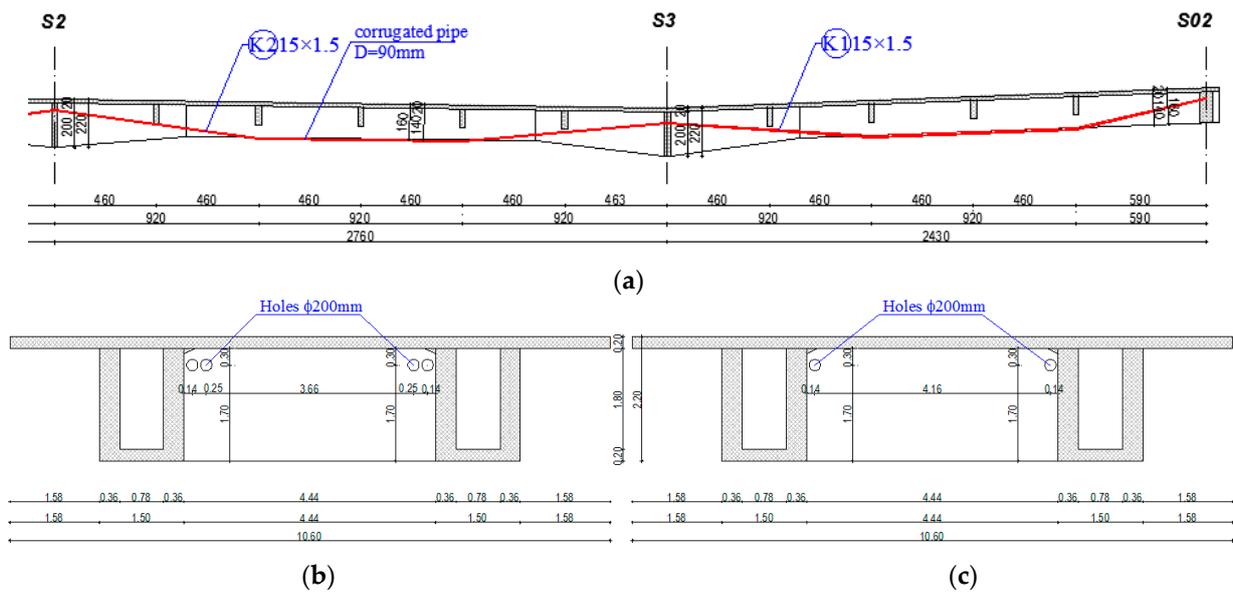
**Figure 10.** Layout of the prestressing cable tendons: (a) longitudinal section (half bridge) and (b) cross-section above piers S2 and S3 and (c) cross-section above pier S1.

Regarding the damages to the bridge deck, the prestressing technique with cable tendons is selected as the solution for longitudinal girder strengthening. This strengthening method had multiple advantages. Even before the damage, the bridge deck structure did not have adequate resistance according to the currently valid domestic provisions adopted after the construction of the bridge. In addition, the formation of two plastic hinges in the bridge deck structure, after the settlement of the river pier, resulted in a redistribution of action effects with the exceeding of the bending moment capacity in several sections.

The arrangement of cable tendons that favorably affects the load-bearing capacity, balances the bridge system, and ensures its adequate resistance was adopted. Two 15 × 155 mm<sup>2</sup> high-grade steel cable tendons of the BBR VT CONA CMI system [54] with a tensile strength of 1860 MPa are used for prestressing. The tendons are placed along the inside part of the main girder (at the supports in the upper zone and in the spans in the bottom zone). The prestressing cable tendons' layout is linear (see Figure 10). One tendon is adopted along each main girder for the entire bridge length, and another two tendons are added in two damaged middle spans (Figure 10). The prestressing is done from both ends. The steel corrugated pipes are used for tendons installation. The deviators have been placed at the span transverse girders to provide adequate eccentricity of the prestressing force (Figure 11). The tendons are embedded into the corrugated pipes and injected with cement emulsion. At the end supports, the existing transverse girders are strengthened to be able to restrain the tendon forces in the anchoring zone. The steel construction of the deviator is designed for the forces caused by tendons (deflection forces and forces caused by friction forces) in tensioning phase and exploitation state using prescribed safety coefficients.

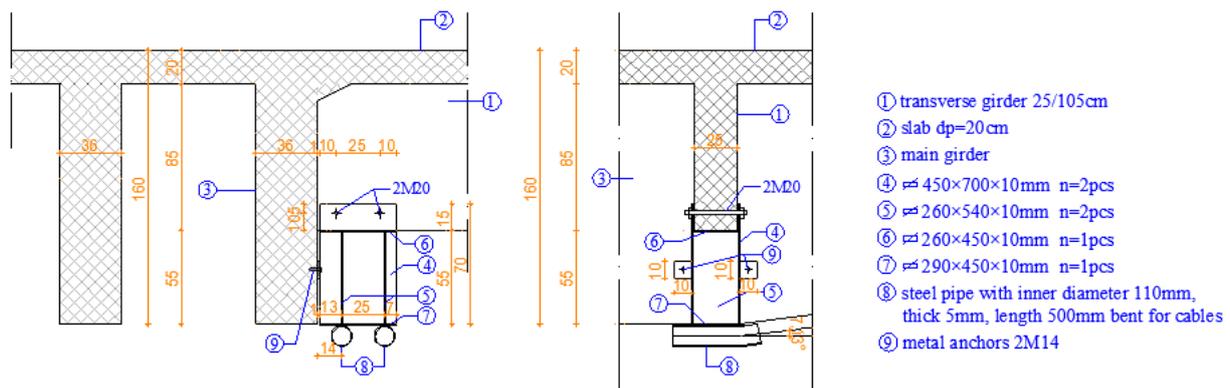
**Figure 11.** Deviator in the span between columns S2-S3 and S3-S02.

For the purpose of verifying the bridge resistance after the adoption of the prestressing cable tendons, a 3D model of the bridge was constructed in the software package TOWER6 [53]. The cables were modeled in the TOWER6 software, taking into account immediate losses (due to friction during cable tension, due to anchoring, and due to the instantaneous deformation of concrete) as well as time-dependent losses. The bending moment demands for the relevant load combination were compared with the capacity moments of the main longitudinal girders for the designed strengthening state (Table 2). For the selected tendons and adopted prestressing forces, the bridge deck structure meets the load-bearing capacity requirements. In addition, the bridge deck structure is strengthened by U-wrapping carbon fibers at the zones of plastic hinge formation for the reason of shear strengthening.

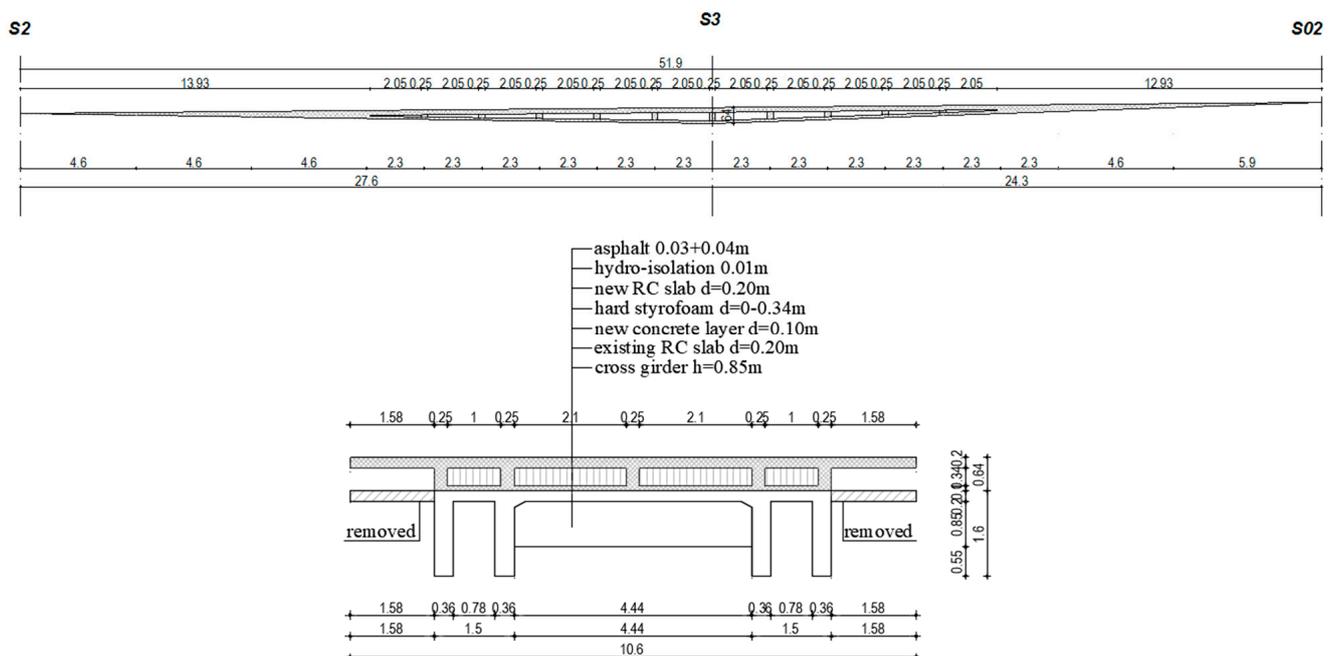
**Figure 12.** The geometry of the RC grill structure.

In order to form the appropriate longitudinal profile level of the bridge at the place of the pier river settlement, a structure of the RC grill beams with a hard styrofoam filling was designed. The geometry of the RC grill structure is shown in Figure 12. The RC grill structure is designed at the settled part of the bridge (between piers S2-S3-S02). The RC grill structure consists of a 10 cm thick RC concrete layer that is placed over the existing RC slab, four longitudinal girders that follow the geometry of the settled alignment, transverse girders that are placed at a distance of 2.3 m, and an upper new RC slab with a thickness of 0.20 m. The bonding of the newly added grill structure was accomplished with steel anchors drilled into the existing concrete and by applying a coating for the bonding of old and new concrete.

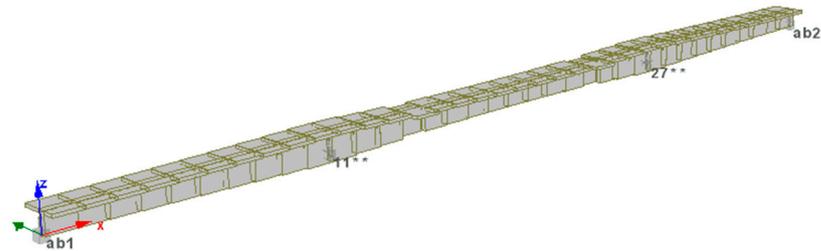
In order to design the appropriate structural strengthening of the damaged bridge 2 as well as to obtain real action effects in bridge 2 for the new damage state, a nonlinear analysis of bridge 2 due to the settlement of the pier was performed. A schematic representation of the model is shown in Figure 17.

**Figure 17.** Schematic representation of the bridge 2 nonlinear model (\*\* nodes at the bents).

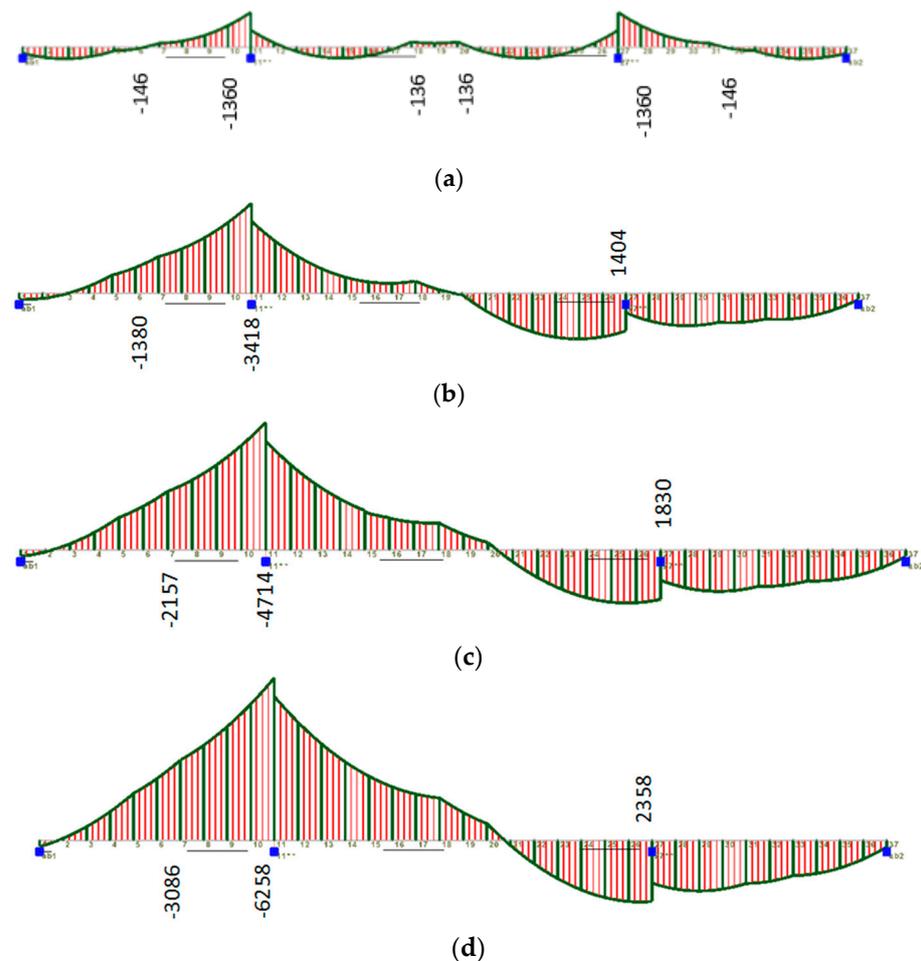
The bridge deck bending moment diagram for several settlement values under the pier S2, including permanent gravity loads, is presented in Figure 18b–d. The initial state shown in Figure 18a refers to permanent gravity loads acting on the deck structure.

**Figure 18.** (a) Bending moment diagram—initial state (units in kN·m). (b) Bending moment diagram—settlement of 0.08 m under S2 (units in kN·m). (c) Bending moment diagram—settlement of 0.20 m under S2 (units in kN·m). (d) Bending moment diagram—settlement of 0.64 m under S2 (units in kN·m). (\*\* nodes at the bents).

As expected, an increase in negative bending moments at the cross-section above pier S1 up to 4.6 times is noticed, as well as a decrease in negative bending moments at the cross-sections near pier S2 and even their transformation to the positive moments for the significant values of settlement. An increase in bending moments at the upper edge in the first span (S01-S1) is also noted.

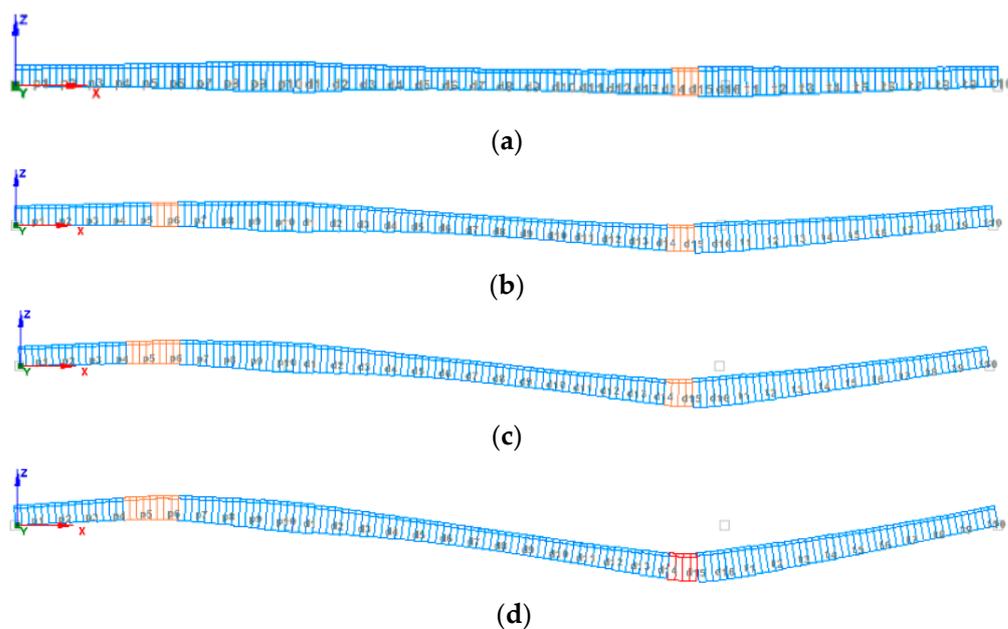
The reinforcement yield occurred in the next order: (1) at node 26 located 1.81 m from pier S2, for settlement of S2 pier of 0.08 m; (2) at node 7 located 10.8 m from left abutment S01, for settlement of S2 pier of 0.20 m, (3) at node 6 located 9 m from left abutment S01, for settlement of S2 pier of 0.32 m and (4) at node 5 located 7.2 m from left abutment S01, for settlement of S2 equal to 0.39 m. Chord rotation capacity was reached at node 26 for settlement of S2 pier equal to 0.64 m. Figure 19a–d show a schematic bridge deformed shape at the analysis steps when checked performance criteria are reached.

**Figure 19.** (a) Step 9: the reinforcement yield at 1.81 m from S2 pier for 0.08 m settlement of S2 pier. (b) Step 21: the reinforcement yield at 10.8 m from left abutment for 0.20 m settlement of S2 pier. (c) Step 40: the reinforcement yield at 7.2 m from left abutment for 0.39 m settlement of S2 pier. (d) Step 65: the chord rotation capacity reached at 1.81 m from S2 pier for 0.64 m settlement of S2 pier.

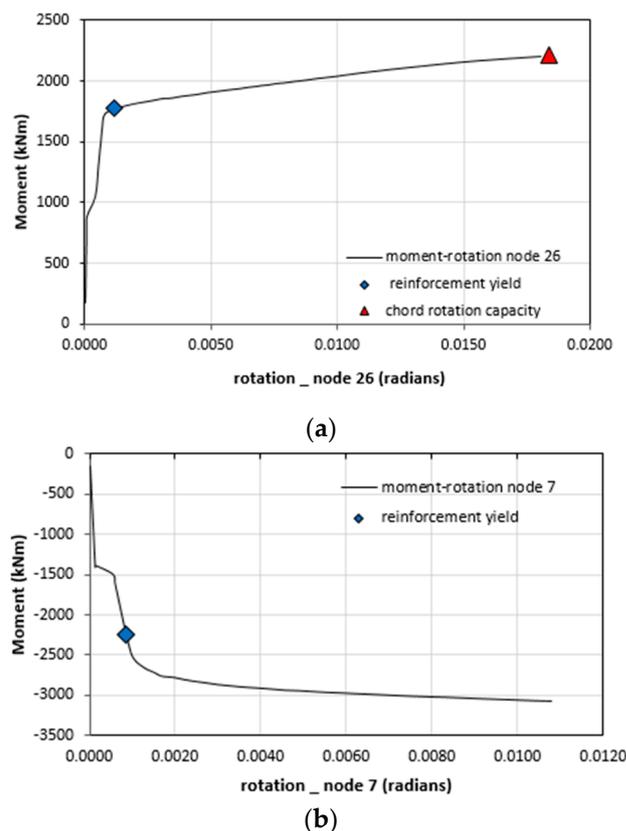
Figure 20 shows the bending moment-rotation diagrams for nodes 26 and 7. The points of reaching performance criteria are marked on charts.

Based on the results shown it can be concluded that deck critical sections, located above pier S2 and at the first span, exhibit significant inelastic behavior right after the yielding in reinforcement is detected. Sections of the deck near to pier S2, located at 1.81 m in the inner span, reach the chord rotation capacity (value of 0.018408 rad) at the analysis step that corresponds to the settlement of S2 pier equal to 0.64 m. At this step, the rotation of node 7 is 0.011144 rad, which is 2.5 times less than the rotation capacity of this node. The sections in which significant reinforcement yielding occurred in the nonlinear model (zones of nodes 26 and 7) correspond to the cross-sections in which the damage occurred in the bridge (zone 1 and zone 2). In the zone of node 26 corresponding to zone 1 of bridge damage, the rotation

capacity was reached, which clearly indicates the complete plastification of the plastic hinge. This was obvious from in situ bridge damage in zone 1 where the cracks about 10 mm wide opened in the bottom zone, while the concrete in the upper zone was crushed. In zone 2, where similar damage occurred as in zone 1 but with cracks in the upper zone and crushing of concrete in the bottom zone of the main girders, the plastic hinge formation occurred but rotation capacity was not reached (39% of the rotation capacity was reached). Since the rotation capacities were exceeded in zone 1 and 39% of the capacity was reached in zone 2, the new structural system of the bridge with hinges (in zones of plastic hinge formation) should be considered for designing structural strengthening.

**Figure 20.** Moment rotation curve for nodes (a) 26 and (b) 7.

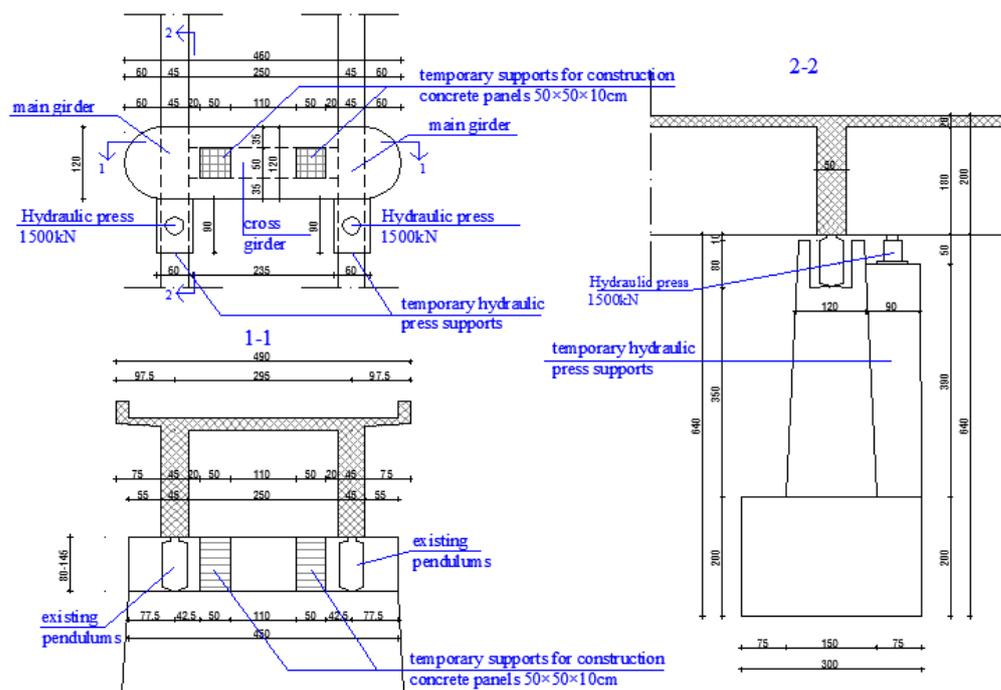
Figure 22. The disposition of constructed system for deck structure raising.

To lift up the deck, the temporary RC supports were made on the right face of the pier, 0.75 to 0.95 m thick and 0.60 m wide. These supports are placed just below the main girders supported at their base by the existing foundation. They are constructed so that their upper edge is 0.50 m from the girder's bottom edge. The existing pendulums are

partially demolished so that temporary supports can be placed under the transverse girders and the pendulums can be removed. Additional pier concreting to the required height is done so that the new bearings can be installed. During the lifting, the deck is transferred to the temporary supports by using the press releasing it from the pendulum at the same time. The pier is concreted to the designed elevation after the deck lifting is completed. After the concrete hardens to at least 70% of the designed strength, moveable bearings are installed, and the bridge deck structure is transferred from temporary to newly installed bearings using hydraulic presses. The temporary supports for presses are removed. The disposition of constructed system for deck structure lifting is shown in Figure 22.

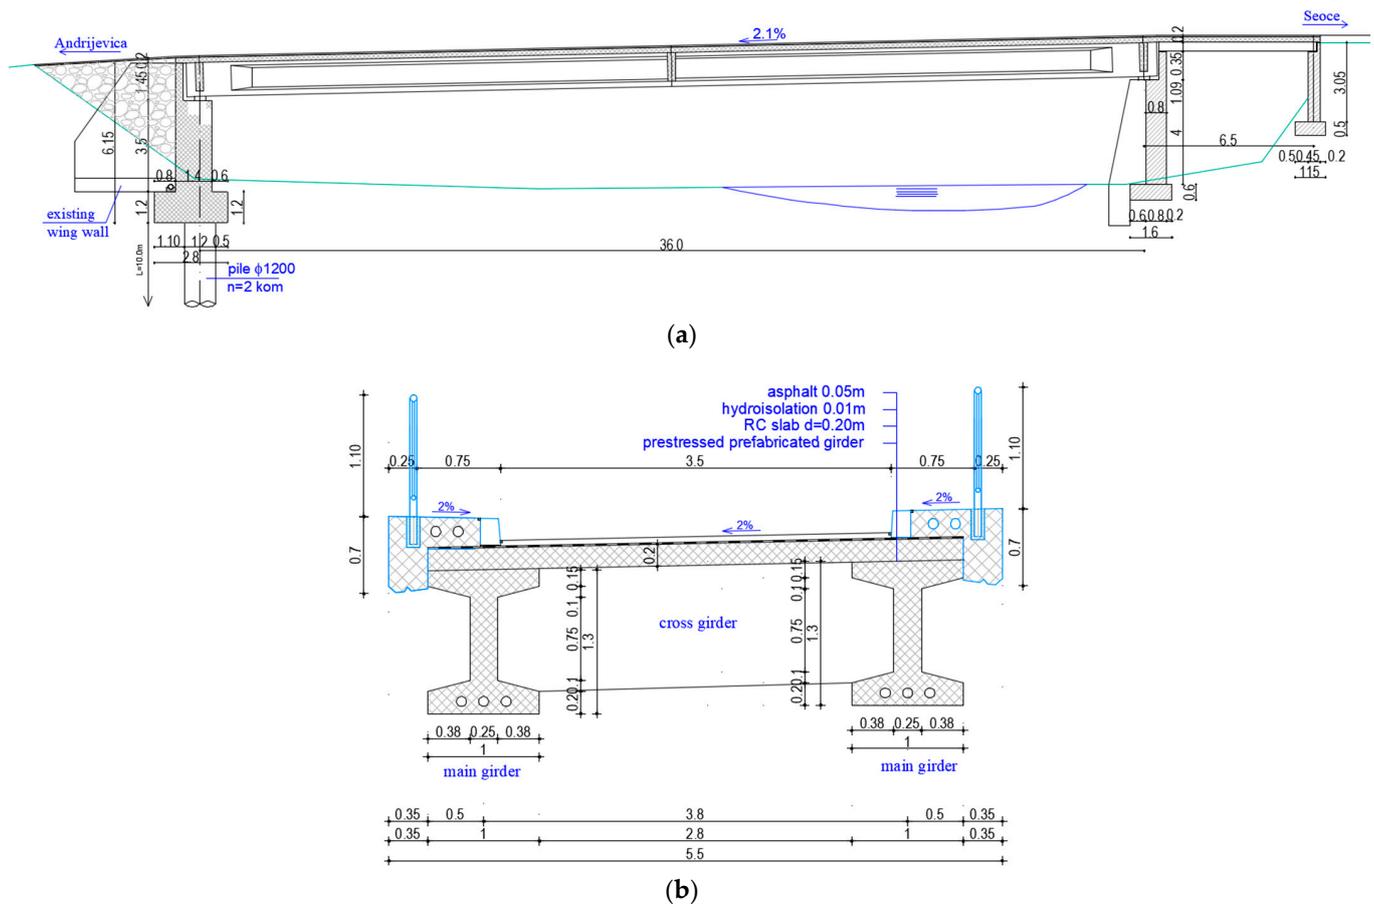
The deck supporting structure consists of two abutments and two river piers. The right abutment and right river pier are founded on the rock while the left abutment and the left river pier are founded on gravel. Due to the high water level of the Lim River and the local scour in the foundation of the left pier and left abutment zones, the river flow carried away both these piers as well as the deck over two larger spans of 18 m. Only a deck over a span of 6.20 m remained with the right river pier, right abutment, and the wing walls of the left abutment. The reasons for the collapse of this bridge were inadequate funding of the left river pier and left abutment in combination with extreme water levels and inadequate water flow profile. Figure 23 shows the bridge at its collapse.

**Figure 24.** The designed reconstruction of the bridge: (a) longitudinal section and (b) cross-section in the middle of the span.

upstream face of the piers increasing pressure on the structure and changing river flow. In the case of bridges 3 and 4, the scouring occurred in the abutment foundation zone, which were inadequately founded in gravel deposits or alluvial sediments.

Having in mind the causes of the bridge collapse and remaining undamaged bridge elements, at the phase of reconstruction design, a solution for crossing the river Lim with one span, i.e., without river piers was adopted to avoid the negative effects of high water level oscillations. The new bridge structure with one span of 36.00 m was designed. The right-approaching bridge slab with a span of 6.2 m has been retained as part of the new bridge since it was undamaged. The structural system of the new bridge consists of two prefabricated prestressed RC girders with an “I” cross-section of constant height of 1.30 m, placed at a distance of 3.8 m. The longitudinal section and bridge deck cross-section in the middle of the span is shown in Figure 24. These girders are monolithized with a 0.20 m thick RC slab. The flange width (upper and bottom) is 1.00 m, the thickness of the lower flange is from 0.20 to 0.30 m, and the upper flange thickness is from 0.15 to 0.25 m. The thickness of the web is 0.25 m. The prefabricated girders are connected on supports and in the middle of the span with transverse girders 0.30 m wide and 1.10 m high. Over the existing RC approaching slab 0.35 m thick and 3.20 m wide, a new 0.20 m thick and 4.80 m wide RC slab is added over it. At the connection between the new bridge girders and the retained approaching slab, above the pier, a hinge is formed in the slab. The retained right pier is widened to form a suitable support for new prefabricated girders. The existing right abutment has been also retained. The adopted bearings are high-quality elastomeric pot bearings, fixed placed over the right support and moveable placed on the left support. The main girders are prestressed with three  $15 \times 150 \text{ mm}^2$  tendons with a tensile strength of 1860 MPa. The prestressing tendon layouts are linear and parabolic.

Based on the geotechnical survey on the left riverbank, the thickness of the gravel layer above the solid rock is 7.0 m. For these reasons, the left abutment is founded on 1.2 m diameter piles. Two piles placed in the axes of the main girders were designed. The pile cap of  $2.8 \times 1.2 \text{ m}$  was constructed over the piles. The designed length of the piles is 10 m with at least 4.0 m inside the solid rock. The existing wing walls are retained and connected to the new abutment.

For bridges 3 and 4, taking into account the causes of damage, reconstruction solutions have been designed such that the Lim River is crossed by one wider span or without a pier in the riverbed to avoid the negative effects of high water level oscillations. A solution with two prestressed RC girders of the "I" cross-section, monolithized with RC slab and with high-quality elastomeric pot bearings, on one side fixed and movable on the other side, was designed. For bridge 3, where a thicker gravel layer above the rock existed, it was necessary to design the left abutment foundation on piles with a diameter of  $\varnothing 1200$  mm 10 m deep, while the abutments of bridge 4 did not require a deep foundation. In the case of bridge 4,

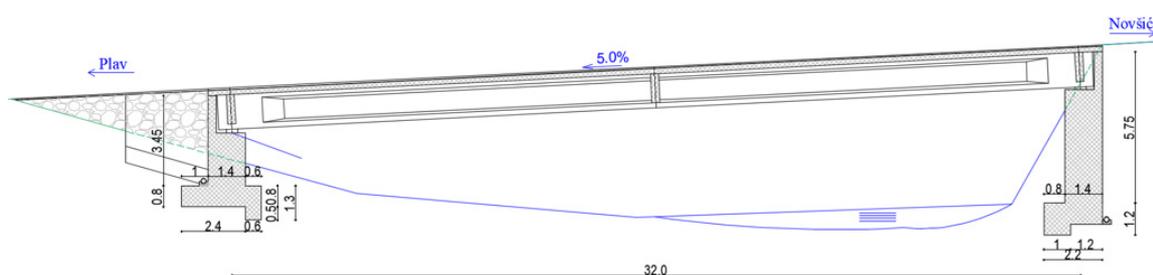
**Figure 26.** Longitudinal section of the designed bridge reconstruction.

Taking into account the causes of the bridge collapse and the current on-site situation, similar to bridge 3, the reconstruction solution by crossing the river Lim with one wider span was selected to avoid the negative effects of high water level oscillations. The bridge with one span of 32.00 m was designed over the river. The longitudinal section of the designed reconstruction of the bridge is shown in Figure 26. The selected structural system of the bridge is the same as for bridge 3 (Figure 24b). In addition, the same supports of the girders are selected. Three  $15 \times 150 \text{ mm}^2$  tendons with a tensile strength of 1860 MPa are used for prestressing. The prestressing tendon layouts are straight and parabolic. Considering the severe damages to the right abutment, a completely new abutment has been designed. All cracked and degraded parts of the rock at this site are removed so that a healthy and solid rock is reached, on which the new abutment is founded. Anchors are drilled into the existing rock to connect the abutment foundation and the rock. The left abutment with wing walls is founded on a rock. In front of and behind the bridge, as well as in the wing zone, the large stone blocks are used to stabilize the slope and prevent erosion.

a completely new right abutment was designed, while all cracked and degraded parts of the rock mass were removed in order to reach a healthy and solid rock.
