Impact Analysis of a Building Collapse Caused by a Rainfall-Induced Landslide in Kerala, India

Abstract: This study presents the experimental, numerical analysis, and dynamic impact analysis of a building collapse caused by a rainfall-induced landslide (vertical cut slope failure) on 15 August 2018, in Peringavu, Kerala, India, which resulted in the death of nine people. The volume of 1500 m³ soil-applied lateral thrust force on the building's rear side led to its demolition. The study includes extensive geotechnical characterization. General limit equilibrium and finite element methods were used in the numerical analysis. The infiltration analysis involved a rainfall pattern of low, moderate, and higher intensities on the slope. The study involved a two-stage analysis. Firstly, the analysis of the vertical cut slope with the application rainfall intensities, and second, the analysis of the building under the dynamic impact of the landslide. As a result of the study, the failure mechanism of the vertical cut during intense rainfall and triggering factors were evaluated. The dynamic impact analysis was carried out to examine the effects of the impact of the landslide debris on the

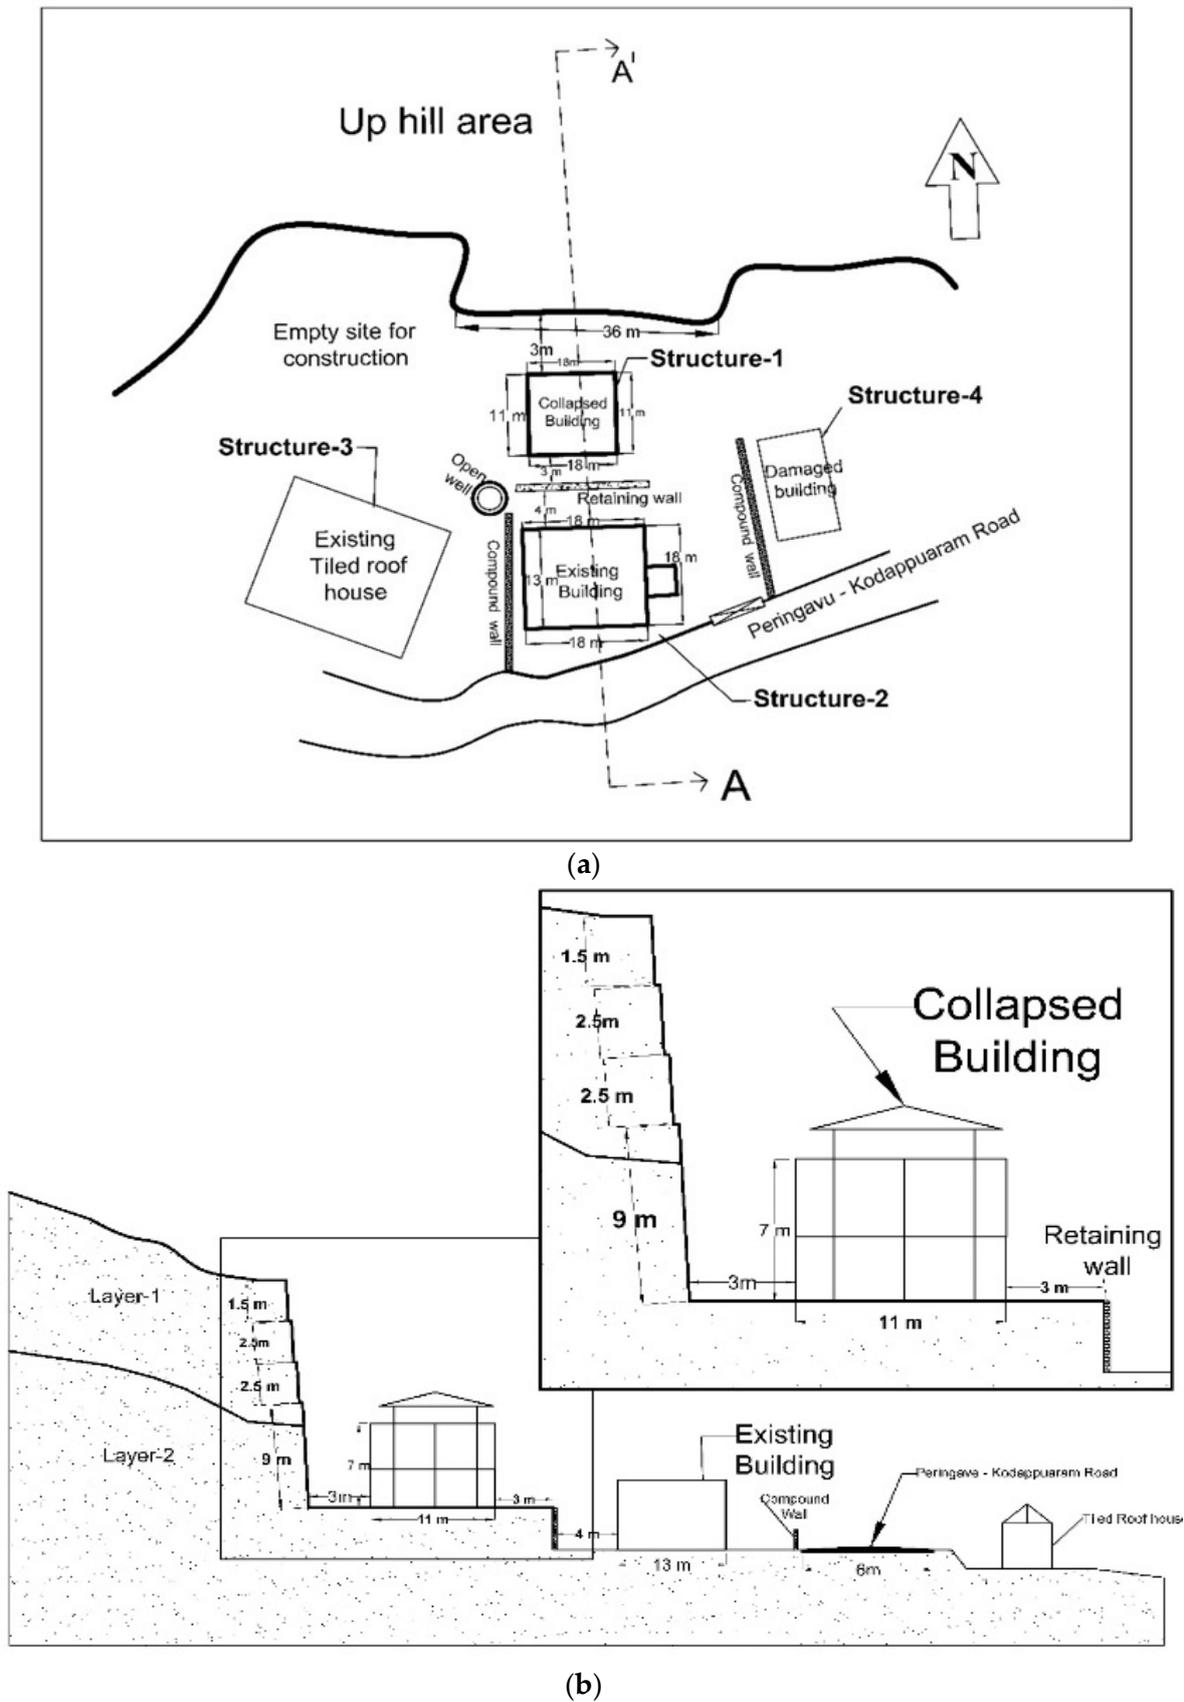
Figure 2. Landslide location plan & section view: (a) Plan of the landslide location and adjacent structures; (b) Sectional plan (A-A') of the vertical cut and houses.

In the year 2010, the slope was excavated as a vertical cut. About 12 months later, the house (collapsed building) was constructed. The building plan and pictorial representation of the area prior to landslide event are shown in Figure 2. To create a space on the back side of the building, the natural slope was excavated to a larger height, and a vertical cut was made, which was not supported by any stabilization method (Figure 2). As depicted in Figure 2a, structure 1 (a two-story building) in the traditional Kerala type, was built very close to a vulnerable vertical cut (3 m). The dimensions of the vertical cut were 36 m wide and 15.5 m high, with four tiers with short foot berms (Figure 2b). Partially damaged houses (structures 2, 3, and 4) surrounding the collapsed building are depicted in Figure 2.

Limit equilibrium analysis was performed on the cut slope before failure (Figure 2b) to study the mechanism of failure due to very heavy rainfall. Figure 2a shows that the residential structure (structure 1) was in close proximity to the toe of the cut slope. The geometry and structural mesh of the cut slope along with the building are portrayed in Figure 6a. The cut slope consisted of four tiers, and each tier had small berms, producing a height of 15.5 m (Figure 2b). The height of each tier is shown in Figures 2b and 6a. The building details are explained in the previous section (Insights into Kerala landslides and building failure in Peringavu).

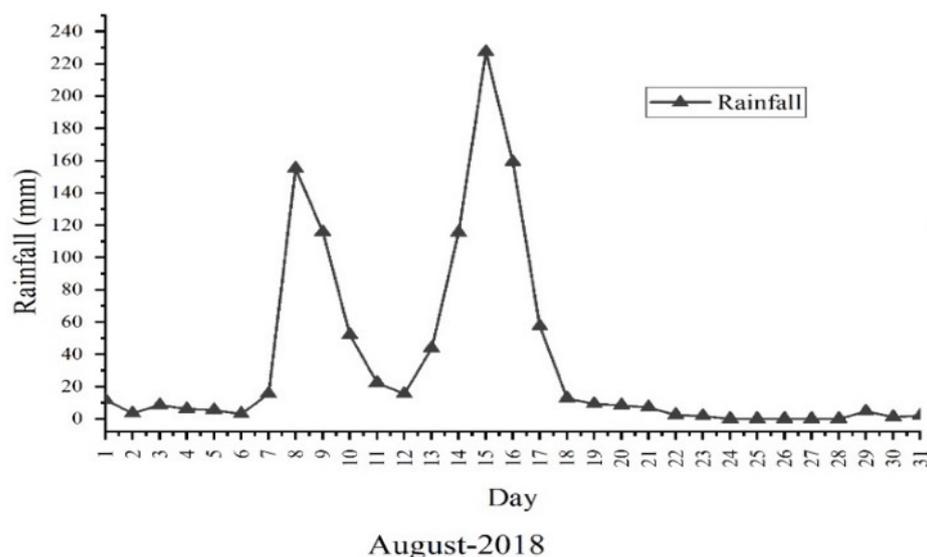
Figure 4. Daily rainfall graph for August 2018.

Kerala state receives rainfall mainly from monsoons. The state has 120 to 140 rainy days per year on average. Kerala received 3518 mm of rain in 2018, 20% higher than the normal rainfall, and 2516 mm in the south-west monsoon, which was 24% higher than the monsoon normal rainfall. Rainfall received in the south-west monsoon period was recorded as the highest since 1961 [38]. Figure 4 depicts the daily rainfall in August 2018 recorded at the Indian Meteorological Department (IMD) rain gauge located at Karipur Airport. The monthly rainfall data of Kerala state in 2018 are presented in Table 2. In 2018, August recorded 821 mm of rainfall, which is 96% higher than August's normal rainfall [39]. The IMD rain gauge stations and geomorphological atlas of the Malappuram district are shown in Figure 5. Since the Karipur airport rain gauge is near Peringavu (Figure 5), rainfall data recorded from this rain gauge were used for the numerical analysis. In 24 h (from 14 August 8:30 AM to 15 August 8:30 AM), the landslide area received very heavy rainfall of 227 mm. The importance and influence of antecedent rainfall can be observed in Figure 4. The Peringavu area received very high daily rainfall and high antecedent rainfall (Figure 4) [31,39]. Hence, rainfall statistics and data analysis play an important role in evaluating the failure mechanism of the landslide in Peringavu that resulted in the demolition of the building and buried nine people alive [29].

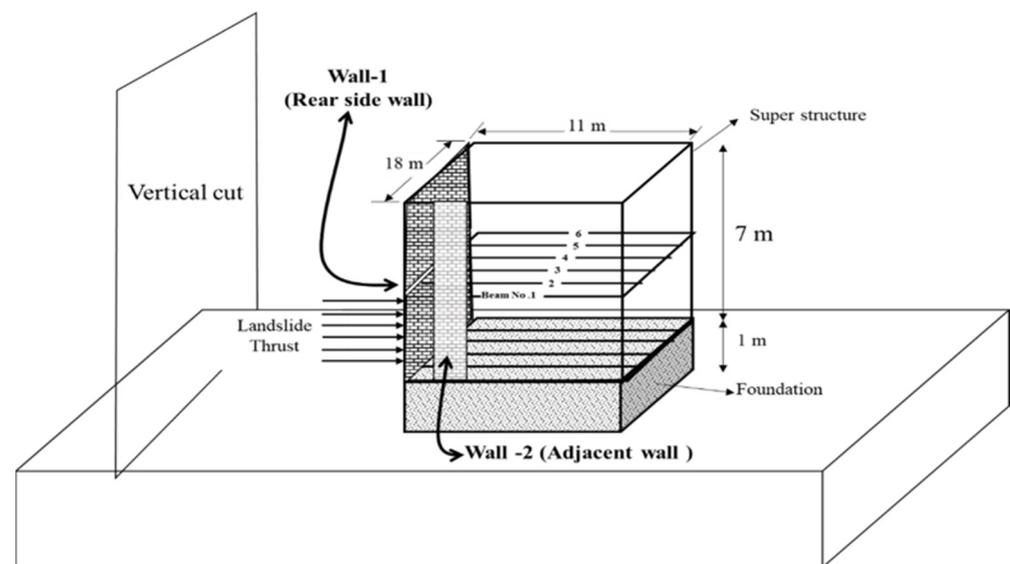
Figure 8. Schematic representation of the building model for the dynamic impact analysis.

Figure 8 depicts the schematic line diagram of the building model and landslide thrust. The building width, length, and height were 18 m, 11 m, and 7 m, respectively. The building foundation soil was modeled as ten-node tetrahedral elements. The Mohr–Coulomb constitutive model was used to model the foundation soil [59].

The failure criteria of the load-bearing walls of building were studied in two aspects: tensile stress failure (out-of-plane behavior) and shear stress failure (in-plane behavior). The loadbearing walls considered for the determination of permissible stress are shown in Figure 8: the flexural failure criteria out-of-plane behavior studied for wall 1 (rear side wall) and the shear failure criteria in-plane behavior studied for wall 2 (adjacent wall).

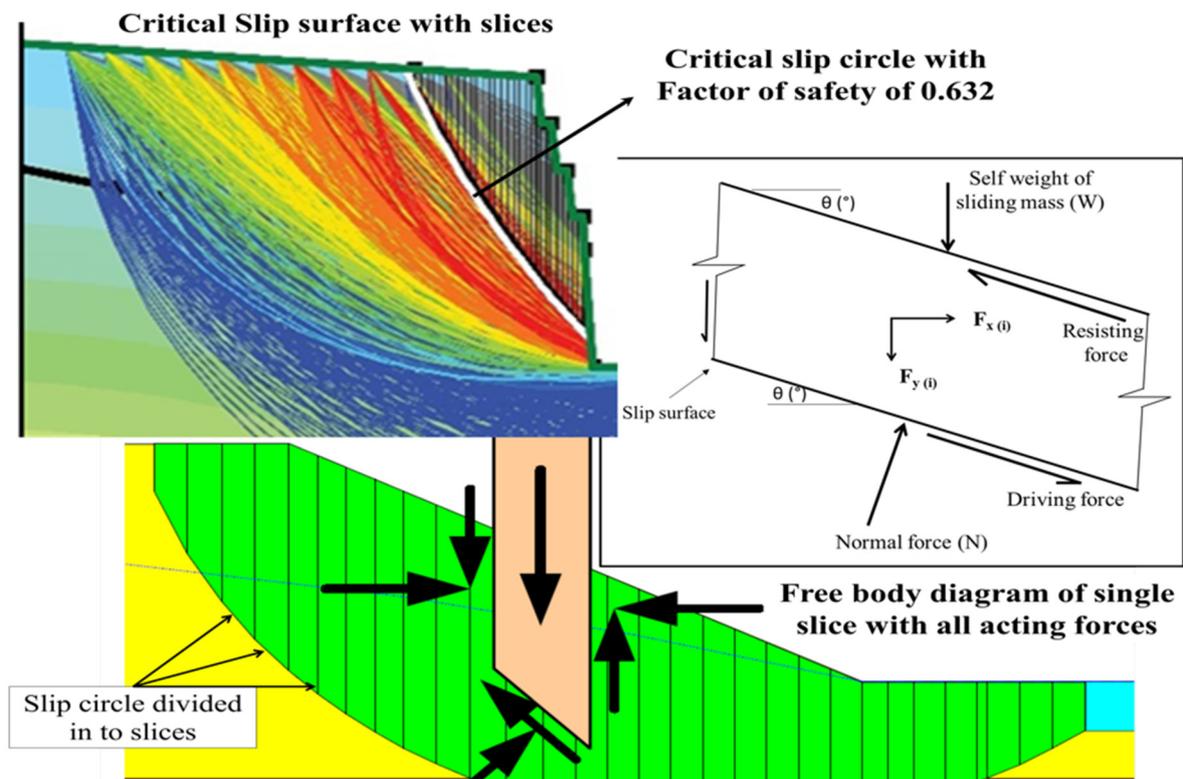
Figure 9. Pictorial representation of sliding forces and the free body diagram of a slice.

The landslide thrust force was evaluated by employing the residual-thrust method, which is extensively applied for landslides and slope stability analysis [60,63]. Figure 9 describes the typical slip surface with the slices, the free body diagram of one slice with force representation, and the critical slip with a factor of safety value of 0.632. The landslide mass was split into multiple slices in this process (Figure 9), and force analysis was carried out on each slice. In this way, it is possible to determine the thrust of a landslide mass by utilizing the actual shape and profile of the sliding/failure surface, including under complex loads [11]. Figure 9 describes sliding forces and the free body diagram of a typical slice with various forces at a critical slip surface. The landslide thrust (q) was determined by applying the empirical Equations (2)–(4). In this method, infiltration seepage was considered under different rain conditions analyzed using the Slope/W and Seep/W applications [52].

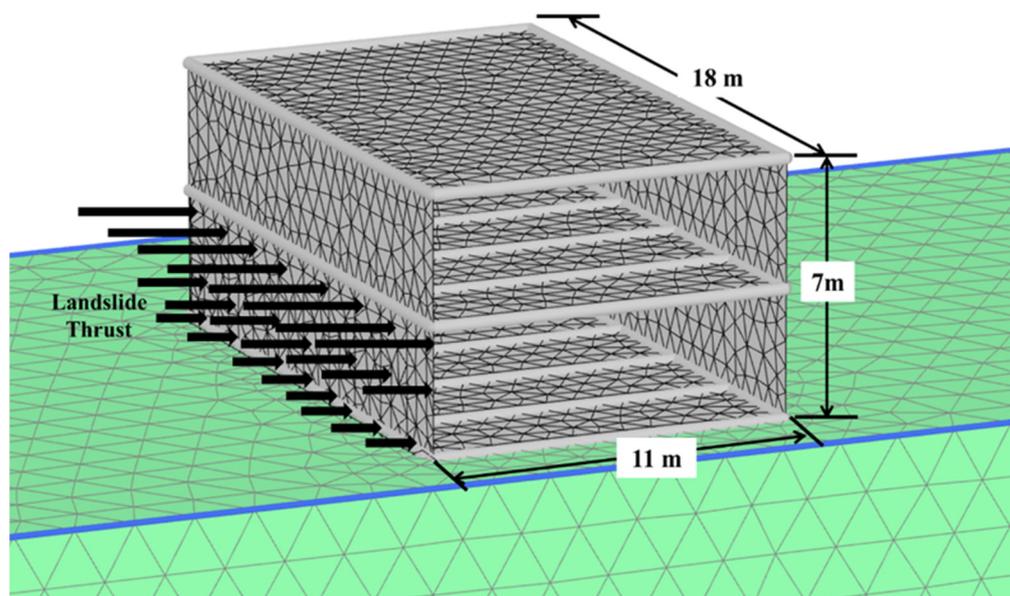
Figure 10. The geometry of the building and generated mesh.

The landslide thrust (q) was applied on the rear side of the building for the different vertical distances from the toe of the landslide. The calculated landslide thrust (q) at 5 m height was 428 kN/m, at 4 m height was 347 kN/m, at 3 m height was 266 kN/m, at 2 m height was 185 kN/m, at 1 m height was 103 kN/m, and at 0.5 m height was 64 kN/m. Figure 10 shows the landslide thrust on the rear side of the building, the generated mesh, and the geometry of the building modeled using finite element analysis.
