Article Research on Deformation Analysis and Rehabilitation for a Beam–Arch Combination Bridge Suffering an Extreme Temperature Field

Citation: Fu, M.; Liang, Y.; Wu, B.; Zhang, L.; Tang, G. Research on Deformation Analysis and Rehabilitation for a Beam–Arch Combination Bridge Suffering an Extreme Temperature Field. *Appl. Sci.* 2022, *12*, 6909. https://doi.org/ 10.3390/app12146909

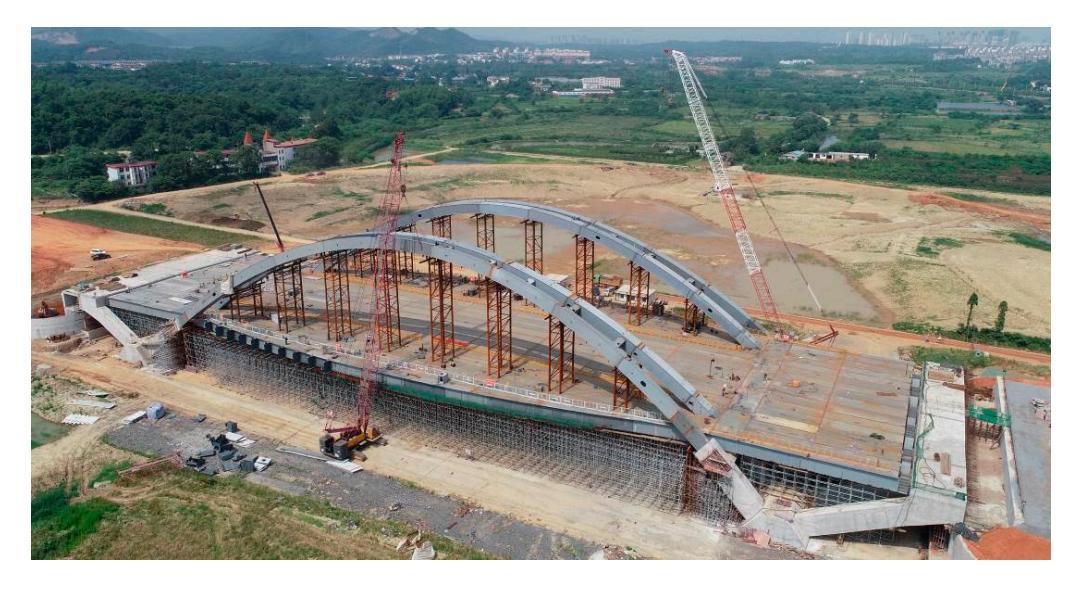
Figure 4. Steel box girder and arch ring construction completed.

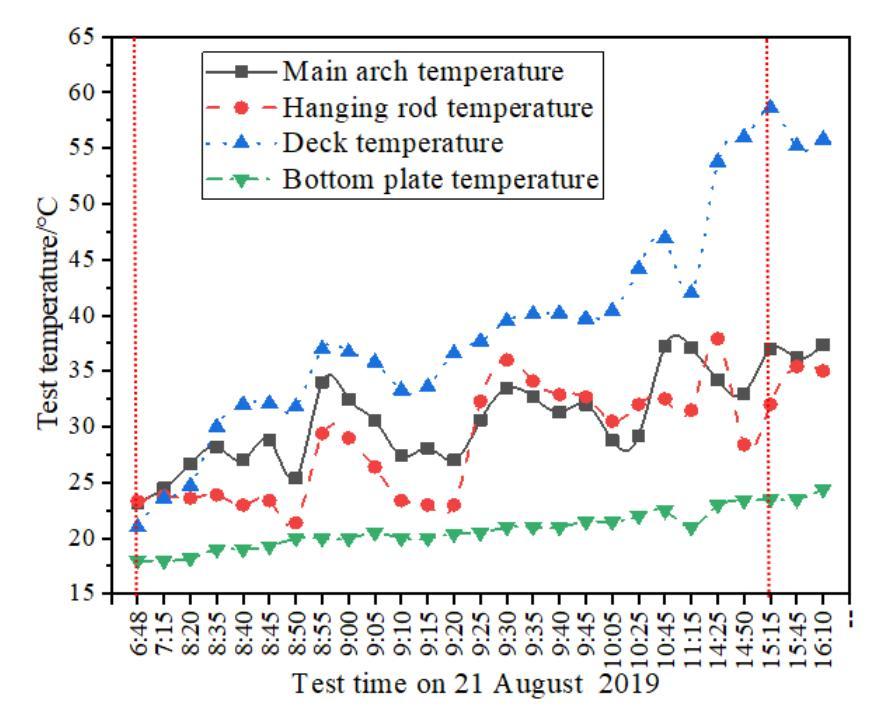
Figure 12 shows the monitored temperature of different parts of the bridge in one day (on 21 August). Figure 12 indicates that the rate of temperature increase on the deck was the fastest among all the parts, the rate of temperature increase on the bottom plate was the slowest, and the maximum temperature difference between the bridge deck and the bottom plate was 35 °C. This result indicates that if the deck was installed at a time with a high temperature on a hot day, while the remaining parts of the box girder were installed at a time with a lower temperature, once the bridge temperature reached uniformity during that night, the cooling value of the bridge deck was substantially higher than that of the remaining box girder.

Figure 12. Monitored temperature of different parts.

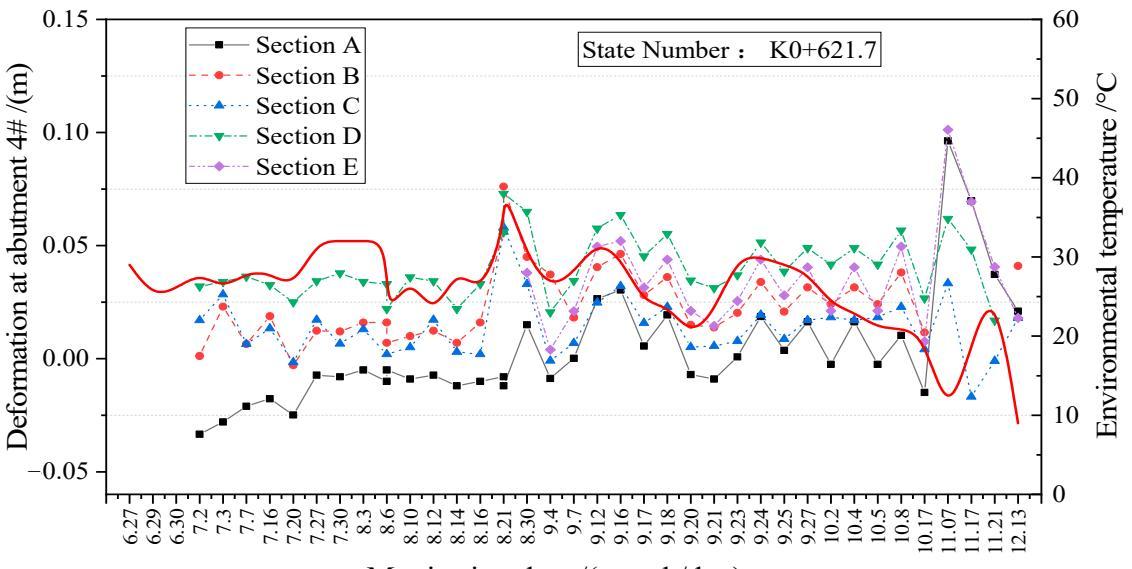
Figure 16 shows the deformation monitoring historical curves of the end of the box girder above abutment #1 (bridge state location K0+ 458.8). Figure 17 shows the deformation monitoring historical curves of the box girder at the mid-span of the main span. Figure 18 shows the deformation monitoring historical curves of the end of the box girder above abutment #4 (bridge state location K0+ 621.7). Figures 16–18 show that the line shape was stable during the assembly stage of the box girder and the pre-stress of the tie bars. On 12 August 2019, when Typhoon Lekima arrived, the deformation monitoring historical curves of the end of the box girder above abutments #1 and #4 suddenly changed upwards. On 4 September 2019, the deformation of the box girder decreased after the demolition of the frame scaffolding of the middle span. After the second fine-tuning of the stretch of the hanger rods on 23 September 2019, the deformation returned to a certain extent. The deformation monitoring historical curves show that the deformation of the box girder fluctuated with the temperature on different dates. When the temperature dropped to 9 °C on 7 November 2019, the warping of the end of the box girder above the abutment was particularly obvious. The ichnography of the box girder's deformation after the frame scaffolding's demolition is shown in Figure 19. The most significant deformation of the middle span is 0.085 m, and the shape of deformation appears to be 'a lid cover'.

Figure 18. Deformation monitoring historical curves of the box girder above abutment #4.

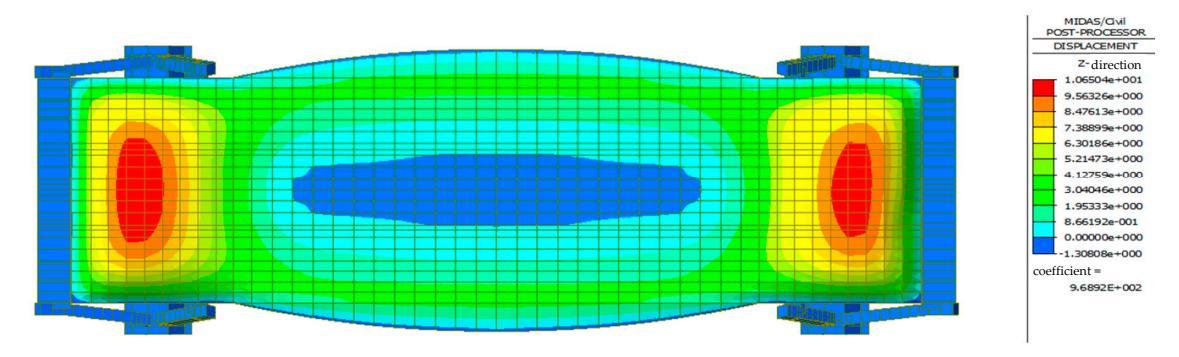
Figures 22 and 23 show the FE simulation results of the deformation of the steel box beam in different construction stages under the measured temperature field. The environmental temperature stabilized after installing the bottom plate under a high temperature of 60 °C; after installing the bottom plate the low temperature reached 20 °C; and the edge of the steel box beam underwent twisting deformation. The temperature gradient action generated inside the steel box beams caused the edge of the steel box beam to undergo twisting deformation, and the maximum twisting deformation was 6.3 cm. Figure 23 shows the upward twisting deformation at the end of beam and the two lateral free sides of the steel box girder in the FE model. The scaffolding only provided the vertical compression reaction force and the downward deflection deformation of the steel box girder was small enough to be almost negligible.

Figure 22. Deformation of the box girder after installation of the bottom plate (unit: mm).

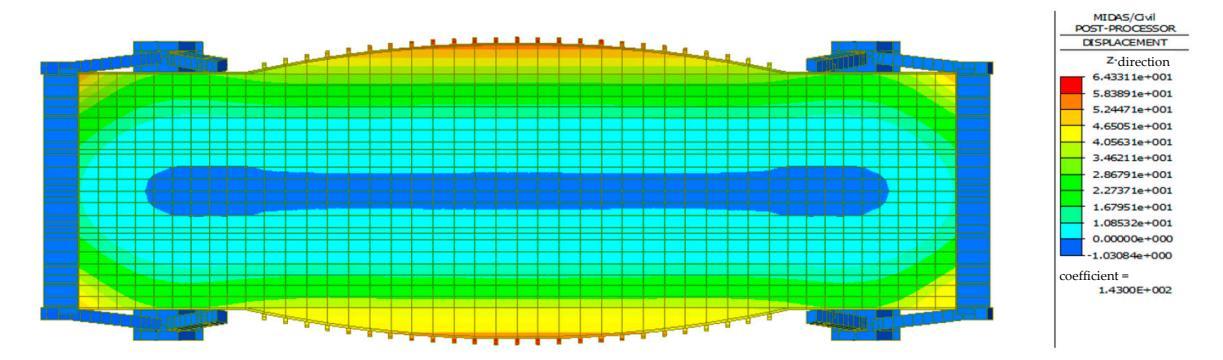
Figure 23. Deformation of the box girder after installation of the top plate (unit: mm).

Figure 26 shows the deformation monitoring results of the steel box girder after removing the frame scaffolding. The figure shows that the two ends of the steel box girder are warped upwards, and the middle span of the box girder is concave, which coincides with the numerical simulation results in Figure 23. The deformation monitoring results of the steel box girder after the installation of hanging rods are shown in Figure 27 and are consistent with the numerical simulation results in Figure 23. As evidenced by the on-site monitoring and simulation results, the exact cause of the abnormal bridge

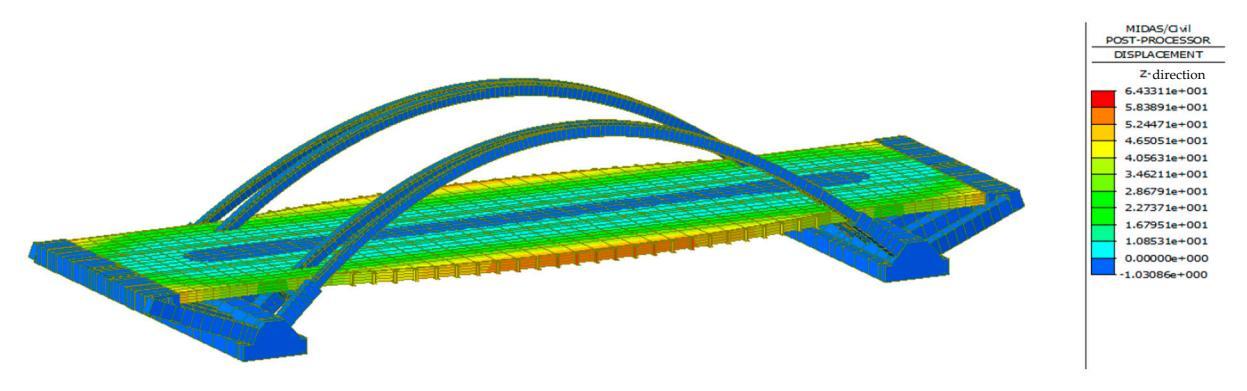
As shown in Figures 24 and 25, deformation still existed even after installing the steel arch ribs and hanging rods, which was consistent with the in situ monitoring results, and the deformation at the end of the box girder led to upwarping overall following local upwarping after the removal of the frame scaffolding.

Figure 24. Deformation of the box girder after installation of arch ribs (unit: mm).

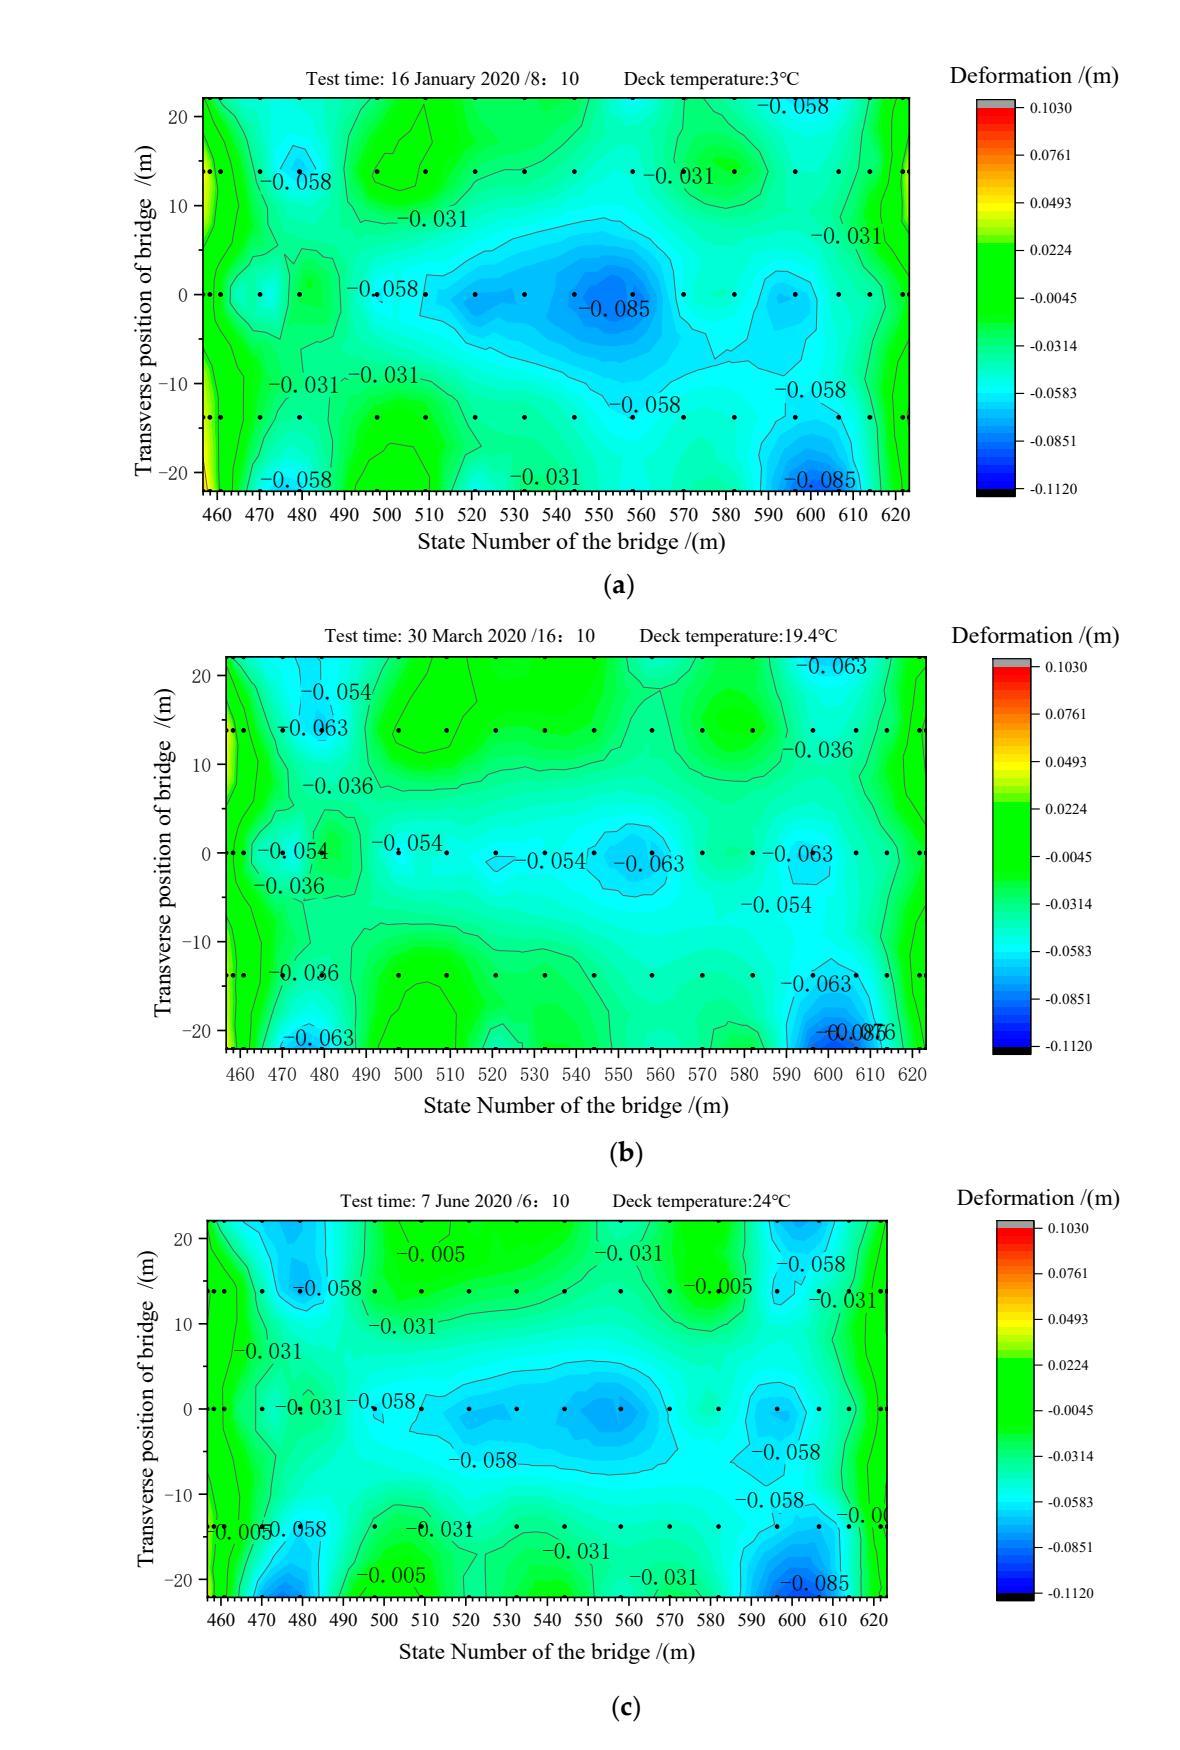
To ensure that bridge deformation after rehabilitation does not develop in service, long-term monitoring of the deformation was performed at different temperatures. Representative deformation monitoring data are shown in Figure 35, from 16 January 2020, 30 March 2020, and 7 June 2020, with temperatures of 3 °C, 19 °C, and 24 °C, respectively. Figure 35 shows that the box girder's deformation at the bridge's central axis at 3–24 °C was mainly from -4.0 cm to -6.3 cm, and the deformation area was stable, which indicates that the bridge can withstand different temperatures under service.

Figure 35. Long-term monitoring of the deformation at different temperatures of different times. (a) Test result on 16 January 2020, 3. (b) Test result on 30 March 2020, 7. (c) Test result on 7 June 2020.

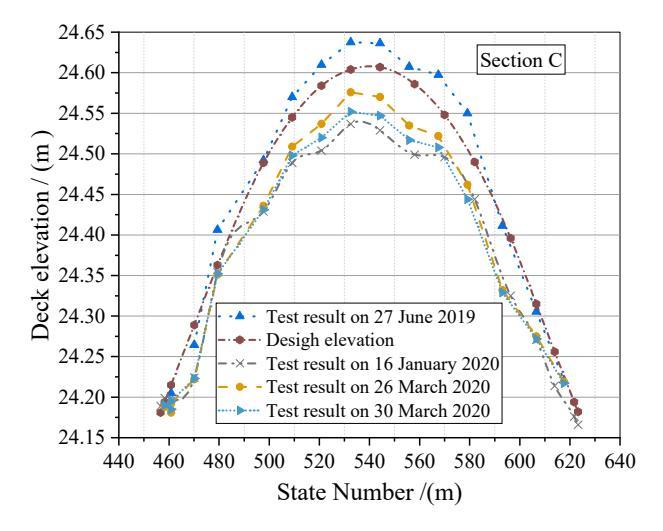
Figure 36 compares the box girder elevation and design theoretical elevation at the longitudinal section of the central axis of the bridge. The elevation is generally 4 cm to 6 cm lower than the design elevation. Because the entire support elevation was uniformly reduced by 4.5 cm during rehabilitation processing, the actual elevation error can be considered to compensate by 0.5~1.5 cm.

Figure 36. Elevation of the box girder after demolition of rehabilitation measures.

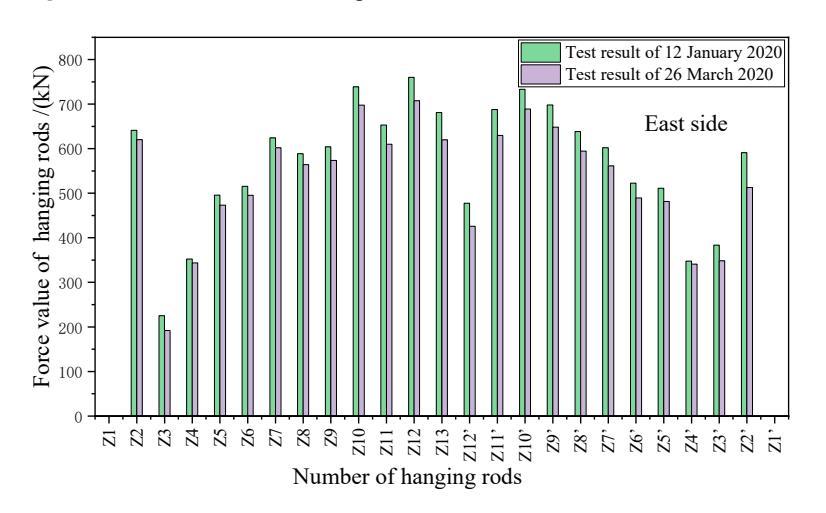
Figure 37 shows that the measured forces of the main arch hanging and the vice arch hanging rods were stable, the environmental temperature was 3 °C on 13 January, and 25 °C on 26 March 2020. The intermittent relaxation of the states after Typhoon Lekima no longer appears. Hence, the rehabilitation measures proposed in this paper achieved the expected target to solve the abnormal deformation of the bridge.

Figure 37. Measured force value of the main arch hanging rods.
