Failure Analysis of Subway Box Structures According to Displacement Behavior on a Serviced Urban Railway

Keywords: failure analysis; displacement behavior; visual inspection; numerical analysis; subway box structure

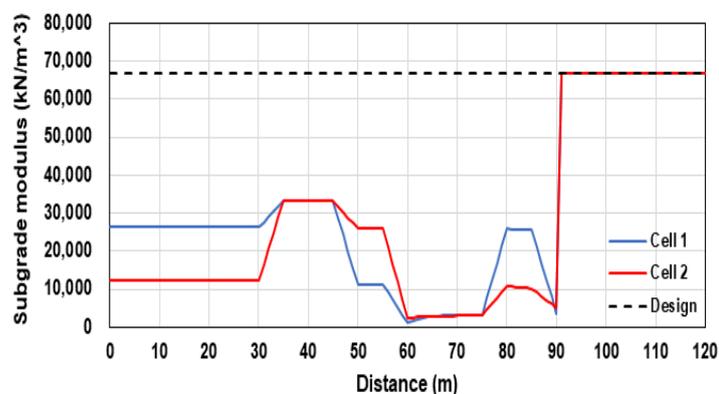
Figure 5. Comparative analysis results of subgrade reaction modulus.

As shown in Table 1, the subgrade reaction modulus due to settlement and heaving differed depending on the location. Additionally, the subgrade reaction modulus in the maximum settlement section was reduced by approximately 95% compared to that in the maximum heaving section.

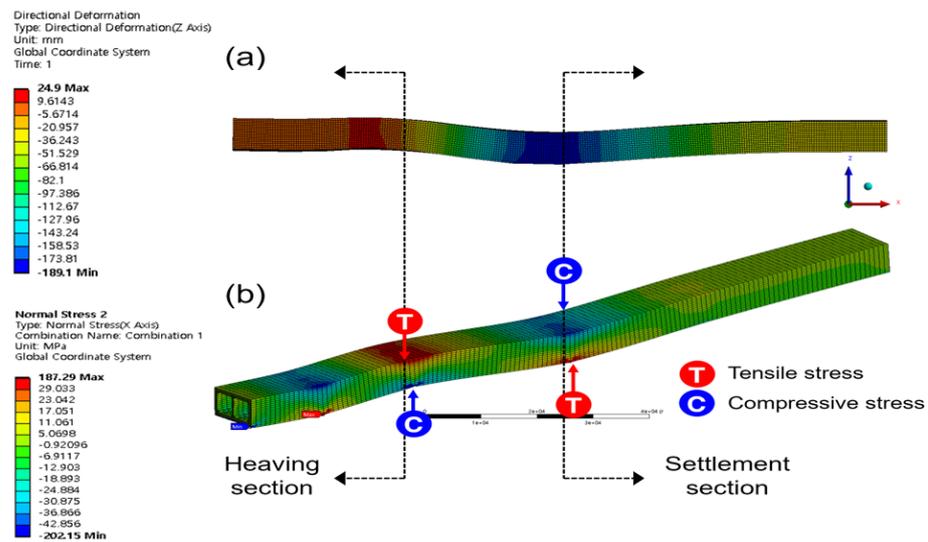
Figures 7 and 8 show the displacement behavior and generated stress in the underground structure, respectively. The analysis results in Figures 7 and 8 indicate that the displacement behavior of the underground structure directly impacts the stress characteristics. Tensile stress was dominant in the upper slab, where maximum heaving occurred, whereas compressive behavior was induced in the lower slab. However, for the settlement section, compression occurred in the upper slab, whereas tension occurred in the lower slab, indicating a clear contrast between the stress location and that in the heaving section.

Figure 7. Vertical displacement analysis results: (a) deformation; (b) stress.

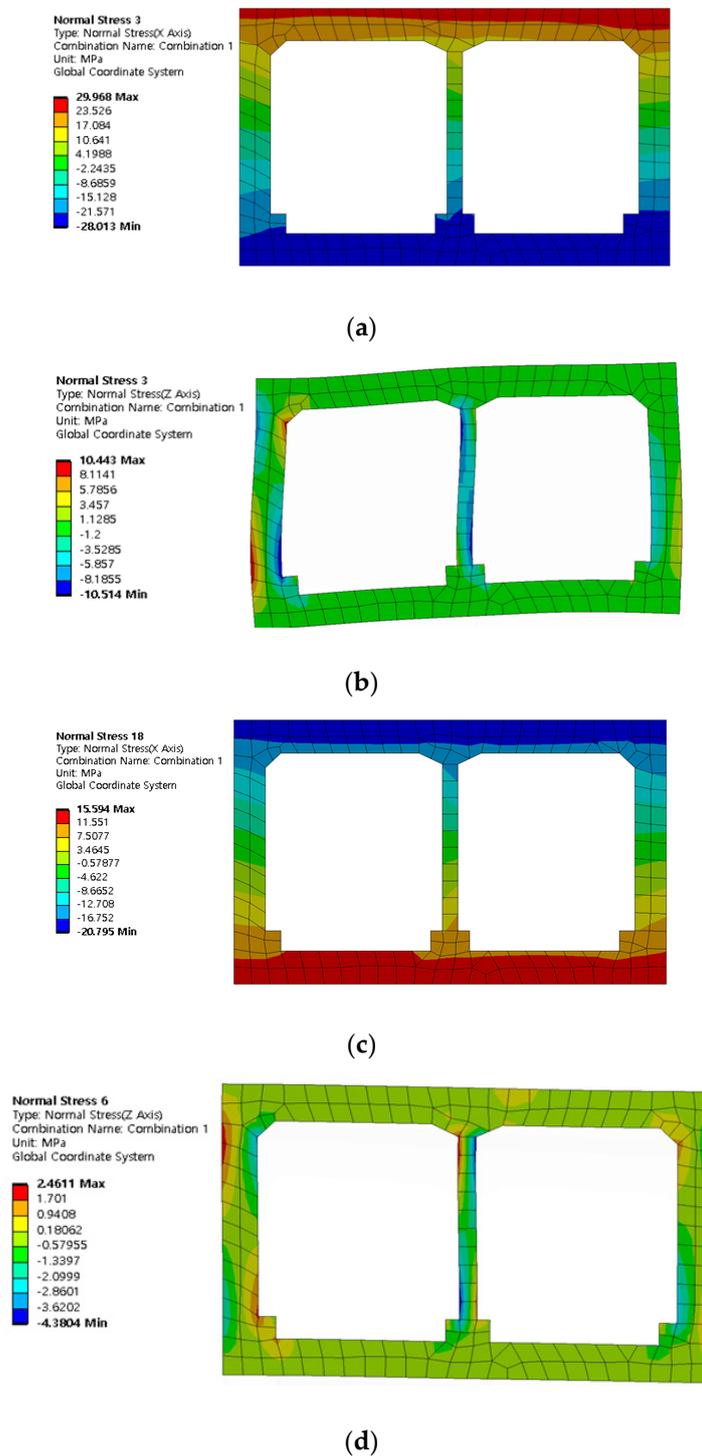
Figure 8. Stress analysis results in the position of maximum heaving and settlement: (a) normal stress (x-axis) at maximum heaving point (30 m); (b) normal stress (z-axis) at maximum heaving point (30 m); (c) normal stress (x-axis) at maximum settlement point (70 m); (d) normal stress (z-axis) at maximum settlement point (70 m).

Furthermore, as shown in Figure 8a–d, the box structure in the section where the maximum heaving and settlement occurred was a continuum structure with a nonuniform subgrade reaction modulus in the longitudinal direction. There was a significant difference in the deviation of stress in the corner, exterior, and lower haunches owing to the displacement behavior of the box structure, thus inducing torsional behavior.

As shown in Figure 8, not only the inner side of the cross-section of the box but also the exterior side in contact with the subgrade may have been damaged because of the displacement behavior of the underground box structure. The damage that occurred on the inner side of the box structure can be identified through visual inspection and can be appropriately repaired and reinforced accordingly. However, the damage that occurred on the exterior side of the box's cross-section could not be visually identified, which is probably a vulnerable damage section in the long term. Therefore, it is essential to have a measure to repair and reinforce both the inner and exterior sides by predicting the damage that is likely to occur on the exterior side by identifying the damage on the inner side.

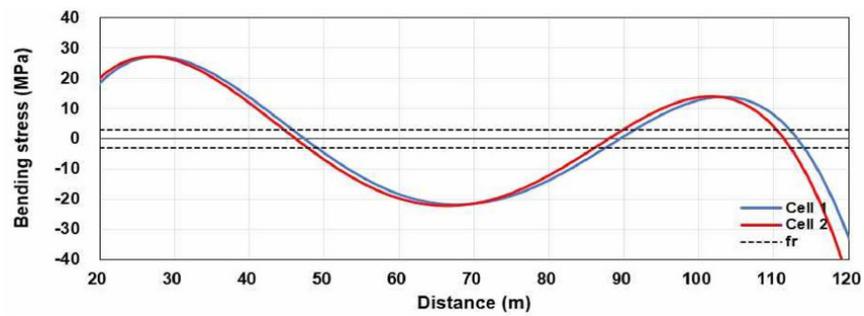
Figure 15. Comparison result of elastic beam analysis (bending stress).

The bending stress exceeded the concrete rupture modulus in most sections. The concrete rupture modulus in Figure 15 was obtained using Equation (4).
