# Slurry Discharge Pipeline Damage and Wear Due to Transporting Rock Particles during Slurry Shield Tunneling: A Case Study Based on In Situ Observed Results

In this study, data from a slurry shield tunneling machine used to dig a tunnel for the Beijing South-to-North Water Diversion Auxiliary Project were introduced. The tunnel, 6 m in outer diameter and 5.4 m in inner diameter, ran through a pebble layer and rock ground. During machine driving, natural rock particles from the pebble layer and rock fragments due to rock cutting when tunneling through the rock ground were transported in the slurry discharge pipelines of the slurry shield machine. Based on field-measured and observed data, the mechanisms and causes resulting in the observed large, uneven damages and wear were identified and assessed. Countermeasures to address issues such as adjusting pipeline layout, welding reinforcement plates in advance, and preparing additional pipelines were highlighted. The wear rates of different types of pipelines, the effectiveness of new pipeline fixing methods, and the probability of pipeline leaks in different strata were discussed in detail.

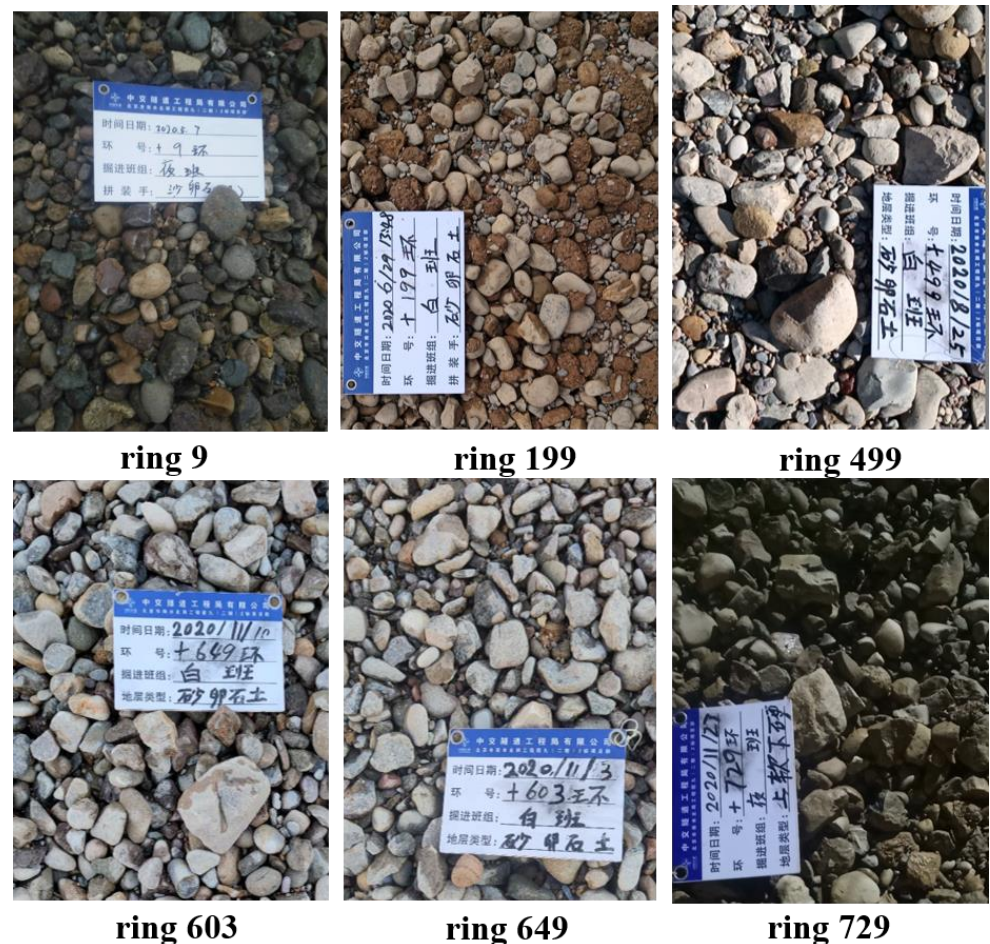
**Figure 4.** Separated rock particles when shield tunneling in the pebble layer. (The Chinese characters on the card are the date, ring number, time and geological type of the rock particles being recorded).

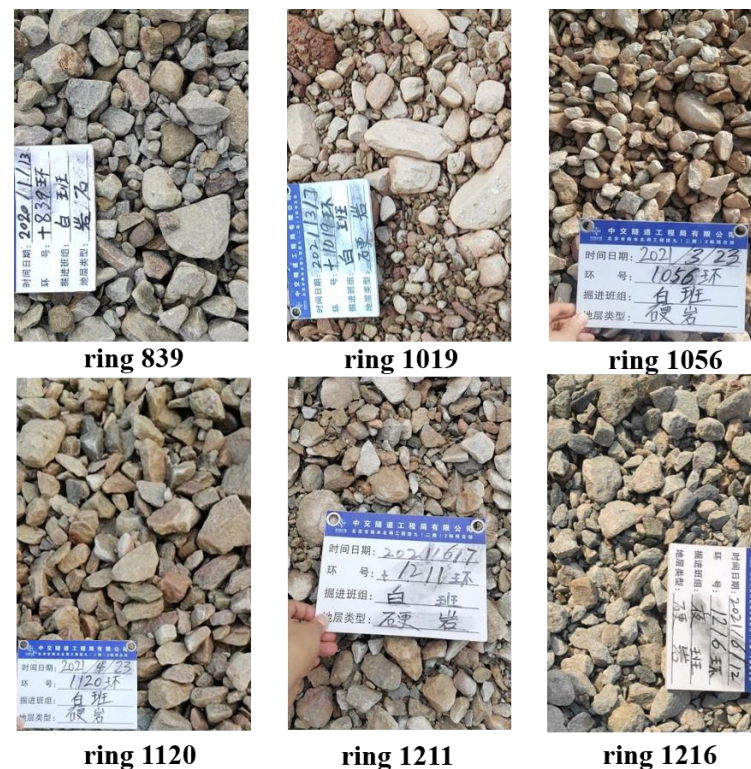
**Figure 5.** Separated particles when shield tunneling in the rock ground. (The Chinese characters on the card are the date, ring number, time and geological type of the rock particles being recorded).
