Influence of Discontinuous Linear Deformation on the Values of Continuous Deformations of a Mining Area and a Building Induced by an Exploitation of Hard Coal Seam

Justyna Orwat

Faculty of Mining, Safety Engineering and Industrial Automation, Silesian University of Technology, Akademicka 2A Street, 44100 Gliwice, Poland; justyna.orwat@polsl.pl

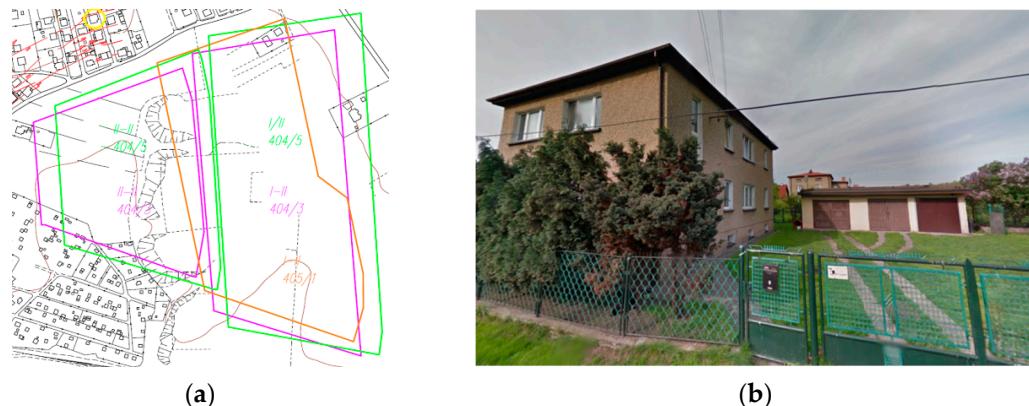
Figure 2. A residential building: (a) on the background of the longwall’s contours in the 404/3 seam—pink line, the 404/5 seam—green line and the 405/1 seam—orange line (yellow circle); (b) a view from north-eastern side.

The building is located to the north of the exploitation and in the fault zone, i.e., in the region where numerous discontinuous linear deformations have occurred (the yellow circle in Figure 2a). It has the shape of a square with a side length of 13 m, with a small cut in the south-eastern part. The building has one overground storey and is 9.5 m high. It was made with traditional technology from bricks and has a load-bearing wall structure. The entrance to the building is on the north side. Three garages are located perpendicular to the building (Figure 2b).

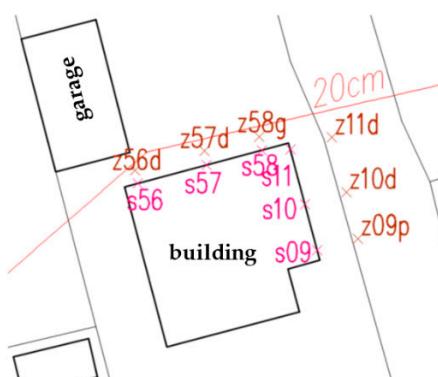
Figure 3. Location of the measuring points in a ground (a brown color) and on a building (a pink color) and a discontinuous linear deformation (a red line).
