A Brief Report on the Explosion on 13 June 2021 at a Market in Shiyan, China

Abstract: A huge gas explosion occurred on 13 June 2021 in Shiyan City, China, resulting in 25 casualties and serious injuries to 37 people. The main victims of this explosion were stall keepers and customers buying breakfast and fresh vegetables in the food market. There is a continuous need to enhance the understanding of such unfortunate events, given the dangers they pose. This study analyzes the causes of this accident considering the general background and scenes of the explosion, and then describes the rescue operations undertaken. The investigation results revealed that the explosion was caused by the poor maintenance of gas facilities and negligence of safety regulations. It is, therefore, recommended that the control of these two main aspects be strengthened to reduce the recurrence of such unfortunate accidents.

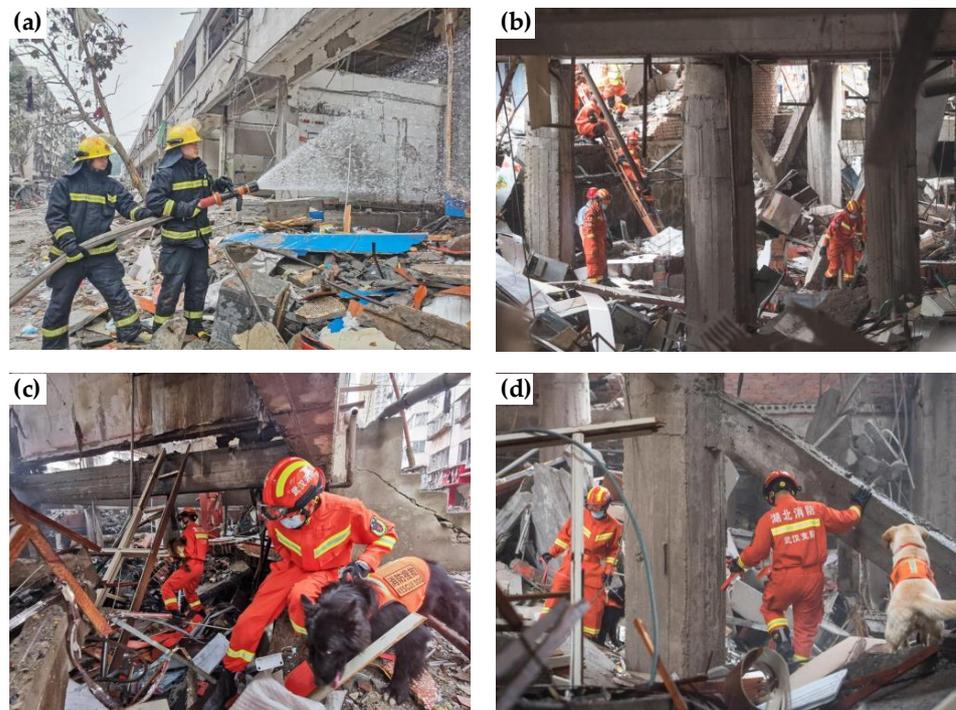
Figure 5 illustrates the firefighters in action, searching for and rescuing the wounded. In fact, an important task force (comprising all fire rescue personnel) was mobilized by the local government in a timely and efficient response to the blast. Specifically, the authorities established an accident rescue headquarters with eight working groups. About 913 residents and businesses at the scene of the accident were evacuated. Figure 5 shows some firefighters climbing over damaged concrete slabs to reach people trapped below. Sniffer dogs were also used in the search and rescue process, as well as for detecting other dangers. It should be noted that nearby cadres and groups also actively participated in the rescue operation, searching for survivors in the rubble [27]. The latter were taken to

Figure 5. (a–d) Firefighters in search and rescue operation soon after the blast (Source: <https://7news.com.au/news/disaster-and-emergency/at-least-12-dead-in-china-gas-explosion-c-3098789>, accessed on 14 August 2021).
