Environmental Decay of Ignimbrite Patrimonial Monuments in the Dry, Urban, and Non-Industrial Atmosphere of Morelia (México)

Rosalia Ruiz-Ruiz ^{1,2,*}

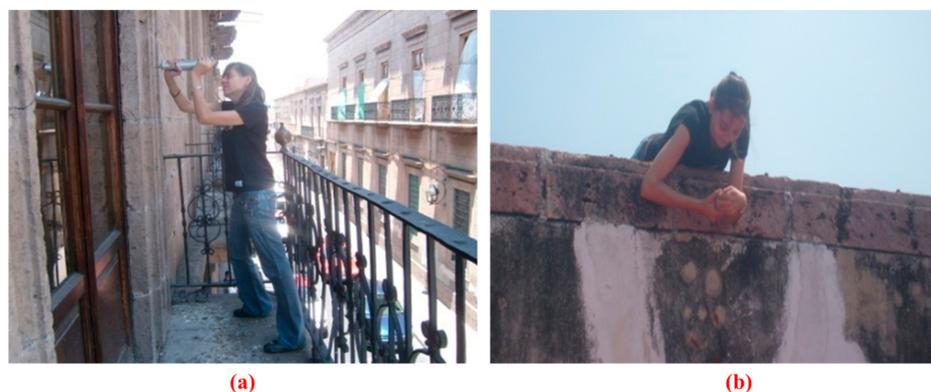
Figure 7. (a) Sclerometer or Schmidt hammer and (b) the test with the sclerometer at the Regional Museum of Michoacan (MR).

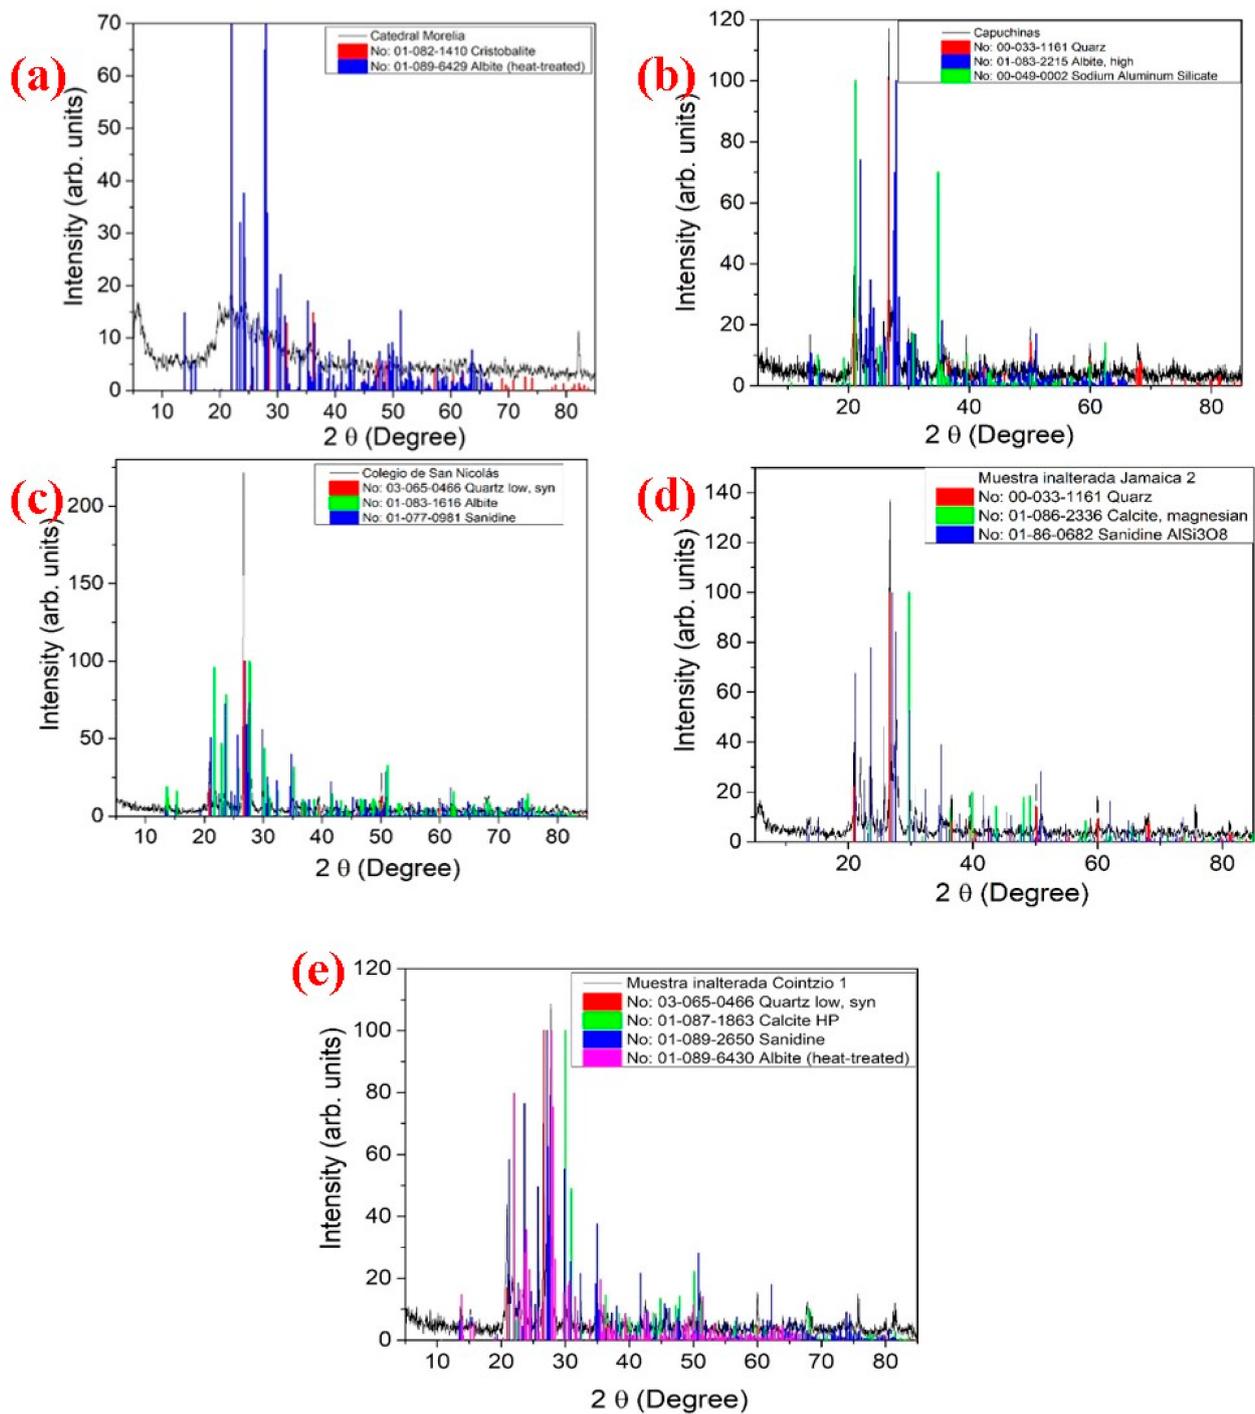
It is evident that there is deterioration in the buildings studied in this research; the damage is mainly in the lower zone of the facades, in the stones, and in the mortar that joins them. It was found in the altered samples of the different historic buildings and healthy rocks that there is a presence of silica (SiO_2), quartz (SiO_4), and albite, among other mineral particle compounds from each sample (Figure 10). According to the mineralogy of the SAN samples, the matrix is a greenish-brown glass with abundant recrystallization points and incipient appearance of chalcedony, containing small plagioclase microlites, pyroxenes transformed to magnetite or antigorite. The Capuchinas church (CAP) sample also presents a dark greenish matrix containing fragments of minerals and lithics of basaltic composition; in some parts of it, there is chalcedony and the punctual replacement of calcite. The few lithics it contains present an andesitic composition with plagioclase (Andesine) and pyroxenes (Augite) that, in some cases, are chloritized or transformed to antigorite. The ignimbrites are mainly composed of rhyolite [70].

Figure 10. The ignimbrite shards were ground until mesh 400 ASTM. Diffractograms: (a) CAT, (b) CAP, (c) SAN, (d) Jamaica (Jam), and (e) Cointzio (Coin).

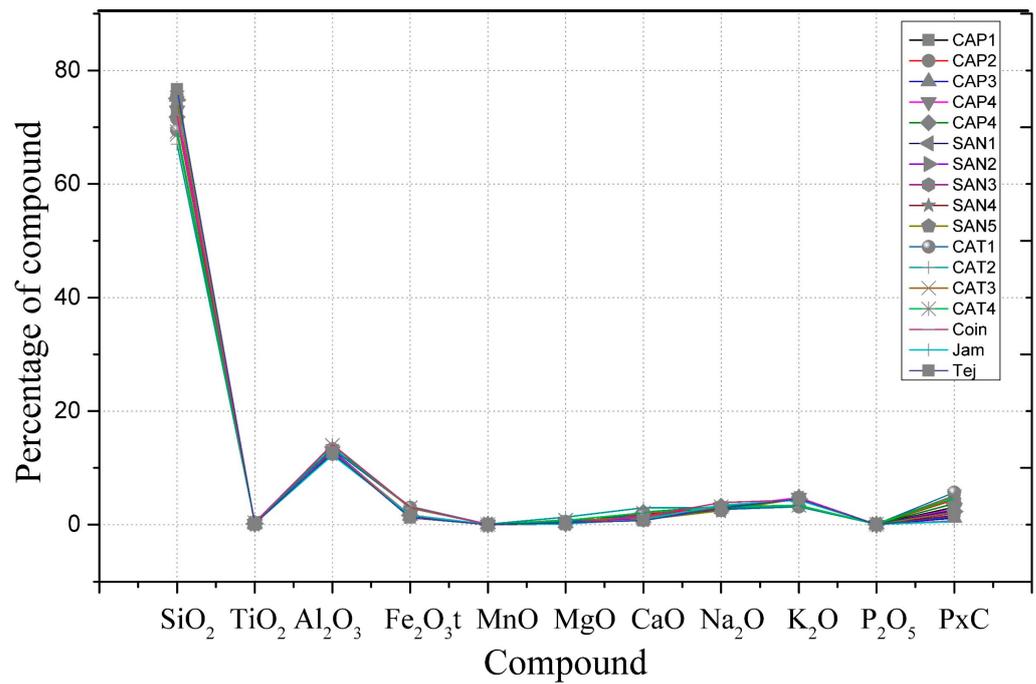
With the analytical technique of X-ray fluorescence, the chemical composition of the rocks was determined, with it finding that the historic buildings were built with very similar ignimbrites, and this is demonstrated in Figure 11, where the average percentage of SiO_2 is in a range between 71.6% and 75.1%. A very similar trend in chemical composition (TiO_2 , Al_2O_3 , F_2O_3 , MnO , MgO , CaO , Na_2O , K_2O , and P_2O_5) is evident, so there is homogeneity in the composition of the samples analyzed, since the ignimbrites come from the same magmatic event of the Mexican Volcanic Belt.

Figure 11. X-ray fluorescence in the samples from the historic buildings and the samples from the quarries.

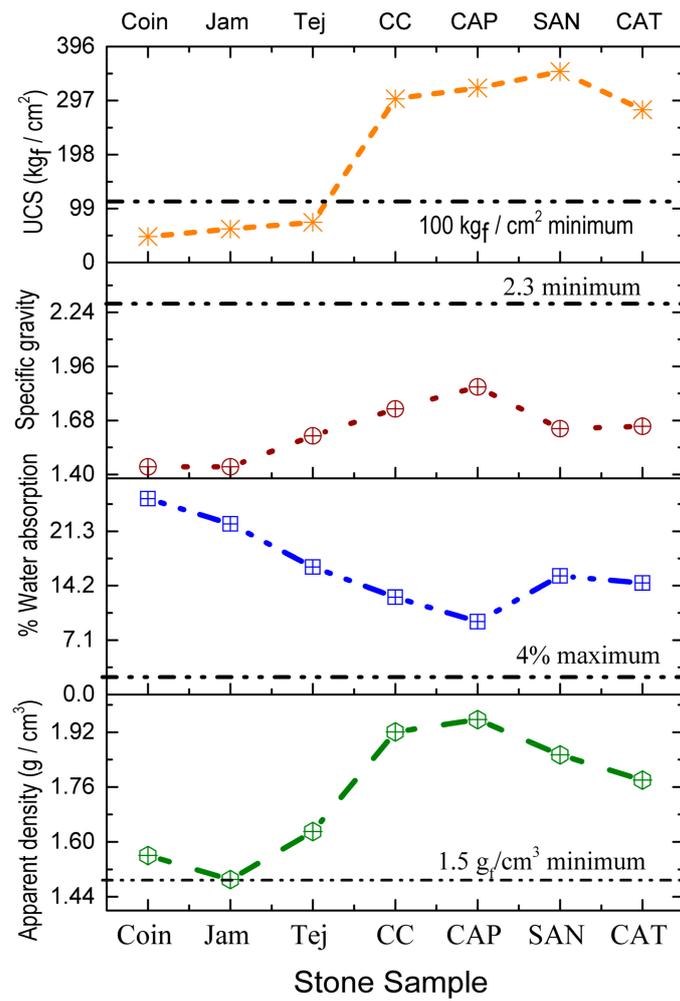
The results of the physical and mechanical tests are shown in Figure 14. In the rocks studied, mechanical compressive strength is proportional to both bulk density and specific gravity (volumetric mass) and inversely proportional to water absorption. In addition, the UCS values of recently excavated sound quarries (Coin, Jam, and Tej) vary from 40 to 100 kg/cm² compared to those located in historic buildings (CC, CAP, SAN, and CAT), which range from 290 to 350 kg/cm² made in rock cubes.

Figure 14. Physical and mechanical tests.

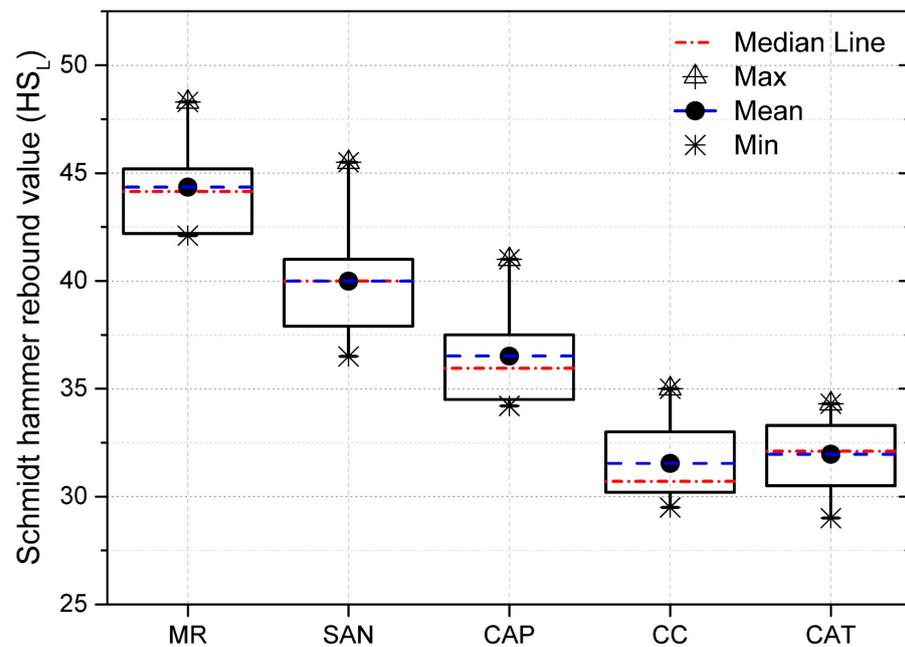
The box-plot diagrams (Figure 15) show the values of the rebound performed with the Schmidt hammer and provide information such as measures of central tendency and data dispersion around the median. In addition, it can be observed that the rebound number value (HS_L) ranges from 29 to 48.3. The rocks with which the historic buildings were constructed have a different hardness among them because of the damage generated over the years. However, there are some overlaps as CC and CAT have very similar rebound values. The historic building MR has higher rebound values compared to CC, CAT, CAP, and SAN, with the values of the studied banks of Cointzio (Coin), Jamaica (Jam), and Tejocote (Tej) being well below the estimated UCS value of the studied buildings.

Figure 15. Statistics of the rebound value of the Schmidt hammer for all orientations (north, south, east, and west).

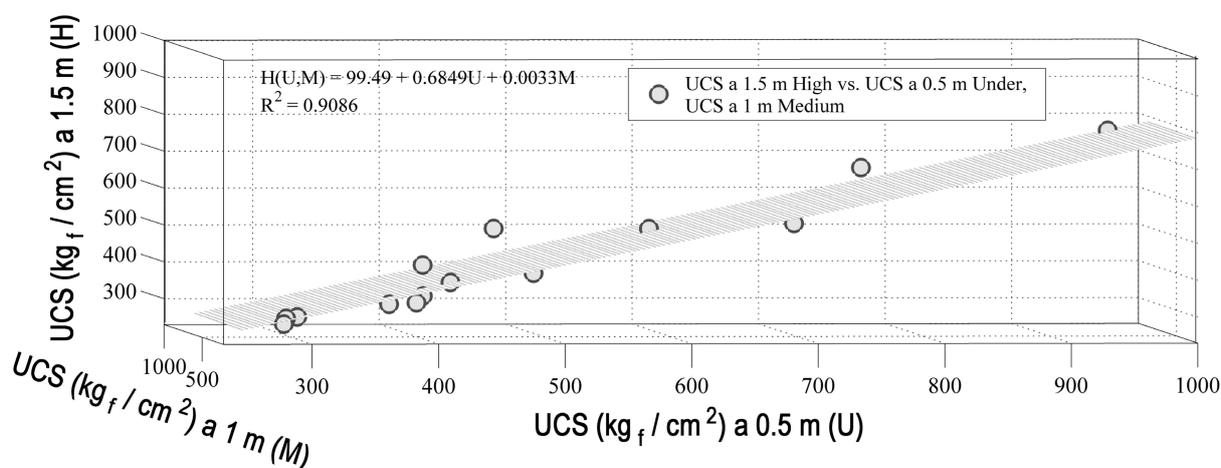
A mathematical model was obtained to estimate the UCS based on the results of sclerometry at heights of 0.5 m, 1.0 m, and 1.5 m above the bench level. With this correlation, it is observed that despite the ignimbrites being damaged at the surface level in their different orientations (north, south, east, and west), it is once again demonstrated that the ignimbrites used in the construction of the historic buildings come from the same geological origin since the correlation coefficient R^2 equal to 0.9086 is excellent (Figure 18).

Figure 18. Correlation of the uniaxial compressive strength (UCS) at the heights of 0.5 m, 1 m, and 1.5 m above the level of the sidewalk of the five buildings (north, south, east, and west facades).

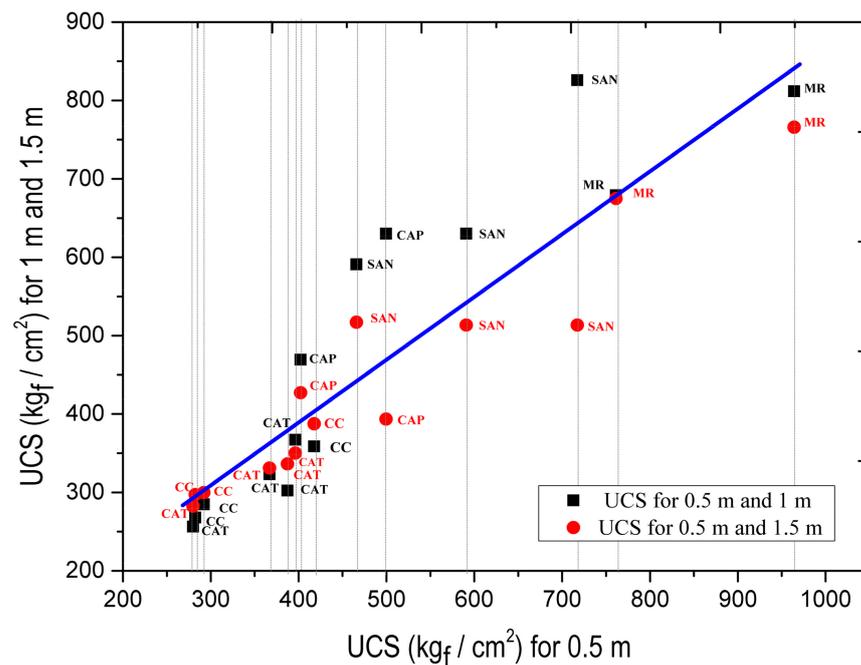
The logistic classification is a statistical method of binary classification that, in this research, allows for observation of the resistances from 0.5 m to 1 m and from 0.5 m to 1.5 m. The decision boundary, which is the blue line delimits the existence of higher damage at the height of 1.5 m for the facades with higher UCS (MR, SAN, and CAP) and higher damage for the facades with lower UCS (CC and CAT) at the height of 1.0 m (Figure 19). This can be proven by Figure 8c, where it is shown that the greater damage in the MR monument occurs above 1.5 m, while in the cathedral (CAT) occurs around 1.0 m. However, there is some damage at a height below 0.5 m at the focal points of the different facades, such as the loss of ignimbrite surfaces (Figure 9). UCS values for the different historic buildings are also observed, where the clearest difference is presented when comparing the regional museum (MR) and the cathedral (CAT), which present the highest and lowest UCS values, respectively.

Figure 19. Logistic classification of UCS comparing the resistances at 0.5 m with 1 m and 0.5 m with 1.5 m.
