Use of LiDAR Technology for the Study and Analysis of Construction Phases and Deformations in the Gothic Church of Biar (Spain)

Heritage **2024**, *7*, 122–138. <https://doi.org/10.3390/heritage7010006>

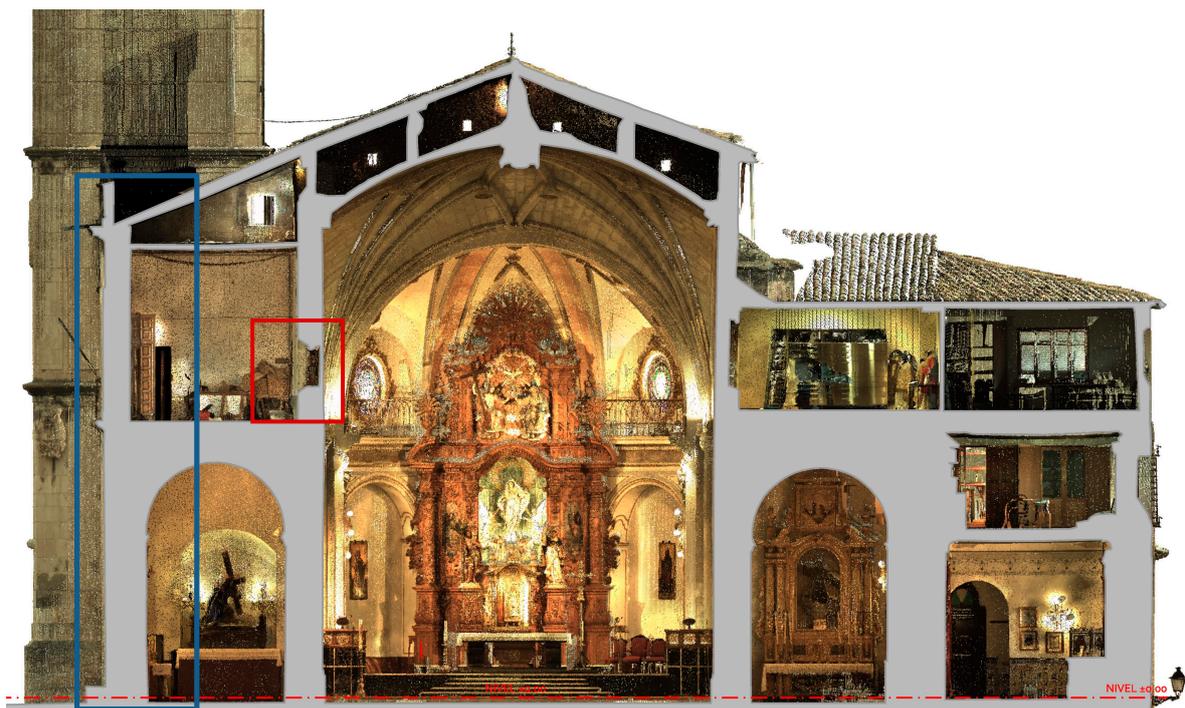
Figure 8. Church section, indicated in Figures 7a and 9c. The northeast façade under study is located inside the blue box. The Gothic rose window is located inside the red box.

The reference plane taken corresponds to the wall built at the end of the 15th century and is formed by three points on the façade of the chapels coinciding with the best possible plane of the wall without deformation. Subsequently, the deformations with respect to this plane were studied with different distance ranges.

It has been observed that the central area of the façade protrudes outwards by more than 3 cm. This part coincides with the horizontal thrust of the arch between the chapels that absorbs the loads of the vaults and transmits them to the wall, indicated as “6” in Figure 9c.

The row of ashlar below the current intermediate cornice, indicated as “5” in Figure 9c, is not built on the same plane as the lower masonry and corresponds to the Gothic façade. In addition, the row of ashlar just below shows much greater degradation, as indicated above. This could indicate that the Late Gothic masonry was finished off in the deteriorated course with larger ashlar and therefore the Baroque masonry begins in the course indicated as “5”.

As for the degradations of the walls, the lower part of the façade shows multiple anomalies, as well as the encounter with the masonry belonging to the original tower, indicated as “2 and 4” in Figure 9c.
