Article

Morphological Characteristics of Catalyst Layer Defects in Catalyst-Coated Membranes in PEM Fuel Cells

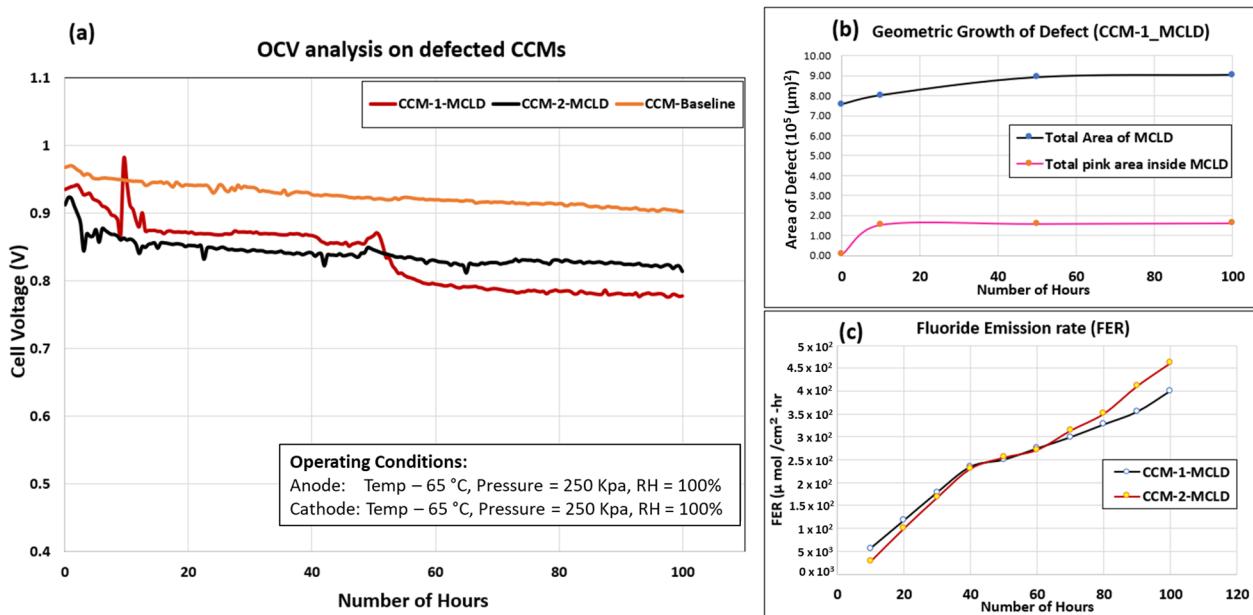
Figure 5. (a) OCV measurement of defective and nondefective CCMs, (b) areal growth of MCLD, and (c) fluoride emission rate (FER) at the cathode over the course of 100 h OCV-AST (Figure 4a–d).

Although CCM-2-MCLD and CCM-baseline did not reach their EOL at the end of 100 h, the experiments were terminated at this point since the aim was to compare the rate of OCV degradation with that of CCM-1-MCLD. The OCV of CCM-1-MCLD was found to drop more severely than that of the other two—from 935 mV to 776 mV at an average degradation rate of 1.6 mV/h. The OCV of CCM-2-MCLD degraded from 923 mV to 820 mV at an average rate of 1.0 mV/h. The OCV of the CCM baseline degraded more slowly than the defective CCMs from 968 mV to 909 mV at a rate of 0.6 mV/h. As noted previously, the testing of CCM-1-MCLD was interrupted at time intervals of 10, 50, and 100 h for inspection of the morphological changes in MCLD. As evident in Figure 5a (red line), this disturbance had some effect on the measured OCV. No such disturbance was observed in the case of CCM-2-MCLD which was removed from the cell for microscopic inspection only at the end of 100 h of OCV measurement. In both cases, similar types of catalyst degradation were observed inside the MCLD, as will be described in Section 3.3.1.

A primary focus of this study was to investigate the relation between the evolution of the MCLD and its loss in OCV as the CCM ages. As shown in Figure 5a (red line), CCM-1-MCLD experienced a noticeable voltage degradation of 7.4% over the first 10 h of operation as its voltage decreased from 935 mV to 865 mV. A particularly noticeable voltage drop of 36 mV from 901 mV to 865 mV between the 9th and 10th hours of OCV was observed. To determine if this loss in performance was reflected in a change in the MCLD, we carried out an image analysis of the CCM after the 10th hour (i.e., MOL-1). Further image analysis was performed on the aged CCM after 50 h (MOL-2) and 100 h (EOL) when the OCV was observed to drop by 10.1% and 17.8%, respectively, with respect to its initial voltage.

A comparison of the dark triangular area in Figure 4b with that in Figure 4a shows that the MCLD grows by 5.9% with an aspect ratio of 4.4 over the first 10 h. The cumulative total areal growth of the MCLD (black curve) and the total catalyst loss inside the MCLD (pink area) with respect to time are shown in Figure 5b. Furthermore, the total pink area inside the MCLD increased by more than 2000%, indicating extensive catalyst degradation within the defect.

Over the interval between MOL-1 and MOL-2, the OCV diminished at a rate of 0.85 mV/h from 874 mV to 840 mV. However, minimal growth of the MCLD was observed over this period. Most of the CCM damage appeared to involve the propagation of cracks in the catalyst layer (compare Figure 4b,c). At this stage, the MCLD area (dark triangular area) shown in Figure 4c increased by 11.3%, relative to that measured at MOL-1 with an aspect ratio of 4.11, whereas the growth of the pink area increased by only 2.7% with respect to MOL-1 (Figure 5b). Overall, the catalyst loss in the defect appears to have stabilized between MOL-1 and MOL-2.

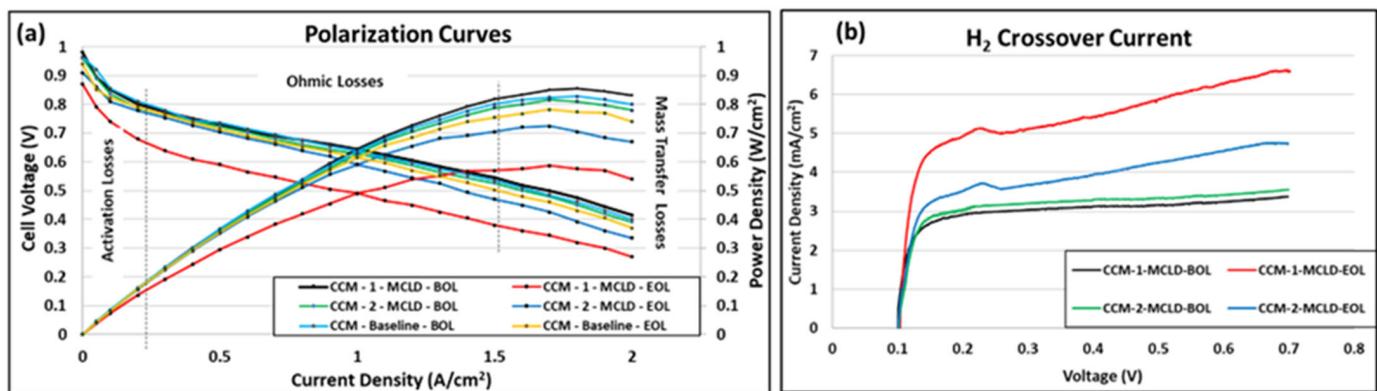
Obviously, another possible cause for some of the voltage loss in CCM-1-MCLD at EOL was its removal and examination twice during the OCV-AST (after 10 and 50 h) to characterize the MCLD using optical microscopy. This could have caused some of the membrane to dry out, leading to structural damage to the catalyst layer, an increase in the ohmic resistance of the electrode, and irreversible voltage loss in the cell during polarization. On the other hand, CCM-2-MCLD was not removed during the OCV-AST, and hence its polarization response was more suitable for comparison with that of the nondefective CCMs. At zero current density, the OCVs measured in CCM-2-MCLD and CCM-baseline decrease by 5.6% (from 0.962 V to 0.908 V) and 2.5% (from 0.966 V to 0.941 V),

respectively, between BOL and EOL. At the maximum current density (2 A/cm^2), the cell voltage decreased by 9.7% (from 0.389 V (green) to 0.351 V (blue)) in CCM-2-MCLD and 5.2% (from 0.400 V (orange) to 0.379 V (yellow)) in CCM-baseline between BOL and EOL. These results show that the performance deteriorated to a greater extent at both low and high currents when the CCM initially contained an MCLD than when it is defect free. This finding suggests that the crossover flux had a major impact on the cell potential at zero and low current density (activation region), but not at higher currents. Kreitmeier et.al showed that gas permeability across membranes decreases at a high current density which leads to an increase in humidity and membrane swelling and a reduction in the size of pinholes in the membrane [36]. On the other hand, the minimal losses seen in the mass transfer region were associated with water flooding in damaged areas across cracks, delaminated areas, and empty sites within the MCLD. A closer study of the effect of current density on MCLDs would be helpful in gaining a deeper understanding of the influence of catalyst layer defects on cell performance.

Figure 8. (a) Polarization curve of CCM-1, CCM-2, and CCM-baseline operated at 90°C and 80/80% RH on anode and cathode at a pressure of 250 kPa. (b) Hydrogen crossover current of defective CCMs (CCM-1 and CCM-2) obtained at a scan rate of 2 mV/s.
