# Investigation on Pollution-Induced Flashovers of In-Service Insulators in Ethiopian Power Transmission Lines

**Abstract:** Power transmission lines in Ethiopia are experiencing an alarmingly high frequency of unexplained outages triggered by environmental factors, which significantly undermine the reliability of the country's power system. This paper presents investigations aiming to identify those among the unexplained fault records that have been caused by pollution induced flashovers. An identification method is developed, which associates the contextual fault features, such as information about the characteristics of the fault, fault location, and time of day, as well as month of its occurrence with local meteorological/climatic and environmental conditions. A total number of 4231 unexplained faults, recorded between 2015 and 2022, were analyzed. Among them, 1045 faults (24.7%) were identified as being most likely caused by pollution induced flashovers. The entire network suffered from more than 130 pollution-induced flashovers annually with a frequency of about 0.8 faults/100 km/year. The fault frequency strongly differed among the grid regions, being highest in the Northea

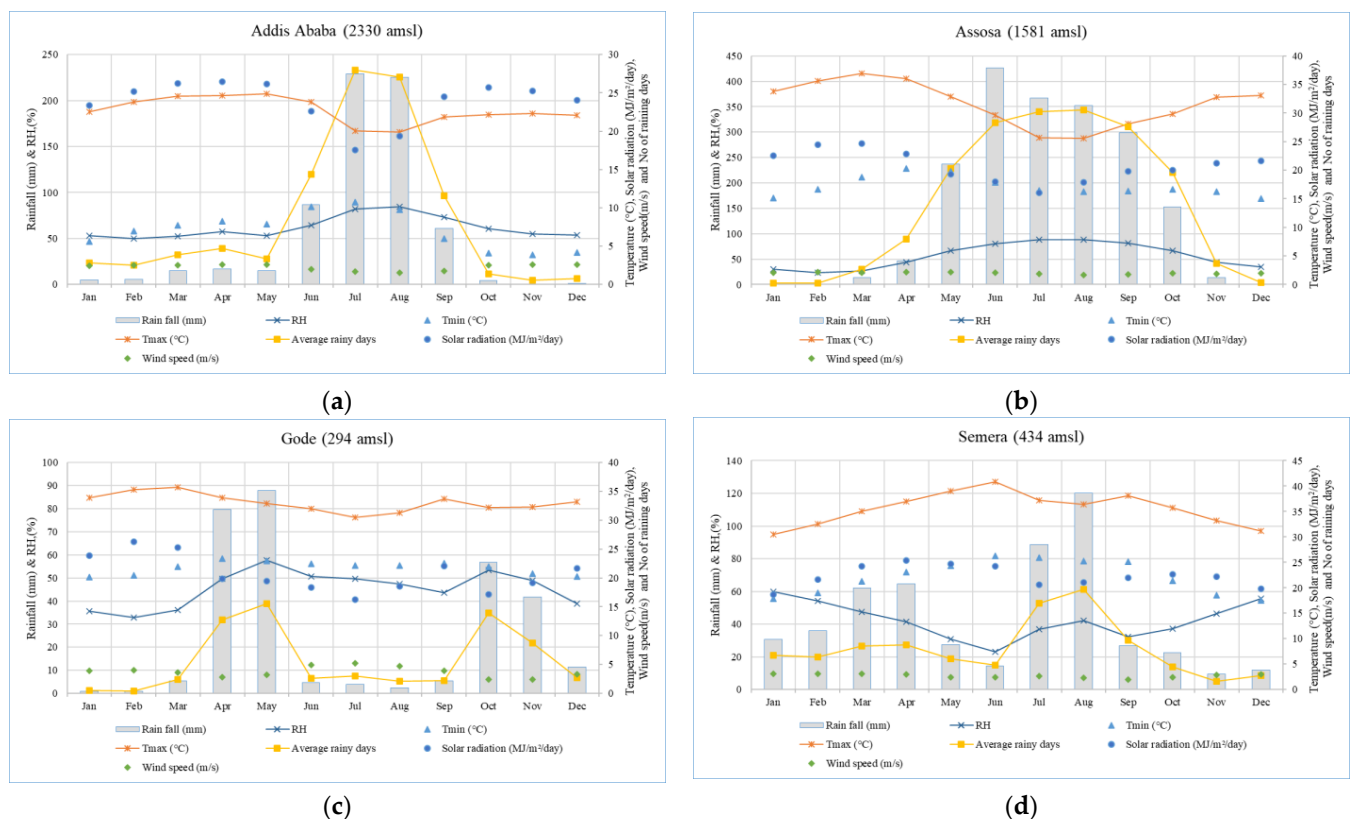
**Figure 2.** Illustrations of annual variations in meteorological parameters (derived from 30 years of data [28]) for four representative sites in Ethiopia. (a) Addis Ababa; (b) Assosa; (c) Gode; (d) Semera.

The meteorological conditions for Group 1 areas, as shown in Figure 2a, are predominantly dry from October to February of the next year, while the period from March to

As shown in Figure 2b, the period spanning from October to February of the next year is mainly dry. The average monthly rainfall during this period is 6.7 mm. Moreover, periods with less than 20 mm rain are in March and November, whereas periods with less than 10 mm rain begin in December and continue to the end of February. During the primary rainy season from March to September, the monthly average rainfall reaches 200 mm and secures natural washing of insulator surfaces.

As shown in Figure 2c, the main dry season in regions of Group 3 is from June to September and from December to February of the next year, while from October to November there is a short rainfall season. During the former periods, the average monthly rainfall is low, respectively, 17 mm and less than 10 mm. During March to May (the main rainy season), the weather is moist, and the average rainy days and average monthly rainfall reach 10 days and 44 mm. The natural washing of insulators by rain increases in this period.

As shown in Figure 2d, the periods from October to February of the next year and from March to May are the main dry seasons. During these periods, the average monthly rainfall is low, around 27 mm. Moreover, less than 20 mm rain periods are during January and June, and less than 10 mm rain periods begin in November and December. During June to September (the main rainy season), the weather is moist, but the rainfall is usually light. Most of the rainy days are continuous drizzle or scattered rains, and the average monthly rainfall reaches 45 mm. Hence, the washing effect during this period is minimal.

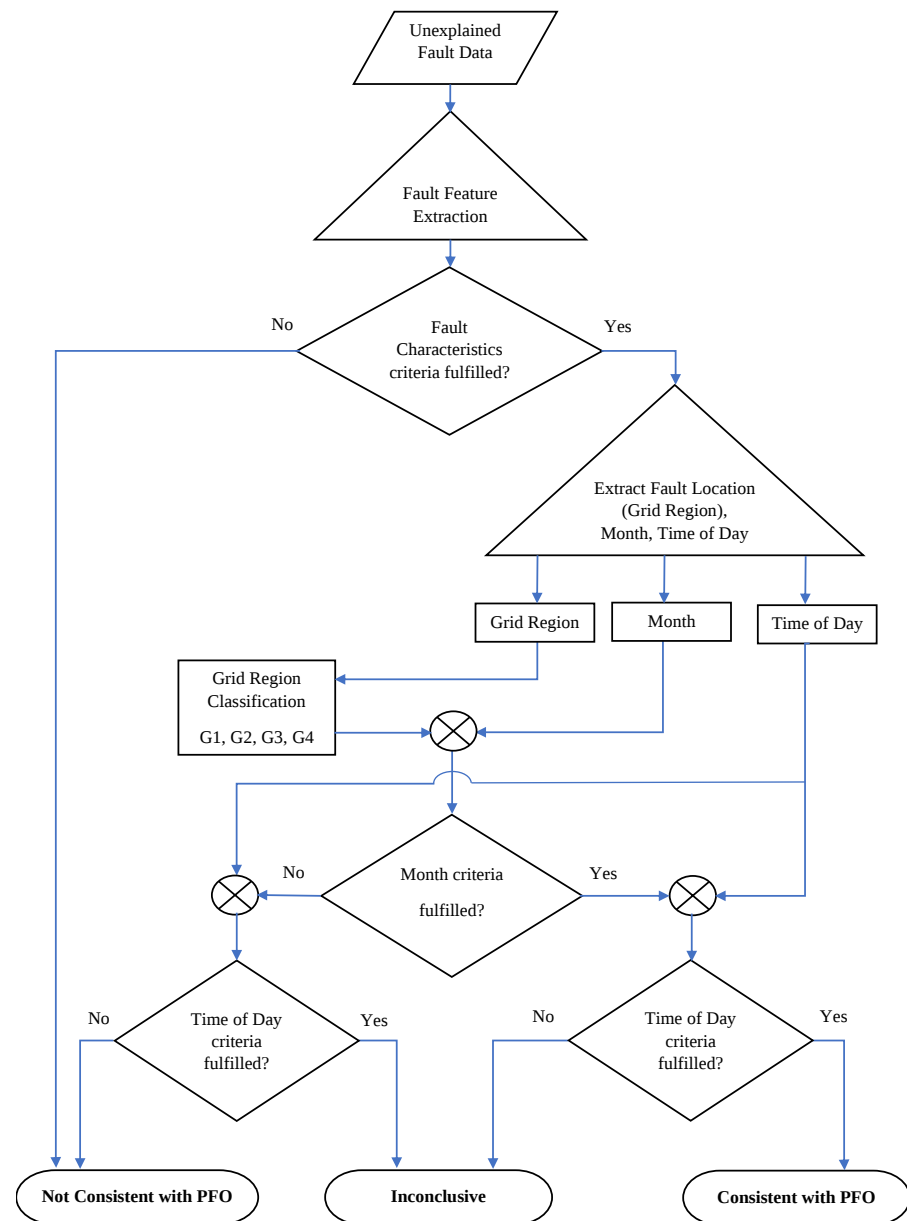
**Figure 3.** Procedure for application of criteria for identifying pollution flashover-induced faults.

The implementation of these criteria can best be demonstrated through the flowchart depicted in Figure 3. The criteria and the procedure described in the flowchart serve as a general guideline for evaluating the roots of unexplained faults. The first decision block checks whether an unexplained fault fulfils the characteristics criteria outlined in Section 2.1.5. If the unexplained fault does not satisfy this criterion, then this fault is not considered as pollution caused and categorized as “Not Consistent with PFO”. Otherwise, the process continues, and information on the fault location (Grid Region), month, and

time of its appearance is extracted. The subsequent decision blocks in the flow chart use the criteria presented in Sections 2.1 and 2.2 as well as in Table 1.

In the following steps, after assigning the right grid region group to the fault, it is tested for the month and time-of-the-day criteria. If the conditions are fulfilled, then the fault is categorized as “Consistent with PFO”. If only one of the criteria is fulfilled, then it becomes difficult to assign it as PFO because other possible environmentally induced causes of unexplained fault may also exhibit similar characteristics. So, such cases are “Inconclusive” and need further investigations to assign their possible causes. Moreover, if it fails to fulfill both criteria, then it is not considered as pollution-induced flashover and hence assigned as “Not Consistent with PFO”.

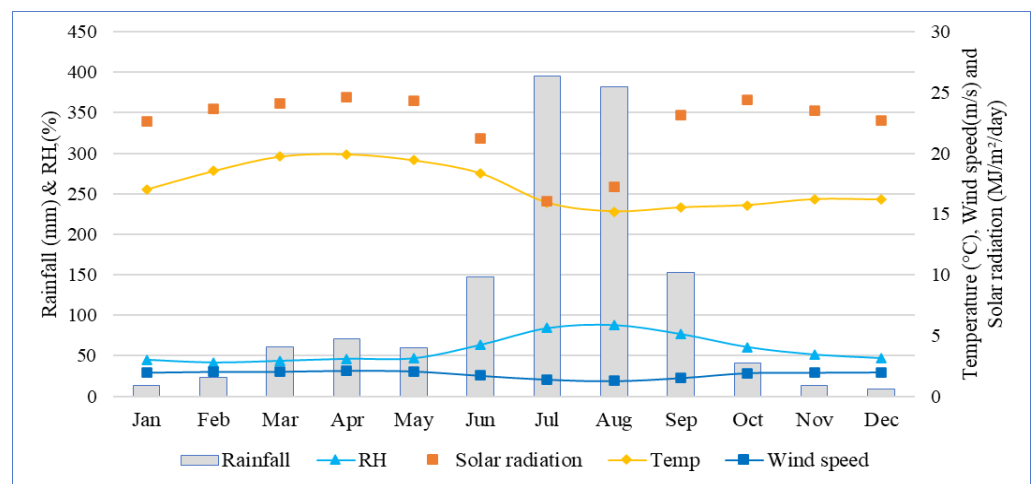
**Figure 14.** Monthly average meteorological parameters across the entire length of the Bahir Dar II—Debre Markos—Sululta 400 kV line [28].

The Bahir Dar II—Debre Markos—Sululta 400 kV line spans 410 km, extending from the northwestern highlands of Ethiopia to Addis Ababa, crossing subtropical highland and tropical savanna climatic conditions. The environmental conditions along the route of the line are characterized by a mixture of desert, industrial, and agricultural pollutants. The main sources of pollution in the area are from transportation, construction, quarry sites, naturally occurring dust from local soils, cement factories, and agricultural activities such as ploughing, fertilizers, crop spraying, and harvesting. The line is insulated with glass-cap and pin strings. The line is known for having a high number of unexplained outages, and the performed analysis identified a total of 72 pollution induced faults on it for the period between 2015 to 2022, an average of 9 faults per year. Figure 14 shows the monthly average meteorological parameters across the entire length of the line. The line receives an average rainfall of about 270 mm from June to September and an average relative humidity above 58%, temperature above 17 °C and windspeed 1.8 m/s for the whole year.
