Conservation of Monuments by a Three-layered Compatible Treatment of TEOS-nano-Calcium Oxalate Consolidant and TEOS-PDMS-TiO₂ Hydrophobic/Photoactive Hybrid Nanomaterials

Supplementary Materials

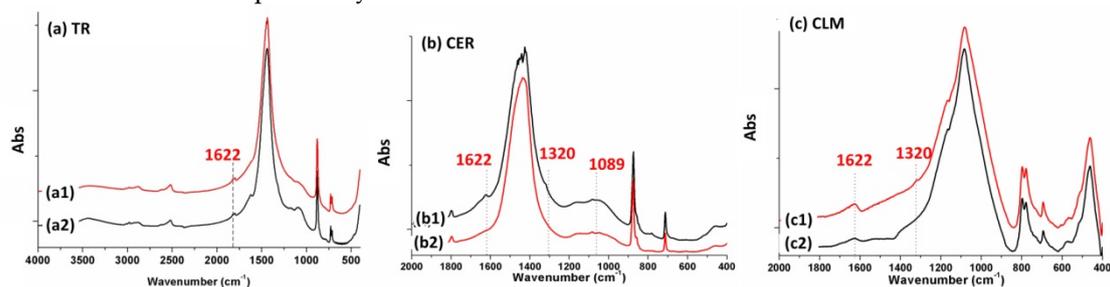
Figure S1. FTIR spectra indicating the penetration depth of TCO in: (a) TR at 0 mm (a1) and 20 mm (a2) from the surface, (b) CER at 0 mm (b1) and 4 mm (b2) from the surface and (c) CLM at 0 mm (c1) and 15 mm (c2) from the surface.

Powders originating from the surface layer of the substrates and from different depths were examined in order to detect the maximum depth of the TCO presence. In Figure S1, representative FTIR spectra of the treated substrates are illustrated showing the penetration depth of the TCO material after the consolidation process. The two prevailing peaks of calcium oxalate, which appeared at 1622, 1320 cm⁻¹, were mainly monitored in order to evaluate the existence of calcium oxalate. In TR travertine, the TCO product penetrated up to a depth of 20 mm from the surface, whereas in the cementitious lime materials (CLM) TCO was measured at 15 mm. Regarding CER, the spectra revealed the presence of TCO at 4 mm. The variations of the penetration depth of TCO are probably ascribed to the different porous system of the substrates.

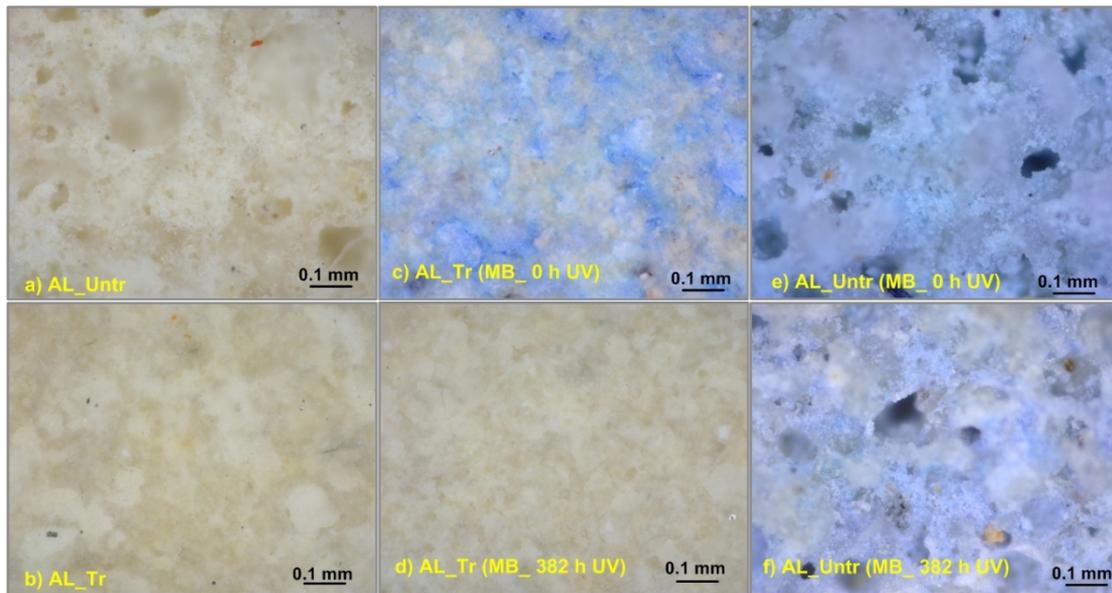
Figure S2. Optical Microscopy images of AL substrate: untreated (a), treated with TCO&SP&T (b); treated and stained: before (c) and after (d) UV irradiation; untreated and stained: before (e) and after (f) UV irradiation.

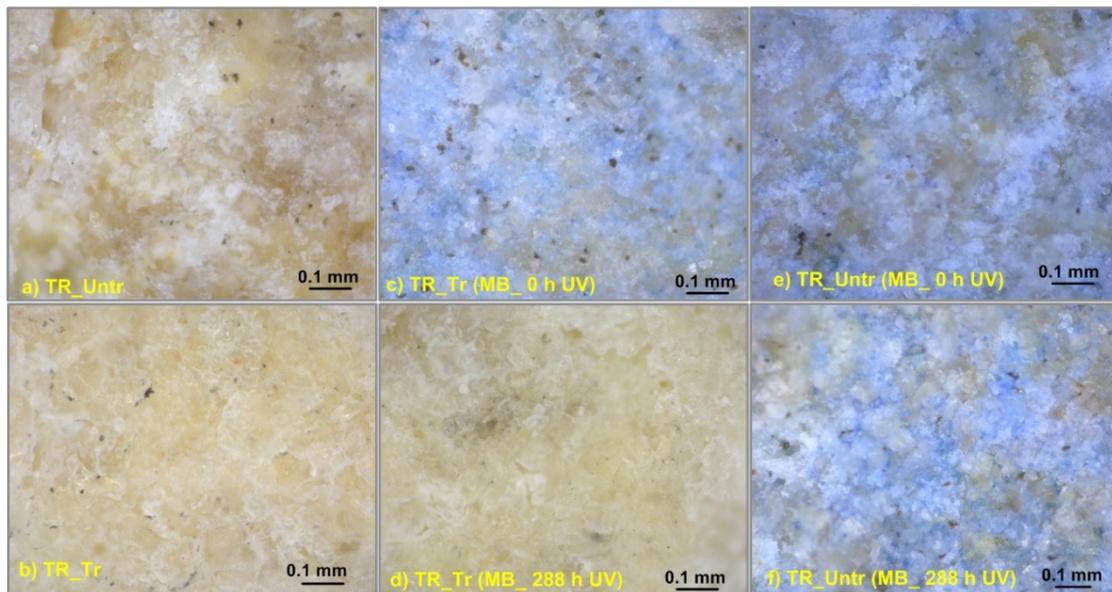
Figure S3. Optical Microscopy images of TR substrate: untreated (a), treated with TCO&SP&T (b); treated and stained: before (c) and after (d) UV irradiation; untreated and stained: before (e) and after (f) UV irradiation.

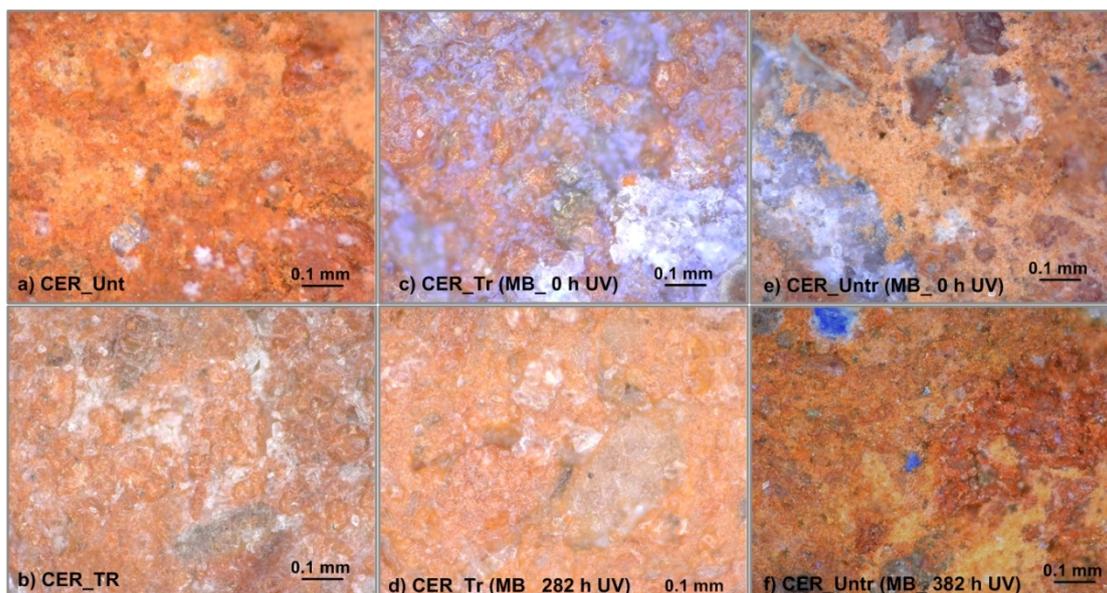
Figure S4. Optical Microscopy images of CER substrate: untreated (a), treated with TCO&SP&T (b); treated and stained: before (c) and after (d) UV irradiation; untreated and stained: before (e) and after (f) UV irradiation.

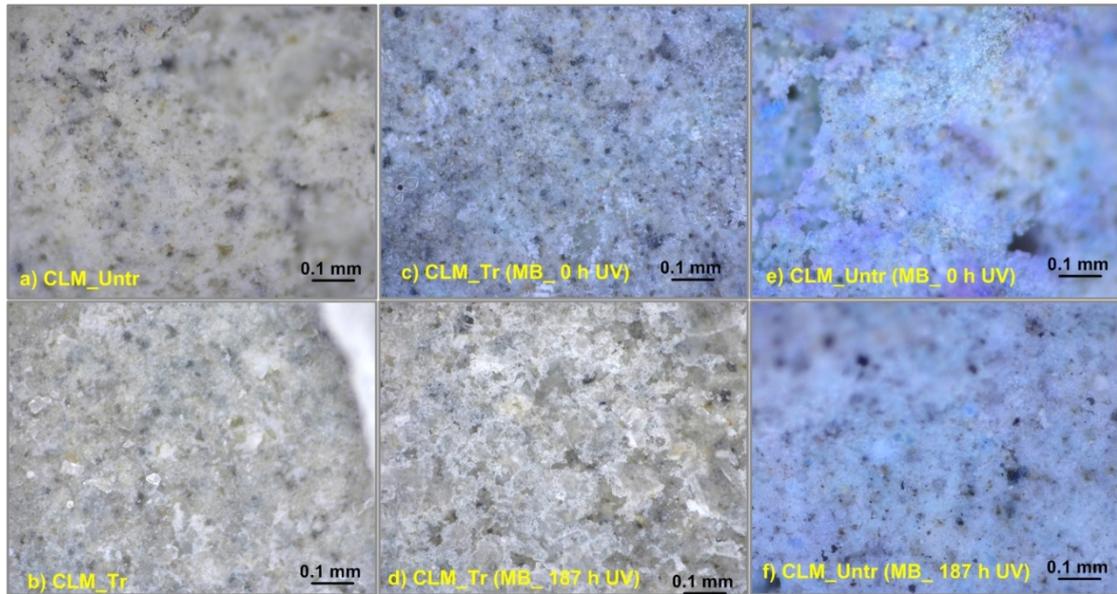
Figure S6. Optical Microscopy images of CLM substrate: untreated (a), treated with TCO&SP&T (b); treated and stained: before (c) and after (d) UV irradiation; untreated and stained: before (e) and after (f) UV irradiation.

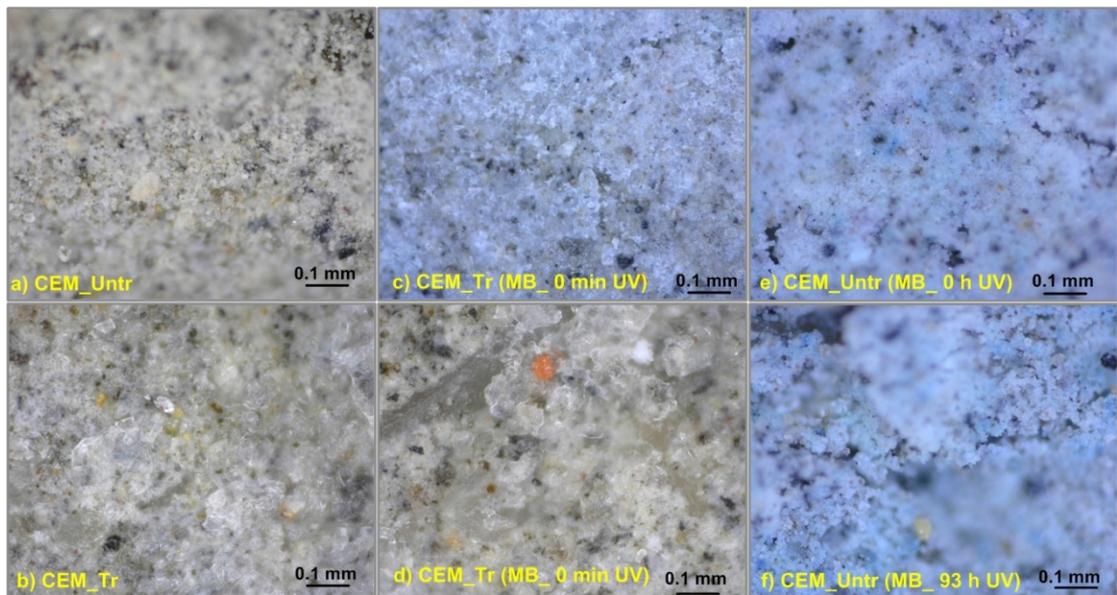
Figure S7. Optical Microscopy images of CEM substrate: untreated (a), treated with TCO&SP&T (b); treated and stained: before (c) and after (d) UV irradiation; untreated and stained: before (e) and after (f) UV irradiation.

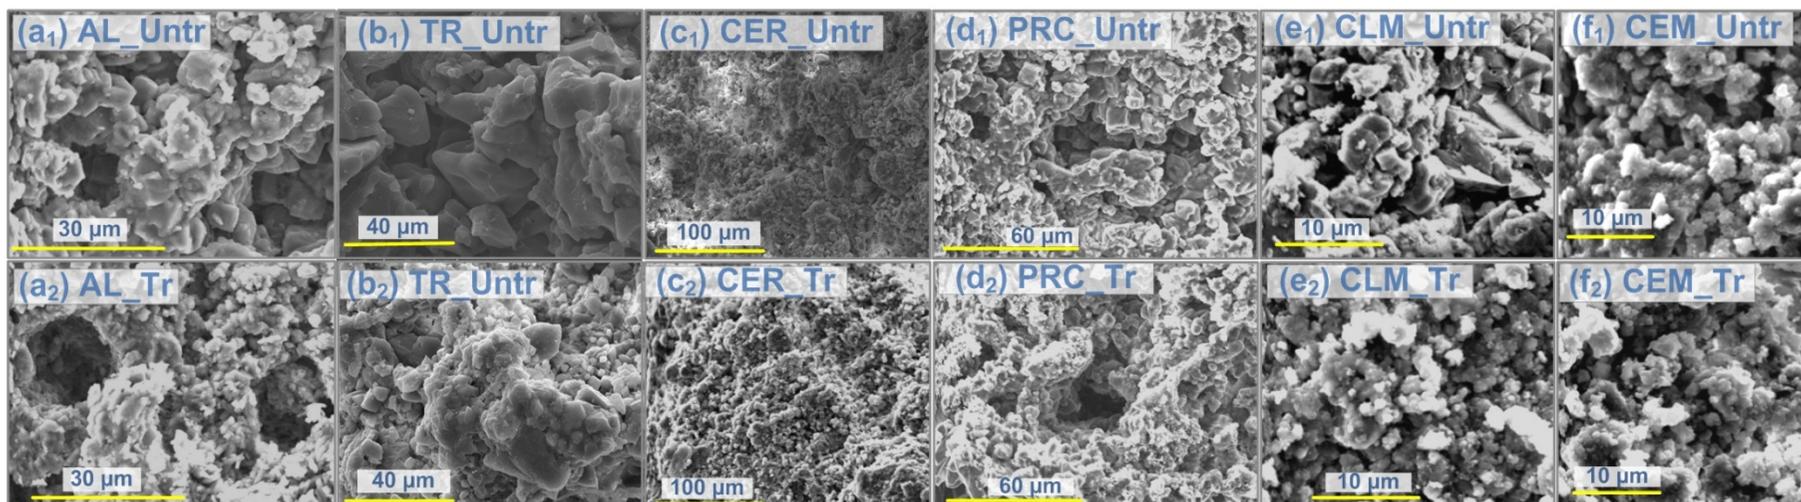
Figure S8. SEM images of untreated (a1, b1, c1, d1, e1, f1) and treated with TCO&SP&T (a2, b2, c2, d2, e2, f2) for AL, TR, CER, PRC, CLM, CEM substrates, respective
