Article Fiber Bragg Sensors on Strain Analysis of Power Transmission Lines

Keywords: monitoring FBG; power transmission tower; civil engineering

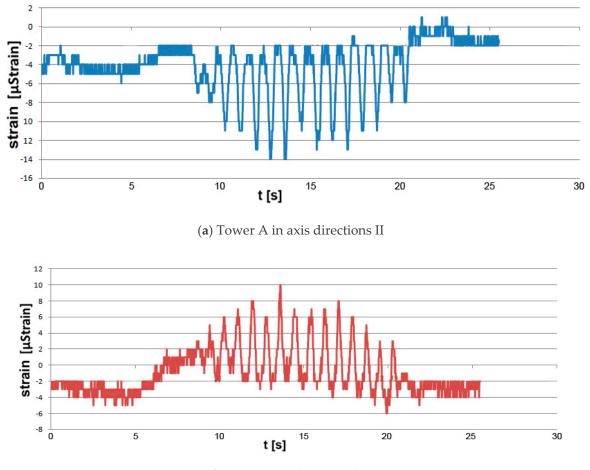
Figure 6. Strains in the legs of tower A under a lateral load: (**a**) in the tower axis direction, (**b**) in the tower diagonal direction.

The load applied to the tower in direction II resulted in compressive strains of -14μ strain in legs 1 and 2. A tensile strain of 10 μ strain arose in the legs on the tower's opposite side. The strain measurement results are presented in Figure 6a,b.

This meant the occurrence of tensile stresses of 2.1 MPa and compressive stresses of about -2.82 MPa. If a load was applied in direction III, the values of strain for leg XP1 total -19 µstrain, and for the leg located diagonally, 14 µstrain. The highest strain values were recorded if the tower was loaded

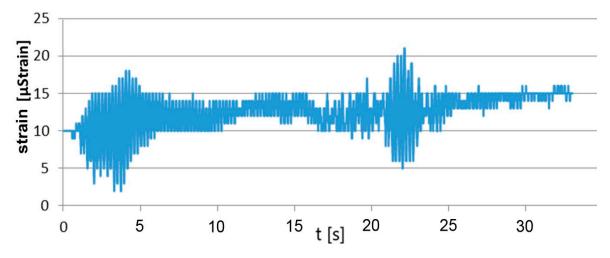
Figure 7. Highest strain values under a lateral load.

along the axis in relation to which the tower apex was shifted. The recorded strain values totaled 21 µstrain (cf. Figure 7), which, based on physical relations, meant a tensile stress of about 4.5 MPa.

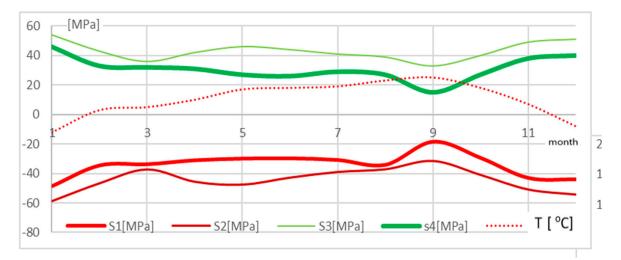
Figure 8. Stress and temperature distribution in the legs of tower A located on an island in a lake.

The second part of the testing concerned the observation of strains arising in selected legs of the tower over a period of one year. In the case of the legs of tower A, located on an island in a gravel mine area, strains rose in the winter period to 230–270 µstrain and then returned, in the case of leg 1, to the initial level of 150 µstrain. In the case of tower B, the course of the changes was similar, but the strain values did not return to the initial state and kept at the level of 230 µstrain. The tower leg was shortened, which meant that the stresses arising in the two legs were compressive. The strain values for the other two legs were similar but with the opposite sign, which meant that there was tension. By determining real strain values in the tower legs, it was possible to define the performance of the tower foundation. The tower rotation axis (direction II) at the tower base is marked in Figure 5. It passed between the legs subjected to compression and those subjected to tension. The hypothesis was also confirmed by the measurements of the tower apex deviation (cf. subsection on validation). Using physical relations (Hooke's law), the values of stresses arising in the tower's individual legs were determined. They are presented in Figure 8.

The changes in stresses were correlated with the changes in temperature (cf. Figure 8). Analyzing the temperature history during the observation, it can be noticed that stresses in the tower varied with changes in temperature. A drop in temperature involved a rise in the compressive stress value in the

tower legs (to observation point 11). The rise in temperature that occurred in the post-winter period caused an increase in compressive stresses. In leg 1, stresses were increased by about 20 MPa, whereas in leg 2 the rise in compression was higher and totaled about 25 MPa. In summer, temperatures were higher and according to the observation results, stresses in leg 1 remained at the same level, whereas compressive stresses in leg 2 dropped to the value of about -50 MPa. The highest calculated value of compressive stress totaled 60 MPa. The stresses were compared to allowable stress values for this type of tower structure, which were defined precisely in [17]; they range from 150 to 250 MPa.

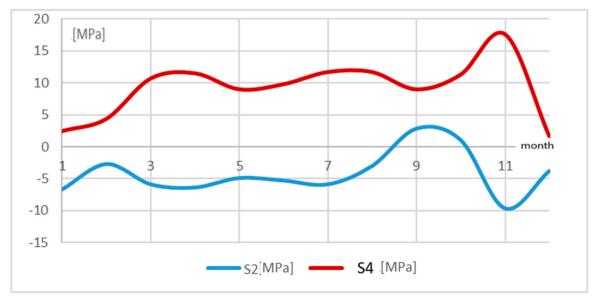
Figure 9. Stress and temperature distribution in the legs of tower B located in the mountains.

The tower located in the mountains did not display such regularity (cf. Figure 9).

This is especially visible in the case of leg 2, for which the relations were the opposite, i.e., a rise in temperature in the initial period involved a drop in stresses by 15 MPa and a change in the nature of the stress, whereas a temperature drop changed the sign of stresses and increased them to the value of 5 MPa. It can be seen that as leg 4 was subjected to tension, leg 4 was compressed. It can be supposed that this is due to the landform features and# the fact that the terrain was unstable and wet. Most probably, the tower foundation rotated in relation to the axis along one of the tower base diagonals. Moreover, each of the tower legs had a separate foundation. The tower's hypothetical rotation at the tower base is presented in Figure 5 (direction III). In such a situation, one side of the tower structure was subjected to tension and the other to compression. This was also confirmed by geodetic measurements of the tower apex.

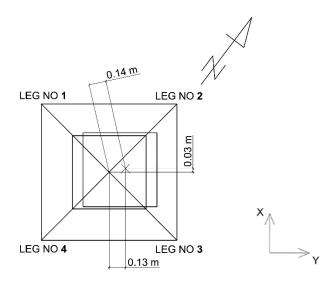
Figure 10. Tower A rotation and translation.

Validation by means of geodetic measurements was carried out on the tower apex deviation from the plumb line. The method of direct projection onto a leveling staff placed on the tower foundation was applied. A Leica TCR 407 tacheometer (LEICA, Wetzlar, Germany) and a measuring staff were used. The measurements revealed a tower axis deviation from the plumb line of 3 and 13.5 cm, respectively, in the direction parallel (component X) and perpendicular (component Y) to the course of the 110 kV high-voltage power transmission line (Figure 10).

The results of the measurements of the tower deviation confirmed the results of the measurements of strains in the tower legs. They indicated that the tower structure inclined towards legs 2 and 3 and caused higher compressive stresses.

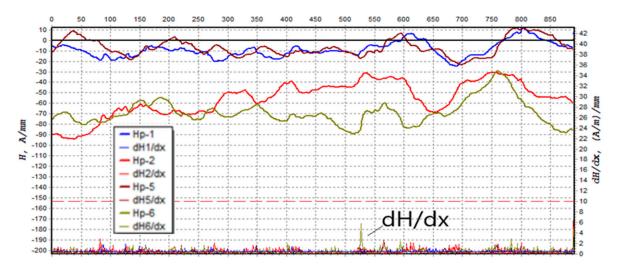
Figure 11. Distribution of the gradient dH/dx tangent component of magnetic field.

The tower legs were also tested using the residual magnetic field (RMF) method. The method is described in [28,29] and makes it possible to detect stress concentration zones in ferromagnetic elements, such as steel, used to build the tower legs. Stress concentration zones occur in areas where the magnetic indicator—the gradient of the normal and the tangential component along the measuring path—reaches a value exceeding 10 [(A/m)/mm.] No such areas were found in the case of the tower legs under consideration. Moreover, the method enables the detection of fractures and microcracks. In these particular areas, the residual magnetic field's normal component becomes zero. Despite the long in-service time, the RMF testing did not detect any cracks in the tower leg. The distribution of the gradient of the tangential component magnetic field along the tower A leg is presented in Figure 11.
