# The Wrinkles Characterization in GFRP Composites by Infrared Active Thermography

**Abstract:** An experimental study has been carried out to assess the effectiveness of infrared thermography in wrinkle detection in composite GFRP (Glass Fiber Reinforced Plastic) structures by infrared active thermography. Wrinkles in composite GFRP plates with different weave patterns (twill and satin) have been manufactured with the use of the vacuum bagging method. The different localization of defects in laminates has been taken into account. Transmission and reflection measurement techniques of active thermography have been verified and compared. The section of a turbine blade with a vertical axis of rotation containing post-manufacturing wrinkles has been prepared to verify active thermography measurement techniques in the real structure. In the turbine blade section, the influence of a gelcoat surface on the effectiveness of thermography damage detection has also been taken into account. Straightforward thermal parameters applied in structural health monitoring systems allow an effective damage detection method to be built. The transmission IRT setup allows not only for damage detection an

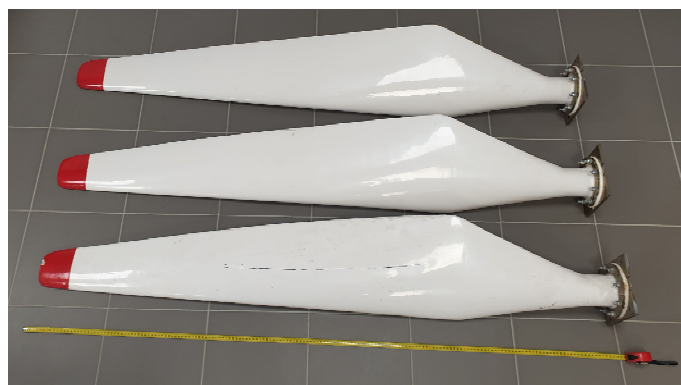
Further research will focus on the application of active thermography in transmission and reflection configurations in the real blades of wind turbines with the horizontal axis of rotation (Figure 11).

**Figure 11.** The horizontal axis wind turbine blades (the length equal to 1.75 m).

The quality control of horizontal axis wind turbine blades allows for the validation of presented results and the assessment of the active thermography of real constructions.
