# Rapid and Non-Destructive Repair of Fused Silica with Cluster Damage by Magnetorheological Removing Method

**Abstract:** The damage repair of fused silica based on the CO<sub>2</sub> laser repair technique has been successfully applied in high-power laser systems in the controllable nuclear fusion field. However, this kind of repairing technique mainly focuses on large-scale laser damage with sizes larger than 200 μm, but ignores the influence of cluster small-scale damage with sizes smaller than 50 μm. In order to inhibit the growth of small-scale damage and further improve the effect of fused silica damage repair, this paper carried out a study on the repair of fused silica damage using the magnetorheological (MR) removing method. The feasibility of fused silica damage repairing was verified, and the evolution law of the number, morphology, and the surface roughness of small-scale damage were all analyzed. The results showed that the MR removing method was non-destructive compared to traditional repairing technologies. It not only effectively improved the whole damage repairing rate to more than 90%, but it also restored the optical properties and surface roughness of the dama

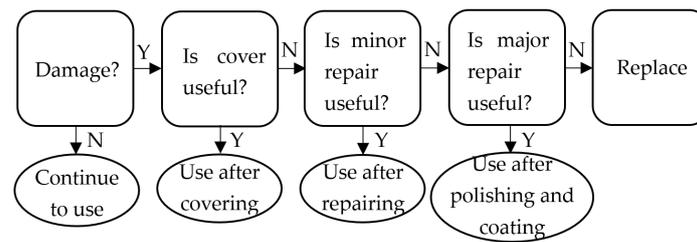
**Figure 1.** Flow chart of optical elements in the NIF system.

Figure 1 shows the flow chart of the optical elements in the National Ignition Facility Project (NIF) system [5]. Three processing methods are proposed for damaged elements: firstly, the damaged area is covered; secondly, if it cannot be covered, it needs to be repaired; thirdly, if it cannot be repaired, it should be replaced [6]. As an important part of the component in the NIF system, damage repair has become key to ensure the stable operation of the whole system.

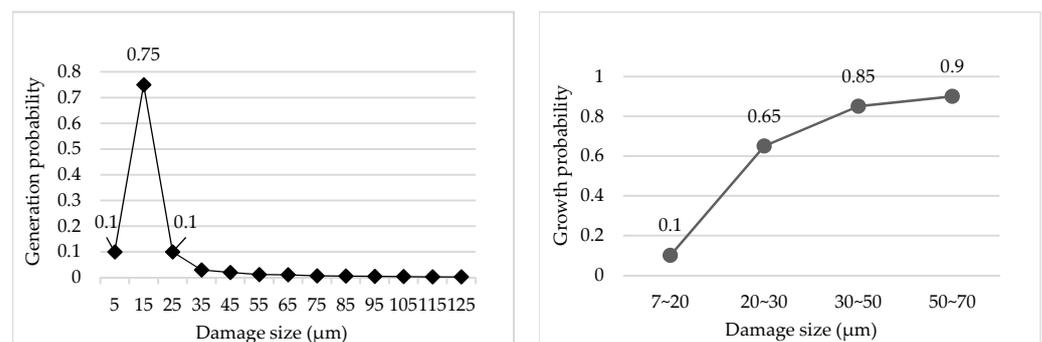
**Figure 2.** Probability of damage generation and growth.

Miller from the Lawrence Livermore National Laboratory, California, USA conducted an in-depth study on the law of damage occurrence and growth, as shown in Figure 2. The research showed that the probability of small-scale damage points with sizes less than 50 μm was more than 95%, and the probability of growth was very high. That is to say, a large number of small-scale damage points would lead to rapid deterioration, and ultimately affect the service life of components [15,16]. Miller used a new terminal optical component damage detection system called the Final Optics Damage Inspection (FODI), which can reliably detect damage sites larger than 50 microns in the repairing process. Then, the small damage points can be repaired and the service life of components can be improved by 40% [15]. Therefore, to the ability to repair small damage points and inhibit their further growth quickly and effectively is critical to improving the optical performance of fused silica optical elements [17].

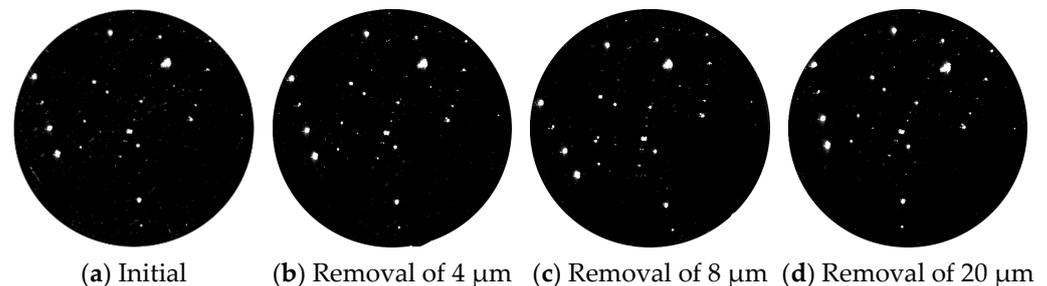
**Figure 3.** Dark field results of damage with different sizes before and after MR repair.

Using the laser scattering defect detector of super-smooth surface, which is made by ZC Optoelectronic Technologies, Ltd., Hefei, China, to measure the evolution of damage quantity in the process of the MR repairing, the dark field image was obtained, as shown in Figure 3. Table 2 shows the change of each size of damage points with the MR removal depth after image processing. Based on the comparison of the test results, the number of component damage points after MR repairing was significantly reduced. When the removal depth was up to 20  $\mu\text{m}$ , the total number of damage points was reduced by 80%. The number of damage points with sizes larger than 20  $\mu\text{m}$  were basically unchanged, but the small-scale damage points with sizes smaller than 50  $\mu\text{m}$  were reduced by almost 90%. This showed that this method can effectively remove a large number of small-scale damage points.

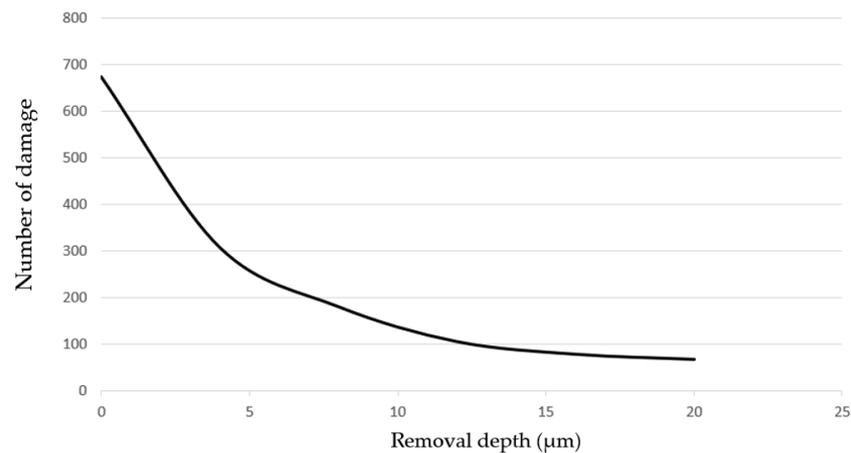
**Figure 4.** Variation of damage number where damage size was smaller than  $50 \mu\text{m}$  with removal depth.

The curve of damage number with transverse sizes smaller than 50  $\mu\text{m}$  variation with the MR removal depth were drawn, as shown in Figure 4. The results showed that the repairing efficiency was very high at the beginning, but the efficiency gradually reduced as the removal depth increased. When the removal depth was up to 20  $\mu\text{m}$ , the overall removal rate of small damage points met the requirements.

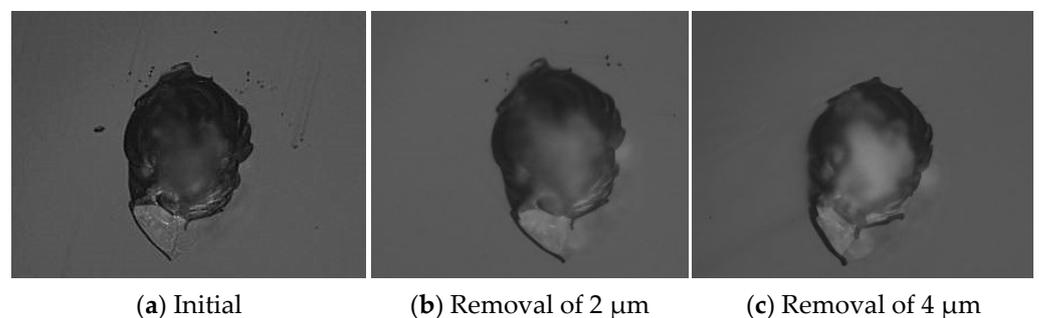
**Figure 5.** Morphology variation of large-scale damage.

Variations in large-scale damage were also observed using the optical microscope, as shown in Figure 5. The results showed that there were clusters of small-scale damage around areas of large-scale damage before the MR repairing. When the removal depth was up to  $2 \mu\text{m}$ , the number of the small-scale damage points were significantly reduced, but it was not completely repaired. When the removal depth was increased to  $4 \mu\text{m}$ , the small-scale damage was basically repaired. However, it was clearly observed that the trailing phenomenon occurred at the damage point. The trailing phenomenon at the small damage points was completely removed in the MR repairing process, but the trailing phenomenon at the large damage points became serious.

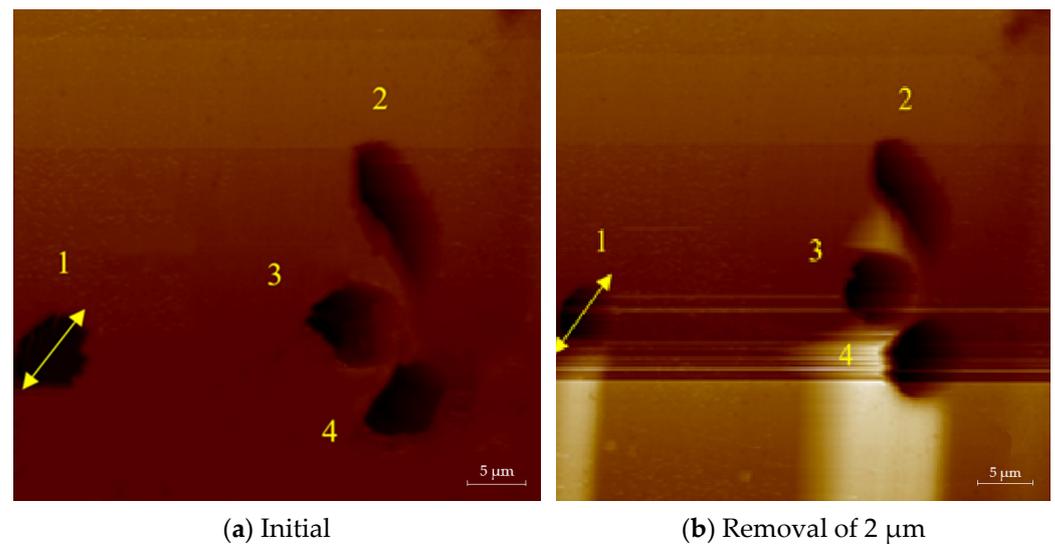
**Figure 6.** Morphology evolution of small-scale damage before and after MR removal.

The atomic force microscope was used to randomly select small-scale damage and observe its repairing evolution process, as shown in Figure 6. Figure 6a is the initial image of the small-scale damage on the element. After removing  $0.5 \mu\text{m}$  uniformly with the MR removing method, the measured results are shown in Figure 6b. The transverse size of the damage became smaller and the damage contour became more regular, as observed by comparing the two images. The profile of damage 1 measured along the MR scanning direction is shown in Figure 7. The width of the damage decreased from  $7 \mu\text{m} \pm 10\%$  to  $4.5 \mu\text{m} \pm 10\%$ , and the depth decreased from  $620 \text{ nm}$  to  $120 \text{ nm}$ . The depth was basically the same as the removal depth of MR, and the contour of the damage opening became smoother. The results showed that the variation of damage depth was consistent with the MR removing depth, and the repairing process did not cause damage to the bottom of the damage. This indicates that the MR removing method can effectively repair small-scale damage.

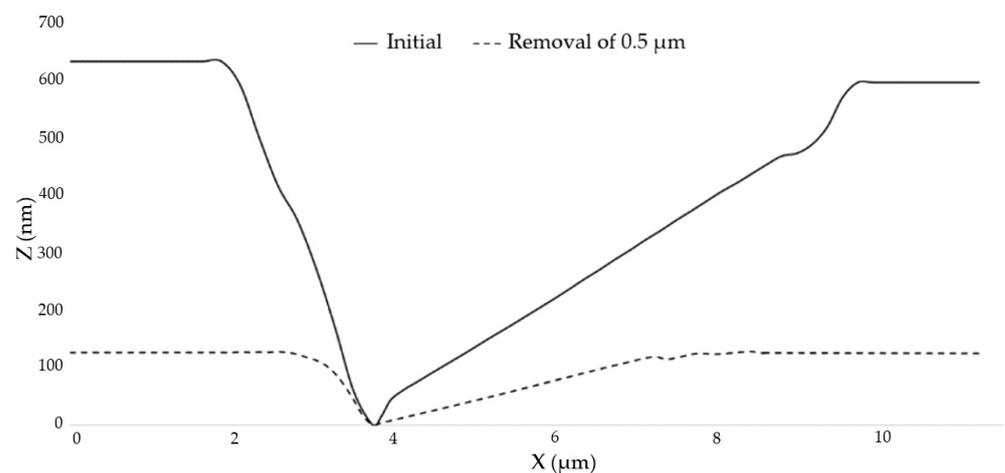
**Figure 7.** Profile evolution of damage before and after MR removal.

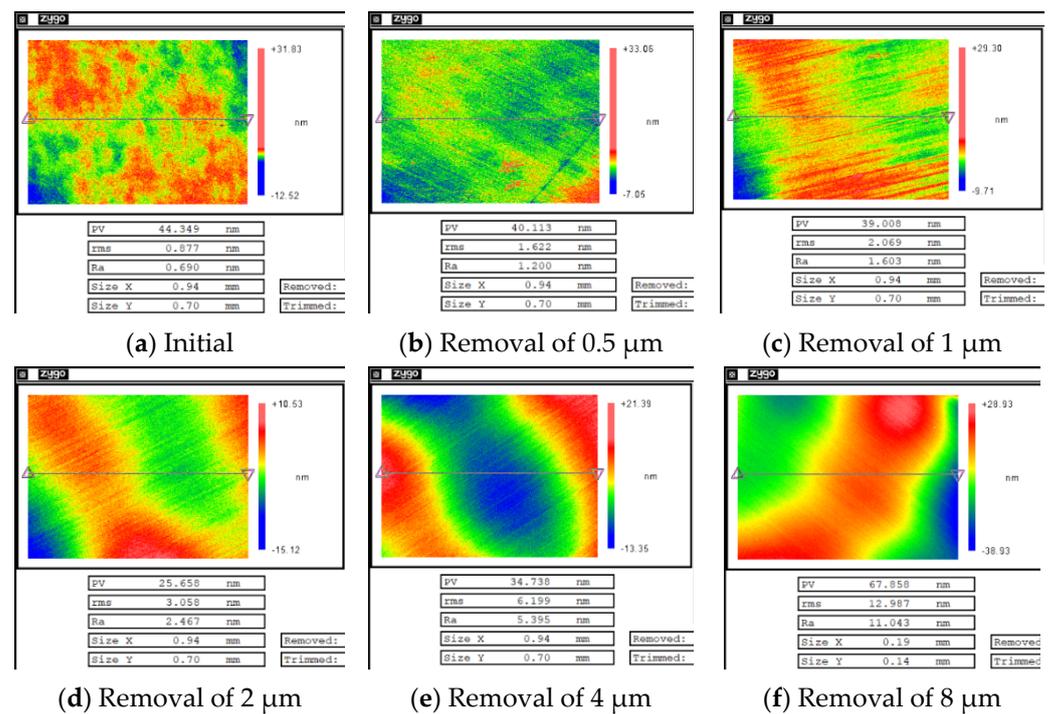
Figure 8. Results of surface roughness of a non-destructive component with different removal depths.

After magnetorheological treatment of the non-destructive component, the white-light interferometers with removal depths of 0.5, 1, 2, 4 and 8  $\mu\text{m}$  were selected. The measurement results are shown in Figure 8. A three-dimensional white light scanning interferometer (NewView 700) made by Zygo Corporation, Connecticut, United States, was used to measure the surface roughness of optical elements. The device is a non-contact instrument for measuring the surface roughness of optical elements. Its field of view is  $0.94 \text{ mm} \times 0.70 \text{ mm}$ , the longitudinal resolution is 0.1 nm, the transverse resolution is 0.36–9.50  $\mu\text{m}$ , and the measurement repeatability Root Mean Square (RMS) is less than 0.01 nm [22].

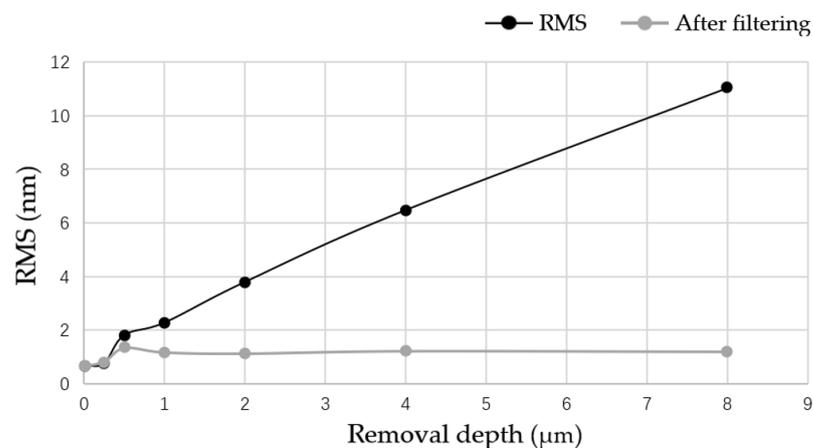
Figure 9. Evolution of surface roughness of a non-destructive component by removal depth.

According to the division of error frequency band by Lawrence Livermore National Laboratory (LLNL), an error with  $F > 8.33 \text{ mm}^{-1}$  was considered a high-frequency error. In order to study the variation of errors in different frequency bands by the removal depth, mid-frequency errors of  $F \leq 8.33 \text{ mm}^{-1}$  were filtered out in the measurement, and the variation results of surface roughness with the removal depth before and after filtering were plotted, as shown in Figure 9.

The results show that the surface roughness of the non-destructive component increased linearly with the increase in the removal depth, and the high-frequency error of the components did not change with the removal depth. This indicates that the MR removing method leads to the increase in the mid-frequency and low-frequency error of the component, which are mainly caused by the convolution effect of the MR removing method. In addition, with the increase in the removal depth, the high-frequency error of the non-destructive element was found to first deteriorate and then tended towards stability, which was mainly determined by the initial surface roughness of the element and the characteristics of the removal function.

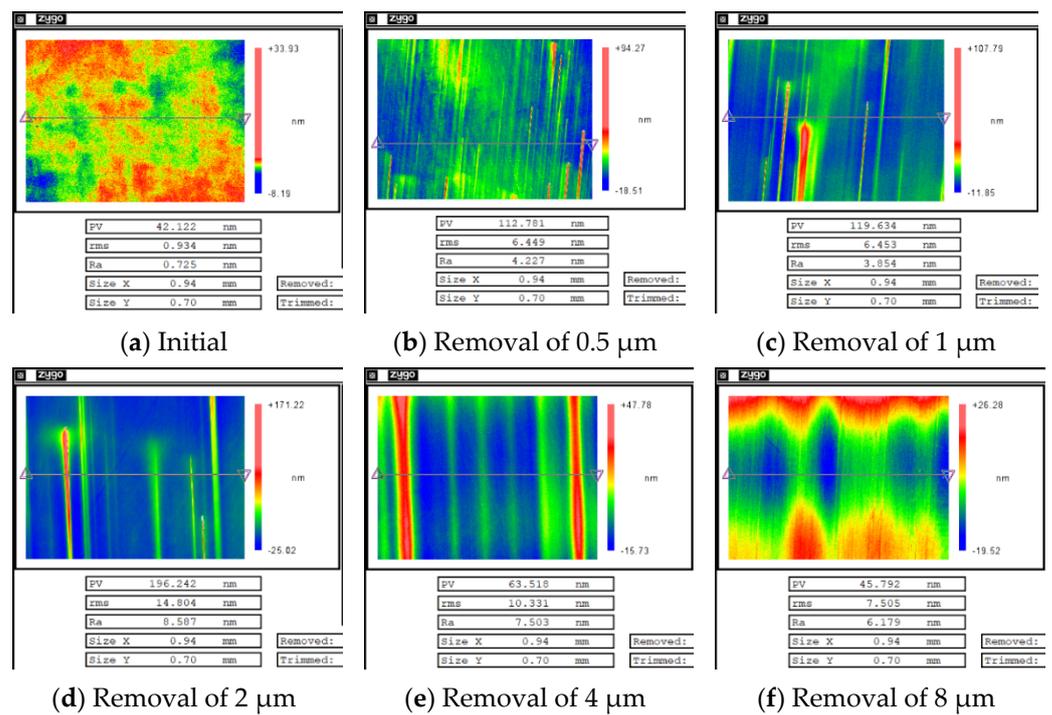
Figure 10. Results of surface roughness of damaged component with different removal depths.

After MR repairing of the damaged component, white-light interferometers with removal depths of 0.5, 1, 2, 4, and 8 μm were selected. The measurement results are shown in Figure 10.

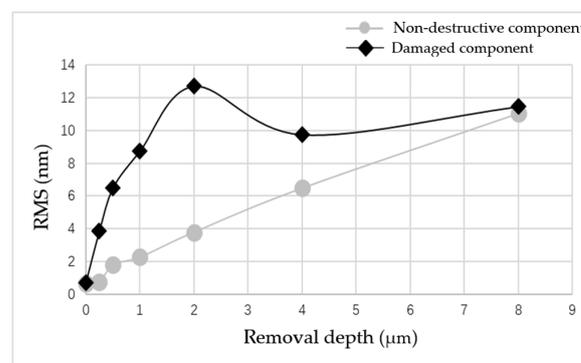
Figure 11. Comparison of surface roughness changes of the two components.

The curves of surface roughness of the non-destructive component and damaged component with different removal depths are plotted together, as shown in Figure 11.

The results showed that when the repairing depth was smaller than 4 μm, the RMS increased rapidly and was is much higher than for the RMS of the non-destructive component. Then, with the increase in removal depth, RMS gradually decreased, and finally it became similar to the RMS of the non-destructive component. From the measurement results in Figure 10, it was found that during the rapid increase in RMS, many non-uniform strip tails were produced on the component surface, which gradually disappeared with the increase in the removal depth. The measurement results showed that in the process of the MR removing method, the existence of damage led to the tailing phenomenon, which was one of the reasons for the rapid deterioration of the surface quality of components. However, with the further increase in the removal depth, the influence of damage on the surface quality was gradually eliminated.

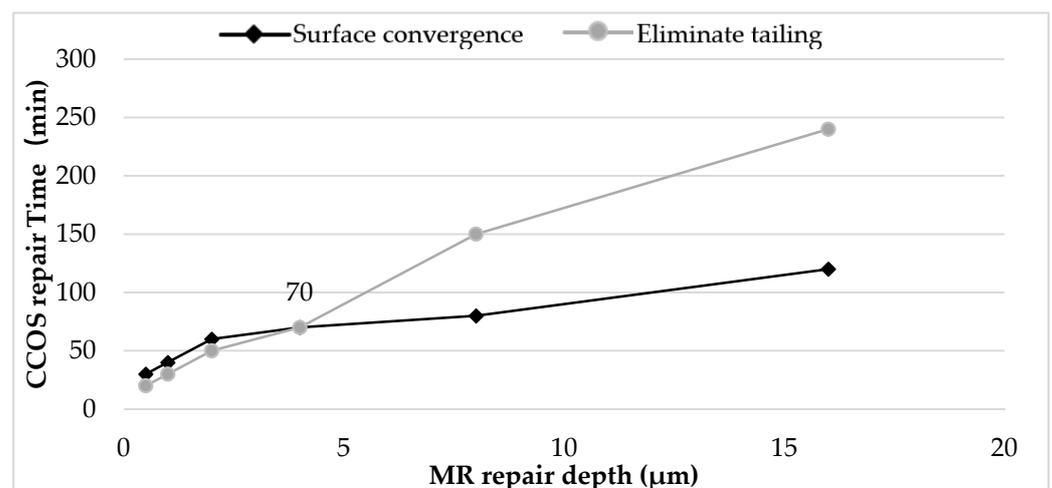
Figure 12. Relationship curves of MR and CCOS process parameters.

This section studies the time required for CCOS to eliminate tailing and restore surface roughness under different MR repairing depths. The results are shown in Figure 12. The black curve in the figure shows the time required for CCOS to recover the surface roughness at different MR repairing depths, and the gray line shows the time required for CCOS to eliminate tailing under different MR repairing depths. The results show that when the MR repairing depth was 4  $\mu\text{m}$ , CCOS repairing needed 70 min to eliminate the tailing and restore the surface roughness. At this time, the revolution speed of CCOS was 150 rotations per minute (rpm) and the diameter of polishing powder was 1.5  $\mu\text{m}$ . Other process parameters are shown in Table 3, and the corresponding depth of 70 min was 700 nm.

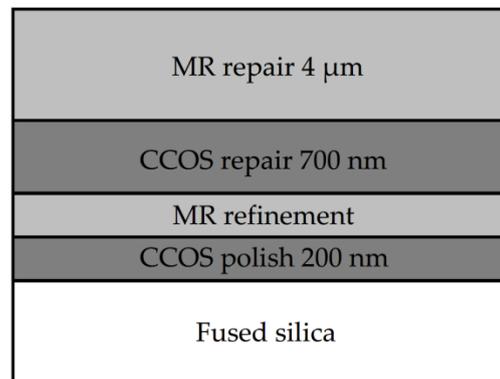
Figure 13. Material removal distribution of each process.

Finally, in order to further improve the surface smoothness and eliminate the sub-surface defects, the combined process parameters were optimized based on the previous process research conclusions. The final repair process is shown in Figure 13. The combination process is as follows: MR repairing of 4  $\mu\text{m}$ ; CCOS repairing of 700 nm with revolution speed of 150 rpm and polishing powder diameter of 1.5  $\mu\text{m}$ . After two cycles to achieve

the ideal repair effect, MR refinement was carried out. Finally, CCOS repairing of 200 nm with a revolution speed of 0 rpm and polishing powder diameter of 0.5  $\mu\text{m}$  should be used. At this time, the damage repair effect and surface quality of components were able to meet the system index.

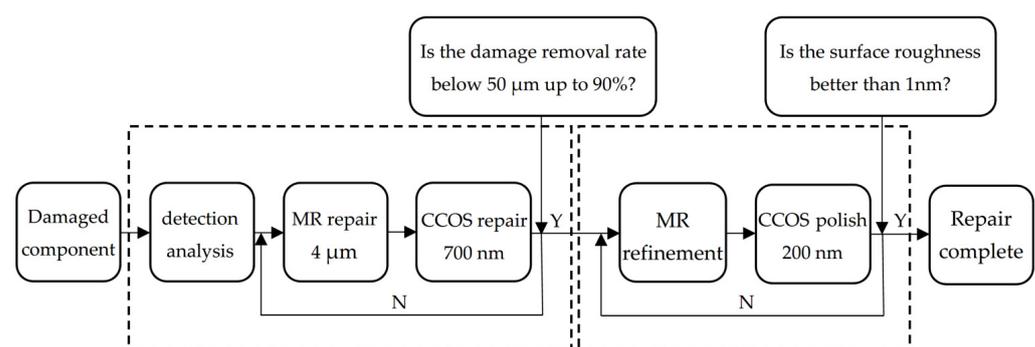
Figure 14. Repair flow chart.

Figure 14 shows the flow chart of the whole repairing process. The repair of small-scale damage of fused silica was divided into three stages: the damage quantity and size distribution detection; the MR repairing of small-scale damage; and surface quality recovery. The specific process steps were as follows: (a) the initial damage detection was carried out on the existing fused silica damage elements and the distribution characteristics including the number and size of the damage was obtained; (b) the MR removing method was used to repair 4  $\mu\text{m}$ , and CCOS with revolution speed of 150 rpm and polishing powder diameter of 1.5  $\mu\text{m}$  was used to repair 700 nm. Two cycles were carried out until the removal rate of small-scale damage was of more than 90%; (c) MRF polishing was used, and then CCOS with a revolution speed of 0 rpm and polishing powder diameter of 0.5  $\mu\text{m}$  was used to polish 200 nm until the surface roughness was better than 1 nm. Finally, the components were cleaned.

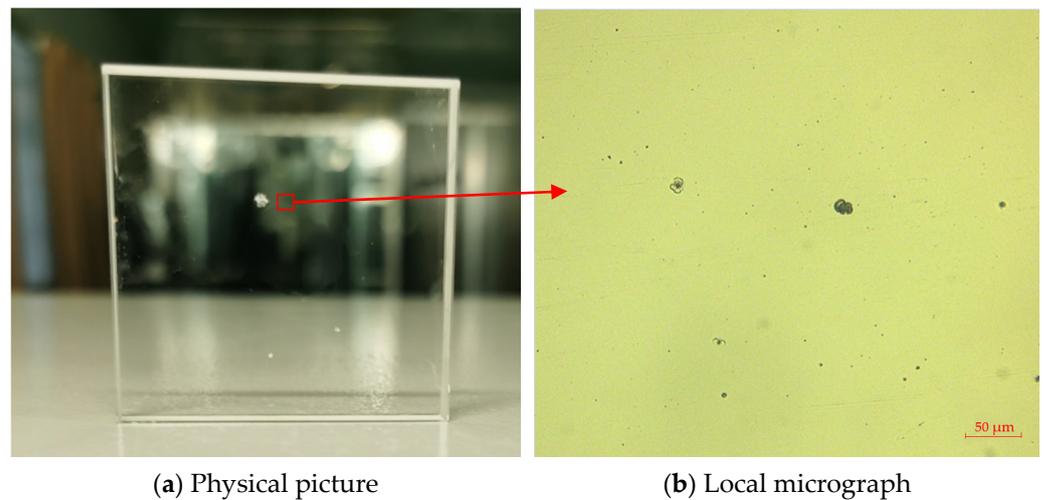
**Figure 15.** Physical and micrographs of damaged components.

In order to verify the effectiveness of the whole repairing process, the above repairing process was used to repair the fused silica damaged components produced by an actual system. The experimental sample was a fused silica damaged component of 50 mm  $\times$  50 mm  $\times$  10 mm. Three large-scale damages were directly observed on the surface of the component. The local image in the red frame was observed through the optical microscope, as shown in Figure 15. There were also clusters of small-scale damage on the surface of the components.

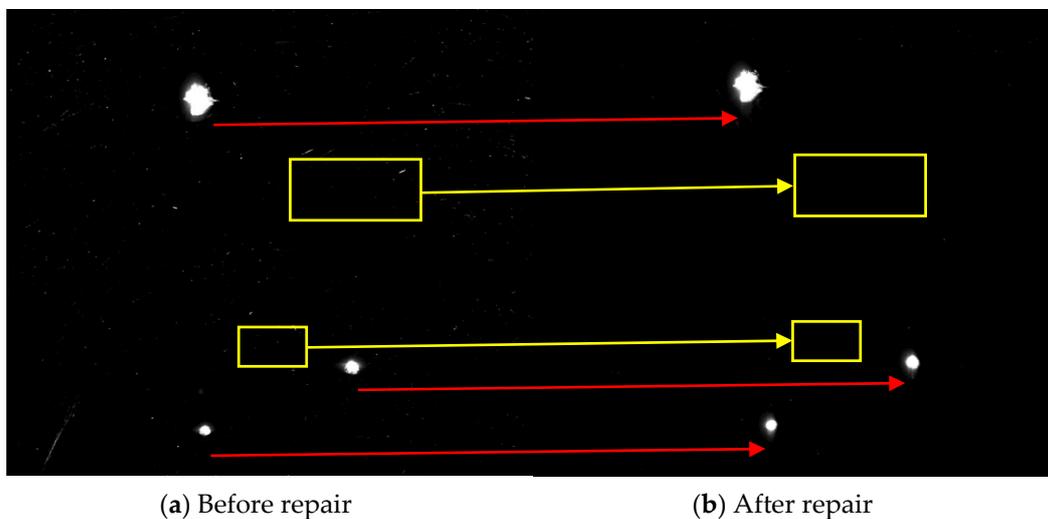
**Figure 16.** Dark field images of damaged components before and after repairing.

The MR repairing method was used to repair 4  $\mu\text{m}$ , and the CCOS was used to repair 700 nm. After the process was completed, the removal rate of small surface damage was more than 90%, and the removal depth was 23.5  $\mu\text{m}$ . Figure 16 shows the comparison of dark field images before and after the MR repairing. Figure 17 shows the distribution of the number of damage points with different sizes. The results show that after the MR repairing, the number of damage points, especially damage points with sizes smaller than 50  $\mu\text{m}$ , were significantly reduced, with a removal rate of 90.4%.

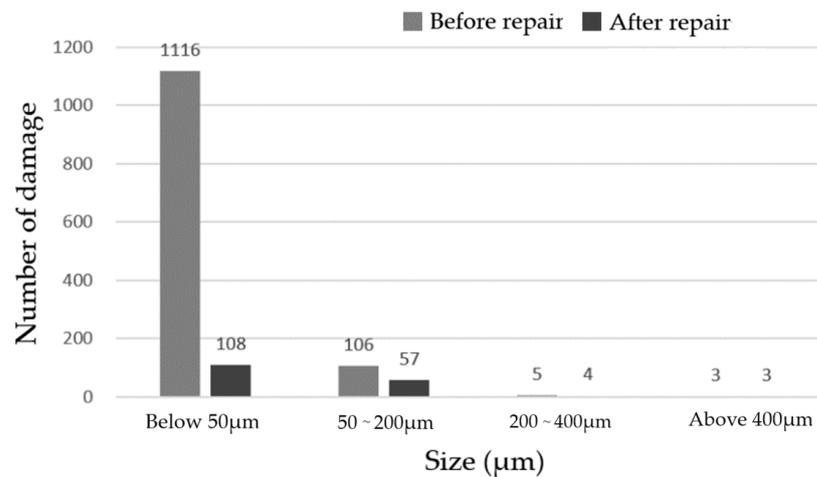
Figure 17. Number of different sizes of damage before and after repairing.

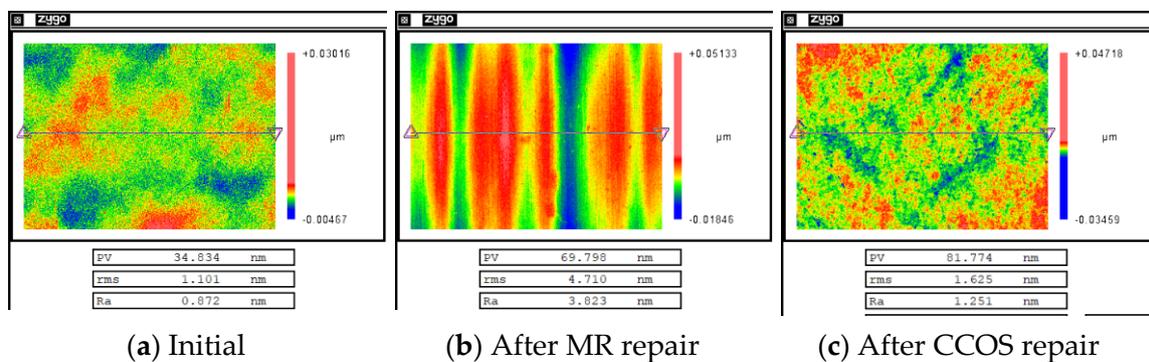
Figure 18. Evolution of surface roughness during the process.

Figure 18 shows the evolution of the surface roughness during the repair process measured by the white light interferometer. The surface roughness of the repaired component was 1.625 nm, which did not meet the system index.

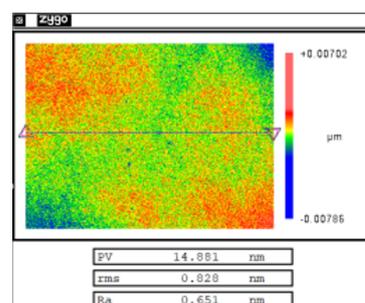
Figure 19. Result of surface roughness after refinement.

The surface roughness of the components was restored by combining MR refining and CCOS polishing. Figure 19 shows the measurement result after the surface quality was restored. At this time, the surface roughness was 0.828 nm, which met the requirement that the surface roughness is better than 1 nm.
