Visual, Non-Destructive, and Destructive Investigations of Polyethylene Pipes with Inhomogeneous Carbon Black Distribution for Assessing Degradation of Structural Integrity

Abstract: Carbon black (CB) is used in polyethylene (PE) pipes to protect against thermal and photooxidation. However, when CB is not properly dispersed in the PE matrix during processing, white regions having little or no CB concentration, known as “windows,” appear within the CB/PE mixed black compound. In some cases, windows can drastically affect the structural integrity of both the pipe and butt fusion joint. In this work, PE pipes with varying amounts of windows were investigated for their characteristic window patterns, as well as quantifying the area fraction of windows (% windows). Tensile test on specimens with known % windows determined a critical limit above which the fracture strain rapidly degrades. Micro-tensile and micro-indentation results showed tear initiation at the window–black PE matrix boundary; however, they did not confirm the mechanism of tear initiation. In support of this work, a method of making thin shavings of a whole pipe cross section was developed, and the best viewing windows

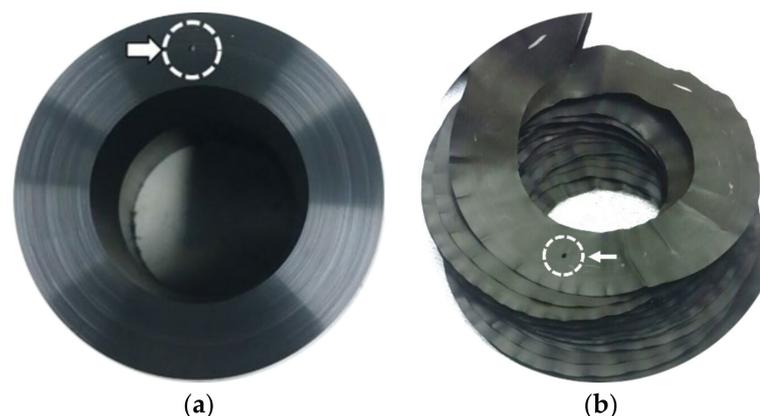
Figure 1. The 110 SDR 5 PE pipe, (a) 1 mm locator hole, (b) 50 μm thick whole pipe cross-section shavings.

Before cutting in the lathe, a 1 mm diameter hole was drilled into the pipe cross section as a locator hole (Figure 1a) for positioning the shavings in the proper orientation (Figure 1b). In order to make the whole pipe cross-section shavings of various thicknesses, the pipe was turned in the lathe at a speed of 55 rpm with compressed air blowing at the cutting area. This condition minimized the twisting and coiling of the shavings being produced. The cutting speed in the pipe axial direction depended on the thickness of the shaving made.

For shavings greater than 50 μm , ironing at 120 $^{\circ}\text{C}$, removed twists and coils to flatten the whole pipe cross-section shavings (Figure 1b). It was noted that when the shaving thickness was less than 50 μm , the surface was no longer flat. Even after ironing, many local wrinkles appeared, which distorted the sample and made direct viewing of the windows difficult.

The visual observations of the windows were made by cutting enough shavings to reconstruct a whole pipe cross section (Figure 1b) and then placing the reconstruction under the transmitting white light, monochromatic light, and polarized lights for viewing. It was determined that a good resolution and contrast for viewing were offered by placing the shaving between two polarizer plates (ESM-647, Intech-optic, Goyangsi, Korea) in cross polarization. The monochromatic light was produced by a sodium vapor lamp (GEO-NH, GEOLighting, Anseong, Korea), and a white LED lamp (LED lamp, Cityo, Incheon, Korea) was used. A light diffuser plate was used for all observations.

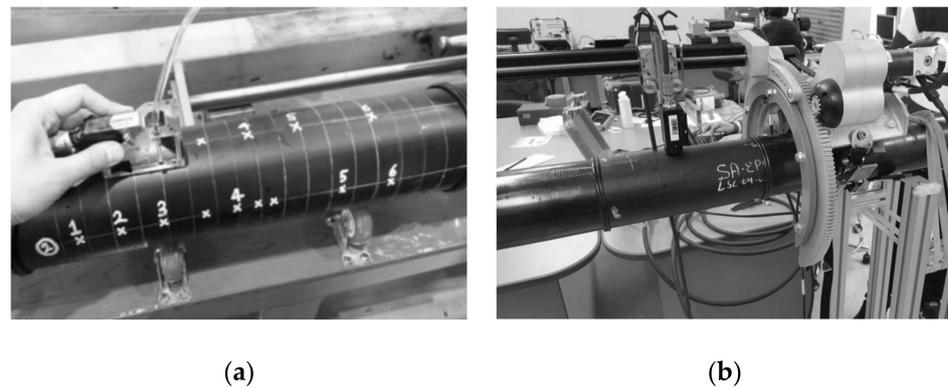
The inspection system for PAUT was an Olympus unit (OmniScan MX2, Tokyo, Japan), consisting of a detector, 2.25-MHz frequency, 32 active elements' transducer water wedge, encoder, and encoder jig, as shown in Figure 2a. Before the inspection, the pipes were marked with a white marker at regular 2 cm intervals along the inspection length considered. At first, the wedge and the transducer assembly were placed in close contact with the pipe surface, and the pipe was PAUT inspected along the circumferential direction by manually rotating the pipe. This procedure was repeated until the entire area of the pipe was examined. The beam was steered from 0 $^{\circ}$ to +85 $^{\circ}$ by sectorial scanning and focusing the beam at two-thirds of the pipe thickness. After scanning, the merged C-scan images were reproduced from the software (Tomoview 2.10 R25) for viewing the window indications.

Figure 2. (a) PAUT and (b) MWI for non-destructive inspection of windows in pipes.

The microwave NDT apparatus used was a single frequency device that operates near 24 GHz (AMWI-SF24G-OW, Advanced Microwave Imaging, Baton Rouge, LA, USA). A microwave sensor consisted of a Gunn diode with a tuned cavity and two Schottky diodes placed in the exiting waveguide section. The microwave sensor was driven in an automated two-axis encoded device that ran axially and circumferentially around the pipe (Figure 2b). An open waveguide acted as the sensor antenna. The Schottky diodes generated a DC voltage in an alternating electric field that was roughly linear with the amplitude and phase of the alternating field. The voltages were recorded at locations along the pipe axial and circumferential scanning path. They were compiled into a viewing algorithm where the voltage variation was assigned a grayscale based on its magnitude, and a complete image of the pipe was created. Because of the very low losses in polyethylene material in the microwave frequency range, the sensor easily captured an image of the entire volume within the sensor aperture range. The open waveguide transmitted a signal that spread out from the aperture opening at a 45-degree angle from the aperture opening; so, the coverage area grew quickly as the beam penetrated the material depth. This ensured beam coverage to the entire pipe cross section; however, it hampered individual resolution of flaws deeper into the part.

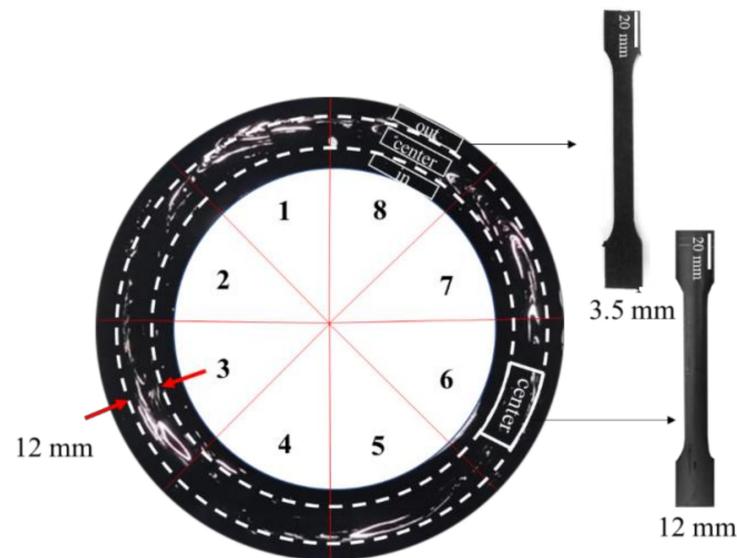
Figure 3. Eight sectors with known % windows where 12 mm thick tensile specimens were taken. The 3.5 mm thick specimen locations are also shown.

Tensile tests on windowed 110 SDR 5 PE pipes were performed using ISO 527-2 [36] Type 1A tensile specimens of 3.5 mm and 12 mm thickness, machined from each pipe sample. Since the windows were observed to reside approximately in the center of the 12 mm thickness portion of the pipe samples, 12 mm specimens were removed from the center of the pipe wall of every eight segmented pipe sectors, as shown in Figure 3. For these eight sectors selected, the % windows were all prior determined. On the other hand, 3.5 mm thick specimens were taken from the outer, central, and inner wall regions (Figure 3) and were used to estimate the change in properties through the pipe wall thickness.

The tensile specimens of 3.5 mm were made first by band-sawing the pipe into eight sectors. Then, a milling machine (Simplex-2, Hwacheon, Gwangju, Korea) was used to obtain the required thickness at their respective positions (Figure 3). The other dimensions were obtained using template machining with a cutter rotating at 3000 rpm. For the 12 mm specimens, the pipes were turned and bored in a lathe (Mecca Turn 400×750, Namsun, Gwangju, Korea) to remove the outer and inner layers until a 12 mm thickness was achieved. The same template machining was used for the final specimen dimensioning.

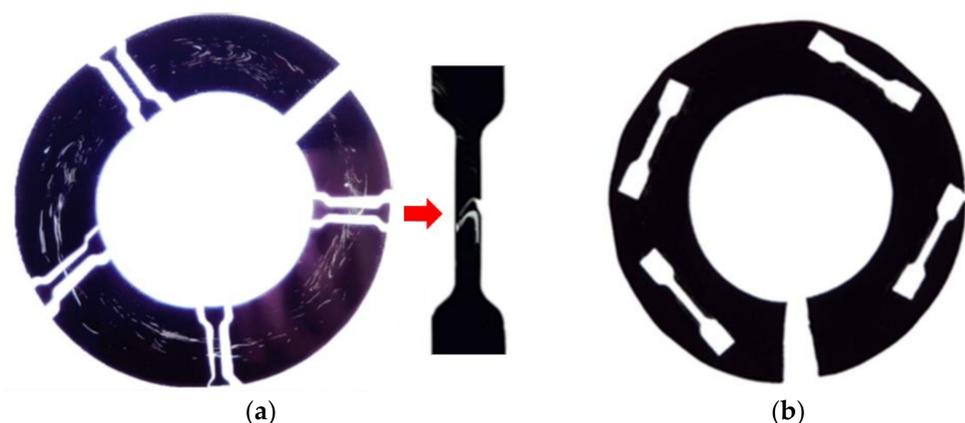
Micro-tensile specimens of ISO 572-2 type 1A [36] on 100 μm thick shavings were made from pipe sample 4 and sample 1, and the photographs are shown in Figure 4. In sample 4, the specimens were punched out perpendicular to the pipe circumference at four high window swirl areas (Figure 4a) and in sample 1, from four positions, as shown in Figure 4b. The specimens were conditioned at 23 $^{\circ}\text{C}$ and 50% RH for at least 24 h prior to the tensile test. Tensile tests were carried out using pneumatic grips on a 500-N load cell at a 100 mm/min cross-head speed (AGS-5, Shimadzu, Kyoto, Japan). No extensometer was used.

Figure 4. Sampling location of micro-tensile specimens. From (a) sample 4 and (b) sample 1.

To further understand how fractures initiate in a static tensile test with windows present, a tensile test was performed on micro-tensile specimens produced from the shavings of samples 1 (windows free) and 4 (high windows). The micro-tensile specimens from sample 4 were taken at four locations along the pipe circumference where intense window swirls were present, as shown in Figure 4. Tensile test results are exhibited in Figure 20. Distinct regions of initial displacement to tensile yield load (onset necking), neck formation, cold drawing, and orientation hardening prior to fracture for sample 1 can be observed. For sample 4, all tensile specimens failed during the early part of cold drawing and did not reach orientation hardening displacement. This is consistent with what was observed for the thicker tensile specimens made from samples 1 and 4 (Figure 13). The fracture mechanism can be inferred by observing the frame-by-frame photos of the tensile test, as

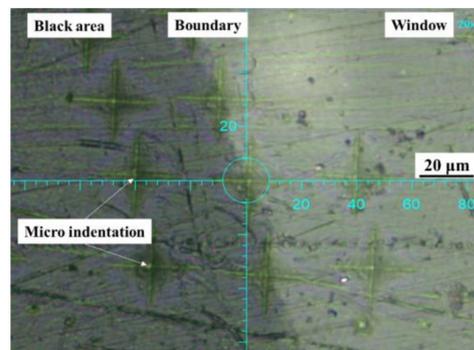
A micro-indentation test was carried out on a 100 μm shaving using a PICODENTOR HM500 (Helmut Fisher, Sindelfingen, Germany) with a 136° plane angle Vickers indenter that utilized the load-indentation depth method in accordance with ISO 14577-2 [40]. First, a shaving with windows was pressed against the glass slide using a rubber roller to obtain a good physical bond between the two. Once the indentation location was identified (Figure 5), a pre-selected load of 30 mN on a Vickers indenter was applied to the shaving for 6 s for the press-in followed by 5 s of indentation hold time. The load was then removed from the shaving at the same speed as the indenter press-in. A total cycle time of 17 s was used to obtain a load-depth profile from which various mechanical properties were computed using the methods in ISO 14577-1 [41]. Measurements included Martens hardness (HM), indentation hardness (HIT), and modulus of indentation (EIT). Figure 5 shows the micro-indentation positions on the window, the boundary, and the black compound.

Figure 5. Micro-indentations on black compound, window, and along the boundary.

To possibly confirm the effect of CB concentration on tear initiation, micro-indentations were made at various locations at specific distances away from the window–black compound boundary, as shown in Figure 5. The micro-indentation results are shown in Figure 22. The Martens hardness (HM) and indentation modulus (EIT) both increased, moving into the black compound area, reaching a maximum value at 100 μm from the boundary, and then began to slightly decrease to a lower value deeper in the black area (200 μm). On the other hand, the lower values were approximately maintained into the windows area. This confirmed that the presence of CB particles increased the hardness and modulus of PE [31]. However, with only about a 7% higher indentation modulus of the black compound (1.5 GPa) compared to the window (1.4 GPa), the shear stress developed at the boundary was unlikely to be high enough to cause ductile tear initiation at the

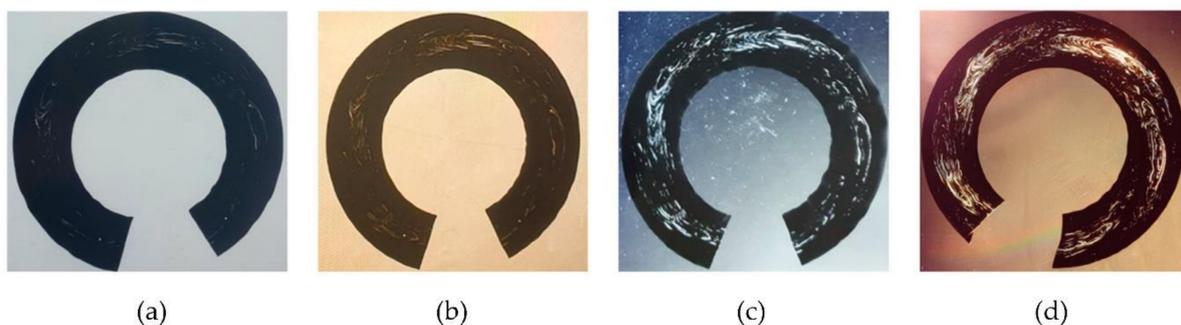
The characteristic in-flow patterns of windows in whole pipe cross-section shavings were observed under the transmitted white light (Figure 6a), monochromatic light (Figure 6b), cross-polarized white (Figure 6c), and monochromatic (Figure 6d) lights. The windows were best observed with a monochromatic cross-polarized light, followed by cross-polarized white light. The shavings of sample 4 viewed under a cross-polarized monochromatic light are shown in Figure 7. The shaving thickness varied from 50 μm to 300 μm , and a higher area fraction of windows (% windows) appeared in the thinner shavings, as shown. Furthermore, at shaving thicknesses above 150 μm , some of the features of the original windows observed at thinner shaving thicknesses disappeared in polarized light. Therefore, in terms of making whole pipe shavings from the pipe, a good visual observation of the windows, ease of handling, and testing shavings, a 100 μm thickness was found to be the most suitable for use.

Figure 6. The 100- μm shaving viewed under: (a) white, (b) monochromatic, (c) cross-polarized white, and (d) cross-polarized monochromatic lights.

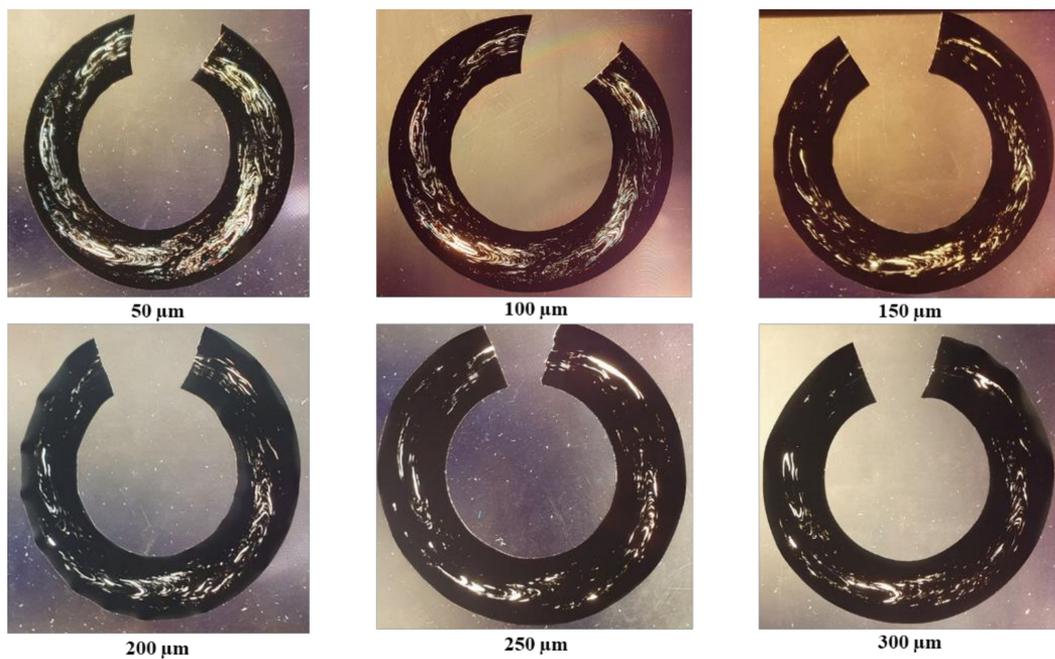
Figure 7. Windows' observation of the whole pipe cross sections in shavings of different thicknesses under cross-polarized monochromatic light.

Figure 8. Color-inverted image of sample 4 (100- μm shaving in Figure 7).

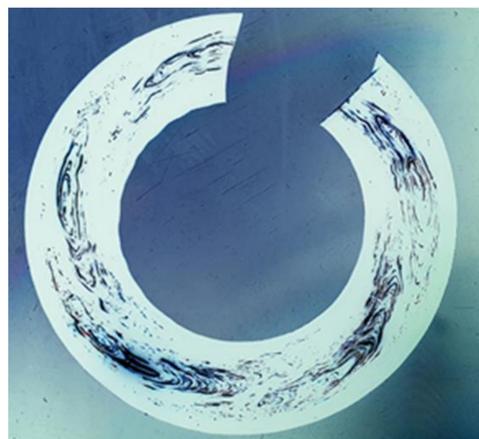
Figure 8 shows a color-inverted image of a shaving. Although the observed window details were similar, using both original and color-inverted images can complement each other to improve the viewing of the details of the windows' patterns.

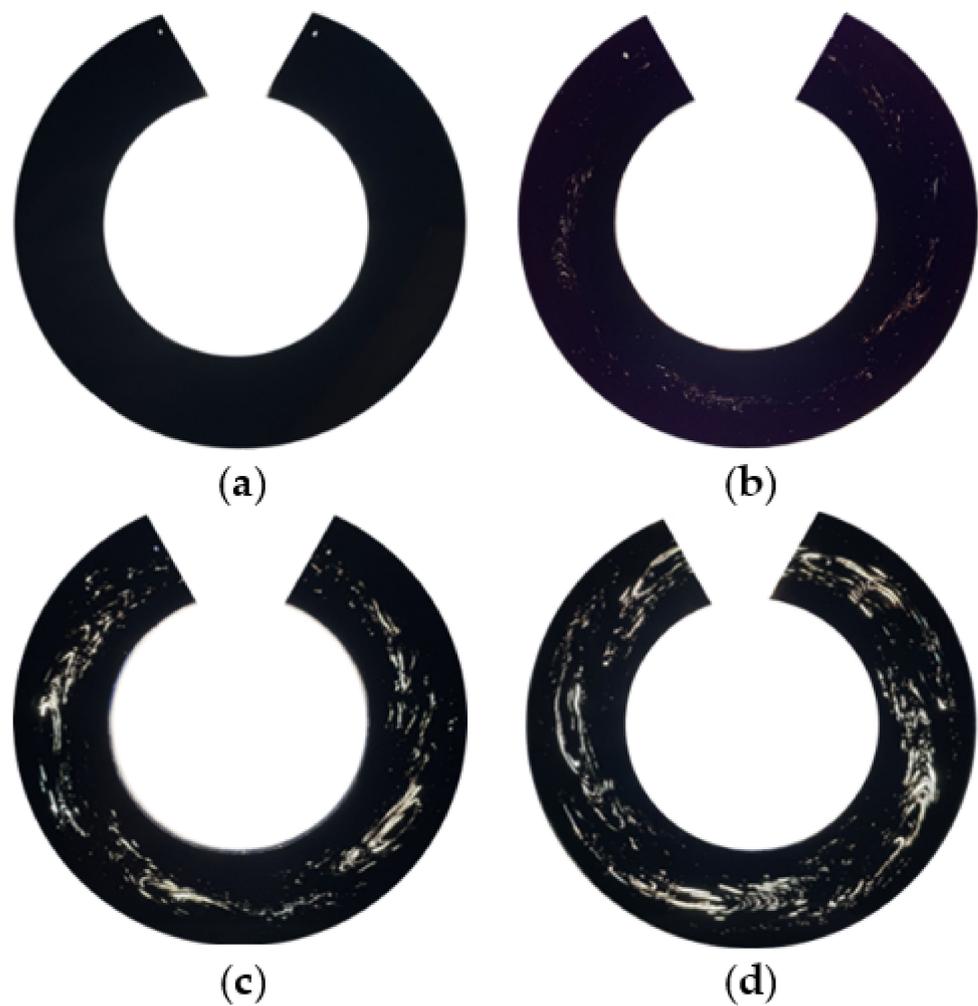
The 100 μm thick shavings of the whole pipe cross section for all pipe samples are shown in Figure 9. In sample 1, no windows appeared as it was made windows-free, whereas highly directional window swirls in the in-flow direction were evident in the shavings from samples 2 to 4. The intensity of the window swirls diminished with decreasing levels of windows in the shavings; they all appeared to be grouped into four distinct swirls' patterns (Figure 9b–d). The formation of such characteristic swirls' patterns of windows was due to using a four-channel spiral die during pipe extrusion in a single screw extruder.

Figure 9. Whole pipe cross-section shavings under cross-polarized monochromatic light. (a) Sample 1, (b) sample 2, (c) sample 3, and (d) sample 4.

Figure 11 shows the resulting C-scan images from the PAUT inspection for sample 1 (Figure 11a), sample 2 (Figure 11c), sample 3 (Figure 11e), and sample 4 (Figure 11g) pipes. The horizontal axis of the C-scan image represents the full pipe circumference, and the vertical axis represents the inspection area in the axial direction of the sectorial scan. It can be seen that the amplitude of the reflected ultrasonic signals varied according to the level of windows present; thus, its distribution could be determined. What appeared to be columns of particulate indications in samples 2 to 4 was correlated to the window swirl clusters observed in the shavings, as shown in Figure 9. No PAUT indication of windows was found in sample 1 (windows free, Figures 9a and 11a).

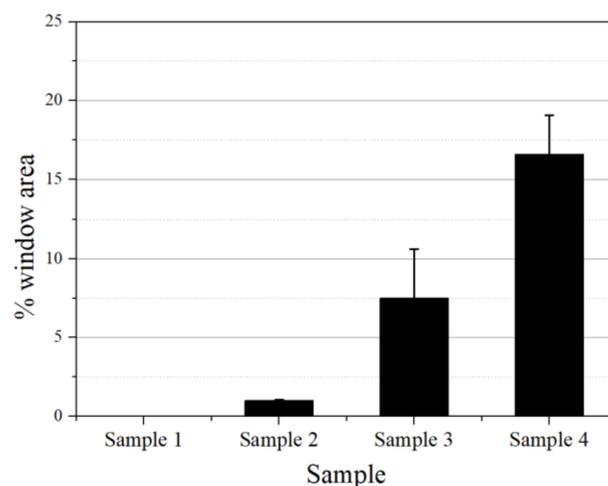
The % windows of shavings determined using the monochromatic cross-polarized light are shown in Figure 10. The mean % windows were found to be 0%, 1.5%, 7.5%, and 16.5%, for samples 1, 2, 3, and 4, respectively.

Figure 10. The % windows determined by the grayscale pixel count on 100 μm whole pipe cross-section shavings under monochromatic cross-polarized light.

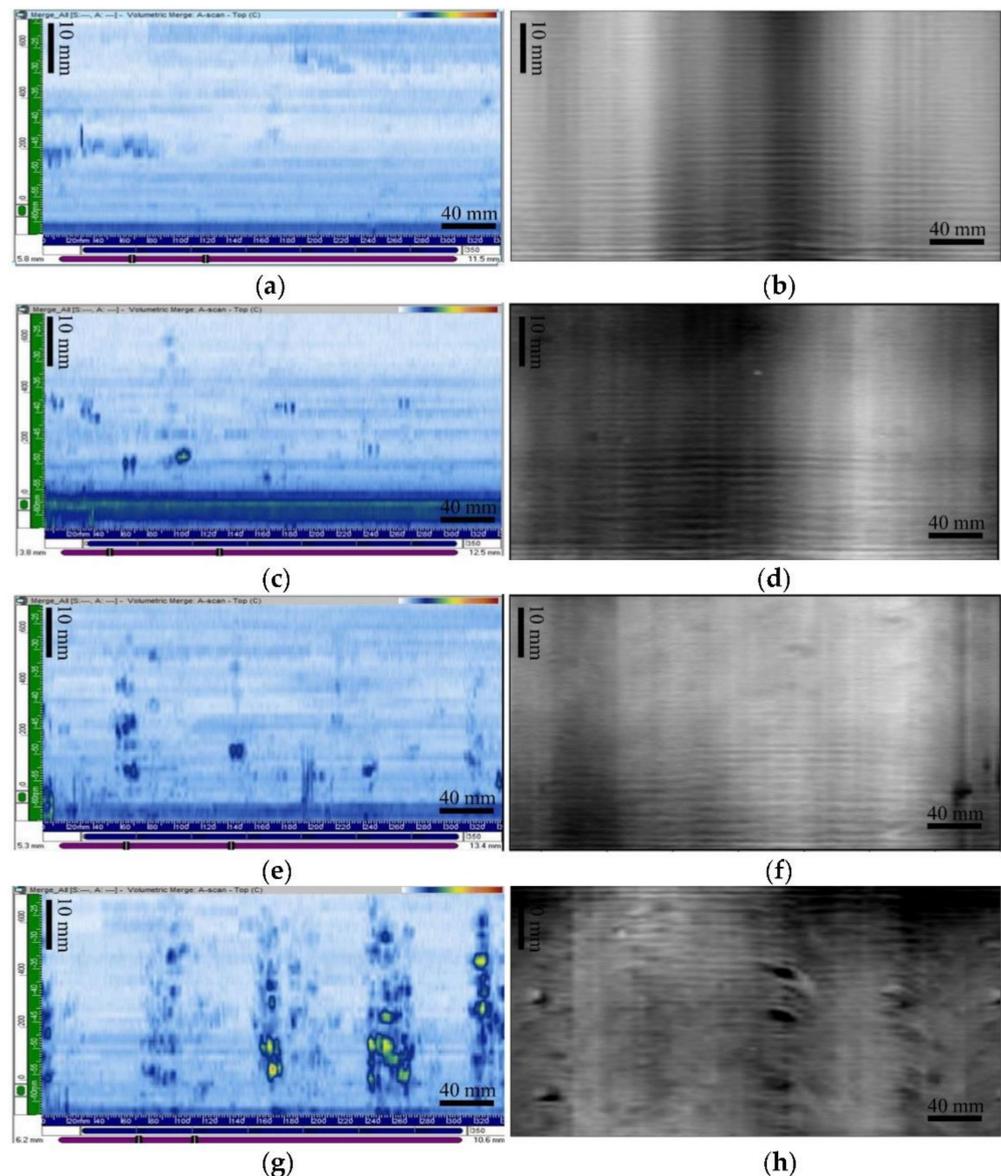
Figure 11. C-scan PAUT (left) and MW (right) images. (a,b) Sample 1, (c,d) sample 2, (e,f) sample 3, and (g,h) sample 4. In both the PAUT and MWI images, the horizontal axis is the pipe circumference from 0 to 360 degrees, and the vertical axis is an axial length of approximately 50 mm.

Similarly, window indications in the form of particulate column images were also displayed with MWI NDT (Figure 11b,d,f,h). The window indications increased going from samples 2 to 4. As with PAUT, no MWI indications of the window were found in sample 1 (Figure 11b). Both the PAUT and MWI indications showed windows clusters in the direction of the pipe axis. These NDT images can be further sectioned into known areas,

and the number and size of windows present in the image can be counted and binned by their relative sizes. This would allow the level of windows to be quantitatively compared and the ranking determined by actual numbers rather than a simple visual comparison. Both approaches have merits and could be reviewed further in the future as the need arises. Therefore, PAUT and MWI are viable NDT methods for windows detection in polyethylene pipes.

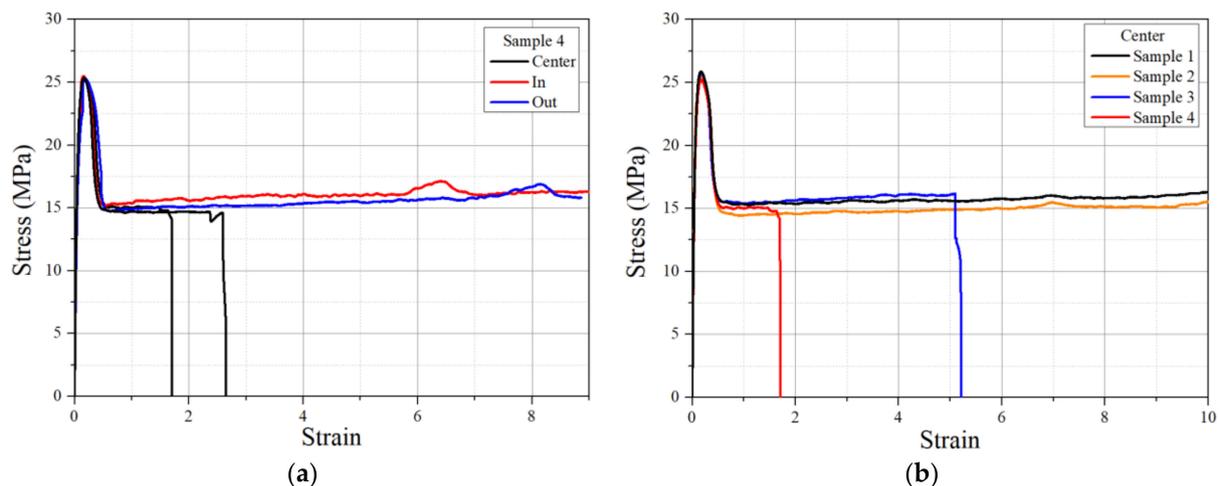
Engineering tensile stress–strain curves from 3.5 mm thick specimens are illustrated in Figure 12. Tensile yield stress of about 25 MPa was indicated for all specimens independent of the position they were removed from. Additionally, as expected, the stress–strain behavior of all specimens from the inner and outer layers was not affected as these were from the pipe thickness free of windows (Figures 12a and 3). However, for specimens taken from the center pipe wall, fracture strains decreased in samples 3 and 4, and no decrease was observed in samples 1 and 2 (Figure 12b). The stress–strain behavior of 3.5 mm thick specimens confirmed the visual observations of the windows being positioned at the inner portion of the pipe wall for pipe samples 3 and 4. This was due to the higher shear stresses for CB mixing produced at the inner and outer walls of the pipe during pipe extrusion. On the other hand, the absence of fracture strain change for specimens from samples 1 and 2 indicated some minimum % windows are needed to cause a fracture strain decrease.

Figure 12. Stress–strain curves of (a) 3.5 mm-thick specimens taken from the inner, mid, and outer walls of sample 4 and (b) specimens from the center wall of all pipe samples.

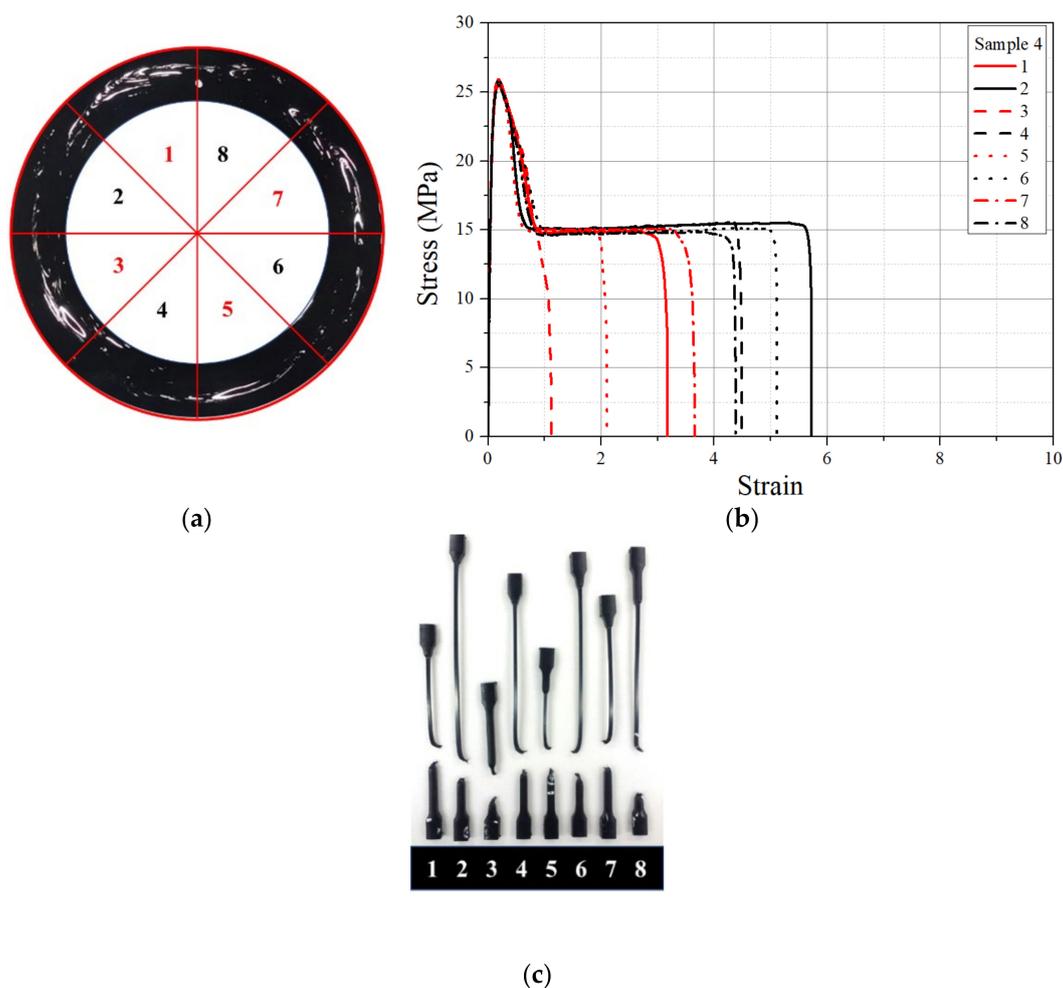
Figure 13. The 12 mm thick tensile specimens from pipe sample 4. (a) Eight sector locations, (b) tensile stress–strain curve of each specimen, and (c) tested specimen.

In order to see the effect of % windows on the stress–strain behavior of the pipe samples, the tensile results from the 12 mm thick specimens were considered. The stress–strain behaviors of 12 mm thick tensile specimens made at eight locations in the cross section with known % windows are shown in Figures 13–15 for pipe samples 4, 3, and 2, respectively. In pipe sample 4, the fracture strain was drastically reduced for all specimens, as seen from the stress–strain graph and the actual failed samples. Tensile specimens 1, 3, 5, and 7 from pipe sample 4 were obtained from high-intensity window swirl locations (Figure 13a), and all showed higher fracture strain reduction (Figure 13b,c). Additionally, as expected, specimens 2, 4, 6, and 8 exhibited less reduction (Figure 13b,c), as they represented specimens from the lower % windows’ portion of the pipe cross section (Figure 13a). A fracture strain reduction pattern was also observed in tensile specimens 1, 3, 5, and 7 and 2, 4, 6, and 8 from pipe sample 3, as shown in Figure 14. For specimens from pipe sample 2, as with pipe sample 1 (windows free), no position dependence of the fracture strain was found, as seen in Figure 15. A single specimen from pipe sample 2 had a premature failure before reaching the maximum strain value, and this was due to the presence of voids, as shown in Figure 15b.

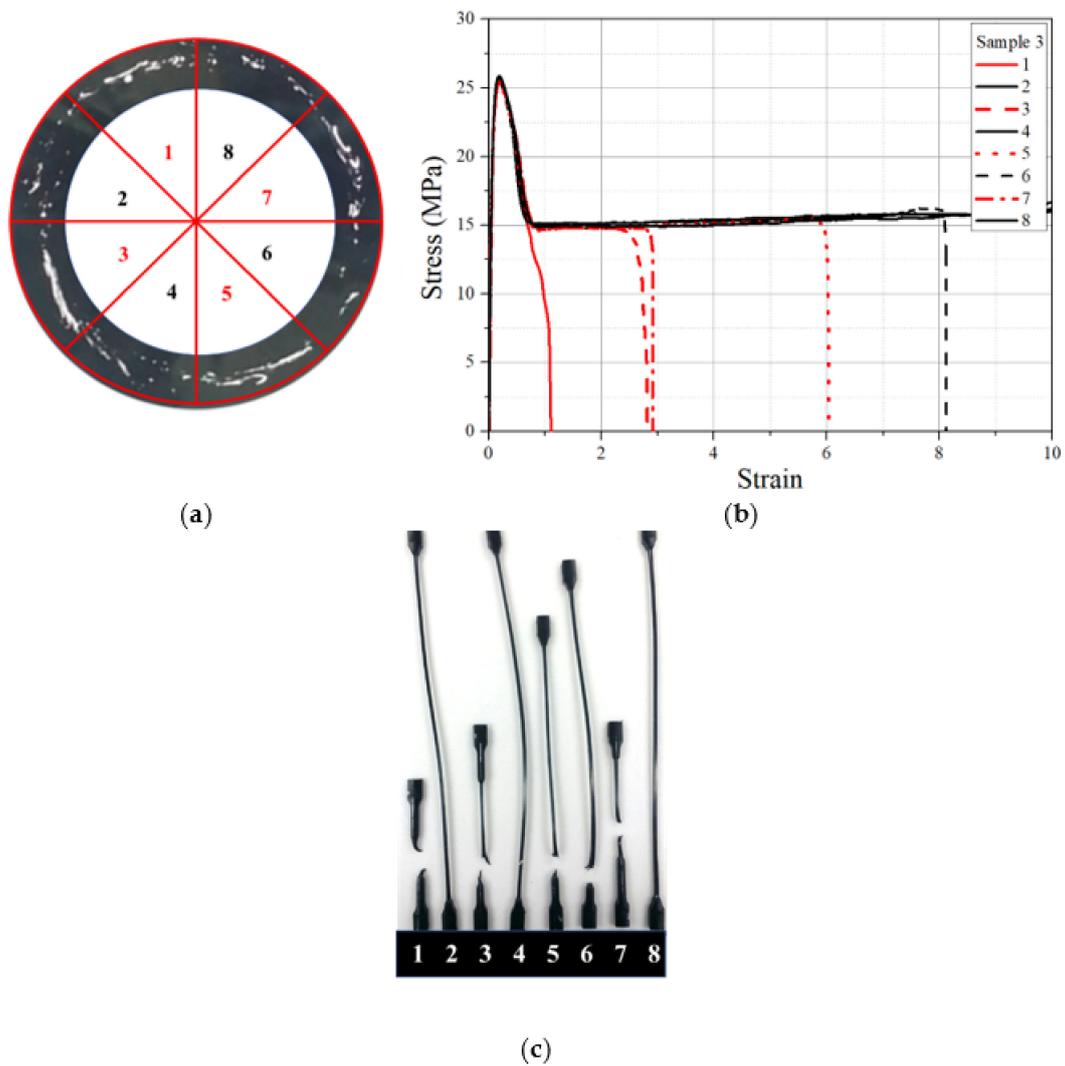
Figure 14. The 12 mm thick tensile specimens from pipe sample 3. (a) The eight sector locations, (b) tensile stress–strain curve of each specimen, and (c) tested specimen.

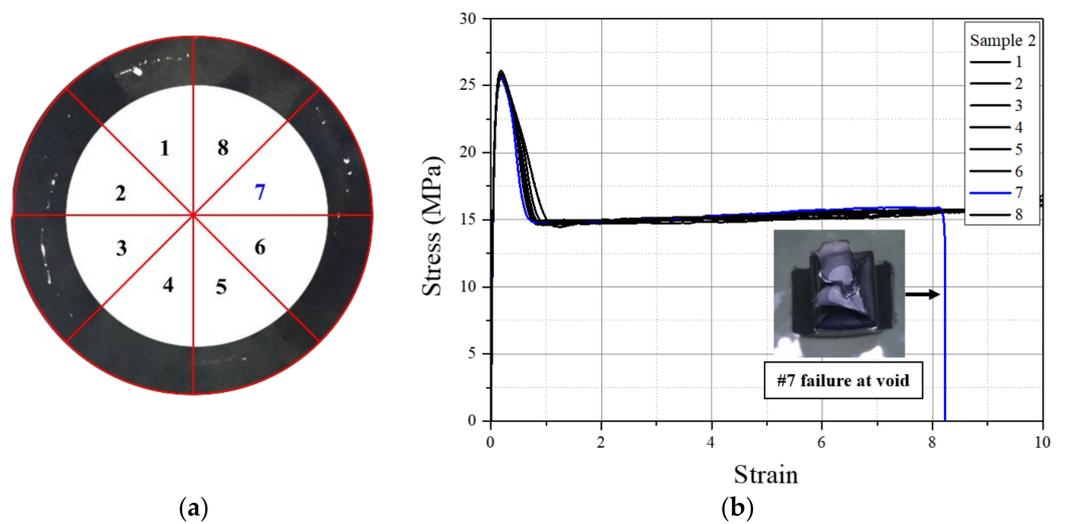
Figure 15. The 12 mm thick tensile specimens from pipe sample 2. (a) The eight sector locations, and (b) tensile stress–strain curve of each specimen.

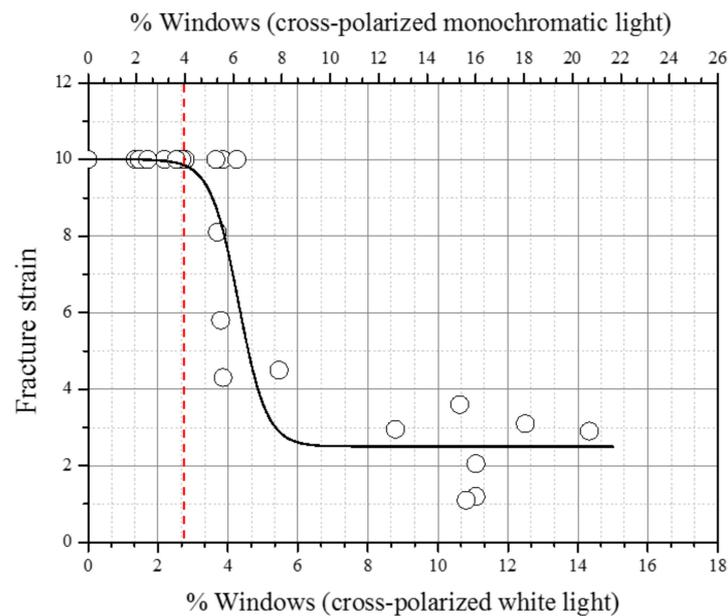
Figure 16. Fracture strain versus % windows of specimens from all sectors.

Figure 16 illustrates the correlation between the % windows determined at each of the eight sectors and the corresponding specimen fracture strains for all pipe samples. The fracture strain was seen to undergo no decrease until about 2.5% windows; then, a rapid decrease to about 250% limiting strain value occurred. From this behavior, one can estimate the limiting % windows at which the integrity of the tensile specimen can be maintained. It is noted that different lighting conditions used to determine the % windows can provide different results. For example, the limiting fracture strain of 2.5% determined with a white cross-polarized light became about 4.0% when a monochromatic cross-polarized light was used (Figure 16). Hence, the type of lighting and the shaving thickness used need to be mentioned when determining the % windows present.

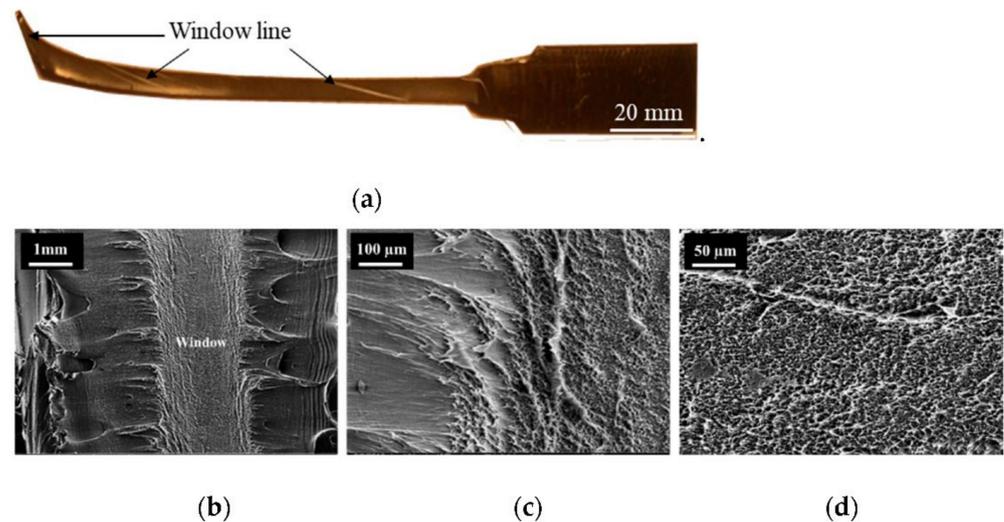
Figure 17 shows the fracture surface of a tensile specimen taken from pipe sample 4. In the cold drawn region of the tensile tested specimen (Figure 17a), windows in the form of a twisted line can be observed along the length of the specimen up to the point of fracture (see the arrows). The fracture surface examined is shown in Figure 17b–d. At lower magnifications ($\times 40$ and $\times 200$), the fracture surface was seen to contain a region of flatter fracture sided by tearing from gross yielding. A further examination of the flat fracture at higher magnification ($\times 500$) showed a short, fibrillated surface, indicating micro-ductility in the windows. In contrast, the yielding tear adjacent to the fibrillated surface indicated shear yielding failure in the black compound area.

Figure 17. (a) Twisted window line along the cold drawn length of the tensile specimen and fracture surface morphology at (b) $\times 40$, (c) $\times 200$, and (d) $\times 500$.

Therefore, it was clear that the windows' fracture produced a fibrillated fracture surface, whereas the black compound failed via a gross yielding tear. Hence, the cause for the reduction in the global fracture strain can be attributed to the presence of windows.

It is noted that the window fractures exhibited different fracture morphology comparing the tensile tested specimen (Figure 17) to the pipe specimen that underwent slow crack growth before the rapid crack propagation failure (Figure 18). The fracture morphology difference was likely due partly to the different loading and specimen geometries between the two cases. Nevertheless, these two examples clearly indicated that the presence of windows was a contributing factor leading to the premature failure of PE pipes.

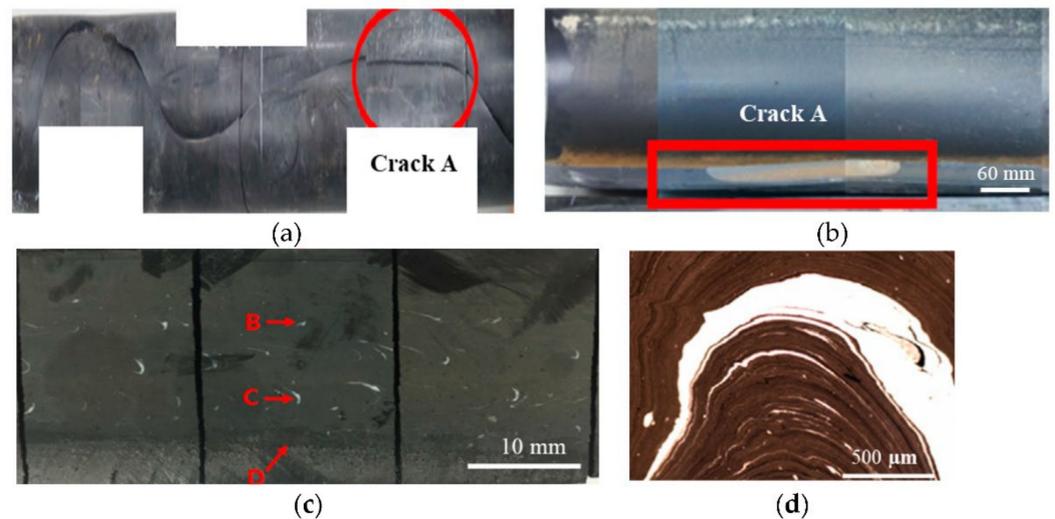
In support of this, Figure 18a shows a rapid crack propagation (RCP) failed 315 SDR 11 black HDPE water pipe and the slow crack growth preceding RCP failure (Figure 18b). The windows are clearly visible on the slow crack surface toward the mid-pipe wall (Figure 18c). They were further confirmed by the white swirls observed in the 15 μm thick film microtomed from the windowed area (Figure 18d). Figure 19 shows photomicrographs of the windowed area B (Figure 18c), seen under a scanning electron microscope (SEM). The windows exhibited a flat, brittle fracture surface. In contrast, the typical micro-ductility fibril morphology of the fracture surface was apparent in the black compound area, indicating that slow crack growth had occurred. Hence, the flat, brittle fracture of the local windows is thought to provide a path for premature failure.

Figure 18. (a) Rapid crack propagation failure, (b) fracture surface at “crack A” indicating slow crack growth, (c) “crack A” fracture surface containing windows, and (d) windows swirls.

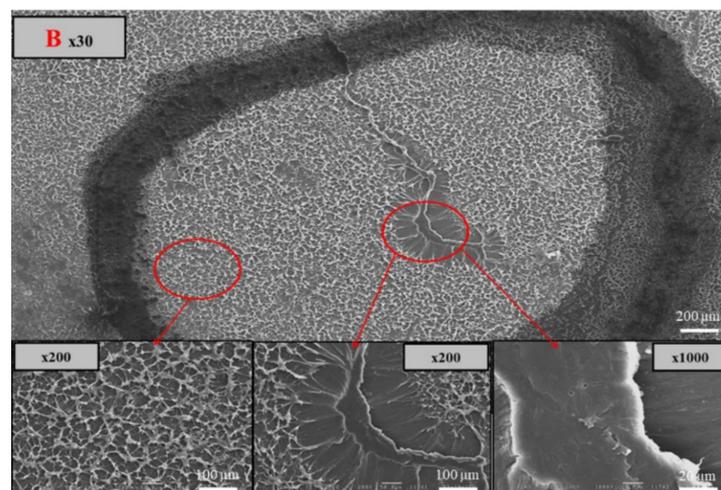
Figure 19. SEM photomicrographs of the fracture surface of the window and black compound regions (region B in Figure 18c).

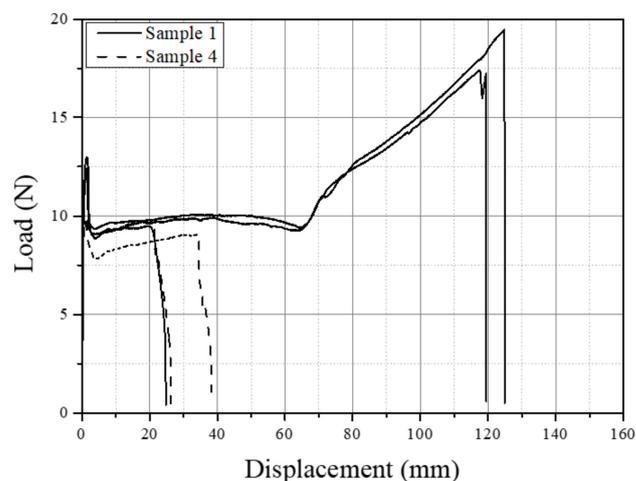
Figure 20. Load–displacement curves of tensile-tested 100 μm thick shaving from samples 1 and 4.

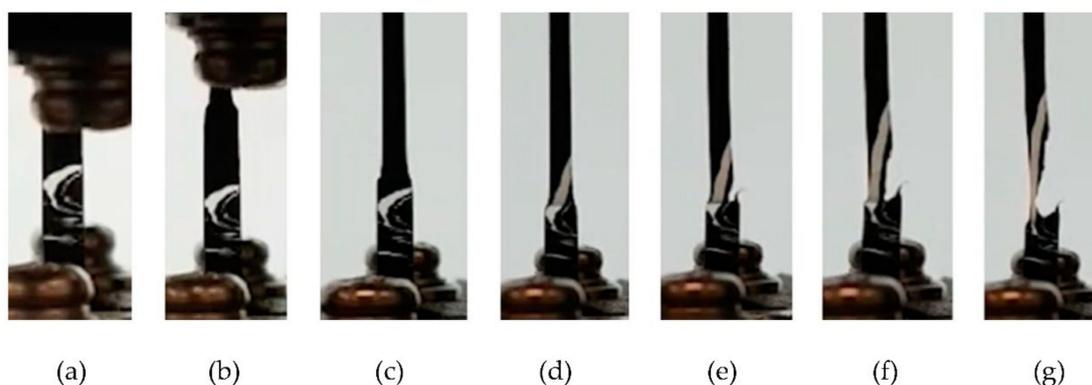
given in Figure 21. The window swirl underwent uniform deformation up to yield (a); the neck formed and the cold drawing began (b); the cold drawing reached the window swirl (c); the cold drawing included windows and continued without any disturbance to the main window (d); further cold drawing caused a tear crack to initiate at the secondary window swirl below (e); the tear propagated (f) until a final failure occurred (g). The tear crack seemed to initiate at the boundary between the secondary window swirl and the black compound region between the main and secondary window swirls (e). Deveci and coworkers [23] also reported the boundary crack initiation in tensile testing of a 15 μm thick microtomed film containing windows. They attributed this to the higher CB concentration at the window–black compound boundary due to the interfacial free energy difference.

Figure 21. Frame-by-frame photographs showing the progression of windows' deformation to tear fracture.

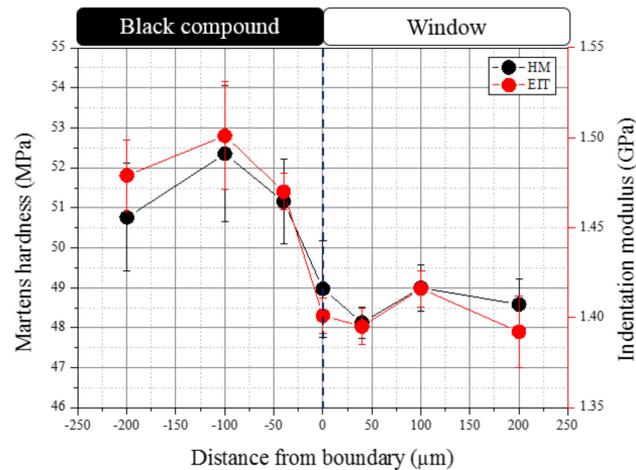
Figure 22. Variation of HM and EIT with distance from the windows–black compound boundary.
