Bank Processes and Revetment Erosion of a Large Lowland River: Case Study of the Lower Tisza River, Hungary

Abstract: Stone and concrete revetments are widely constructed to control bank erosion and thus stabilize river banks. The consequences include accelerated erosion at unrevetted downstream channel sections and in-channel incision at revetted sections. The studied section of the Tisza River (Hungary) was revetted along 49% of its banks in the 20th century with stepped-block and placed-rock revetments. We therefore aimed (1) to study the effects of revetment constructions on channel processes and (2) to evaluate the state and collapse of revetments using a DEM of the channel and ADCP measurements. In the late 19th century, the river had an equilibrium meandering channel, with alternating eroding and aggrading banks. Currently, erosional processes dominate. Thus, 65% of the total channel length is affected by bank erosion. The revetments reduced the active lateral erosional processes only temporarily, as 58% of the revetments, mainly placed-rock, are already damaged. The flow characteristics at the revetted sections were found to depend on the rate and type of revetment collaps

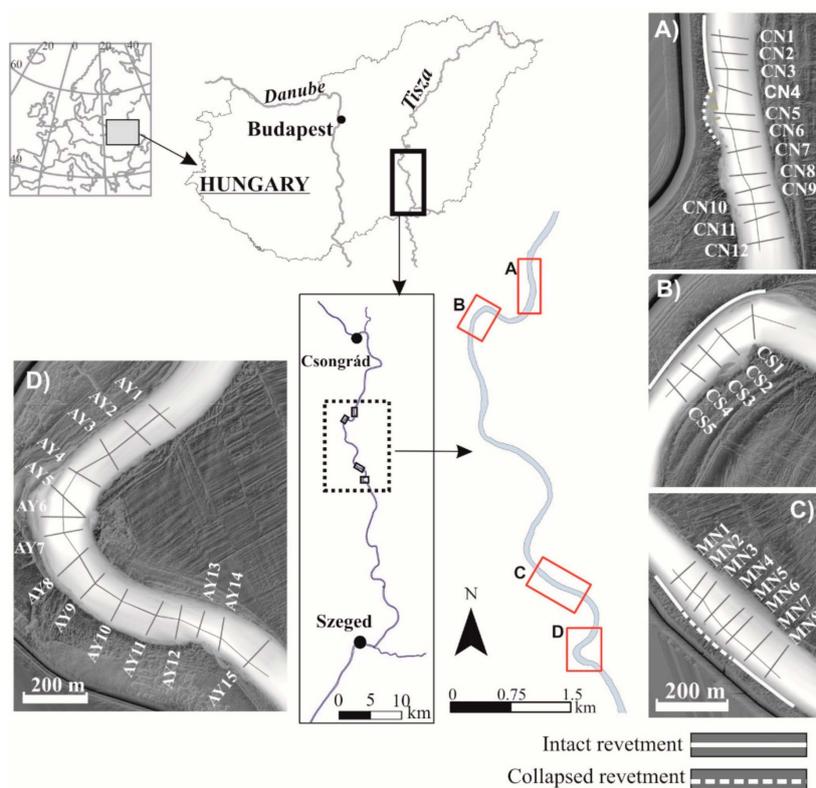
Figure 1. The banks of the Lower Tisza River (Hungary) were studied in detail between Csongrád and Szeged (78 km-long section). A detailed study was carried out at four sites along transects. (A): Csanytelek North; (B): Csanytelek South; (C): Mindszent; and (D): Ányás.

Our research was carried out at two spatial scales: surveys were made along a 78 km-long reach of the Lower Tisza, and more detailed analyses were carried out at four sites (Figure 1), which differ in the type and date of revetment constructions. The northernmost site (CN: 227.4–226.6 f.km) is at a slightly

At the four study sites, a detailed channel and flow velocity survey was conducted at a low stage. The survey was performed along transects spaced at approximately half of the channel width (40–105 m) and along the thalweg (Figure 1). The study employed a boat-mounted RiverRay ADCP (by Teledyne RD Instruments) with a GPS device. The obtained data were analyzed using WinRiver II software. Based on the measurements, the measured wetted width at the actual water level and the actual discharge were determined. The mean velocity for each transect was calculated from the arithmetic mean of velocity fields of bins at all measured depths. The specific stream power (stream power per specific width) was calculated by dividing the product of the discharge, local water slope within the study site, the density of water, and gravitational acceleration by the wetted width of each transect.

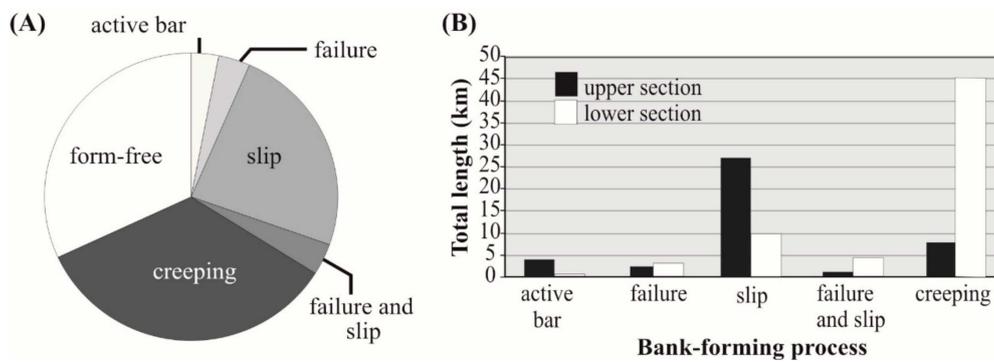
Figure 2. (A) Frequency of active bank processes, and (B) comparison of active processes along the upstream and downstream sections along the Lower Tisza.

Along the 78 km-long surveyed reach of the Lower Tisza, most of the banks (65%) were shaped by active erosion, 3% were characterized by accumulation, and 32% showed no identifiable active erosion or accumulation (Figure 2A). The most common bank erosional processes are creeping (34%, 53 km) and slips (24%, 47.9 km), though failures (3.5%) and failures combined with slips (3.5%) altogether form 10.9 km-long banks. The most interesting result of the survey is that only 20 active bars exist in the area, with a total length of 4.7 km, referring to the existence of few accumulation sections.

The frequency of the various bank-forming processes of the upper meandering section (205–247 f.km) differs from the downstream (169–205 f.km) slightly sinuous section (Figure 2B). More intensive processes (e.g., slips, point bar development) form the upper meandering section, while creeping is the most common process in the lower sinuous section. Quite surprisingly, bank failures, especially slips, appear in similar length along the concave (16 km) and convex (14.5 km) sides of the channel (Figure 3). Slip is the characteristic erosional process of both point bars and convex banks, while failures are more abundant on concave, deeply incised banks.

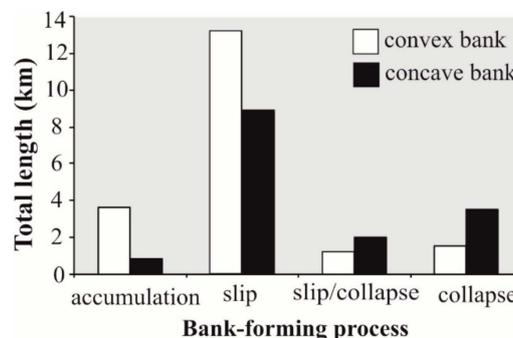
Figure 3. Bank-forming processes on the convex and concave banks of sinuous and meandering sections.

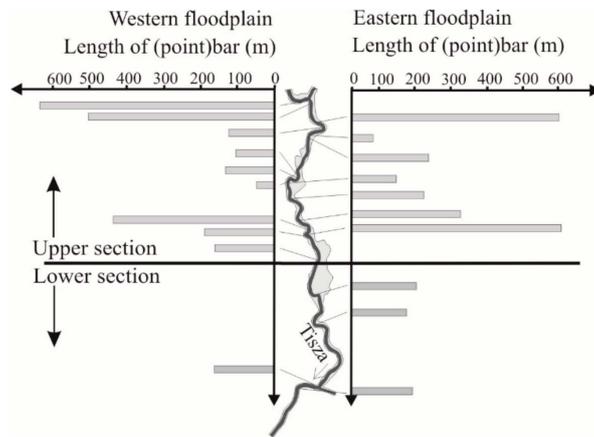
Figure 4. Location and length of active bars.

upstream meandering section of the Lower Tisza, 16 active bars remain, while in the downstream more straightened part, only four very short bar surfaces exist (Figure 4). Most of these bars are point bars developed on the convex side of the meanders, although some side bars also appear along concave or straight sections. All of these active bars also show erosion, as their margins are very steep (ca. 20–60°), and slips often dissect them.

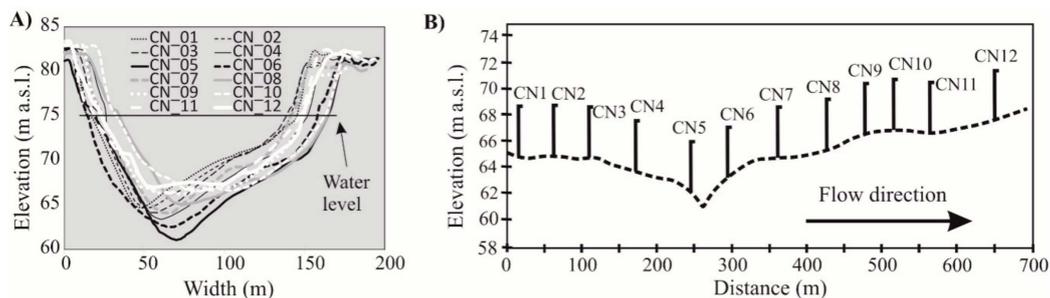
Figure 5. Cross-sectional channel profiles (A) and longitudinal thalweg profile (B) at the Csanytelek North study site.

The channel at the Csanytelek North study site (Figure 5) was stabilized by a revetment on its western bank along 0.3 km (at cross-sections CN1-6) in 1966. Based on our recent survey, the downstream end of the revetment had collapsed (along 110 m at CN5-6). The downstream cross-sections (CN7-12) represented the channel without revetment but with intensive bank erosion (failures) along its western bank.

The first four cross-sections (CN1-4) had a similar shape and width (140–150 m), as the revetment kept the western bank stable, and on the eastern bank, a side bar developed. The channel gradually became deeper (16.2–18.3 m), and the thalweg width increased downstream (CN1: 19 m compared to CN4: 40 m). The thalweg was located ca. 45 m from the western bank at each cross-section, and its longitudinal profile was gently sloping (0.8 cm/m) downstream. The cross-sectional parameters of the

channel at the collapsed revetment (CN5-6) changed characteristically, as here the channel became deeper (18.5–21.0 m; by 14%) and wider (bankfull width: 167–173 m; by 15%). The thalweg was ca. 65 m from the bank, but as the channel became deeper, its bottom also became wider (50–60 m). In front of the collapsed revetment, between the CN5 and CN6 cross-sections, a large and deep pool developed, toward which the thalweg sharply sloped (3.2 cm/m). However, at CN6, the thalweg started to ascend (6.3 cm/m). The channel downstream of the collapsed revetments (CN7-12) gradually became shallower (max. bankfull depth: 13.4–17.5 m) and narrower (140–160 m). The changes in width were related to the active bank-forming processes, as greater width was related to bank failures and slides. The channel became the widest (170 m) and shallowest (15.3 m) at the last cross-section (CN12). The thalweg gradually shifted to the middle of the channel, and the channel shape became more symmetrical. In the meantime, the thalweg became shallower by 7.2 m (average slope: 1.6 cm/m), referring to the development of a riffle downstream.

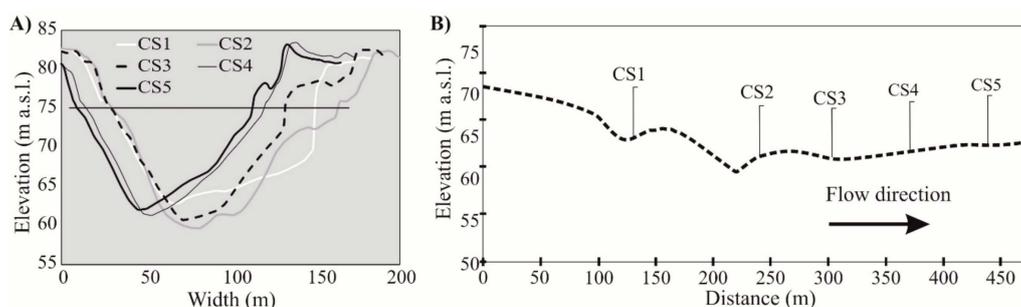
Figure 6. Cross-sectional channel profiles (A) and longitudinal thalweg profile (B) at the Csanytelek South study site.

The next study area is located in a meander where the stepped-block revetment was built in 1940 along the entire concave western bank (Figure 6). A point bar developed along the convex bank. However, slips already dissected its surface. The first channel cross-section (CS1) was the shallowest (bankfull depth: 17.8 m) cross-section of the study site despite its location in a small pool, and from here, the channel became even deeper. Here, the channel was 147 m wide, and the thalweg was located 50 m from the western bank with a high slope (ca. 6 cm/m). Although this cross-section was located at the apex of the meander where the point bar was located, it had a unique cross-sectional shape: The point bar on the eastern side was sliding, thus, instead of having a gentle slope, an almost perpendicular wall developed, representing the front of the slumped material. The erosion of the point bar was the most intensive at the next cross-section (CS2), where the channel was the widest (173 m) and deepest (22 m) at the study site. The thalweg was farthest (ca. 70 m) from the western bank, and its slope was 9 cm/m. The following downstream cross-sections (CS3-5) referred to a more uniform channel (bankfull width: 130–132 m; bankfull depth: 18.3–19.2 m). The thalweg migrated toward the western bank (50 m from the bank) and had a gentler slope (ca. 2 cm/m).

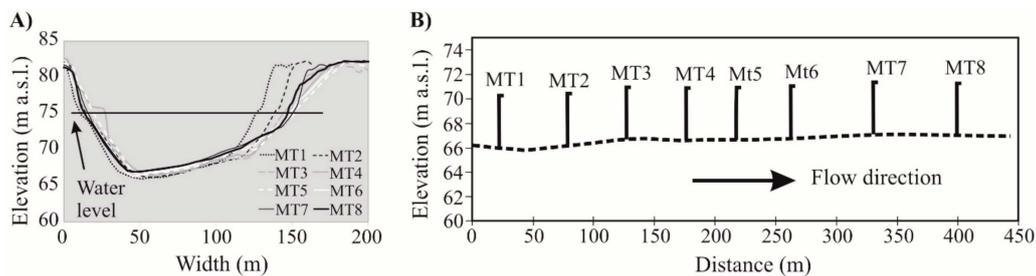
Figure 7. Cross-sectional channel profiles (A) and longitudinal thalweg profile (B) at the Mindszent study site.

The revetment at the Mindszent study site (Figure 7) was built in 1910 along the entire length of the western bank, but has already started to collapse by sliding. On the opposite, convex bank a point bar exists. Here, the cross-sections were very similar to each other: The thalweg was skewed toward the revetted western bank (ca. 50 m). The first two cross-sections (MT1-2), upstream of the point bar, were the narrowest, although their bankfull width increased downstream (139 m and 155 m, respectively). Likewise, the bankfull depth increased downstream (15.2 m and 16.0 m). The middle cross-sections (MT3-6) crossing the point bar along the eastern bank had similar parameters (bankfull width: 174–181 m, and bankfull depth: 15.2–16.5 m). The point bar on the eastern bank had a similar brink-line height (above 81 m a.s.l.) as the opposite bank, but while the concave bank had a steep slope

(ca. 45°), the point bar had a considerably lower slope (14°). Downstream of the point bar, the channel (MT7-8) became narrower (165 m and 175 m) and shallower (14.8 m and 14.3 m) again.

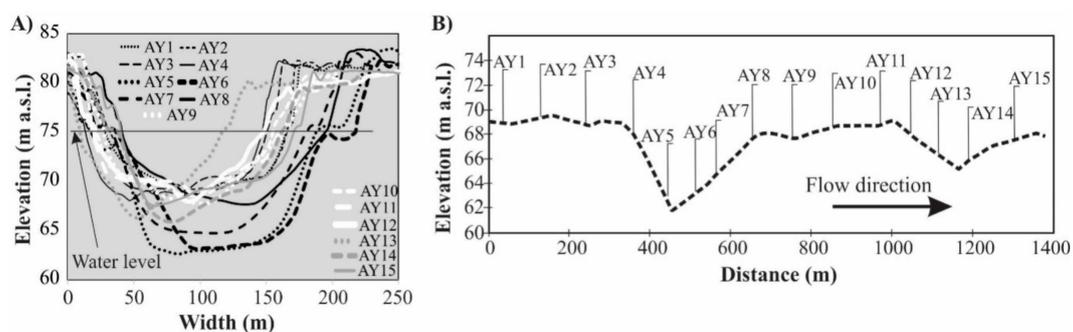
Figure 8. Cross-sectional channel profiles (A) and longitudinal thalweg profile (B) at the Ányás study site.

The Ányás study site represents a free meander without any direct human intervention. Thus, all cross-sections (AY1-15) represented the natural channel morphology with a complex pattern of lateral erosion and active accumulation (Figure 8). The first four cross-sections (AY1-4) referred to a riffle located at the inflection zone between two meanders (bankfull width: 153–203 m; bankfull depth: 10.3–11.8 m). Along this section on the western bank, the formation of a side bar indicates aggradation, while on the eastern bank, slips referred to active erosion. The channel had relatively symmetrical cross-sections, as the thalweg was located in the middle of the channel (slope: 0.3 cm/m). Downstream of the riffle, a sharp transition into a pool was observed. Within this pool, the cross-sections (AY5-7) remained symmetrical, but their bankfull width (200–240 m) and bankfull depth (12–15 m) increased. Here, the thalweg was slightly skewed to the western bank (ca. 80 m from the bank), although the bottom of the channel remained quite uniform. The slope of the thalweg in this pool increased (3 cm/m) with a knick-point upstream of cross-section AY5. Downstream of the pool another, ca. 400 m-long riffle developed (AY8-11). Here, the channel gradually became narrower (bankfull width: 187–170 m) and shallower (bankfull depth: 13.5–11.0 m). The cross-section AY8 represented a transitional character between the previous pool and the next riffle (bankfull width: 188 m; and bankfull depth: 13.5 m). On the western (concave) side of this riffle, the previous surveys [49] indicated intensive bank erosion (ca. 1.2 m/y) with increasing intensity downstream as the slips were replaced by total bank collapse. The point bar on the opposite eastern bank actively accumulated, compensating for the erosion of the other side, thus keeping the channel size relatively unchanged. There was a gradual thalweg shift towards the eastern bank in this riffle section, while at the same time, the elevation of the thalweg increased by 1.2 m (slope: 0.4 cm/m). Downstream of this riffle, another pool developed (AY12-15) with a relatively narrow bankfull width (135–175 m) and deep channel (bankfull depth: 13.7–15.2 m). The thalweg migrated toward the western bank within this pool and had a relatively gentle slope (1.4 cm/m) compared to the larger pool upstream.

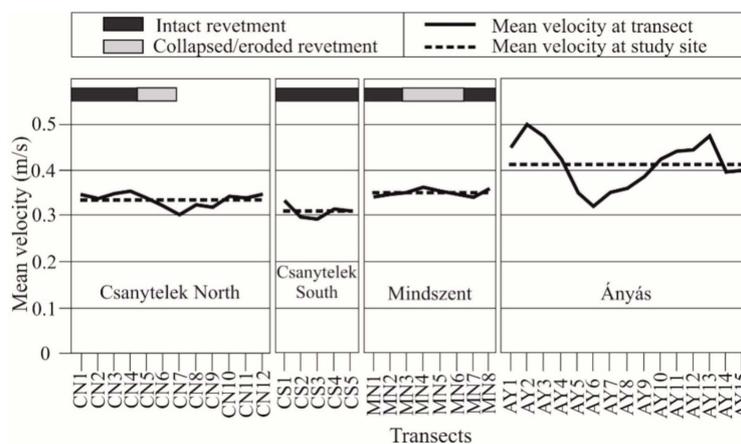
Figure 9. Characteristic velocity values at the study sites and the locations of revetments on the western bank.

Due to the proximity of the Csanytelek North and Csanytelek South sites, the mean velocities at the two sites were similar (Figure 9). The Csanytelek South represented the lowest mean velocity (CS: 0.31 m/s) of all four sites, while the free meander of Ányás had the highest mean velocity (0.41 m/s). Within the individual sites, the mean velocities of transects at Mindszent had the least range (6.3% and 0.02 m/s) in comparison to the other transects (CN: 14.1% and 0.05 m/s; CS: 13.1% and 0.04 m/s; AY: 55.7% and 0.18 m/s). At Csanytelek North, the range of mean velocities within the intact revetted section was only 3%. At the collapsed revetted section, the range increased to 6%, however, at the non-revetted section, it was as high as 13%. Although the Csanytelek South site was fully revetted, the mean velocity differed by up to 13%, with the CS1 transect accounting for more than half of the variation. At the Mindszent site, the velocity variations were similar (6.3%), although the middle four transects (at the point bar and the sliding revetment) had the highest mean velocities (0.35–0.36 m/s) within the site. The highest mean velocities of all study sites were measured at the Ányás site, where two-thirds of the transects had high mean velocities (≥ 0.40 m/s) and only one transect had a similar low velocity (≤ 0.35 m/s) as the other three sites.

The areal distribution of velocity fields indicated that at the revetted study sites, two-thirds of the velocity fields belonged to the range of 0.2–0.4 m/s, while at the freely meandering Ányás site, they belonged to a higher range (0.3–0.6 m/s). At Csanytelek North, the intact revetment transects (CN1–4) were characterized by relatively similar velocity distributions, as ca. 90% of the wetted area had 0.2–0.5 m/s velocity fields. Along the collapsed revetment and its immediate downstream sections (CN5–7), velocity fields were similar, but the same range (0.2–0.5 m/s) occupied less than 80% of the wetted area, as the area of the very low (≤ 0.2 m/s) velocity fields increased. Downstream of the collapsed revetment (CN8–12), the area of the 0.2–0.5 m/s velocity fields gradually increased (84–93%) again. Along the intact revetment at Csanytelek South, a gradual areal increase in the 0.2–0.5 m/s velocity fields was detected in the downstream direction (from 60% to 91%). Although the Mindszent site had collapsed revetment and a point bar within its middle section, the distribution of characteristic velocity fields (0.2–0.5 m/s) was fairly uniform (ca. 90%) throughout the studied section. At the free meander of the Ányás site, the velocity conditions were the most variable related to the pool and riffle series. Within the first riffle section (AY1–4), unlike the other study sites, the 0.4–0.5 m/s velocity field had the highest frequency (20–32%). In the next pool section (AY5–6), lower velocity fields (0.2–0.3 m/s) occupied the highest area (28–35%). Very high-velocity fields (> 0.6 m/s) were recorded in the second riffle section (4–23%), and these high-velocity fields remained even in the last pool section (2–12%).

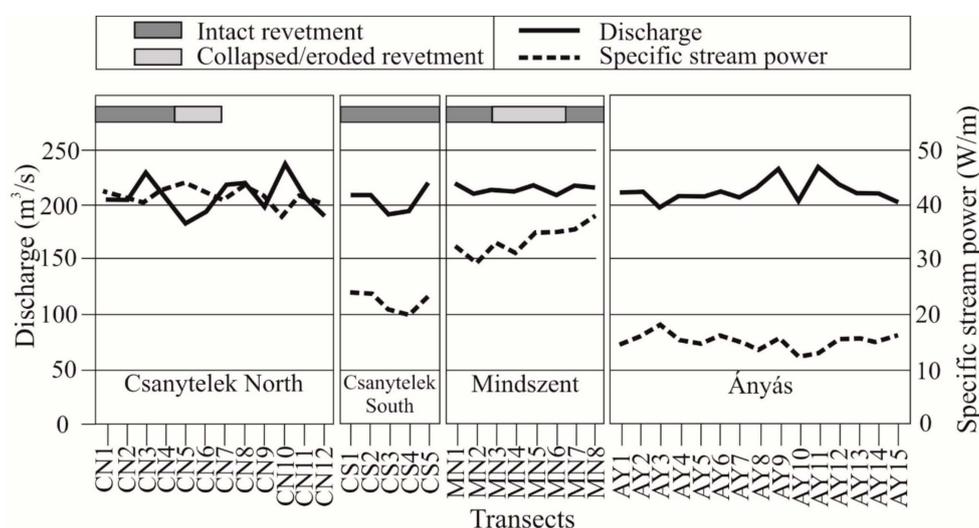
Figure 10. Variation of specific stream power and discharge values along the studied sections showing locations of revetments on the right bank.

Although the measurements were carried out at low stage and discharges were generally similar, the specific stream power was the highest at those sites where the revetments were already collapsing (Csanytelek North and Mindszent), while the meander with the stabile revetment (Csanytelek South) and the free meander at Ányás were characterized by significantly lower specific stream power (Figure 10).

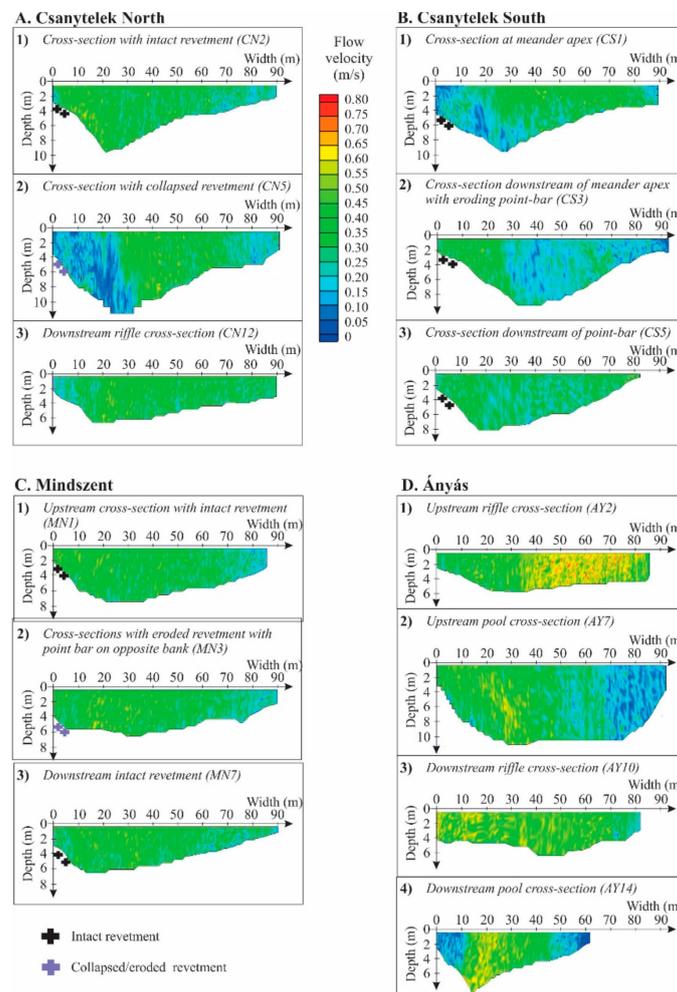
Figure 11. Typical velocity fields of the morphological units of the study sites at (A) Csanytelek North, (B) Csanytelek South, (C) Mindszent, and (D) Ányás. The existence and state of the revetment is indicated by crosses.

The velocity distribution of the flow is closely related to channel morphology and bank characteristics. The upper transects (CN1-4) along the intact revetment had similar morphological characteristics. However, the velocity distribution of the last (CN4) transect was different (Figure 11A). The CN1-4 transects had relatively high mean velocities (0.34–0.35 m/s). The lowest flow velocity was measured above the side bar, while the highest velocity fields (0.4–0.6 m/s) developed within a ca. 40 m-wide zone between the thalweg and the intact revetment. At the CN4 transect, the highest velocity fields (0.4–0.6 m/s) occupied a wider zone (ca. 50 m), and near the bottom, relatively high velocities (0.6 m/s) developed.

In the frontal pool at the collapsed revetment, the flow velocity dropped almost to 0 m/s (the measurement was made at low stage). Thus, the mean velocity of these transects dropped to 0.32 m/s (by 8.5%). The quite low flow velocity was connected to the increase in the wetted area as the result of bank failures and the development of the deep pool. These data characterize not only the collapsed revetment (CN5-6) but also a short section downstream of it (CN7).

In the downstream riffle transects (CN8-12), the mean velocity increased gradually from 0.32 m/s to 0.34 m/s as a response to decreasing width and wetted area, despite the elevating bottom. At the top of the riffle, the velocity distribution of the channel became more uniform in the symmetrical channel.

The Csanytelek South study site had the lowest mean velocity (0.31 m/s) among all the study sites, but showed marked differences (Figure 11B). At the apex of the meander (CS1), the highest flow velocity developed from the site to the downstream section, the bottom of the channel descended, and almost 0 m/s velocity fields were observed along the banks and at the thalweg. The following downstream transects (CS2-3) had relatively high velocities along the revetted bank, but in the pool and above the point bar, low-velocity fields appeared. As the pool terminated, the last two transects (CS4-5) downstream exhibited uniform mean velocities.

The flow velocity distribution in the Mindszent study site was mostly uniform (Figure 11C), as the cross-sectional channel profiles and the longitudinal thalweg profile represented only minor changes. The existence of intact (MT1-2 and MT7-8) and slipped revetments (MT3-6) did not affect the velocity fields considerably as similar velocity fields developed along the western bank.

At this free meander, the alternating riffle-pool sequence and the various bank processes had a considerable effect on the flow velocity distribution (Figure 11D). In the riffle sections and in the relatively shallow downstream pool, the 0.4–0.5 m/s velocity fields were dominant. However, in the deep upstream pool, low-velocity fields (0.3–0.4 m/s) were characteristic.

Within the upstream riffle (AY1-3), the high-velocity fields (0.5–0.7 m/s) skewed toward the eastern bank. Thus, it eroded intensively (1.0 m/y), while along the western bank, a side bar developed under the lower velocity fields. However, transect AY4 had transitional characteristics, as its morphology referred to a riffle, although its velocity fields were as those of a pool.

In the next pool, the first transect (AY5) had very low velocities along its banks, but other parts of the pool were characterized by higher velocities (0.4–0.6 m/s) due to the development of a large whirlpool. At the exit of the pool (AY6-7), the flow distribution became uniform, and high-velocity fields (0.5–0.7 m/s) developed in the ascending thalweg zone.

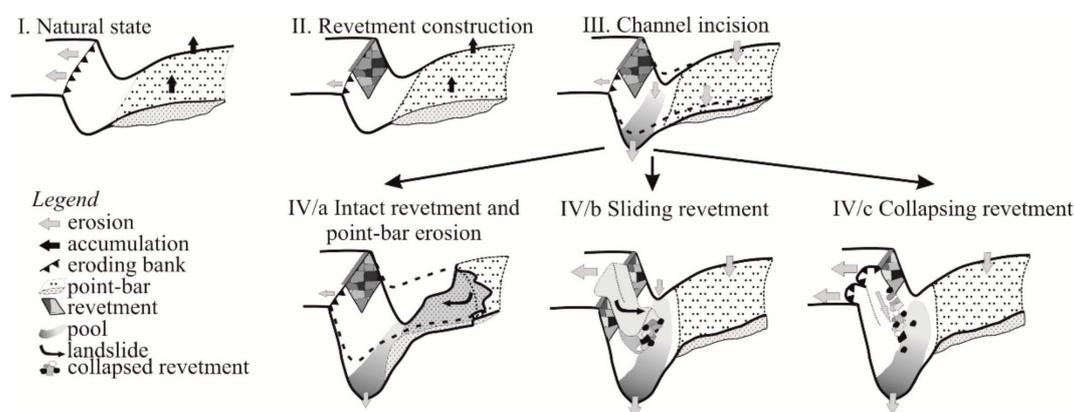
Figure 12. Conceptual model of bank erosion and revetment collapse in the Lower Tisza.

The placed-rock revetments erode in two different ways, as indicated by our conceptual model (Figure 12). High velocities generated near the revetment along the concave bank accelerate vertical erosion. Thus, the channel became deeper by 1–2 m after the river regulations were implemented [36], providing favorable conditions for mass movements along long revetted sections (e.g., at MT) or the collapse of the stones one-by-one (e.g., at CN). In the latter case, the downstream end of a placed-rock revetment erodes first as a result of the co-existence of the following factors: (1) The thalweg is skewed close to the revetted bank, (2) the smooth upstream revetment section has velocity acceleration, and (3) the flow has higher erodibility. In this way, although the revetment protects the bank from lateral erosion, immediately at its end the flow has high erosivity, enhancing vertical and lateral channel erosion immediately downstream of the revetment. Therefore, here, the non-revetted bank is formed by high-intensity failures and slides, and a deep pool develops. However, the erosional front migrates upstream. At first, the skewed thalweg probably increases the size of the pool, providing suitable conditions for the collapse of the revetment rocks one-by-one. Later, as the rocks fall into greater depth, they allow intensive lateral erosion of the formerly protected bank. Based on the longitudinal profile of the channel bottom and the bankline, a knickpoint can be identified: Downstream of this knickpoint, both the vertical and lateral erosion accelerated, creating a small pool at the end of the revetment. This knick-point propagates upstream, and newer parts of the revetment will therefore collapse until the entire revetment is destroyed.
