Regional Distribution and Causes of Global Mine Tailings Dam Failures

Abstract: Tailings ponds are one of the three major production facilities in metal mines. The volume of tailings increases year by year, but the storage capacity of existing tailings ponds is limited. Therefore, tailings dams must become more fine-grained and larger. The potential hazard they represent should not be underestimated. This paper reveals the causes and regional distribution patterns of 342 tailings dam failures globally from 1915 to 2021 through statistical analysis. It was found that tailings pond failures occur almost every year, with an average of 4.4 accidents/year (1947–2021). The frequency has been gradually increasing in recent years, and most tailings pond failures are directly related to heavy rainfall or earthquakes. The frequency of tailings pond failures was significantly higher in Asia (21.3%) and the Americas (57.9%), especially in China ($n = 43$) and the United States ($n = 107$). Causes of tailings pond failures differed among regions. Most tailings pond failures in Asia and Europe were related to hydroclimate, while those in South America were mainly triggered by earthquakes. This

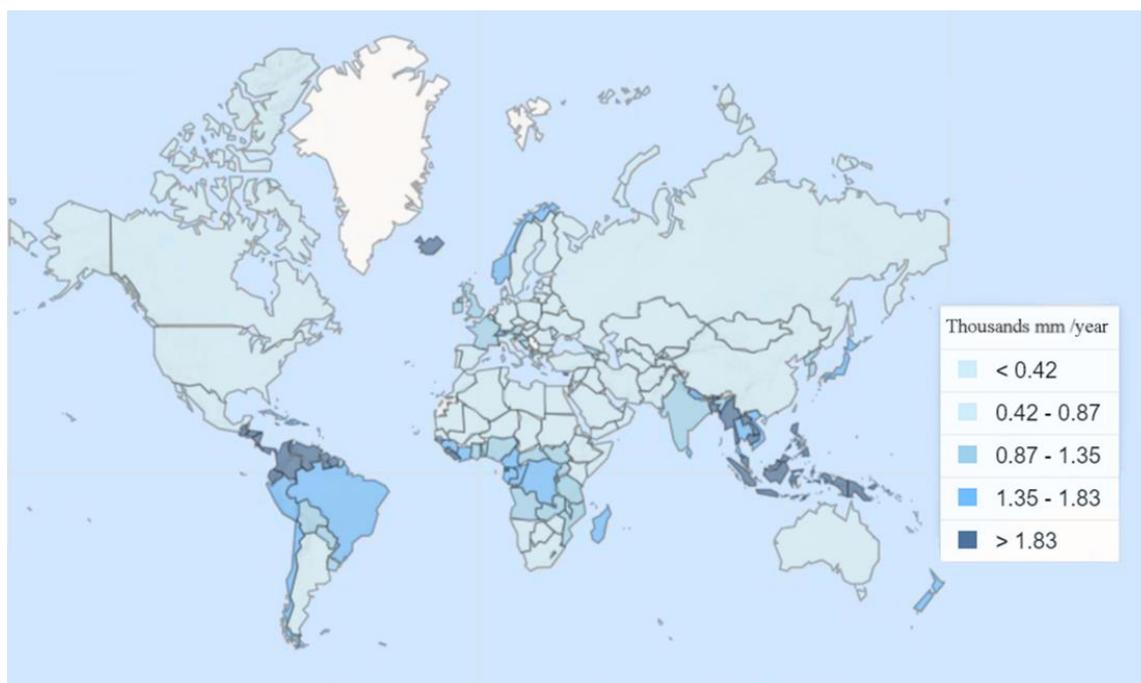
Figure 17. Global average rainfall distribution.
