# Experimental Study of Frame-Supported Shear Wall Structure of High-Rise Buildings with Transfer Slab in Metro Depot

**Abstract:** Taking the frame-supported shear wall structure of a 102.1 m high metro depot as the test object, the structure has obvious vertical irregularity, and a quasi-static test was carried out on the structural model with the scale of 1/5. The damage development and strain of the structure were observed by applying displacement loads under different seismic actions, and the experimental phenomena and measured data were analyzed. The results show that the safety performance of the structure meets the seismic requirements of the MCE (Maximum considered earthquake) condition. Under the action of load, a reasonable damage mechanism is formed in which the components above the transfer story crack first and those below the transfer story crack later, which is in line with the design concept of “the performance objective of the bottom frame structure is higher than that of the upper shear wall structure”. The transfer plate is mainly subjected to shear deformation, the possible shear failure of the transfer plate should be avoided by reasonable design. Due to the

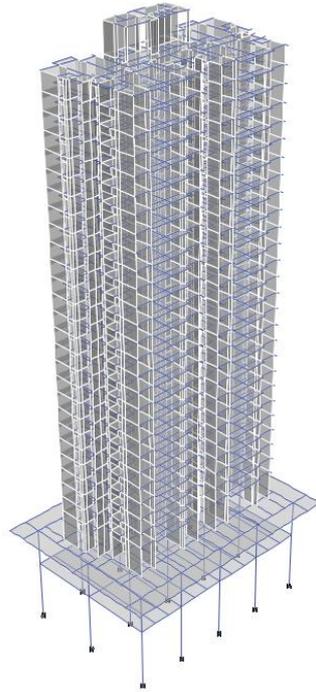
**Figure 1.** Original structure modeling.

The original structure of the experiment model (Figure 1) is a 30-story transfer slab structure with a height of 102.1 m, the first story is the subway parking garage, the second story is the car garage; the first and second stories are the frame structure, the third story and above are the shear wall structure, where the frame and shear wall are connected by transfer slab. As the original structure (Figure 1) has many cross units and is limited by the space conditions of the test site, a simplified structure (Figure 2) was designed to reflect the seismic performance, deformation characteristics, and failure characteristics of the original structure. During the simplification process, the section size of the component did not change. The number of spans was reduced and shear walls were arranged in a manner that is most unfavorable to mid-span columns and plates.

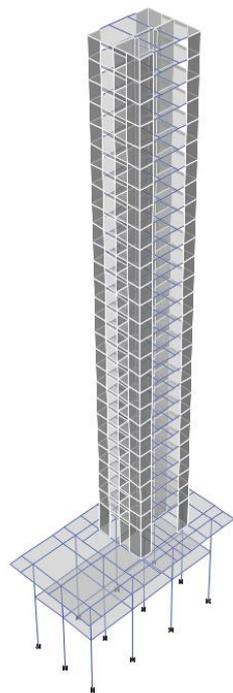
**Figure 2.** Simplified structure modeling.

The simplified structure is scaled down according to the similarity ratio of 1:5. The experiment model with large scale ratio can more intuitively reflect the damage and cracking of the original structure. However, due to the limitation of the space conditions of the test site, the whole building model after scale reduction cannot be taken for experimental research. To study the seismic performance of the transfer thick plate structure, the 1st to 5th floors after scale reduction were taken as the research object (Figure 3). A concrete equivalent mass block was set at the top of the fifth floor, which was used to simulate the vertical gravity action of the upper shear wall structure (Figure 3) because its gravity

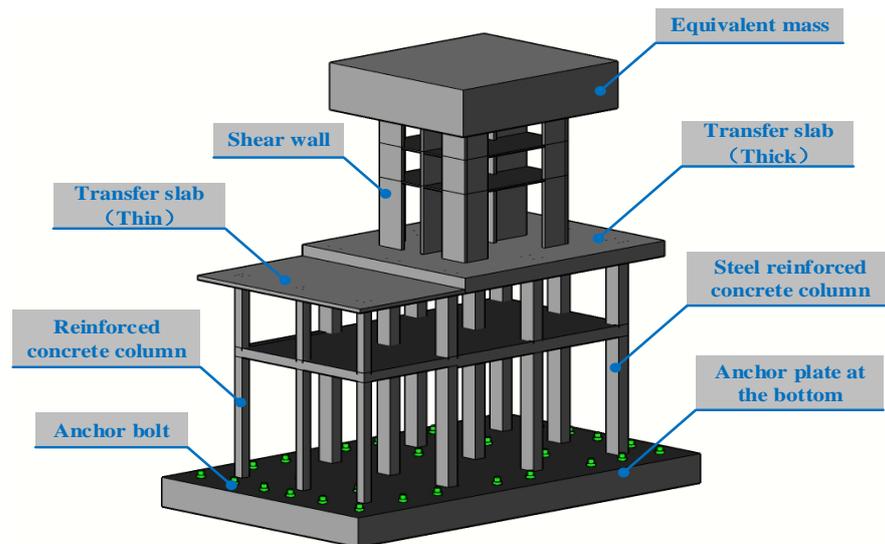
Figure 3. Experimental object.

During the experiment, the axial compression ratio of the structure should be satisfied, vertical loading is done by adding weights. (The vertical loading is the dead load). According to the stress similarity condition, the mass similarity ratio of the model is 1:125, and the gravity similarity ratio is 1:25. The counterweights of each story of the experiment model are listed in Table 1, and are arranged on stories 1–4, respectively. The concrete mass block at the top of the fifth story is poured in an integrated way, as shown in Figure 3. The concrete mass block meets the counterweight requirements of the fifth story.

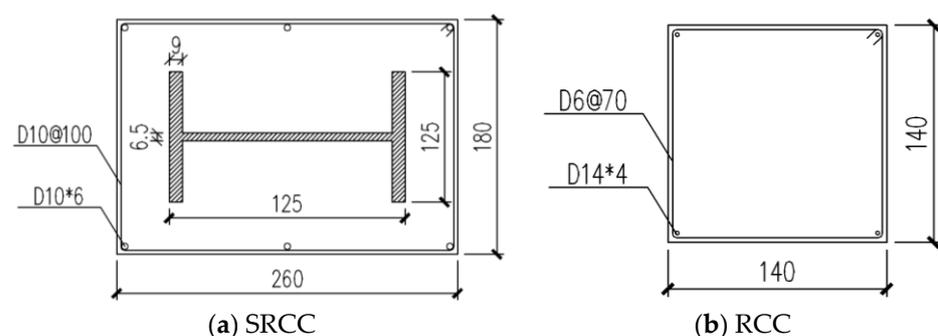
Figure 4. Column reinforcement diagram.

Table 1 shows the scale model and the height of each floor of the original structure. The design strength of the experiment model concrete is C30. The reinforcement ratio of frame structure and transfer slab is the same as that of the original structure, using Q345 I-steel, HRB400 steel bar (diameter 6, 8, 10, 12, 14 mm), and 8# steel wire. The shear wall structure section of the model is too small to arrange steel bars as the research needs. Therefore, when designing the upper shear wall structure model, the internal steel bars should be replaced by 8# steel wire (diameter 4.06 mm) on the premise of the same strength ( $A_b \cdot \sigma_b = A_w \cdot \sigma_w$ ,  $b = \text{steel bars}$ ,  $w = \text{8\# steel wire}$ ). The mass block at the top of the 5th floor is made entirely of concrete, the reinforcement diagram and layout of the test model are shown in Figures 4–6. A similar relationship is shown in Table 2.

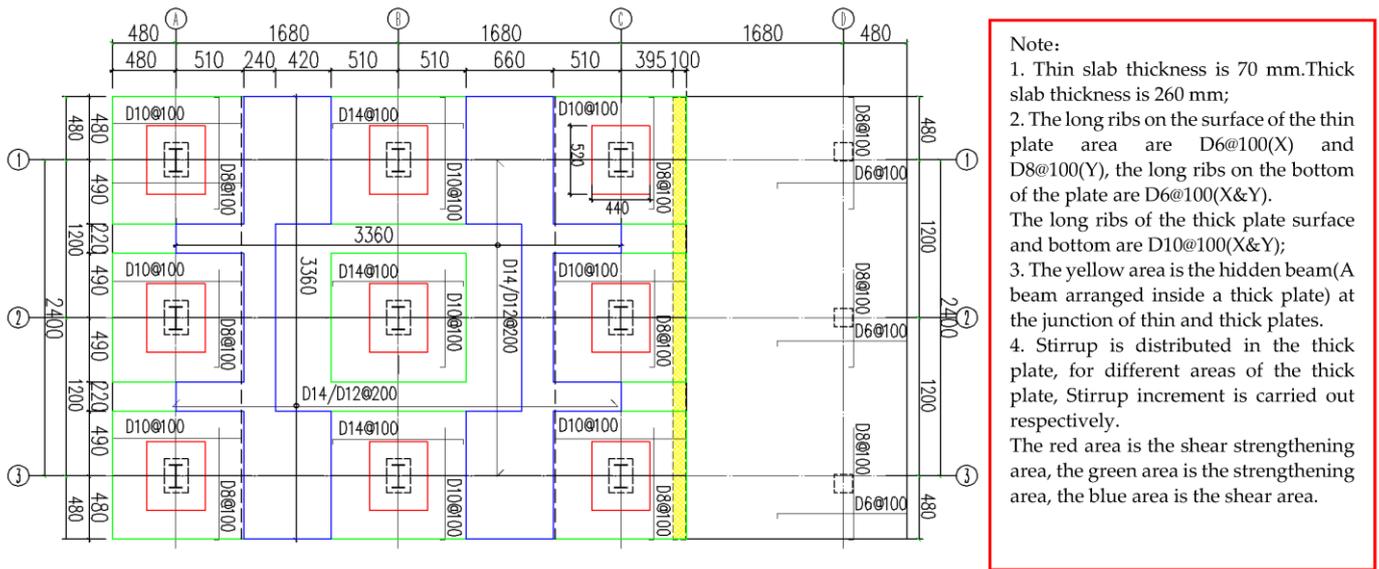
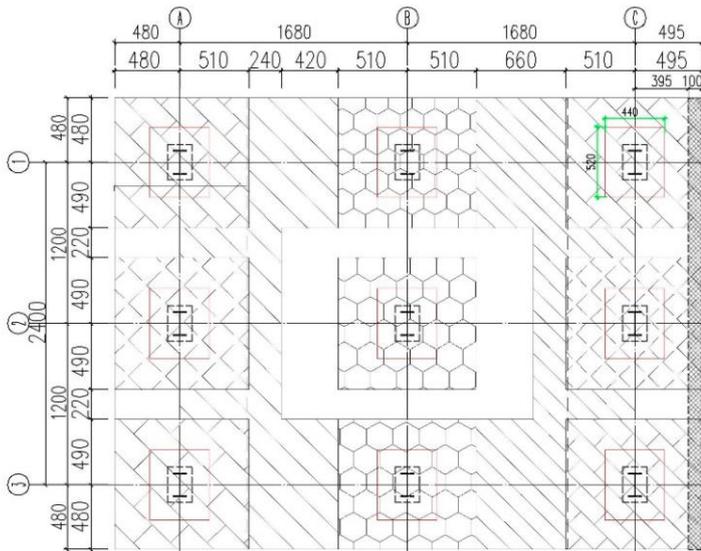
(a) Longitudinal reinforcement

(b) Stirrup (hooping)

Figure 5. Transfer plate reinforcement.

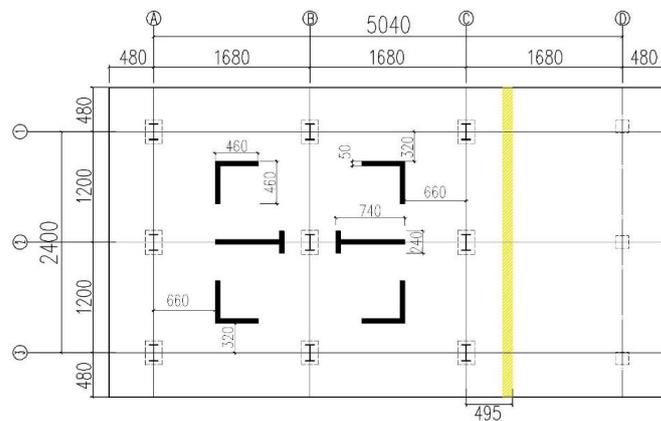
Figure 6. Shear wall layout plan.

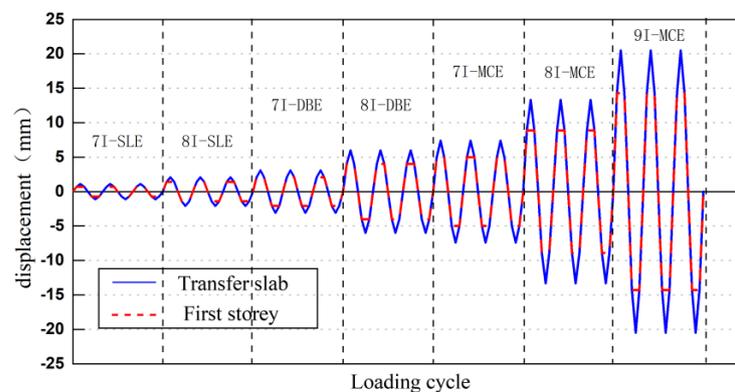
**Figure 7.** Horizontal loading mode.

Two actuators (Model: ZB-300 t, Range: +3000 kN, −1300 kN) were used for horizontal loading, which were respectively arranged on the first story and the second story of the test model. According to the Chinese Seismic design Code [37] (p. 33), the seismic fortification intensity in Guangzhou is 8 degrees. With reference to the maximum horizontal earthquake influence coefficient in the specification (Table 3), the response spectrum method of mode decomposition was adopted to calculate the inter-story shear force and floor displacement of the model under different earthquake actions, so as to obtain the loading displacement. Horizontal loading is carried out after overturning moment loading, including two stages of preloading and formal loading. In the pre-loading stage, force control is adopted for each stage of loading cycle once to ensure that all equipment is in normal working state. Experimental loading is carried out and controlled by displacement, and the loading mode is three times for each stage. The loading regime is shown in Table 4 and Figure 7.

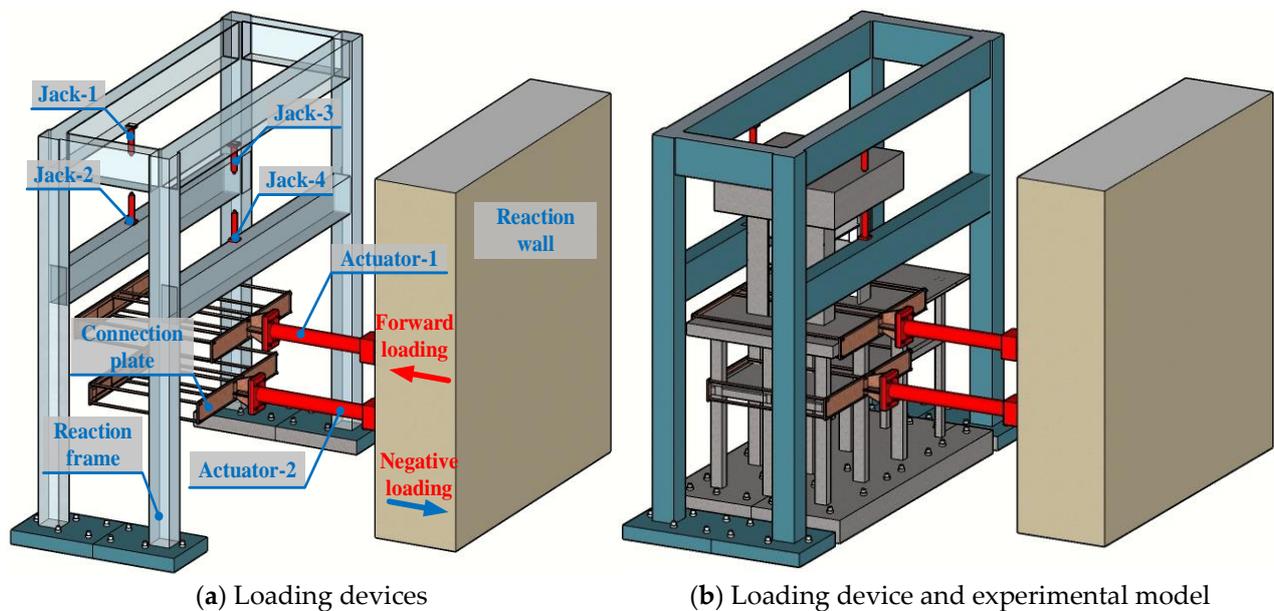
Figure 8. Schematic diagram of loading device and experimental model.

the loading displacement of the jack was obtained by the angle of fifth floor calculated by the mode-superposition response spectrum method, as shown in Table 4. Overturning torque loading includes two stages: pre-loading and formal loading. In the pre-loading stage, force control was adopted for each stage of loading cycle once. After ensuring that all equipment was in normal working state, formal loading was carried out. The formal loading was controlled by displacement, and the loading cycle was three times for each stage. The loading regime is shown in Table 4 and Figure 8.

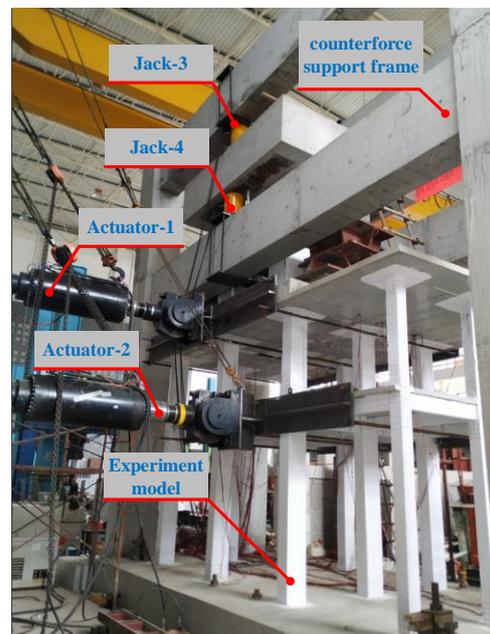
Figure 9. Experimental model.

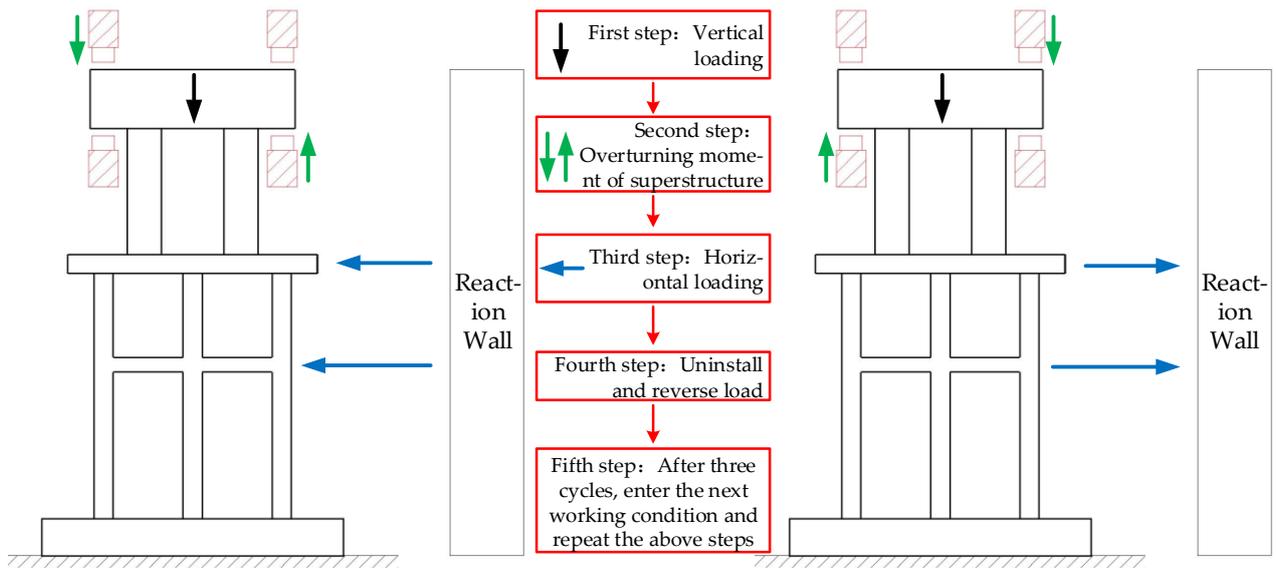
Figure 10. Loading diagram (the left image is positive loading and the right image is negative loading).

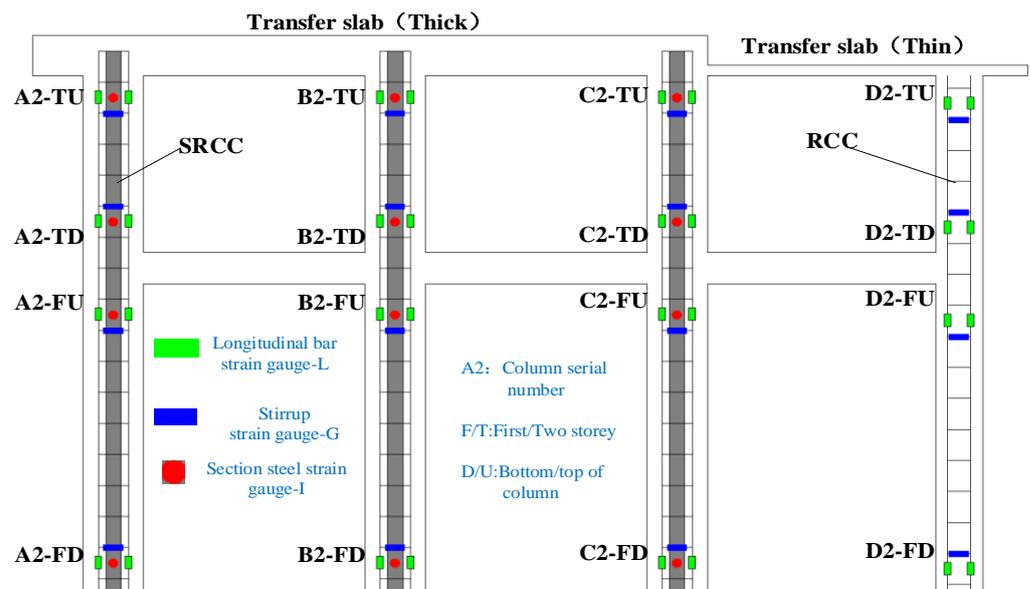
Figure 11. Frame column strain layout plan.

To monitor the deformation of the bottom frame column, strain gauges were arranged at the section steel, longitudinal reinforcement, and stirrup at each column node of axis 2, as shown in Figure 11. Moreover, strain gauges were also arranged on the longitudinal reinforcement and stirrup in different areas of the conversion plate to monitor the deformation of the transfer slab, as shown in Figure 12. In the figure, red parts refer to the strain gauge arranged on the section steel, blue parts refer to the strain gauge arranged on the stirrup, and green parts mean the strain gauge arranged on the longitudinal reinforcement. The diameter of steel wire in the upper shear wall structure was too small to arrange strain gauge.

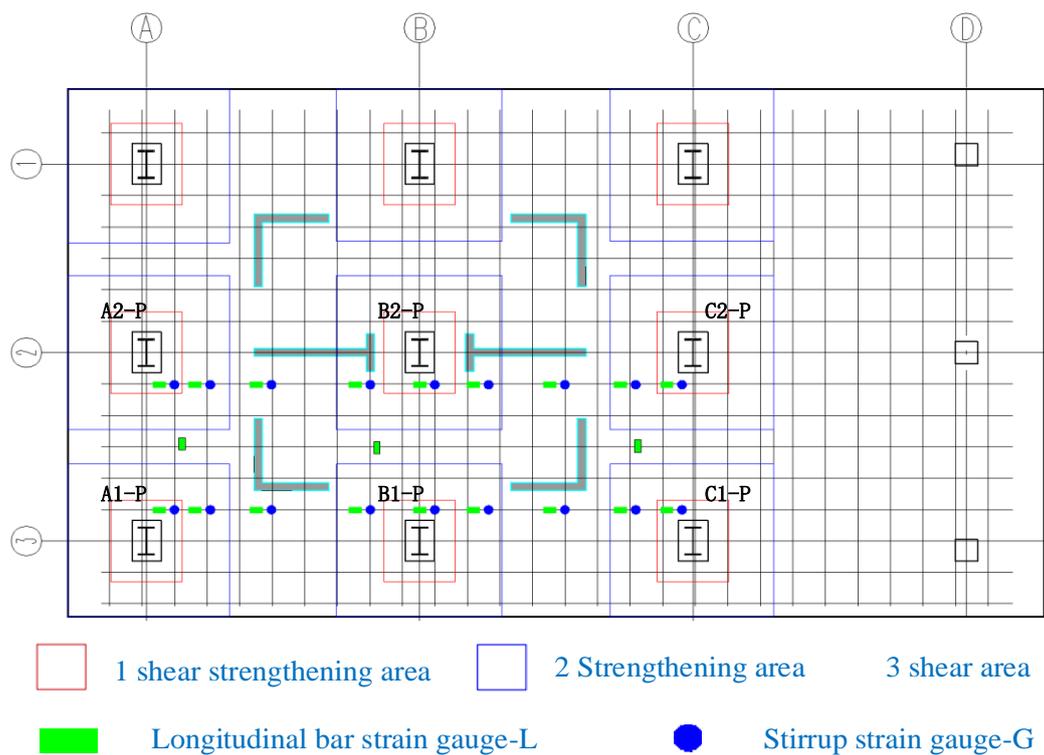
Figure 12. Transfer slab strain layout.

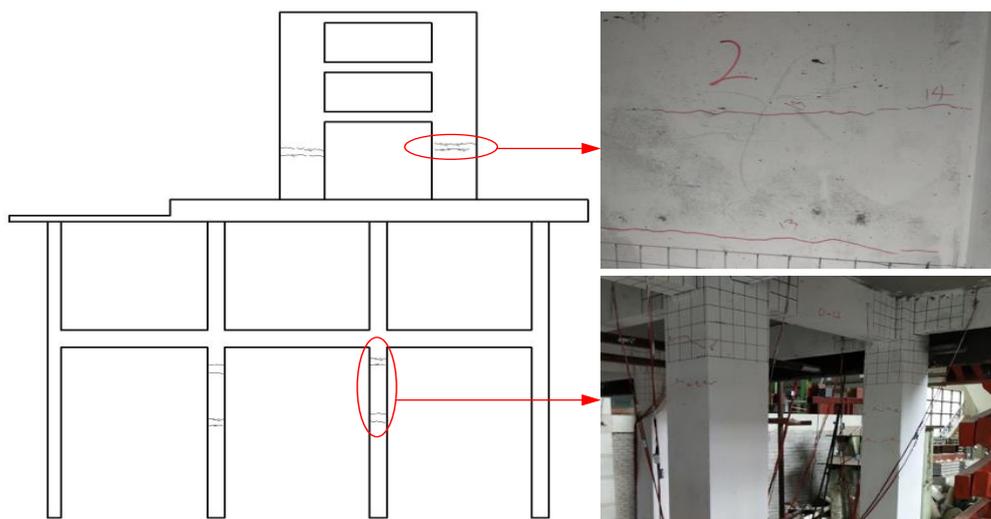
Figure 13. 7I-DBE damage condition.

7I-DBE damage condition: No cracks were observed in the 7I-SLE and 8I-SLE conditions. Under the 7I-DBE conditions, cracks were first observed in the middle area of the three-story shear wall body, and then subtle cracks appeared in the upper area of the first story column, but no cracks were observed in the second story and the transfer slab, as shown in Figure 13.

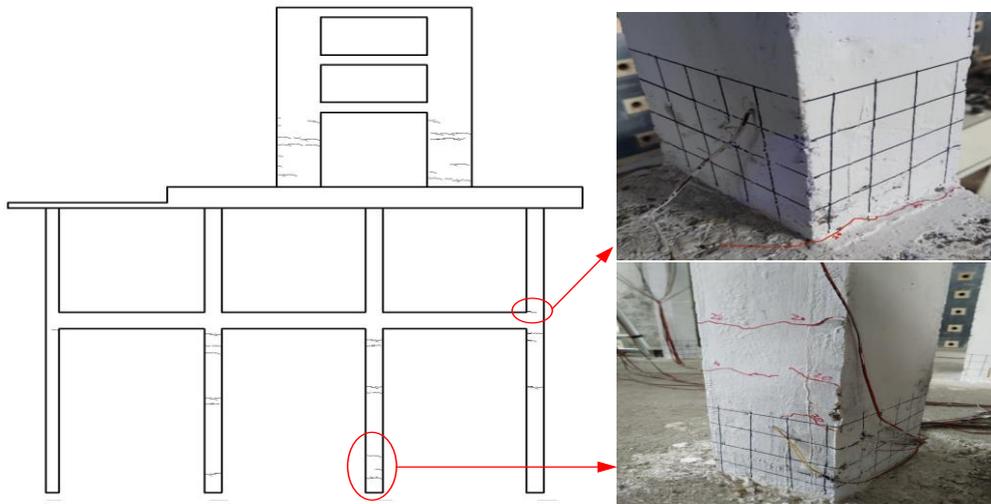
**Figure 14.** 8I-DBE damage condition.

8I-DBE damage condition: the cracks of the columns on the first floor increased, and the cracks appeared at the bottom of the columns for the first time. Meanwhile, cracks appeared on the lower surface of the beam on the first floor, subtle cracks appeared on the node position at the bottom of the columns on the second floor both for the first time, and

the cracks extended to the surface of the slab on the first floor. Cracks increased on the shear wall of the third floor, as shown in Figure 14.

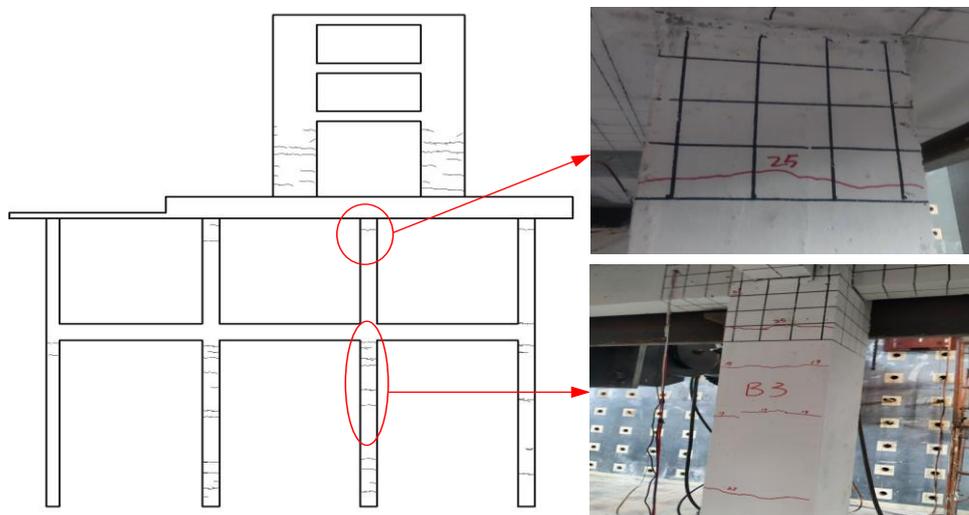
**Figure 15.** 7I-MCE damage condition.

7I-MCE damage condition: The column cracks of the first floor continued to increase, the beam and column nodes of the first floor showed new cracks, the slab surface cracks of the first floor also continued to develop. Horizontal cracks were found at the top of the frame columns on the second floor, but no cracks were observed in the transfer slabs. Cracks increased in the shear walls on the third floor, as shown in Figure 15.

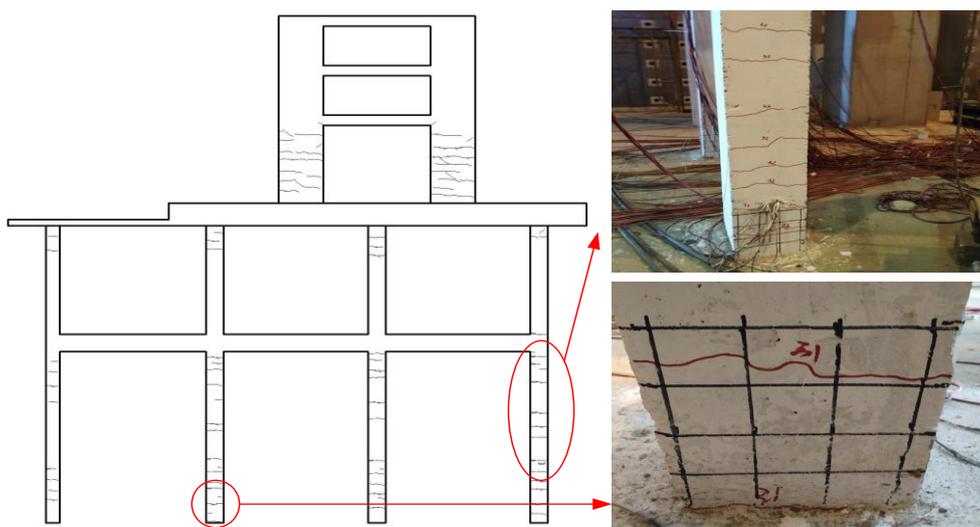
**Figure 16.** 8I-MCE damage condition.

8I-MCE damage condition: The columns on the first floor were seriously damaged, with many long cracks appearing, and new cracks appearing at the embedded ends of the columns at the bottom. There were more horizontal cracks on the top of the second-floor columns, but no cracks were found in the transfer slabs. There were more new cracks in the shear wall and the original cracks continued to develop, as shown in Figure 16.

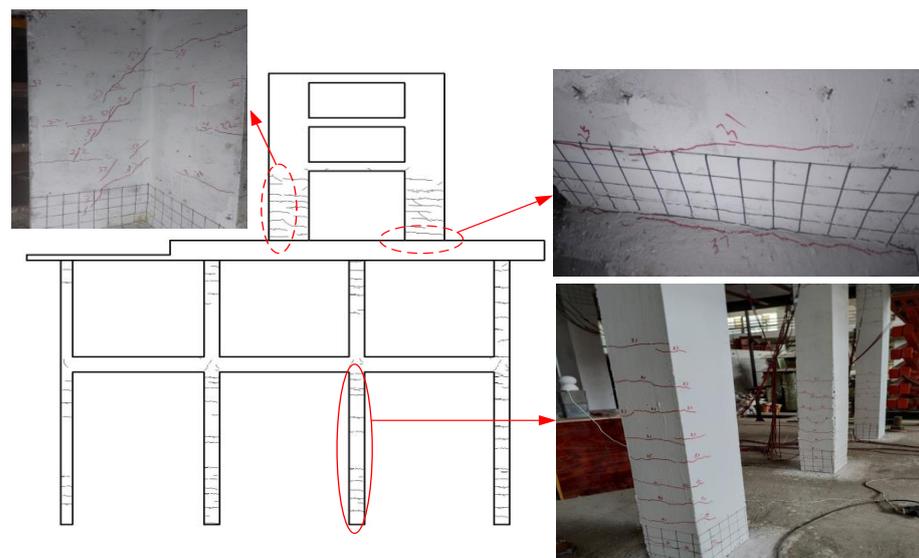
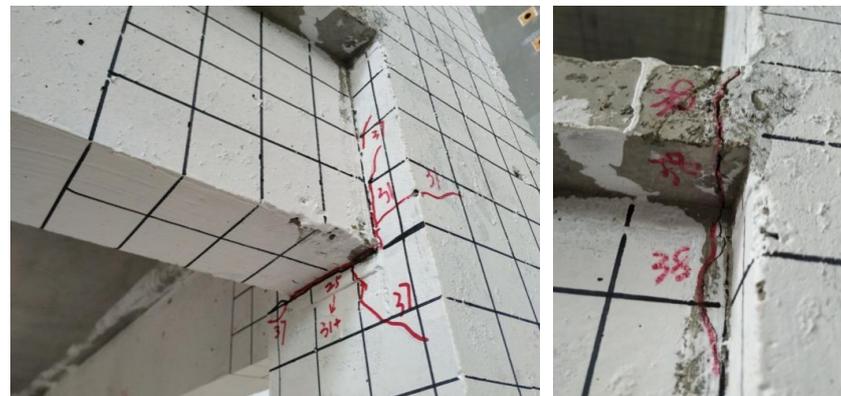
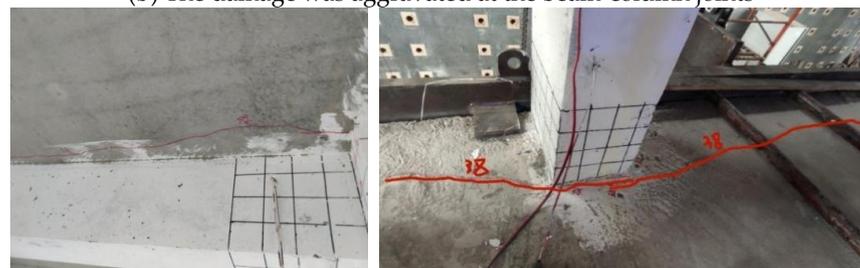
(a) 9I-MCE damage condition

(b) The damage was aggravated at the beam-column joints

(c) The bottom of the first floor appeared horizontal through long cracks

**Figure 17.** 9I-MCE damage condition.

9I-MCE damage condition: Under the 9I-MCE condition, the damage of the first floor was more serious, and cracks appeared at the embedded ends of each column. A horizontal crack with a width of 0.3 mm appeared at the junction between the top of B2 column and the slab for the first time, and a full-length crack appeared at the top and the bottom of slab on the first floor. A large number of new cracks appeared on the top of the columns on the second floor, but no cracks were found on the transfer slab, numerous inclined cracks appeared on the shear wall on the side, and the embedded end of the shear wall was seriously cracked, as shown in Figure 17b,c, which shows the detailed damage diagram of some nodes of the structure under the 9I-MCE condition. The failure of the beam or beam joint can consume energy during the earthquake and reduce the adverse effect of the earthquake on the column. Therefore, in the initial design, the engineers wanted to destroy the beam joints in the frame structure. However, it was found from the experiment results that although cracks were generated in the beam-column joints under the 9I-MCE condition, the damage to the beams or beam joints was not serious, which does not reach the expected design idea. The reason may be that the binding of the connecting plate on the first floor was too strong, resulting in the rotation of the floor being limited.

The story drift ratio (ratio of story displacement to story height) of the transfer slab was 1/226, and that of the first story plate reached 1/154. The safety performance of the structure met the seismic requirements of a nine-degree earthquake. The first-floor frame column and shear wall suffered the most serious damage, while in the meantime, the beam and plate had less damage. The columns of the second floor developed many cracks under the nine-degree earthquake, but no cracks ever appeared in the transfer slab.

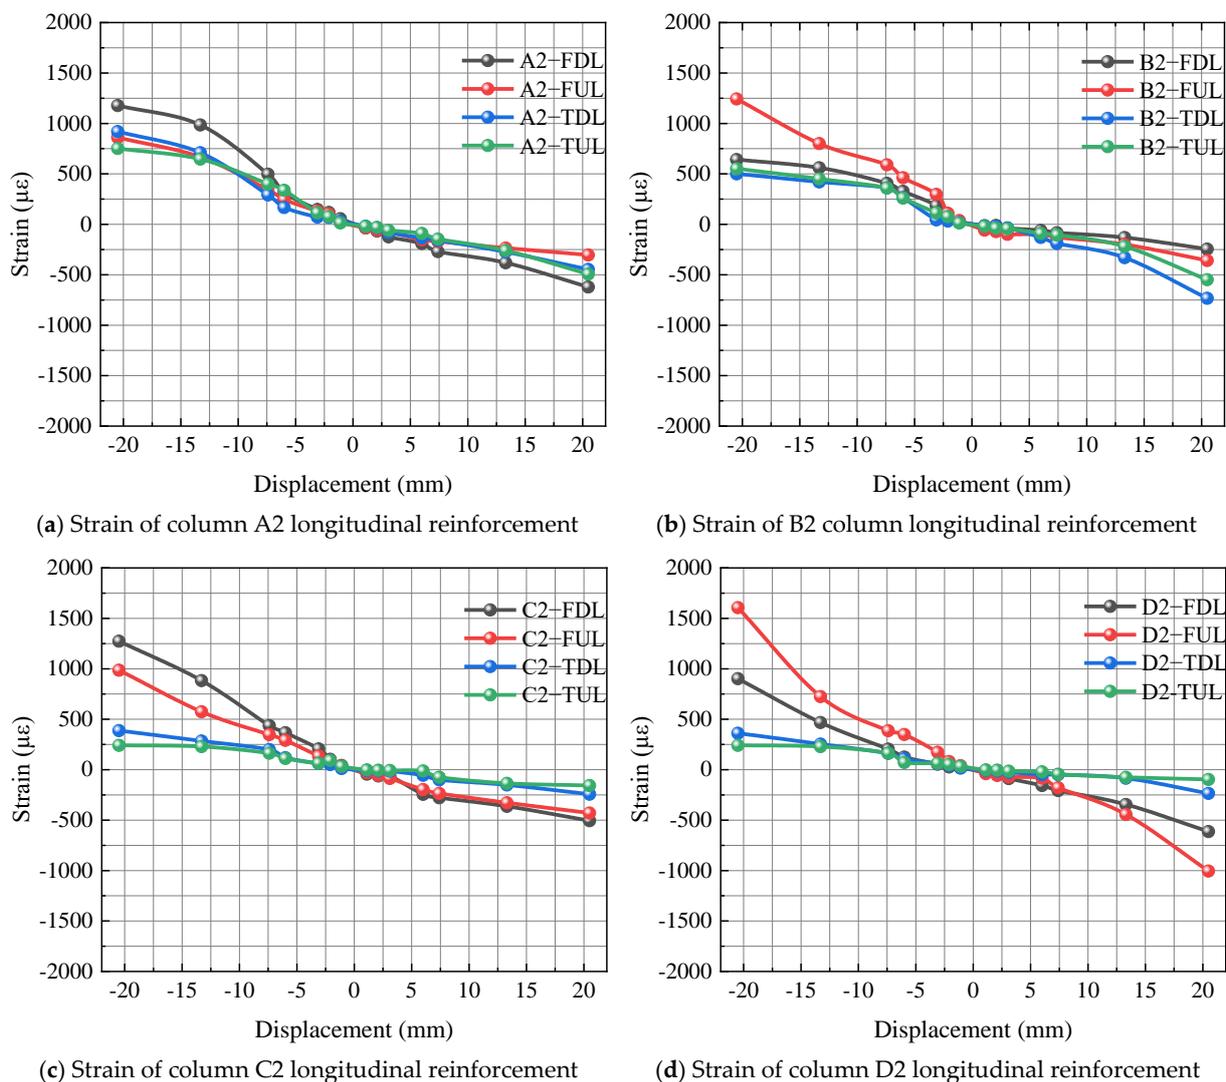
**Figure 18.** Longitudinal reinforcement strain of frame column.

Figure 18 shows the strain curve of the frame column. In the figure, the horizontal coordinate is the loading displacement value of the No. 1 actuator, and the vertical coordi-

nate is the strain. It can be seen from the figure that during the whole loading process, the strain of steel bar was less than its yield strain (HRB400 steel bar yield strain was  $2000 \mu\epsilon$ , the boundary of the Y-axis of the strain diagram was the yield strain), and according to the above failure phenomenon, there was no oblique crack on the column surface, indicating that the seismic performance levels of structure below the transfer story met the requirements of performance level 3 under maximum considered earthquake (MCE) [38] (p. 7). From this conclusion, it can be judged that the bottom frame structure reached the requirements of performance objective B, indicating that the seismic performance of the bottom frame structure was higher than the performance objective C of the structure above the transfer story. It met the design concept of “the performance goal of the bottom frame structure is higher than that of the upper shear wall structure”, so the bottom frame was still in the elastic stage and met the expected design goal.

The strain of the longitudinal reinforcement of the first story was higher than that of the second floor, and the first story was still the weak part of the bottom frame. In many areas, the failure of the soft-story of the structure caused the overall collapse of the building. In order to avoid this phenomenon, the seismic performance target of the bottom frame structure was raised one level in the design of the structure. This design concept can make the structure show a reasonable damage mechanism of “members above the transfer story yield first, and members below the transfer story yield later”.

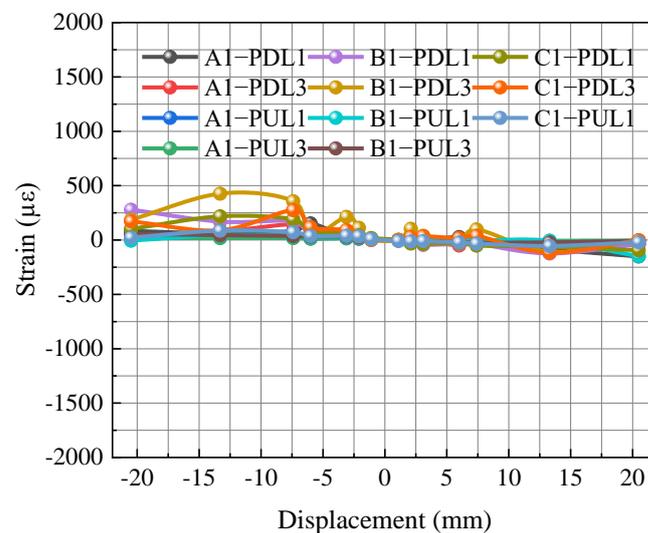
Figure 19. Strain of longitudinal bars in thick plates.

Figures 19 and 20 show the strain of reinforcement in the transfer story, and the reinforcement was in an elastic state during the whole loading process. The stirrup strain increased significantly under the nine-degree earthquake condition, and the stirrup strain in the thick plate near the shear wall was much higher. In the process of positive loading, the overturning moment of the superstructure led to a significant increase in the stirrup force at the junction of shear wall and transfer plate. The strain of the longitudinal reinforcement fluctuated around 0, and the maximum strain of stirrup was  $1775 \mu\epsilon$ , the stirrup strain was higher than the longitudinal strain, and the transfer story was mainly deformed by shear force. The stirrup strain in the transfer story was large and there was no crack on the surface, which indicates that the transfer story may form shear failure (brittle failure). This adverse failure mechanism needed to be avoided by providing sufficient strength on the one hand, and by reasonable design on the other hand, so that the yielding floor appeared at the bottom strengthening site above the transfer story. Therefore, the design should focus on the design concept of “the performance goal of the bottom frame structure is higher than that of the upper shear wall structure”.

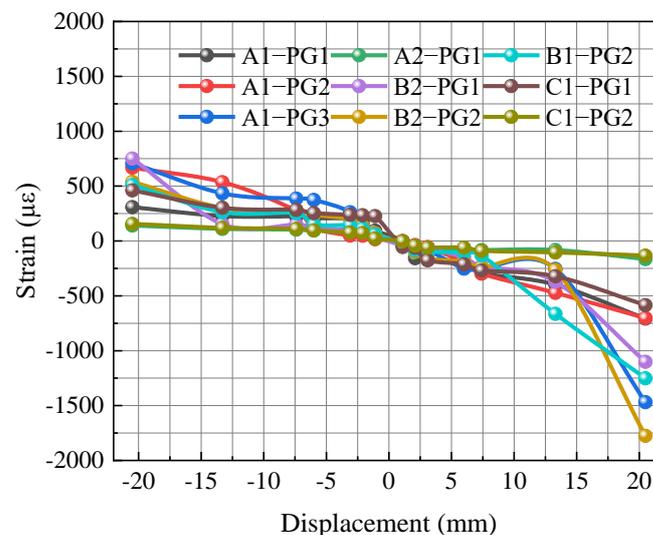
Figure 20. Strain of stirrups in thick plates.

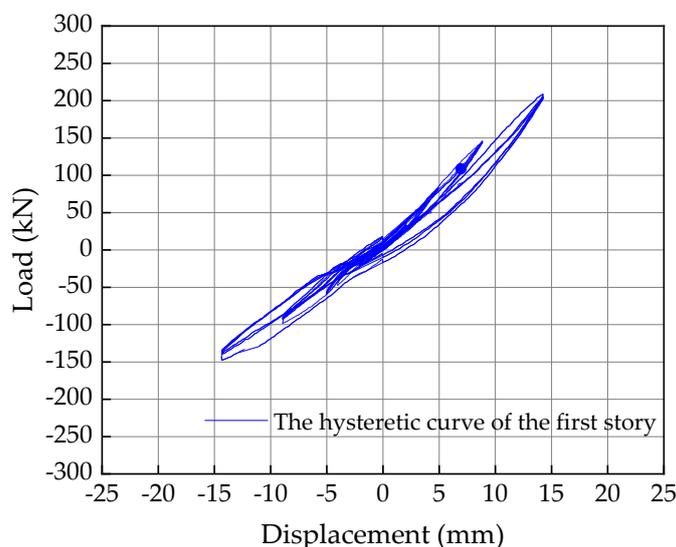
**Figure 21.** The hysteretic curve of the first story.

The hysteretic curve of the first story actuator is shown in Figure 21. Before loading in 9I-MCE condition, the loading path of the hysteretic curve almost coincided with the unloading path, and the residual deformation of the model was small. The area of the hysteretic curve was very small under 9I-MCE condition.

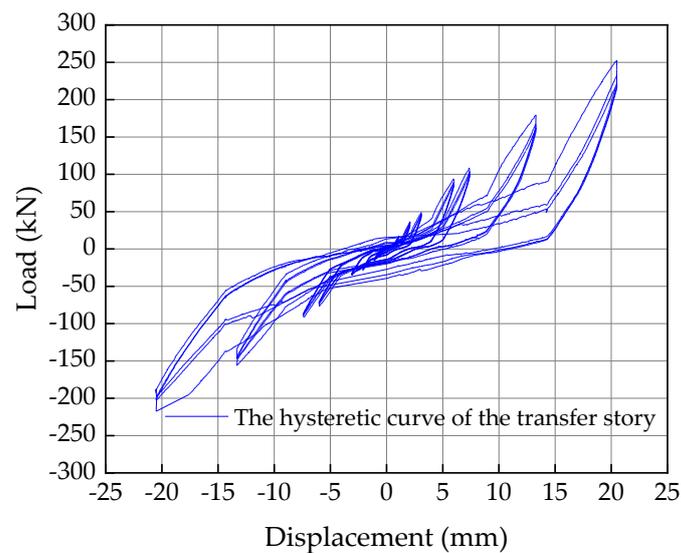
Figure 22. The hysteretic curve of the transfer story.

Figure 22 shows the hysteretic curve of the transfer story actuator. Due to the influence of the cooperative loading mode (meaning that both actuators were loaded simultaneously), the hysteretic curve of the transfer story showed a special “inverse S-shape”. At the beginning of loading, the first story’s actuator was loaded synchronously with that of the transfer story, the horizontal displacement of the transfer story was the same as that of the first story, and load was mainly provided by the actuators of the first story. At this stage, the hysteretic curve of the first story had a higher slope, while the hysteretic curve of the transfer story grew more slowly. When the synchronous loading was completed, the displacement of the first story actuator remained unchanged, and the actuator of the transfer story continued to increase the displacement load. At this time, the lateral resistance provided by the first story’s actuator decreased, and all the resistance originally provided by the first story’s actuator was provided by the actuator of the transfer story, so the hysteretic curve of the transfer story had a sudden change in slope at this stage. With the increase of load displacement, the area of hysteretic curve of the transfer story increased gradually. It can be seen that the area of hysteretic curve of the transfer story was obviously higher than that of the first story, and the loading path did not coincide with the unloading path. The loading path and unloading path of the hysteretic curve of the transfer story no longer coincided since the 7I-DBE started, which indicates that the model had already shown unrecoverable damage, which can also be verified by the cracking phenomenon of the model in the previous discussion.

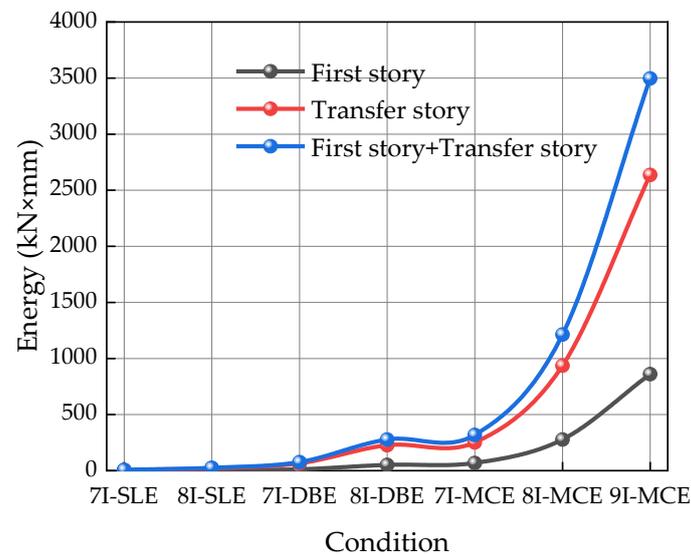
Figure 23. Energy-loading condition curve.

Since the shape of hysteretic curve was affected by the cooperative loading mode, the cumulative energy consumption of the first story and the transfer story was not compared and analyzed. Instead, the cumulative energy consumption of both was superimposed, which can reflect the overall energy consumption of the bottom frame structure. Figure 23 shows the energy dissipation curve. Under the conditions of SLE and DBE, the damage of the structure was small, mainly elastic deformation, and less energy consumption. The energy dissipation curve of the model increased significantly under large earthquake conditions, and the total cumulative energy dissipation of the frame structure increased from 318.46 kN·mm at 7I-MCE to 3496.10 kN·mm at 9I-MCE.

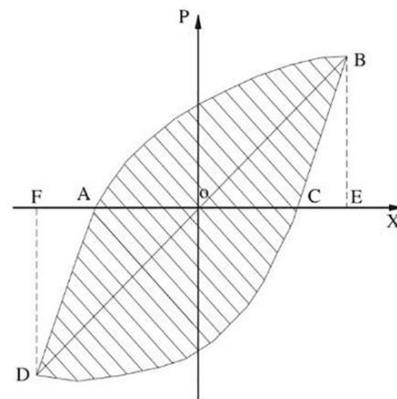
**Figure 24.** Area chart of energy consumption capacity.

The equivalent viscous damping coefficient  $h_e$  is calculated using Equations (1) and (2), where  $S_{(ABC+CDA)}$  and  $S_{(OBE+ODF)}$  are the areas of the hysteretic curve. As shown in Figure 24 and Table 5, with the increase of load, the equivalent viscous damping coefficient (EVDC) of the transfer story rose, and the EVDC of the transfer story was larger than that of the first story.

With loading from 7I-MCE condition to 9I-MCE condition, the EVDC of the first story and the transfer story showed a slow increase. This indicates there was a large amount of irrecoverable damage in the structure, which also led to the increase of the EVDC of the structure. The maximum value of EVDC was 9.26% under the MCE conditions.

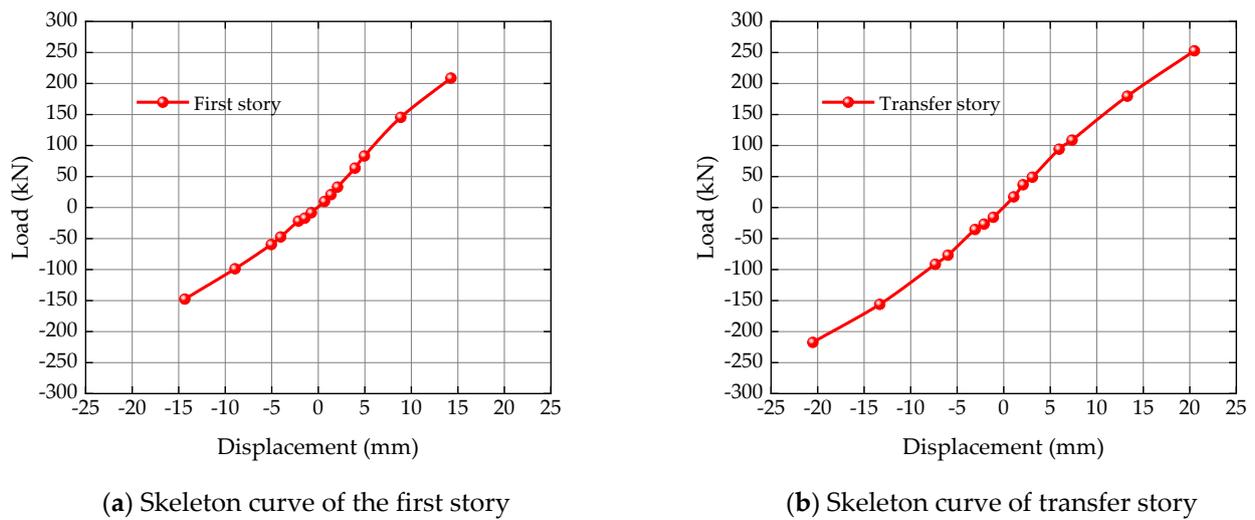
Figure 25. Skeleton curve.

Figure 25 shows the skeleton curve of the model. (The skeleton curve is the track of the maximum horizontal force peak reached by each cyclic loading, which reflects the different stages and characteristics of the stress and deformation of the component). Figure 26 shows the secant stiffness of the model. (Due to the gap between the connector and the actuator, the secant stiffness fluctuated at the initial stage of loading. When the gap was eliminated, the secant stiffness showed a downward trend with the increase of loading displacement. This paper only analyzes the secant stiffness under the action of large earthquakes). The secant stiffness is calculated by Equation (3).

The skeleton curve did not decrease during the loading process. Under the MCE condition, the slope of skeleton curve decreased, and the secant stiffness showed a downward trend with the increase of displacement. (The secant stiffness is equivalent to the slope of the skeleton curve. Therefore, when the slope of the skeleton curve decreased, the secant stiffness showed a downward trend, but the skeleton curve did not decrease). This indicates that the concrete of the frame structure columns had a lot of damage, which is consistent with the experimental results (Figures 13–17) mentioned above.

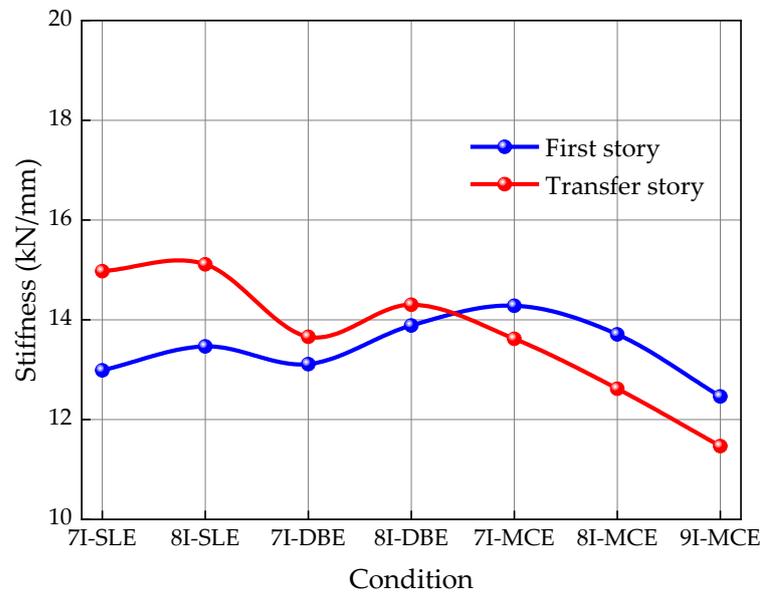
Figure 26. Secant stiffness curve.
